Linear Waterbody Data Sheet

Survey Description			
Project Name: Atlantic Coast Pipeline		Waterbody Name: UNT to Calfpasture River	
Waterbody ID: SAUB105		Date: 4/23/2015	
State: Virginia	County: Augusta	Company: NRG	Crew Member Initials: TP, AS
Photos: 01-03			
Tract Number(s): 07-001-A005, 07-001-A007		Nearest Milepost: 110.55	Associated Wetland ID(s): WAUB100
Survey Type: <small>(check one)</small> <input checked="" type="checkbox"/> Centerline <input type="checkbox"/> Re-Route <input type="checkbox"/> Access Road <input type="checkbox"/> Other:			
Physical Attributes			
Stream Classification: <small>(check one)</small> <input type="checkbox"/> Ephemeral <input checked="" type="checkbox"/> Intermittent <input type="checkbox"/> Perennial			
Waterbody Type: <small>(check one)</small> <input type="checkbox"/> River <input checked="" type="checkbox"/> Stream <input type="checkbox"/> Ditch <input type="checkbox"/> Canal <input type="checkbox"/> Other:

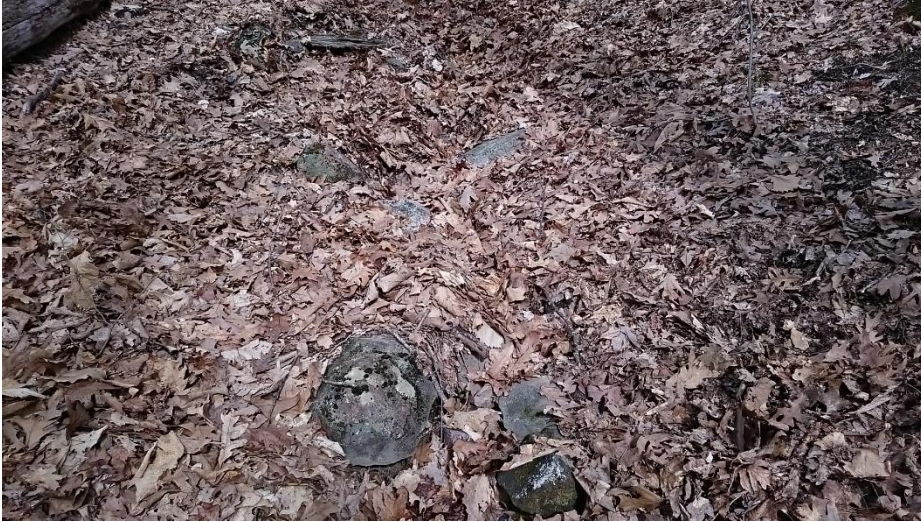
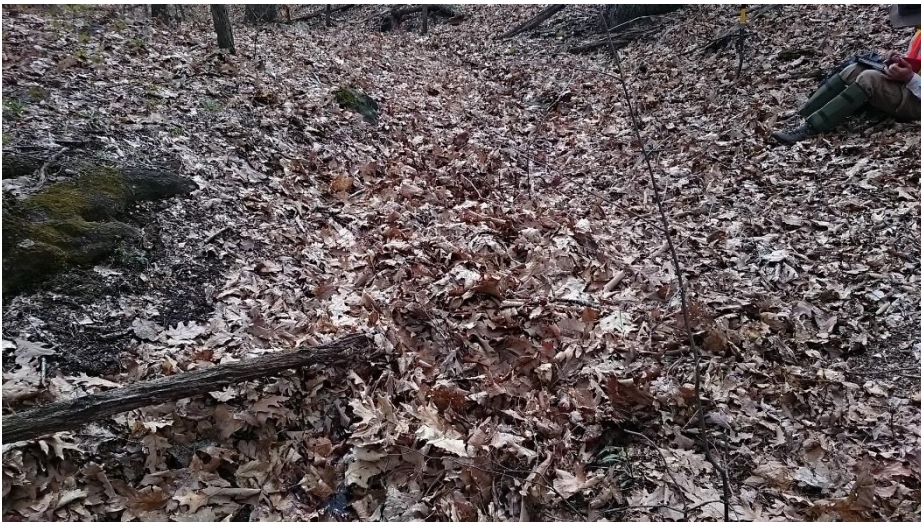
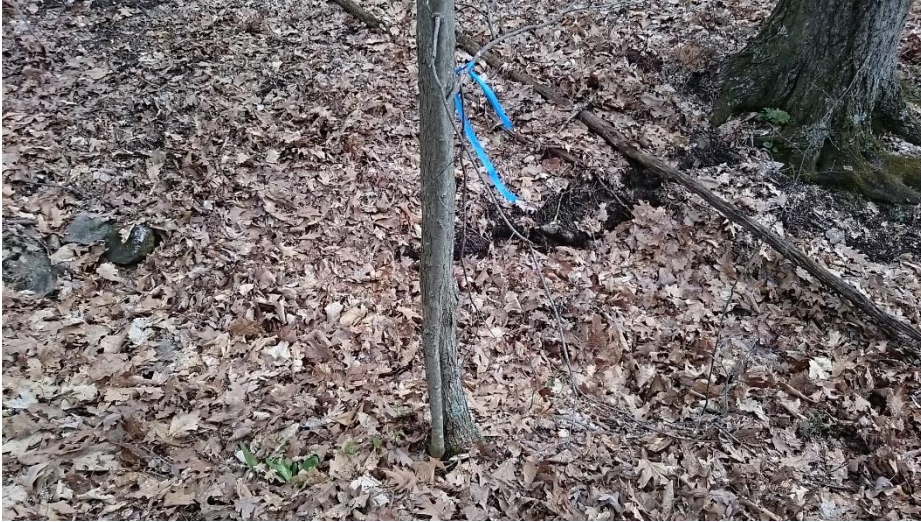
Stream loses bed in some sections when the stream goes underground

Waterbody SAUA423 facing southeast upstream

Waterbody SAUA423 facing northwest downstream

Waterbody SAUA423 facing southwest across

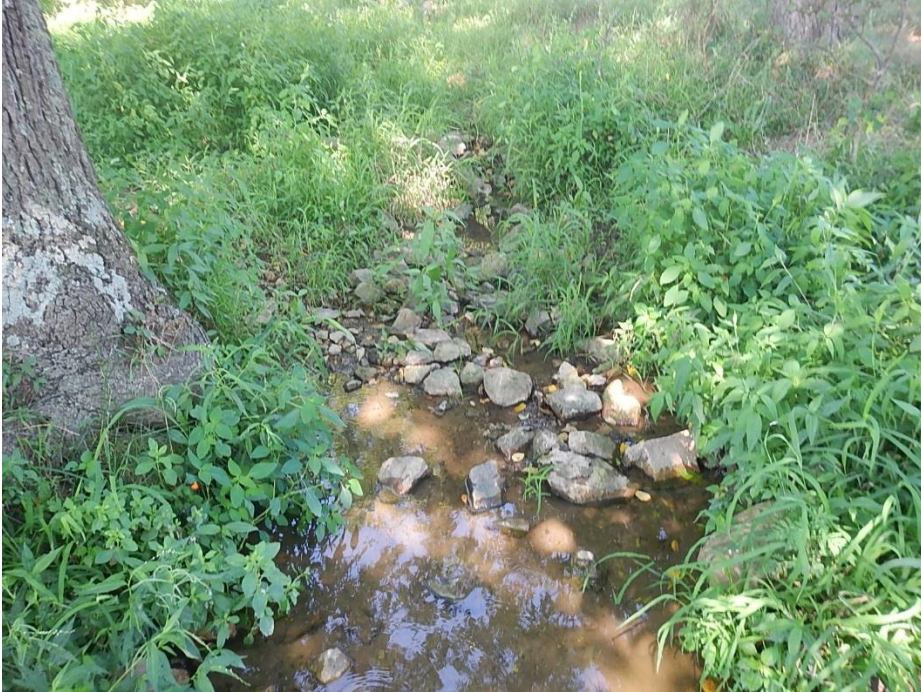
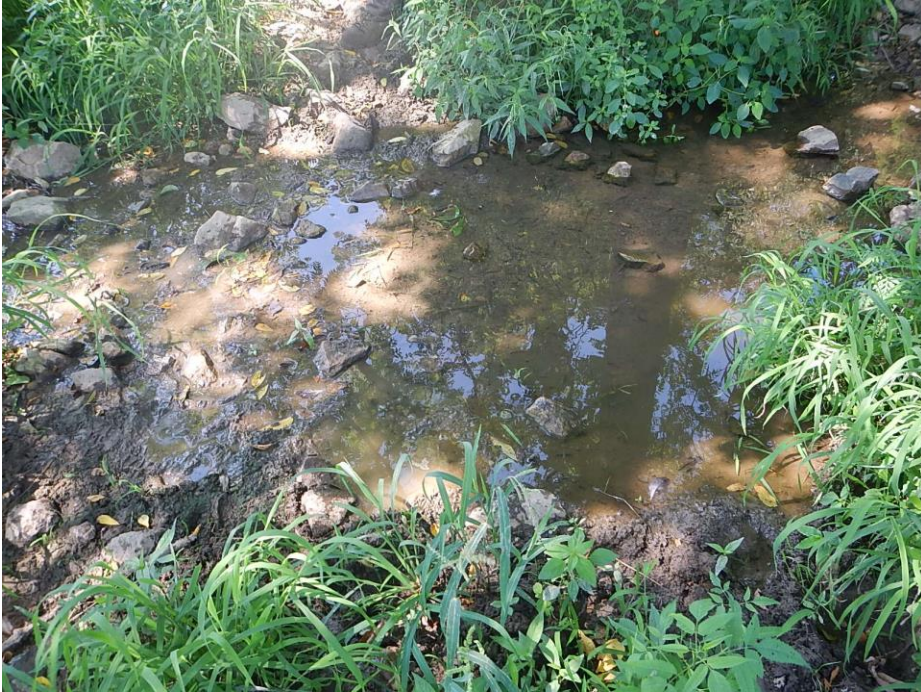
Degraded intermittent stream in cattle pasture. Noted bank failures due to livestock access, which has create fringe wetlands on either side of stream.

Waterbody SAUB119 facing northwest upstream

Waterbody SAUB119 facing west-southwest across

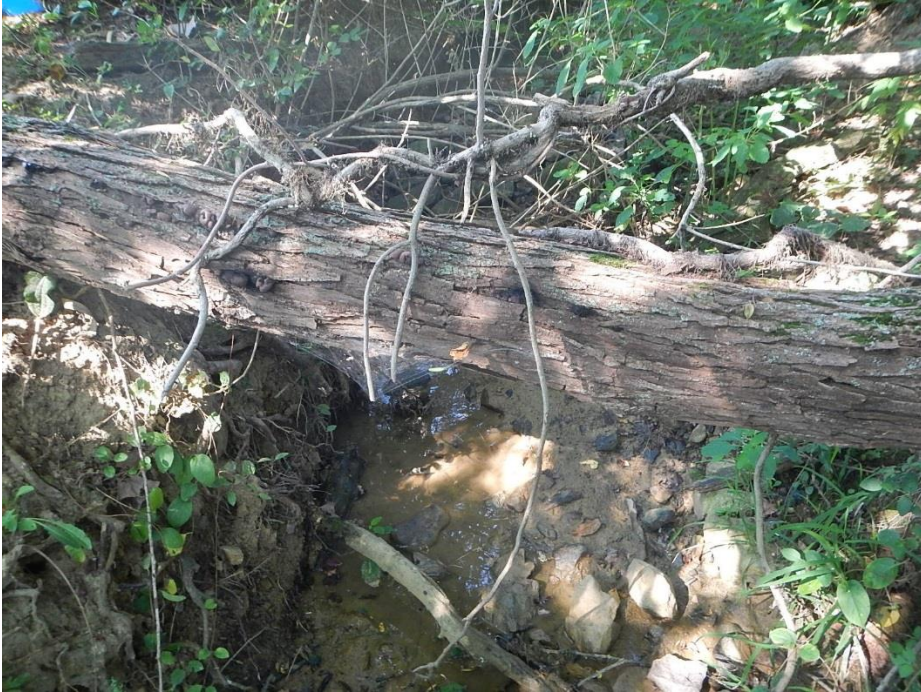
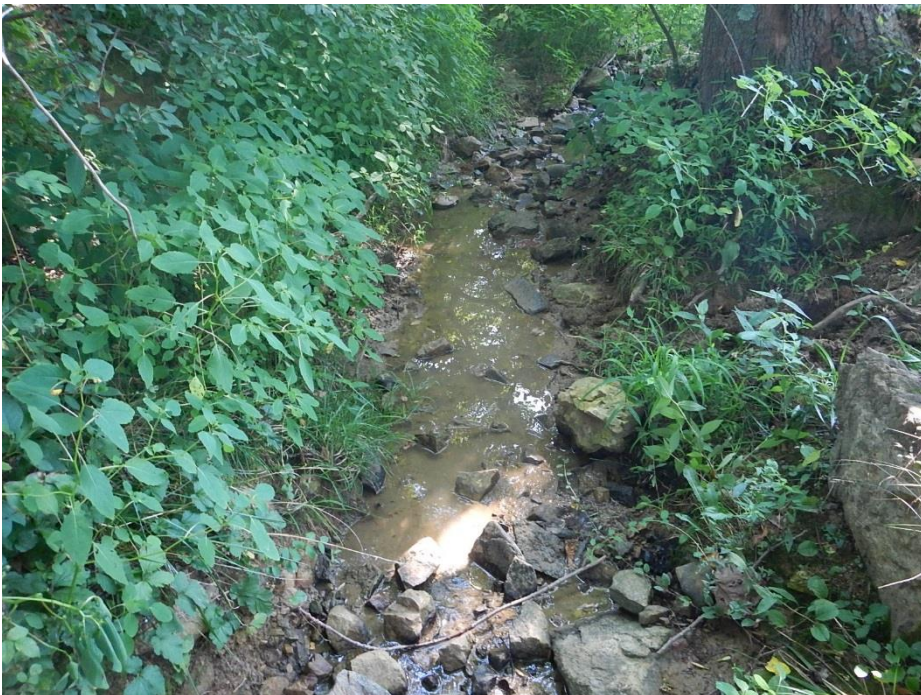
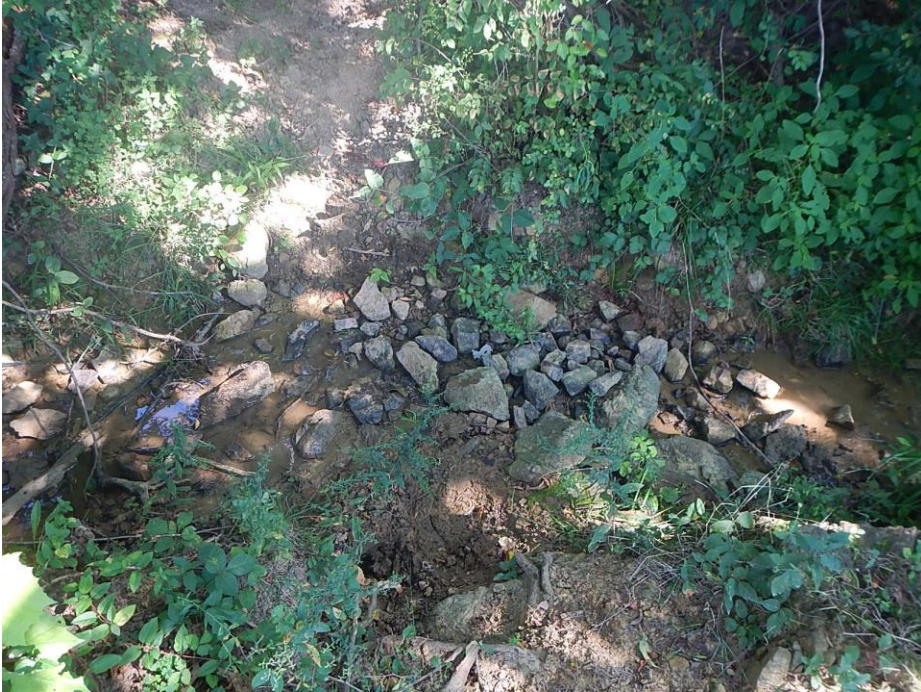
Degraded intermittent stream in cattle pasture. Some bank failures due to livestock, weak sinuosity, weak grade control, a few bars and benches. Fed by WAUB107.

Waterbody SAUB118 facing west upstream

Waterbody SAUB118 facing east downstream

Waterbody SAUB118 facing north across

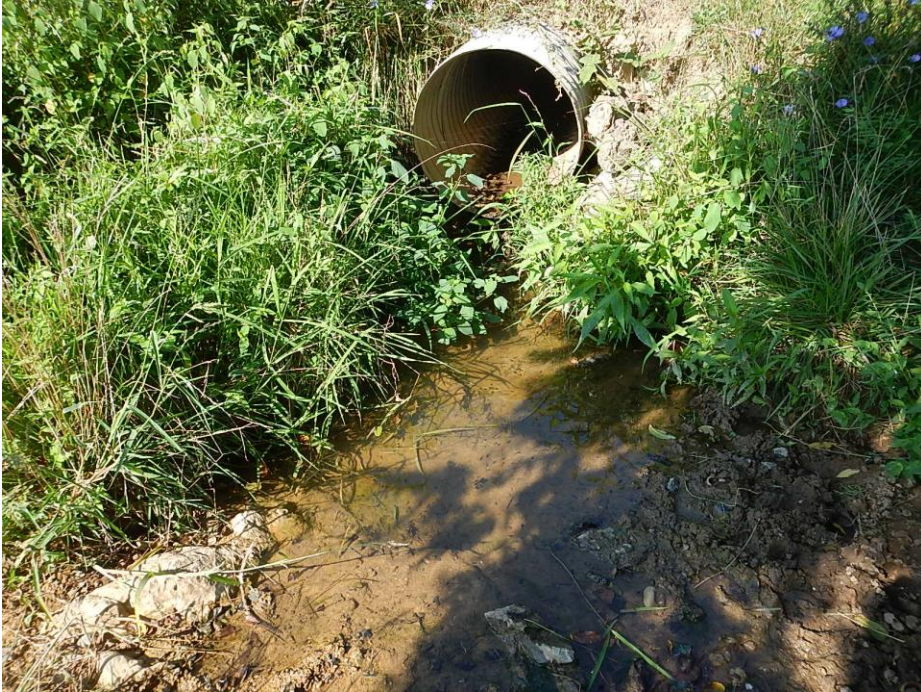
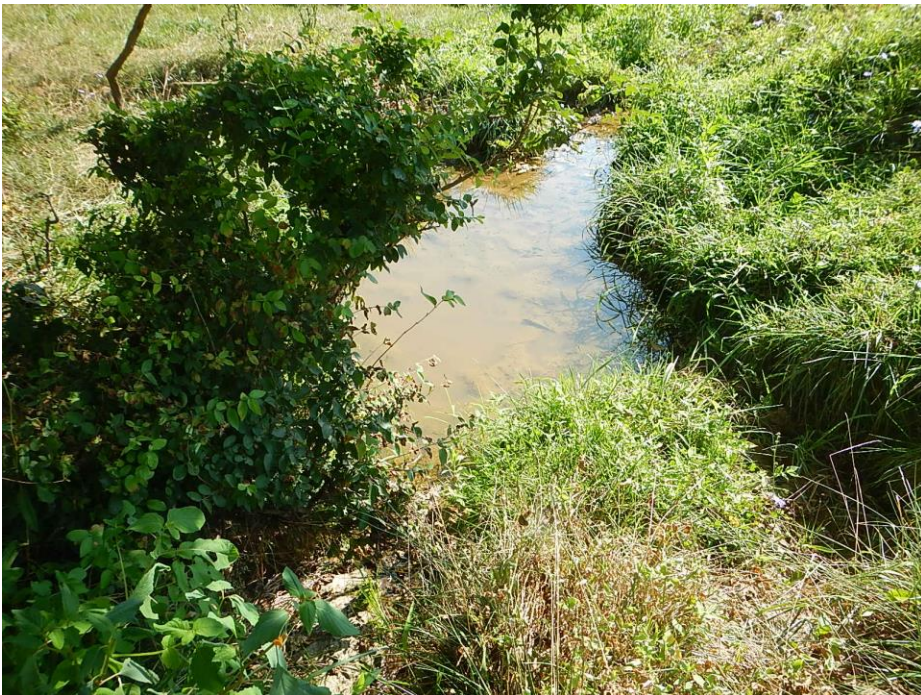
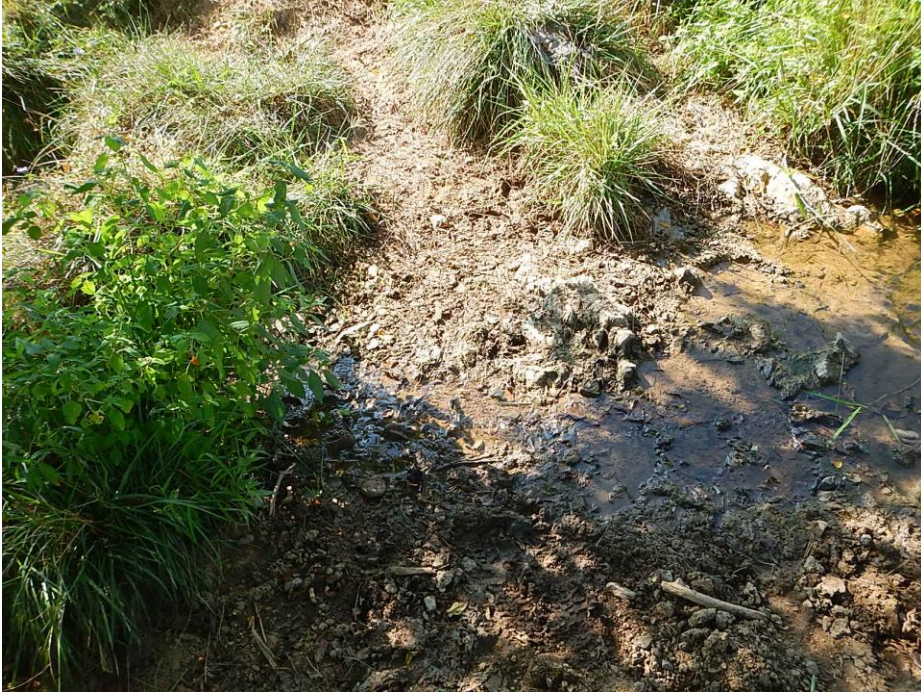
Degraded intermittent stream in cattle pasture. Some bank failures due to livestock, weak sinuosity, weak grade control.

Waterbody SAUB117 facing west upstream

Waterbody SAUB117 facing east downstream

Waterbody SAUB117 facing south across

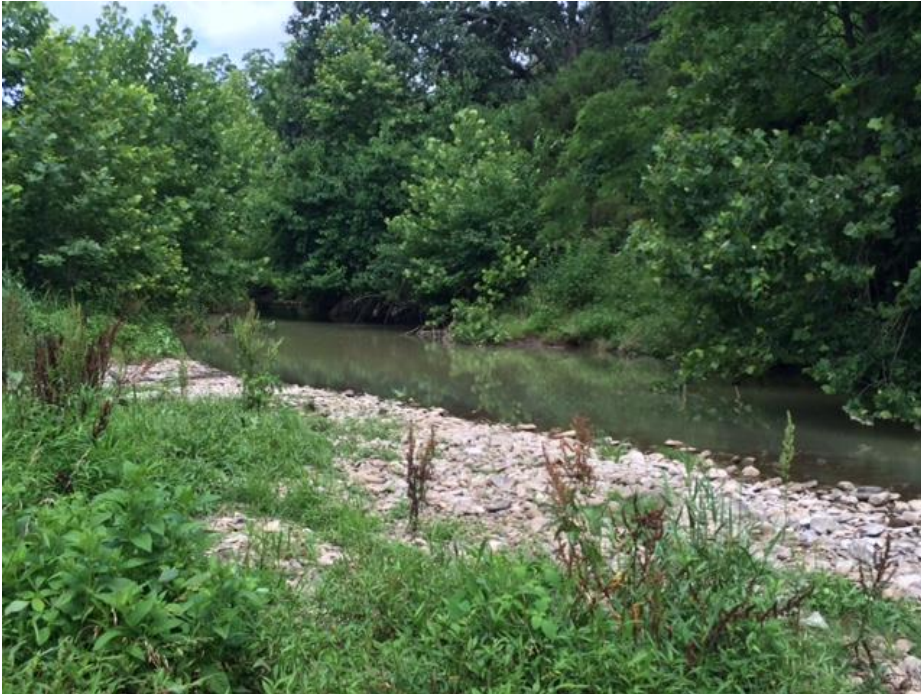
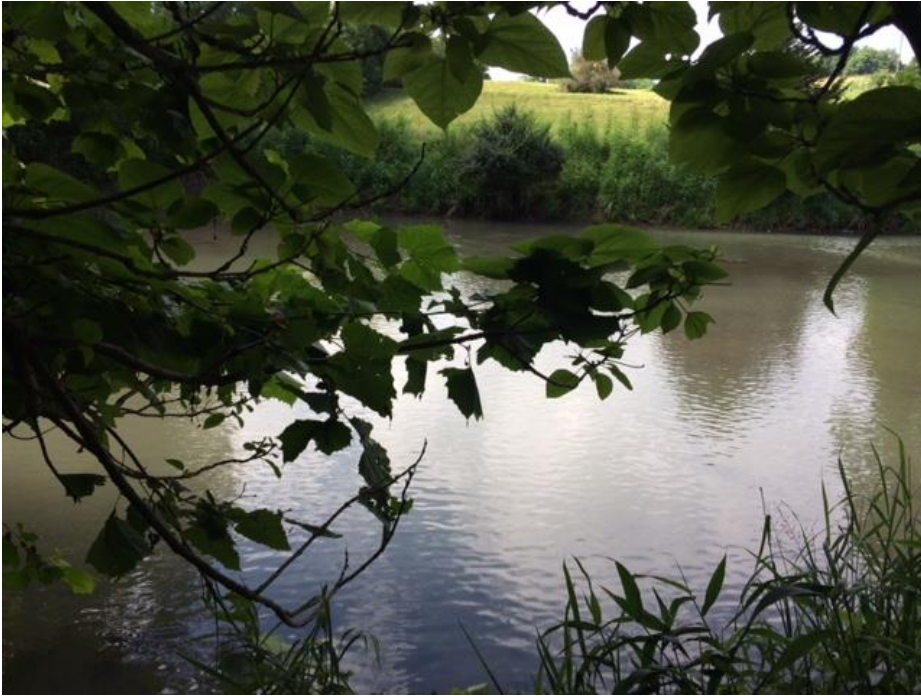
Continues out of survey corridor in both directions; planted white pines to the north; pasture to the south; all cobble and gravel are coated with algal film; numerous snails on every cobble eating algae.

Waterbody SAUA413 facing west upstream

Waterbody SAUA413 facing south across
