# Linear Waterbody Data Sheet

Survey Description			
Project Name: Southeast Reliability		Waterbody Name: UNNAMED TRIB TO NORTH RIVER	
Waterbody ID: SBUK005		Date: 7/18/2014	
State: Virginia	County: Buckingham	Company: WOODARD & CURRAN	Crew Member Initials: RS, JS
Photos: 0052-0054			
Tract Number(s): 09-045		Nearest Milepost: 191	Associated Wetland ID(s): NA
Survey Type: <i>(check one)</i> <input checked="" type="checkbox"/> Centerline <input type="checkbox"/> Re-Route <input type="checkbox"/> Access Road <input type="checkbox"/> Other:			
Physical Attribute			
Stream Classification: <i>(check one)</i> <input type="checkbox"/> Ephemeral <input type="checkbox"/> Intermittent <input checked="" type="checkbox"/> Perennial			
Waterbody Type: <i>(check one)</i> <input type="checkbox"/> River <input checked="" type="checkbox"/> Stream <input type="checkbox"/> Ditch <input type="checkbox"/> Canal <input type="checkbox"/> Other:			
OHWM Width: <u>10</u> ft.		OHWM Indicator: <i>(check all that apply)</i> <input checked="" type="checkbox"/> Clear line on bank <input checked="" type="checkbox"/> Shelving <input checked="" type="checkbox"/> Wrested vegetation <input checked="" type="checkbox"

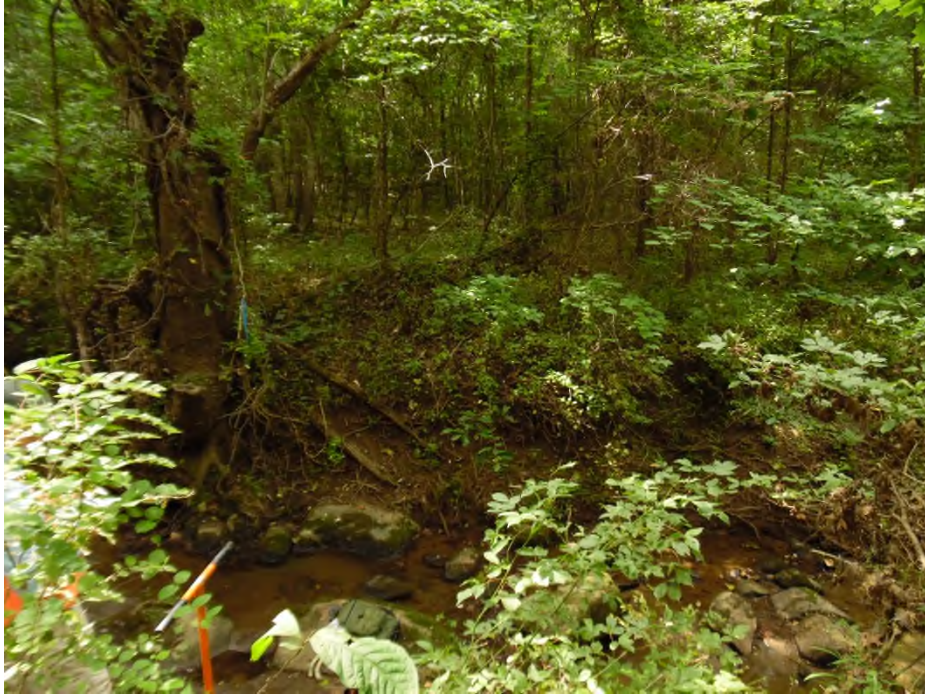
Waterbody point sbuk005 facing northwest and across

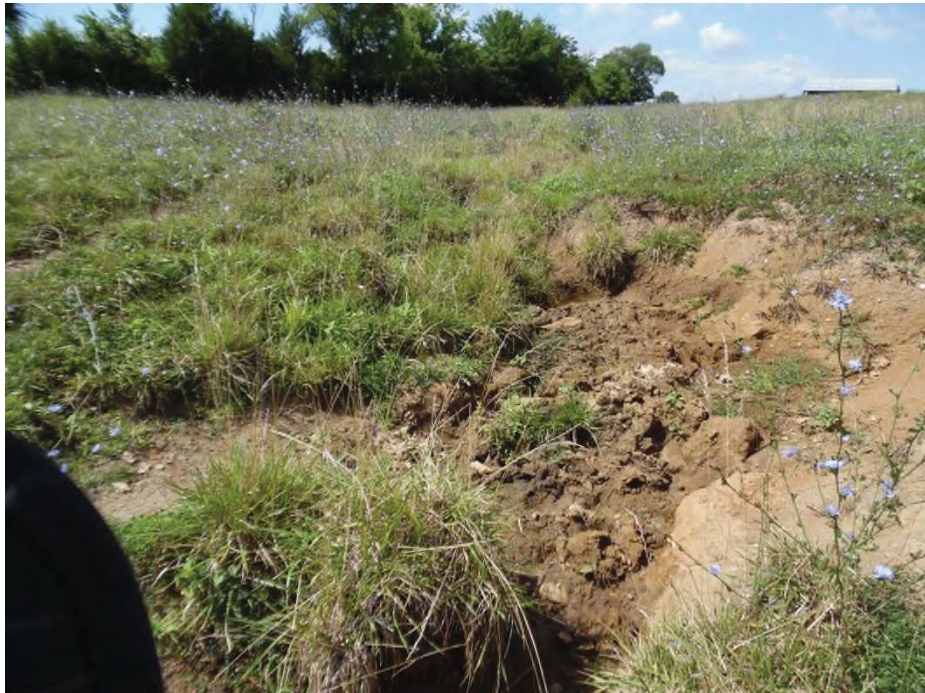
Waterbody point sbuk001 facing southwest and upstream

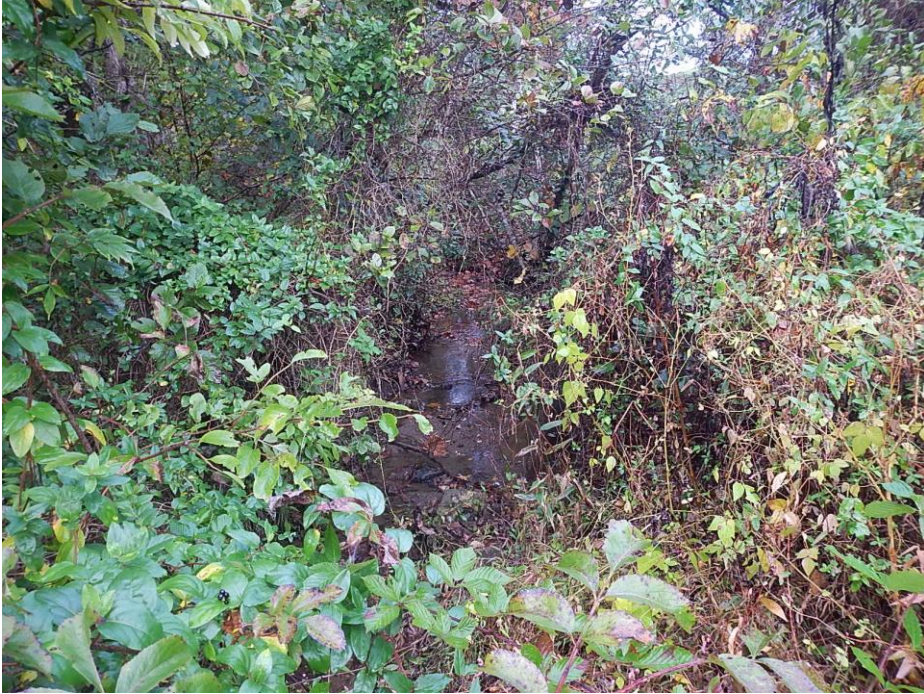
SBUA004 facing north upstream
