Linear Waterbody Data Sheet

Survey Description				
Project Name: ACP		Waterbody Name: UNT to WESTERN BRANCH RESERVOIR	Waterbody ID: SSU0100	Date: 3-8-16
State: VA	County/Parish: Suffolk	Company: ESI	Crew Member Initials: LR, WV	Photos: Facing E, W, N
Tract Number(s): 26-060-4068		Nearest Milepost: 61.8	Associated Wetland ID(s): WSU0029	
Survey Type: (check one) <input checked="" type="checkbox"/> Centerline <input type="checkbox"/> Re-Route <input type="checkbox"/> Access Road <input type="checkbox"/> Other:				
Physical Attributes				
Stream Classification: (check one) <input type="checkbox"/> Ephemeral <input type="checkbox"/> Intermittent <input checked="" type="checkbox"/> Perennial				
Waterbody Type: (check one) <input type="checkbox"/> River <input checked="" type="checkbox"/> Stream <input type="checkbox"/> Ditch <input type="checkbox"/> Canal <input type="checkbox"/> Other:				
OHWM Width: 3 ft.	OHWM Height: 0.5 ft.	OHWM Indicator: (check all that apply) <input checked="" type="checkbox"/> Clear line on bank <input type="checkbox"/> Shelving <input checked="" type="checkbox"/> Wrested vegetation <input type="checkbox"/> Scouring <input checked="" type="checkbox"/> Water s

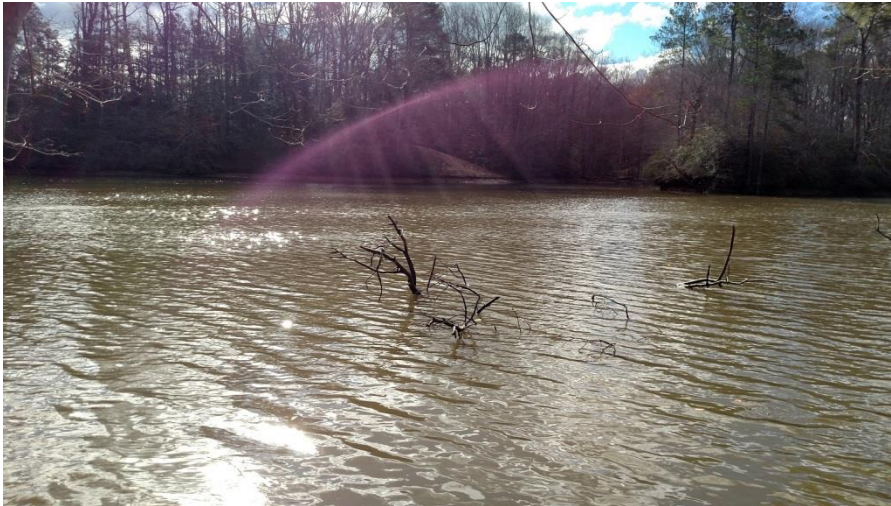
Open waterbody OSUA400 facing east

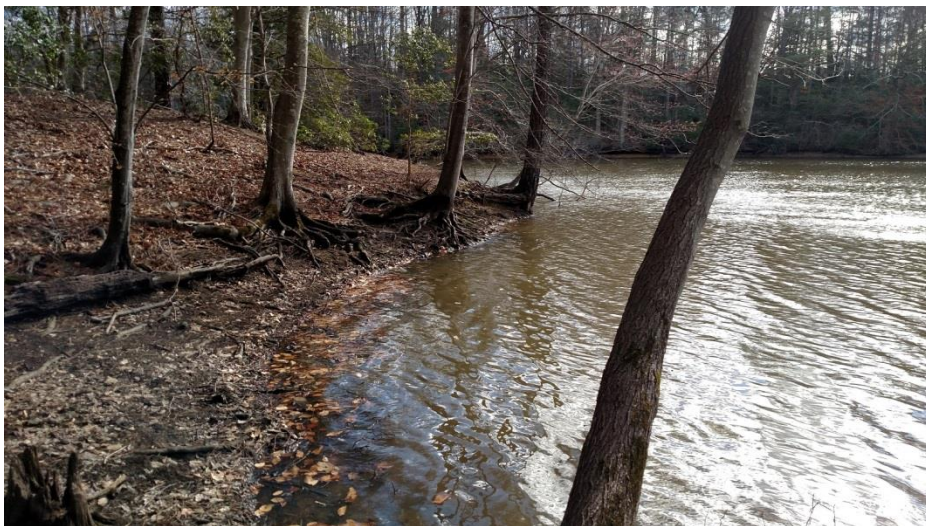
Open waterbody OSUA400 facing northeast
