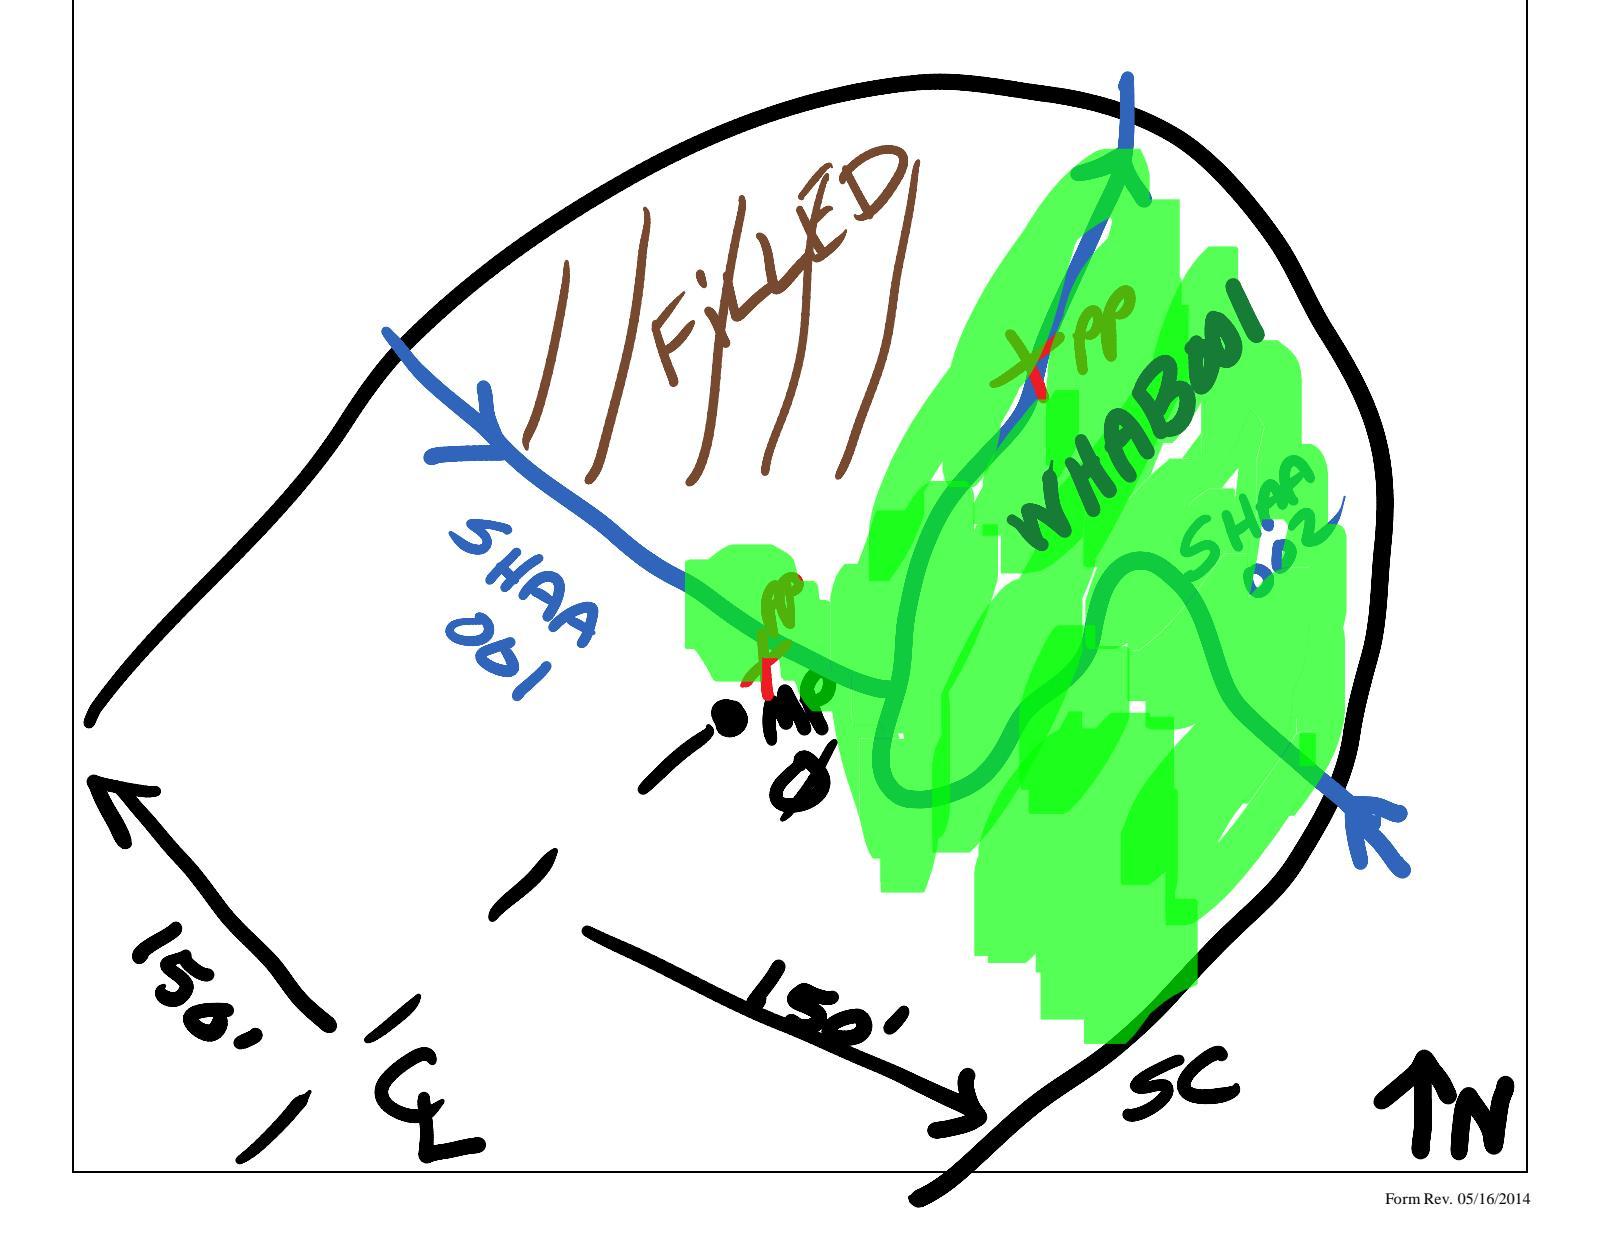
Waterbody Sketch (Include north arrow, centerline, distance from centerline, data point location, survey boundary, and IDs of associated features)

Stream SHAA002 is a tributary; both streams are associated with a saturated PEM/PSS complex-WHAB001

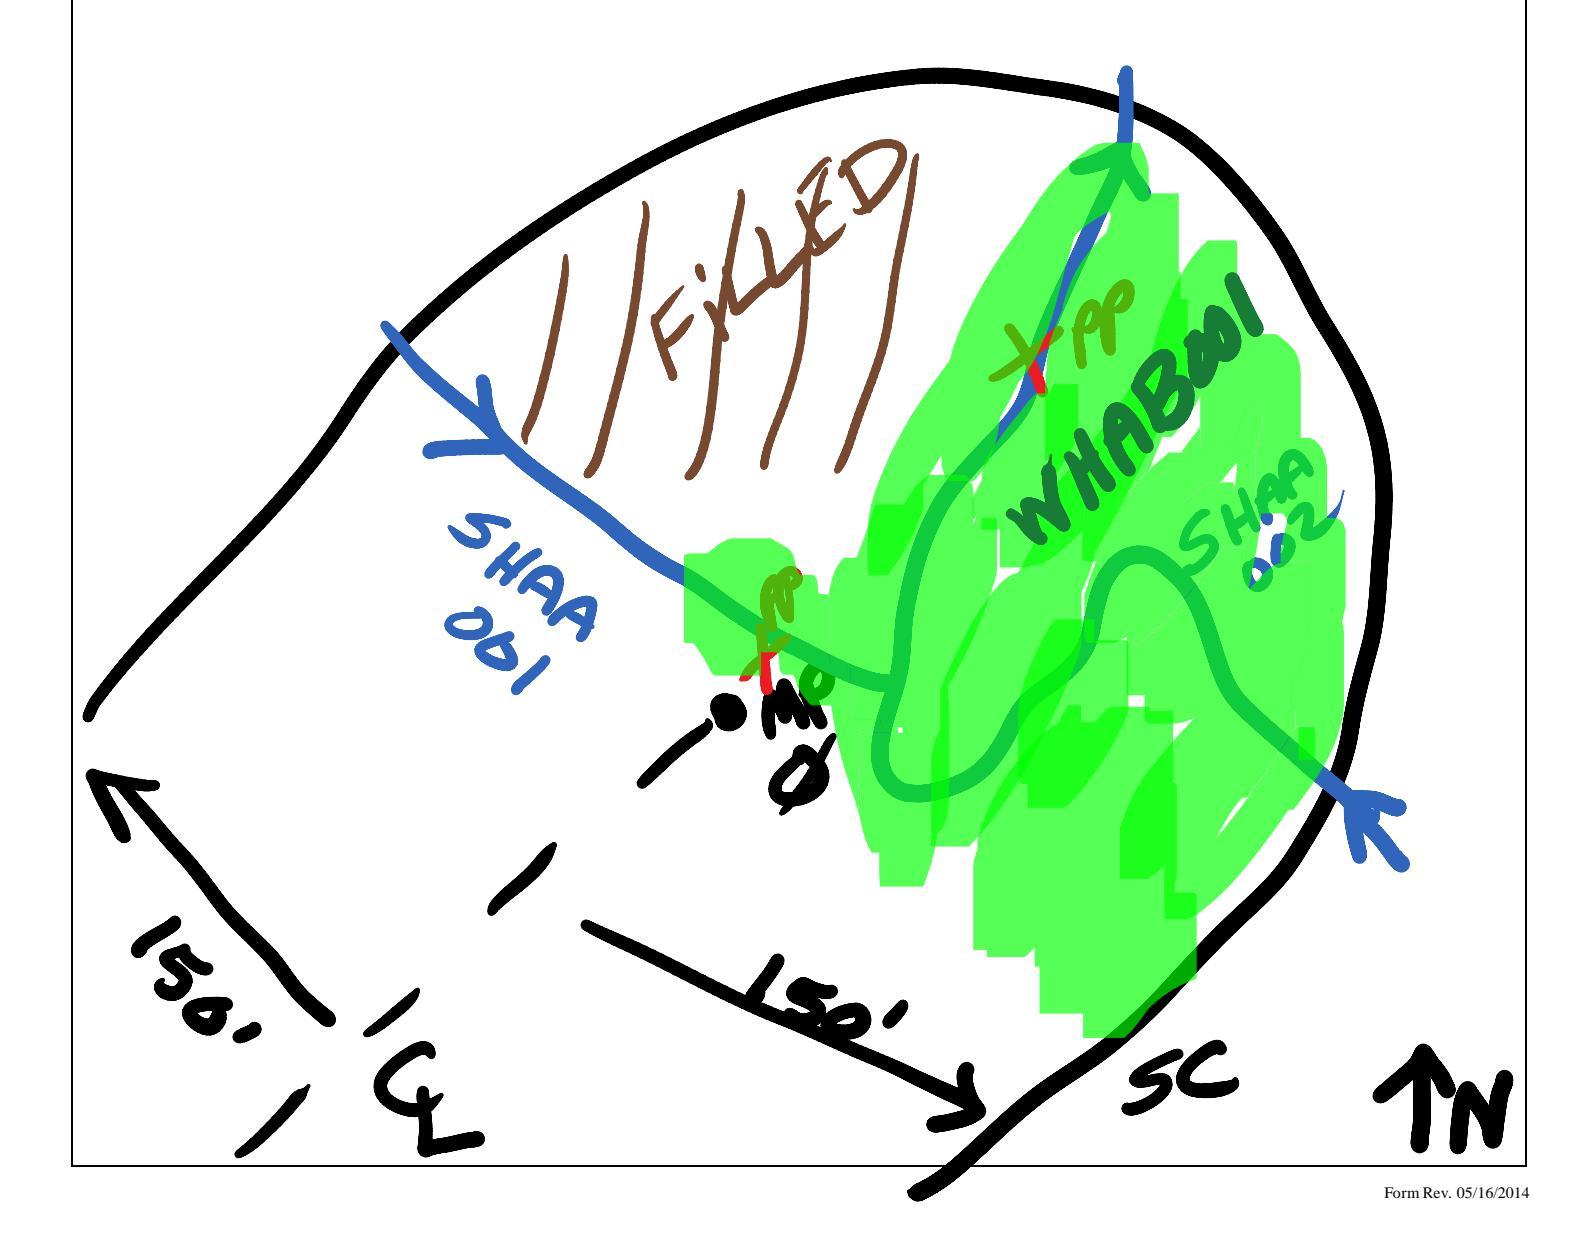
Waterbody Sketch (Include north arrow, centerline, distance from centerline, data point location, survey boundary, and IDs of associated features)

Stream flows into SHAA001; both streams are forks of Tanner Fork; both streams are associated with a saturated PEM/PSS complex-WHAB001

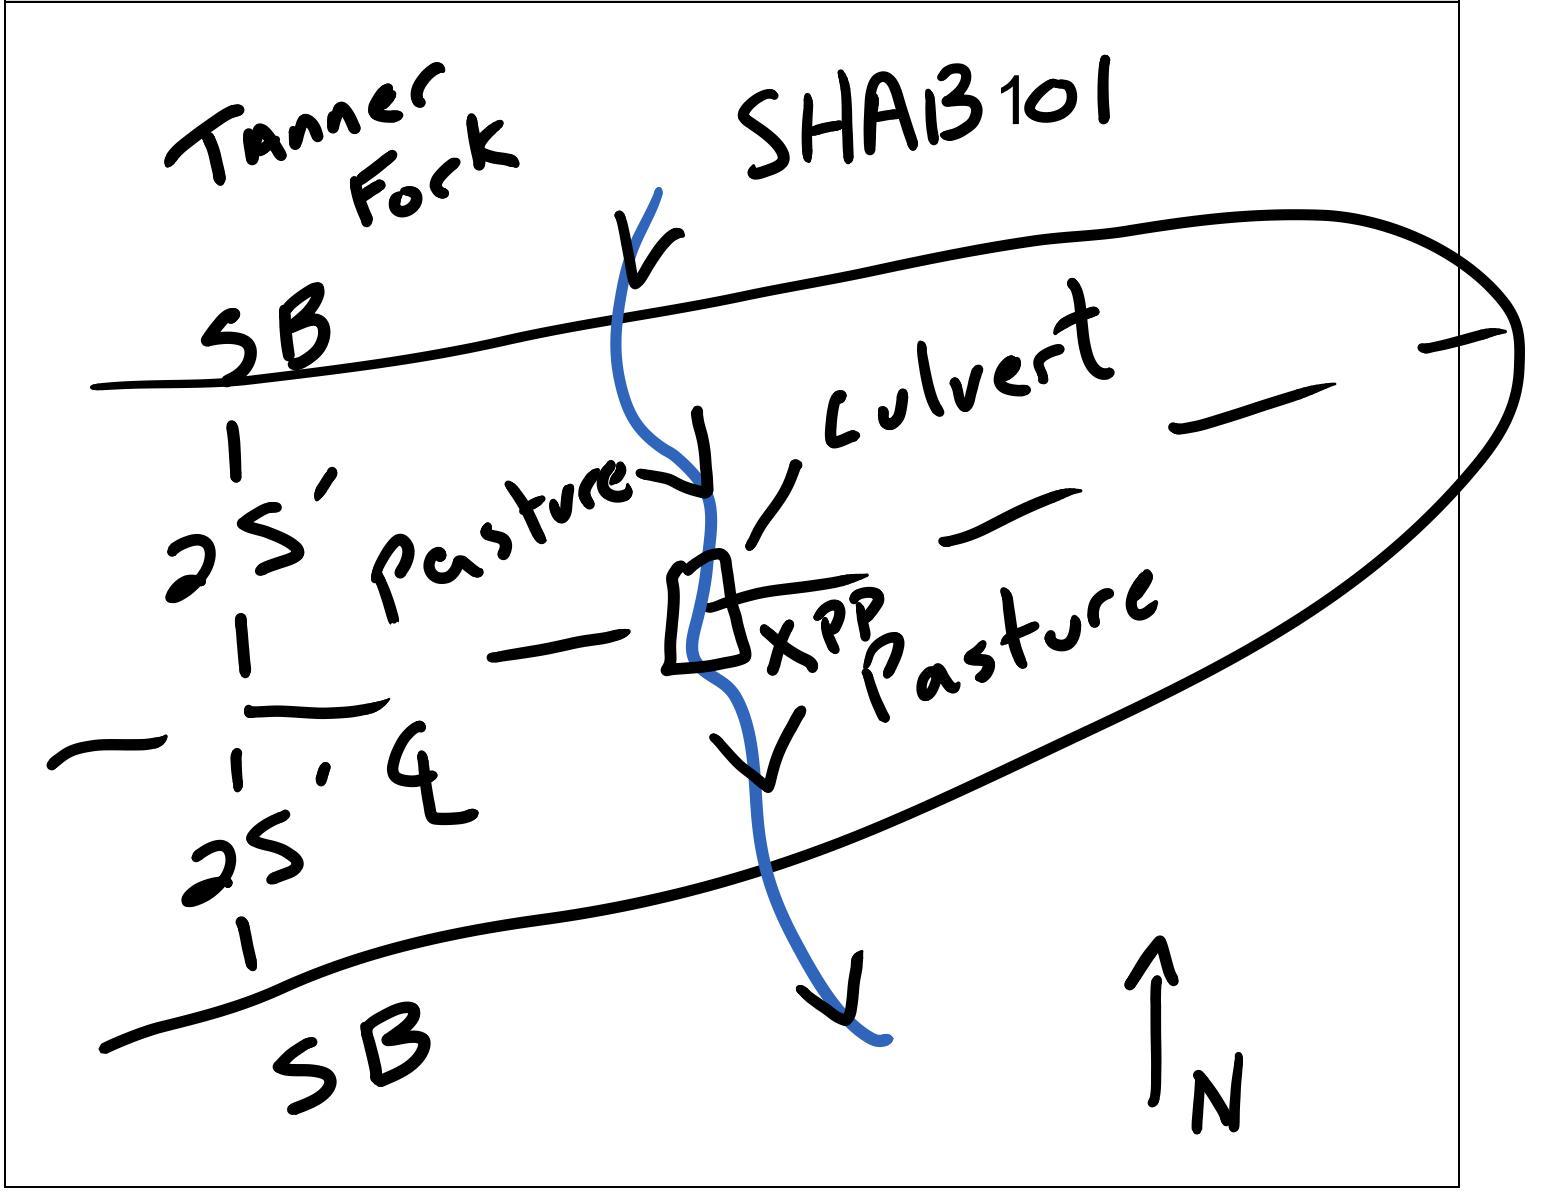
Waterbody Sketch (Include north arrow, centerline, distance from centerline, data point location, survey boundary, and IDs of associated features)

Stream is degraded due to cattle access, no riparian buffers present. Lots of sediment deposition, weak meanders, weak riffle pool sequence. Waterbody ID in Waterbody Sketch was updated to SHAB101 on 9/9/14 JM.
