Linear Waterbody Data Sheet

Survey Description			
Project Name: Southeast Reliability		Waterbody Name: UNT to Jenks Fork	
Waterbody ID: SRAB101		Date: 8/19/2014	
State: West Virginia	County: Randolph	Company: NRG	Crew Member Initials: TP, S
Photos: 001-003			
Tract Number(s): 04-002-A002, 04-002-A003		Nearest Milepost: 43.05	Associated Wetland ID(s): none
Survey Type: <i>(check one)</i> <input checked="" type="checkbox"/> Centerline <input type="checkbox"/> Re-Route <input type="checkbox"/> Access Road <input type="checkbox"/> Other:			
Physical Attributes			
Stream Classification: <i>(check one)</i> <input type="checkbox"/> Ephemeral <input checked="" type="checkbox"/> Intermittent <input type="checkbox"/> Perennial			
Waterbody Type: <i>(check one)</i> <input type="checkbox"/> River <input checked="" type="checkbox"/> Stream <input type="checkbox"/> Ditch <input type="checkbox"/> Canal <input type="checkbox"/> Other:			
OHWM Width: 4 ft.		OHWM Indicator: <i>(check all that apply)</i> <input checked="" type="checkbox"/> Clear line on bank <input type="checkbox"/> Shelving <input type="checkbox"/> Wrested vegetation <input type="checkbox"/> Scouring <input type="checkbox"/> Water

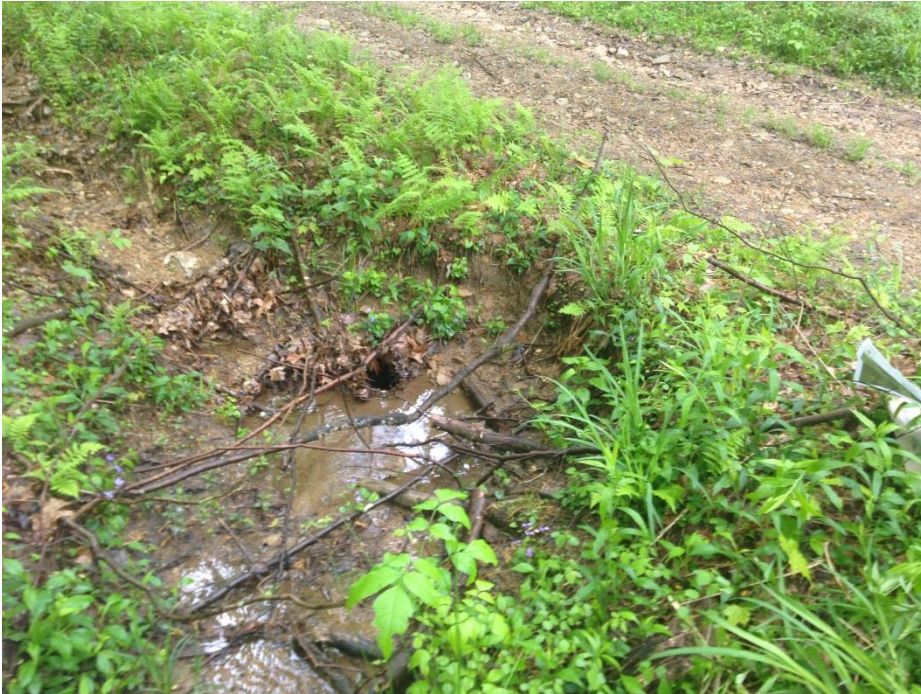
Waterbody SRAC001 facing north downstream

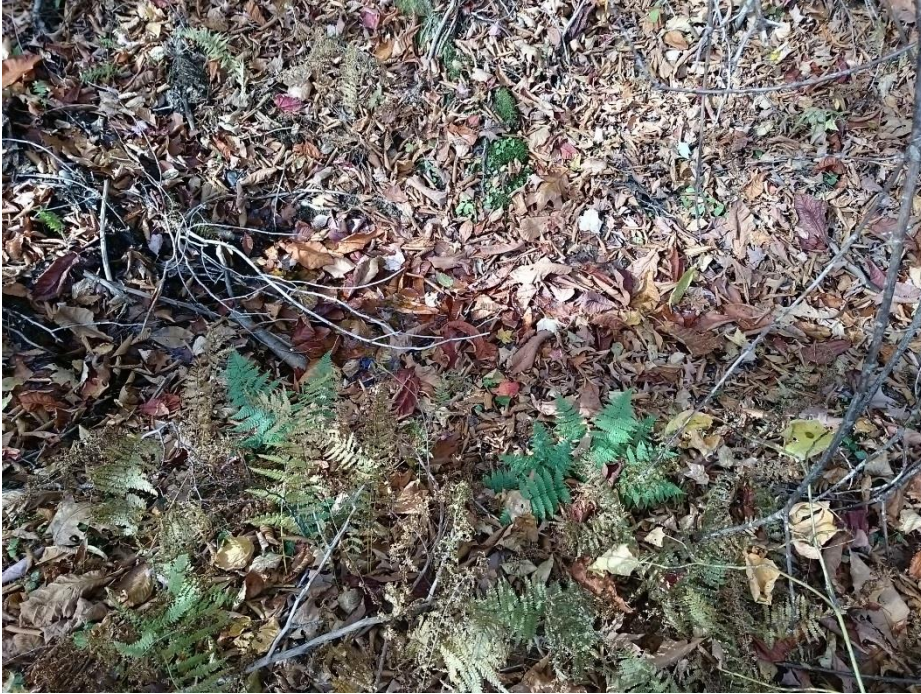
Waterbody SRAA066 facing west across

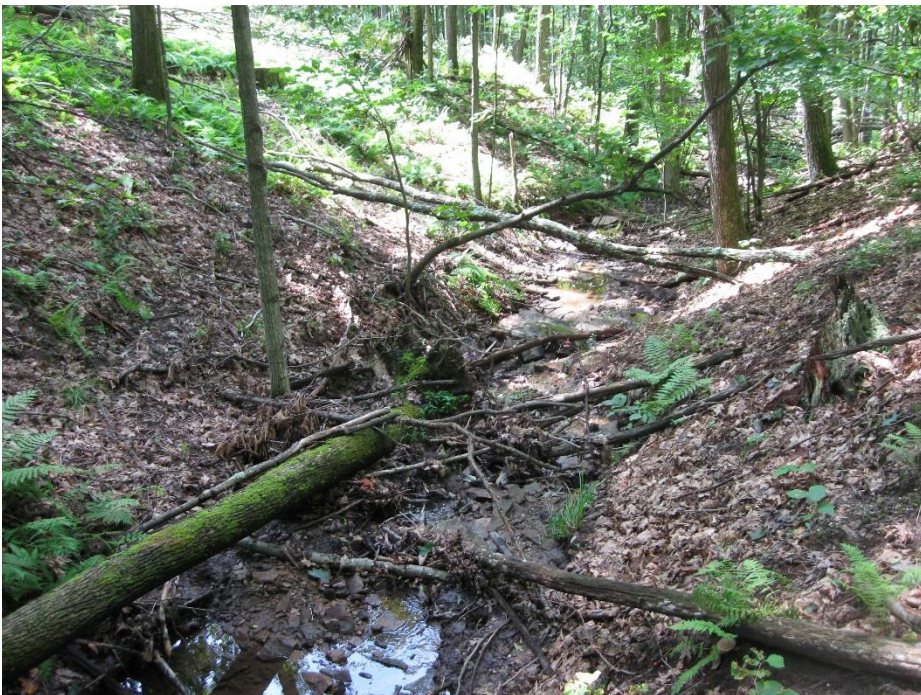
Waterbody SRAB104 facing southwest downstream

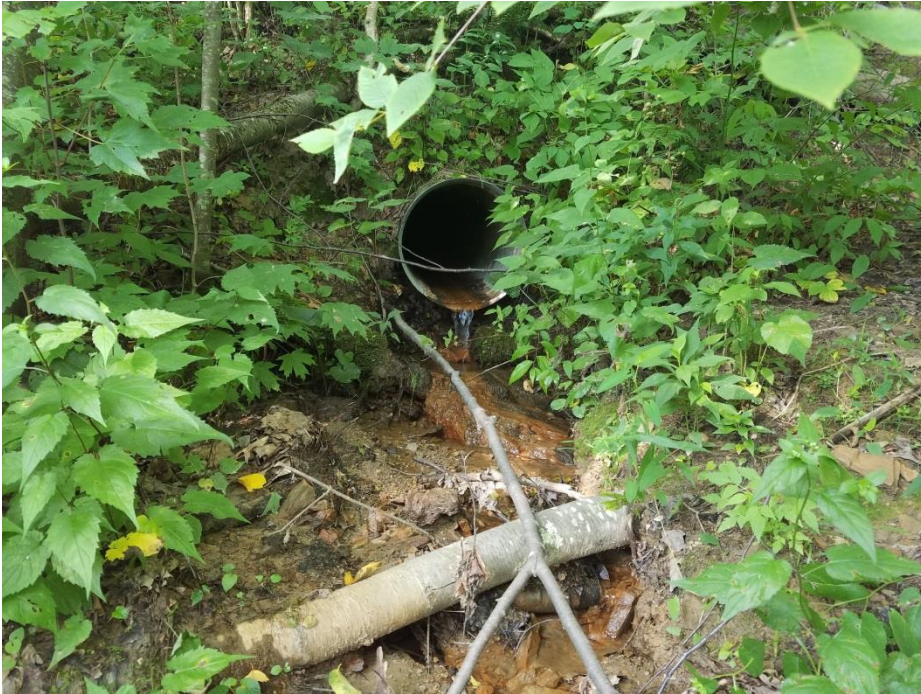
Waterbody srae202 facing southwest upstream

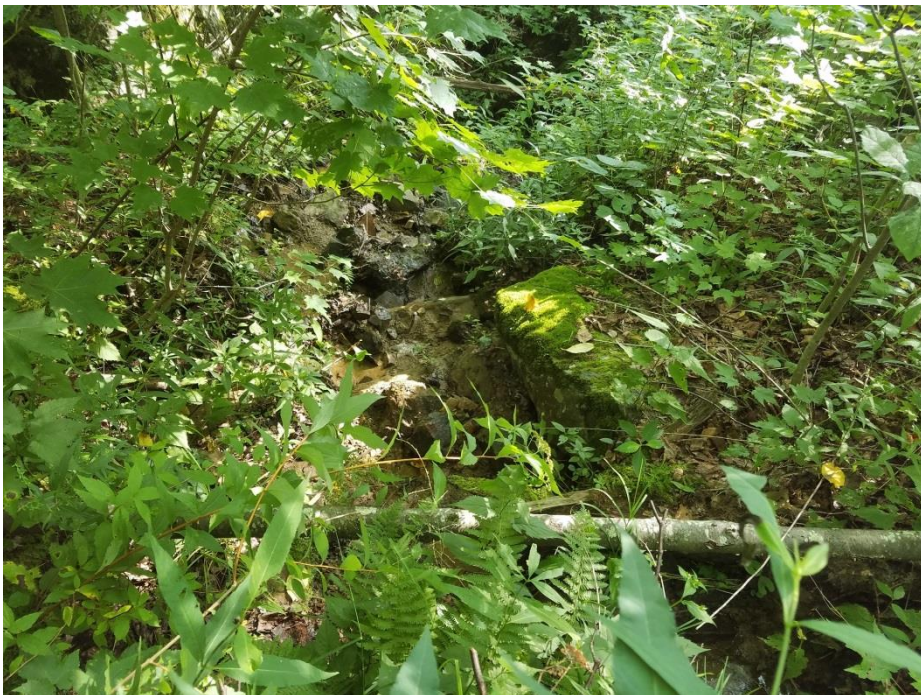
Waterbody srae202 facing northeast downstream

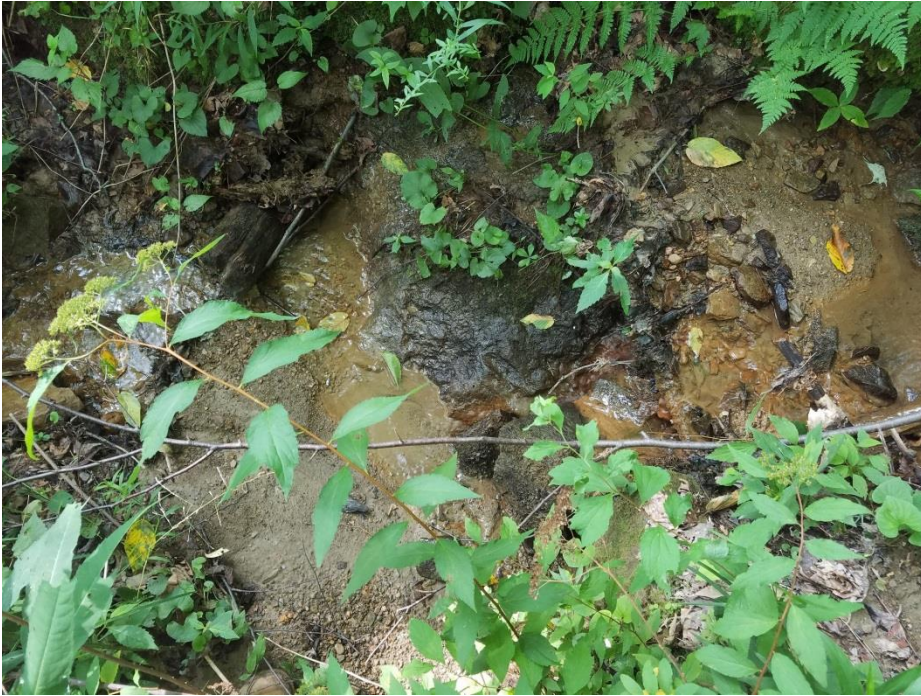
Waterbody srae202 facing southeast across

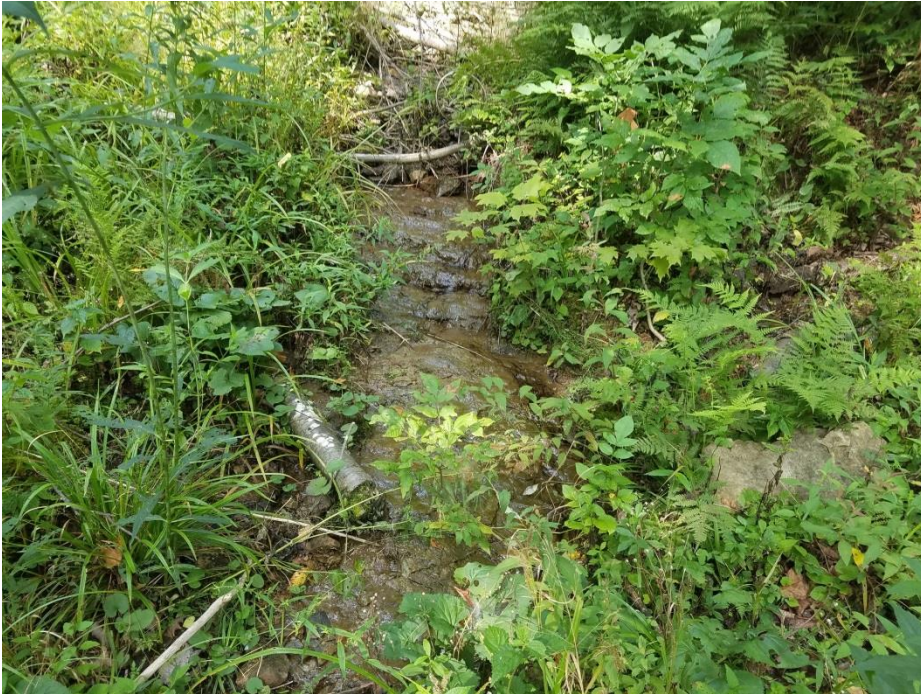
Waterbody srae203 facing southwest upstream

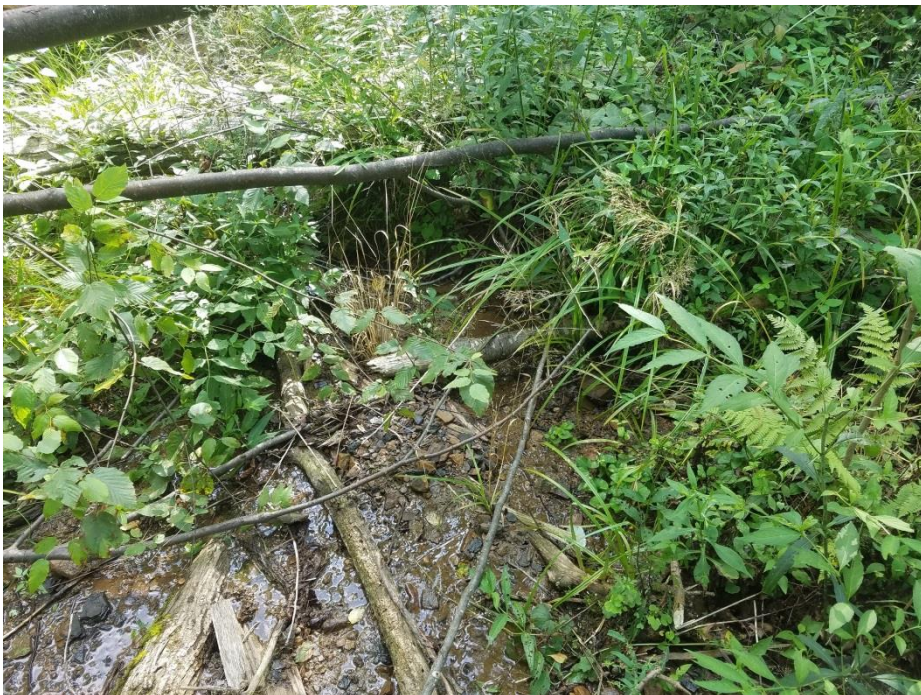
Waterbody srae203 facing northeast downstream

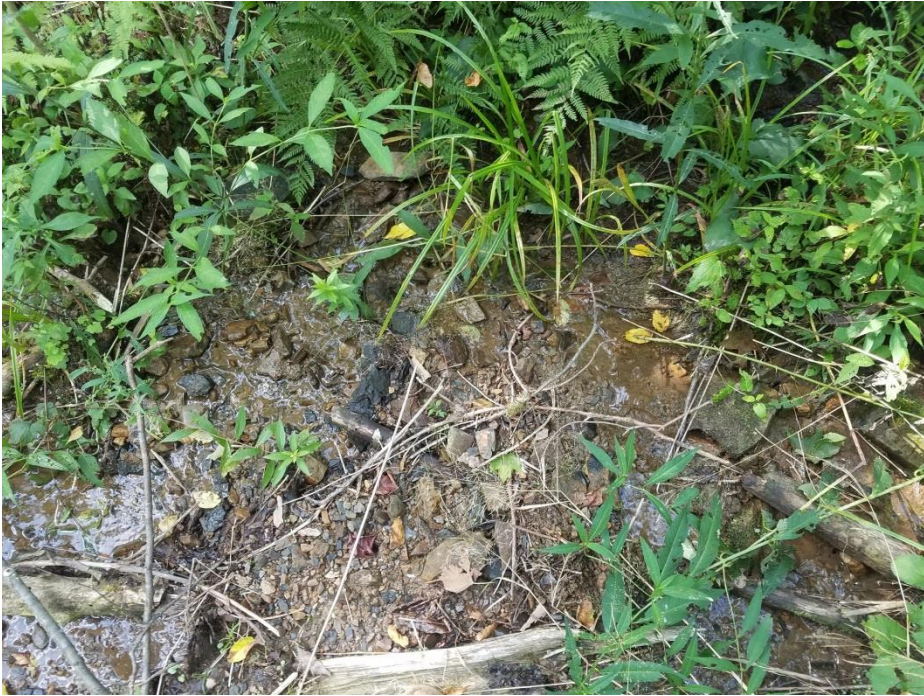
Waterbody srae203 facing southeast across

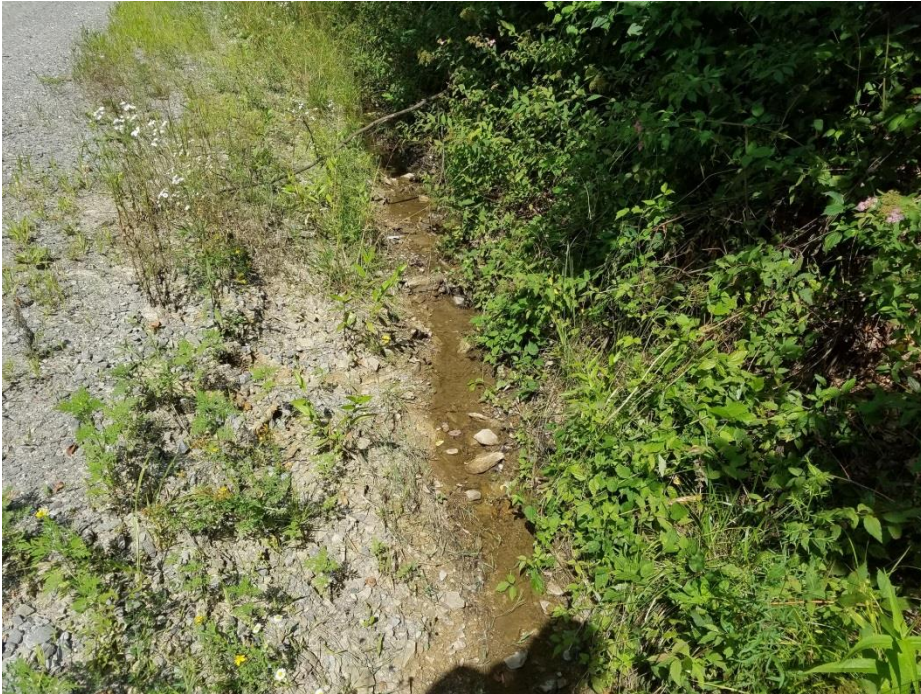
Waterbody srae204 facing southwest upstream

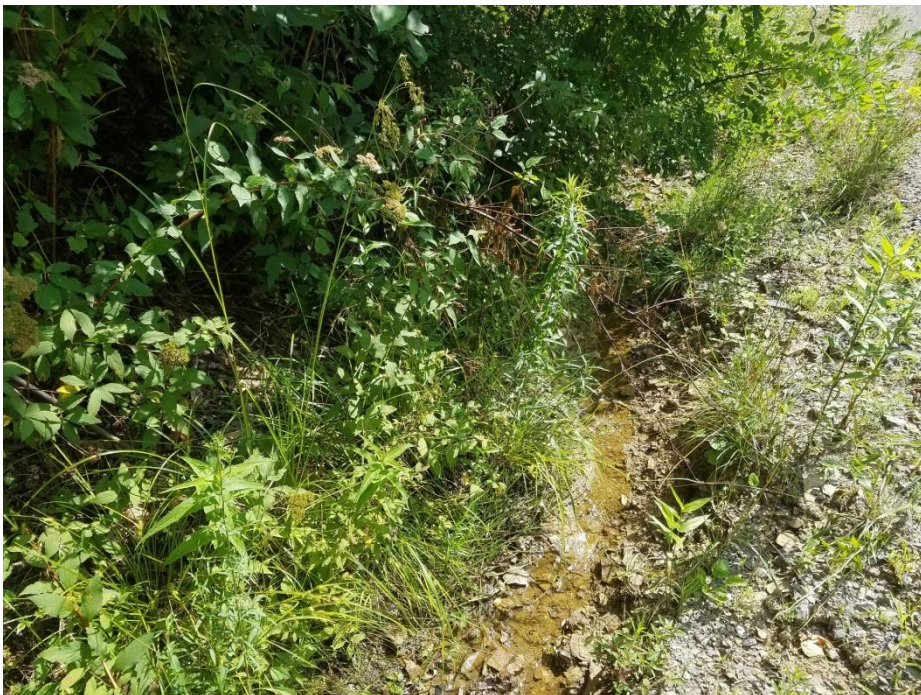
Waterbody srae204 facing northeast downstream

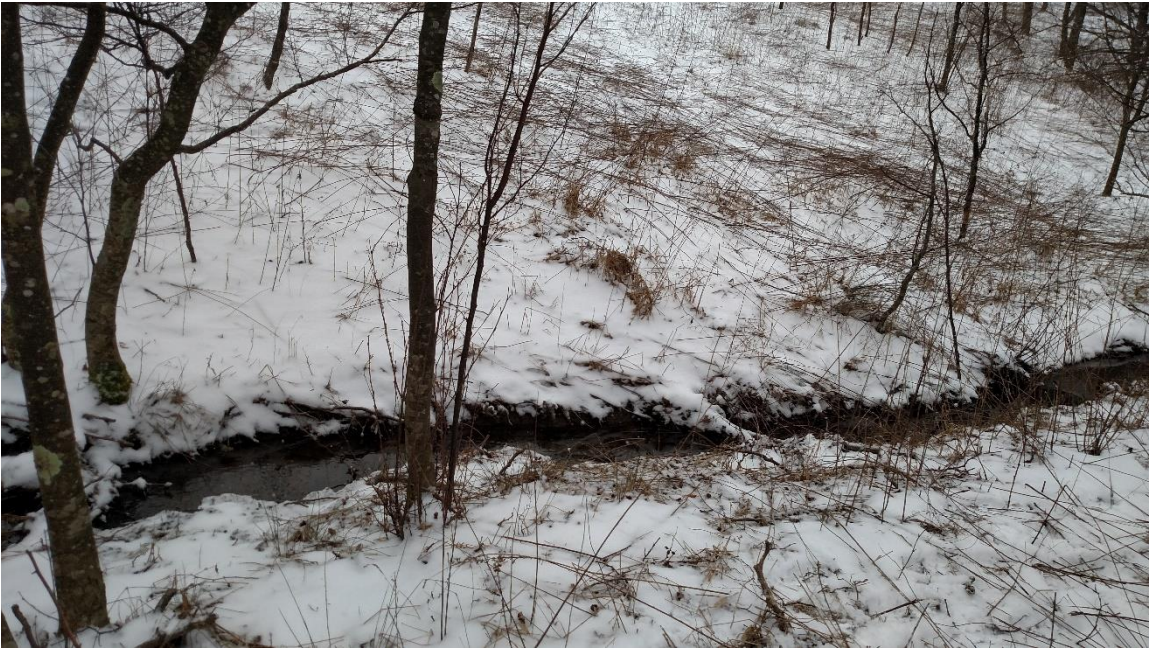
Waterbody SRAC100 facing south across

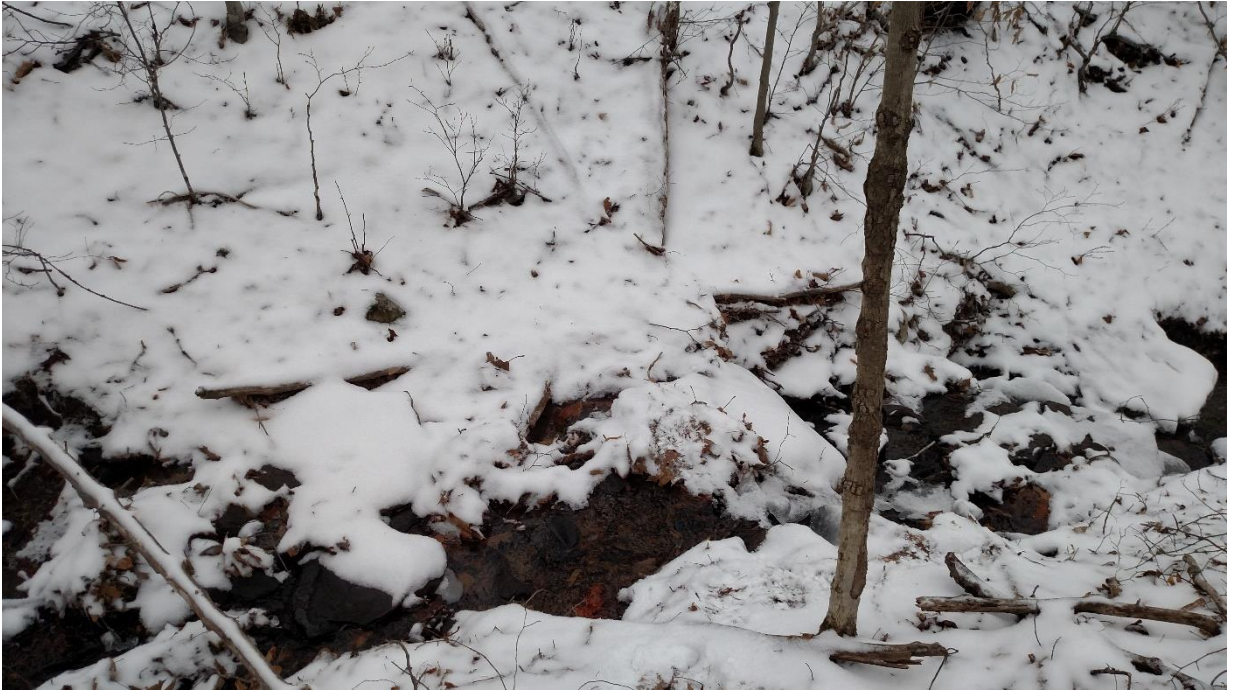
Waterbody SRAC101 facing south across

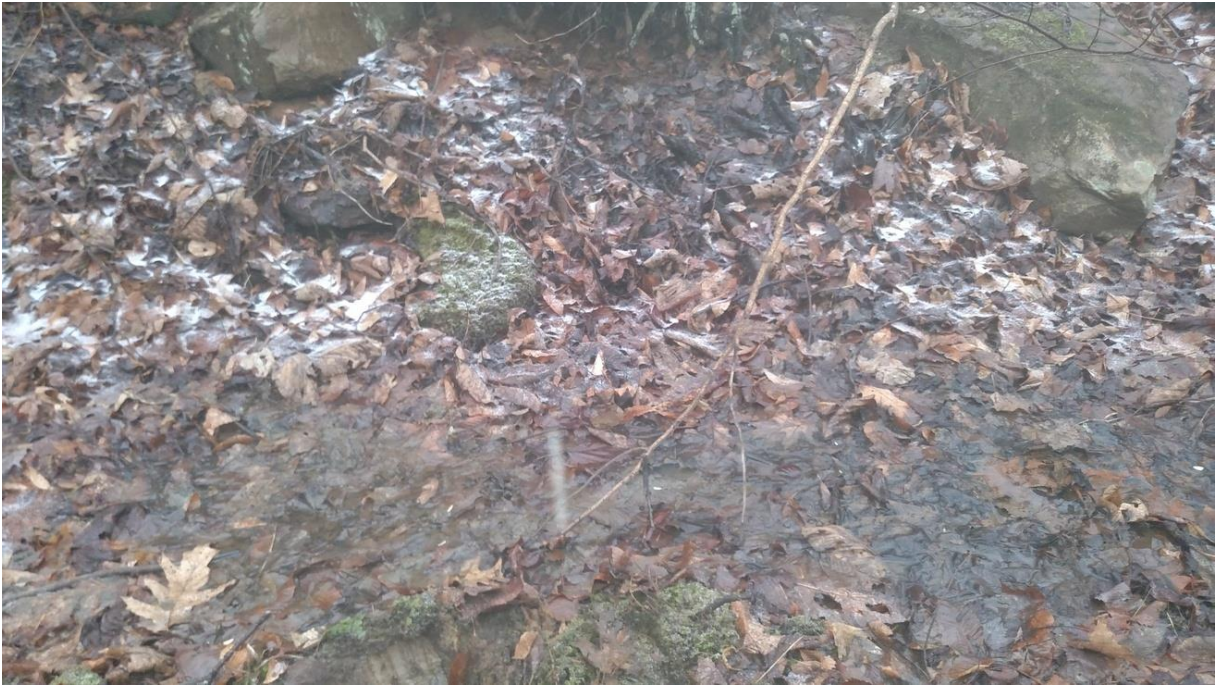
Waterbody srac102 facing north upstream
