Linear Waterbody Data Sheet

Survey Description			
Project Name: Southeast Reliability		Waterbody Name: Kincheloe Creek	
Waterbody ID: SLEA001		Date: 6/11/2014	
State: West Virginia	County/Parish: Lewis	Company: Natural Resource Group	Crew Member Initials: GB, SK, LE, TP
Photos: 3			
Tract Number(s): 01-016, 01-017		Nearest Milepost: 1.15	Associated Wetland ID(s): WLEB001
Survey Type: <i>(check one)</i> <input checked="" type="checkbox"/> Centerline <input type="checkbox"/> Re-Route <input type="checkbox"/> Access Road <input type="checkbox"/> Other:			
Physical Attributes			
Stream Classification: <i>(check one)</i> <input type="checkbox"/> Ephemeral <input type="checkbox"/> Intermittent <input checked="" type="checkbox"/> Perennial			
Waterbody Type: <i>(check one)</i> <input type="checkbox"/> River <input checked="" type="checkbox"/> Stream <input type="checkbox"/> Ditch <input type="checkbox"/> Canal <input type="checkbox"/> Other:

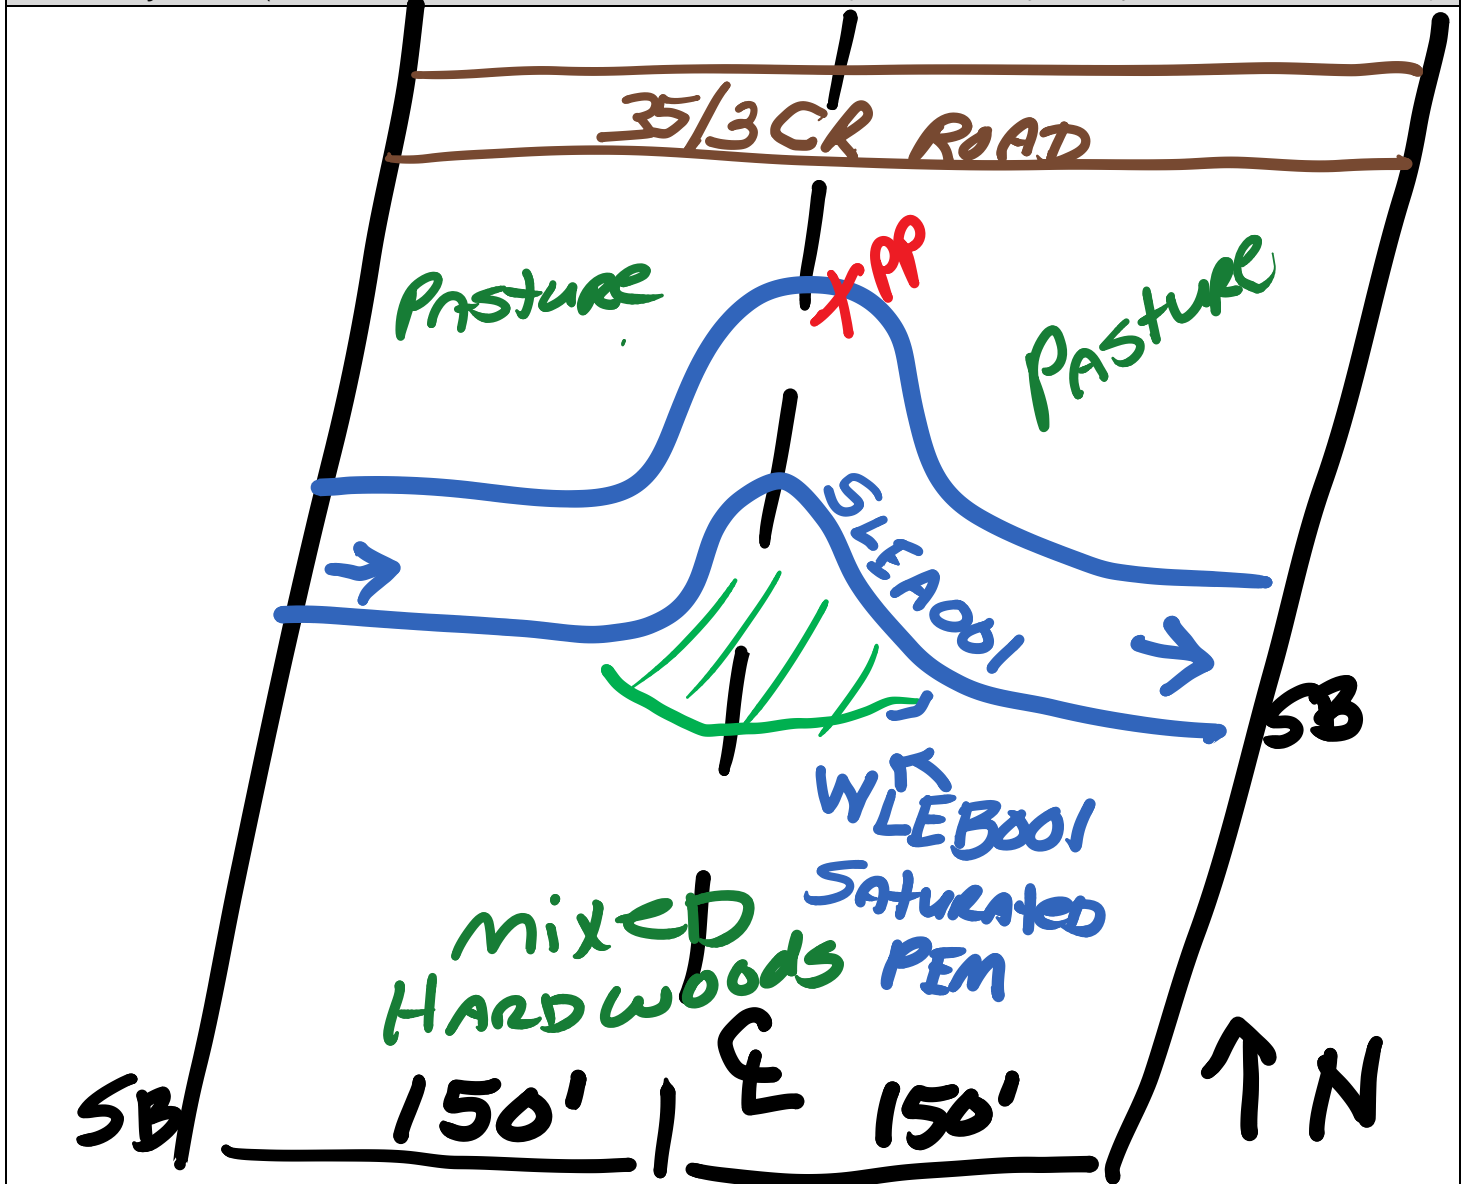
Waterbody Sketch (Include north arrow, centerline, distance from centerline, data point location, survey boundary, and IDs of associated features)

Kincheloe Creek, NHD perennial stream line, stream is Harrison/Lewis County line, continues out of corridor in both directions. North side is pasture. Upline and downline recorded.

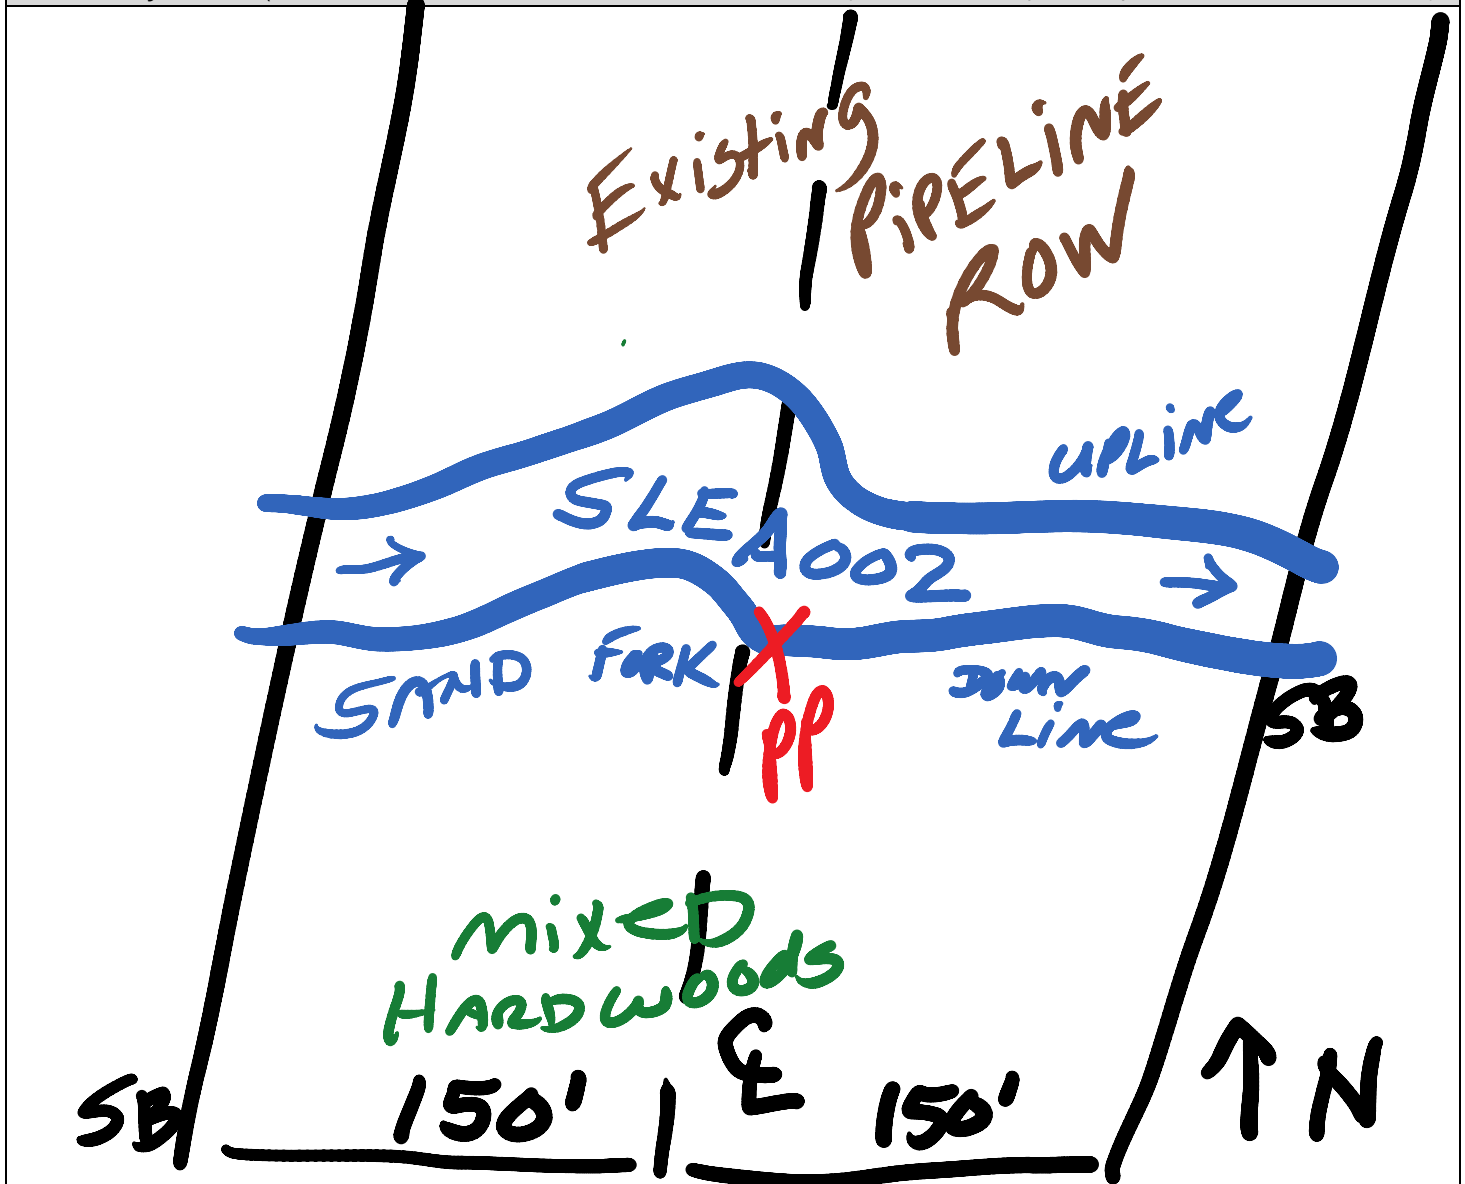
Waterbody Sketch (Include north arrow, centerline, distance from centerline, data point location, survey boundary, and IDs of associated features)

Sand Fork, NHD perennial stream line, parallel pipeline ROW, continues out of corridor in both directions.

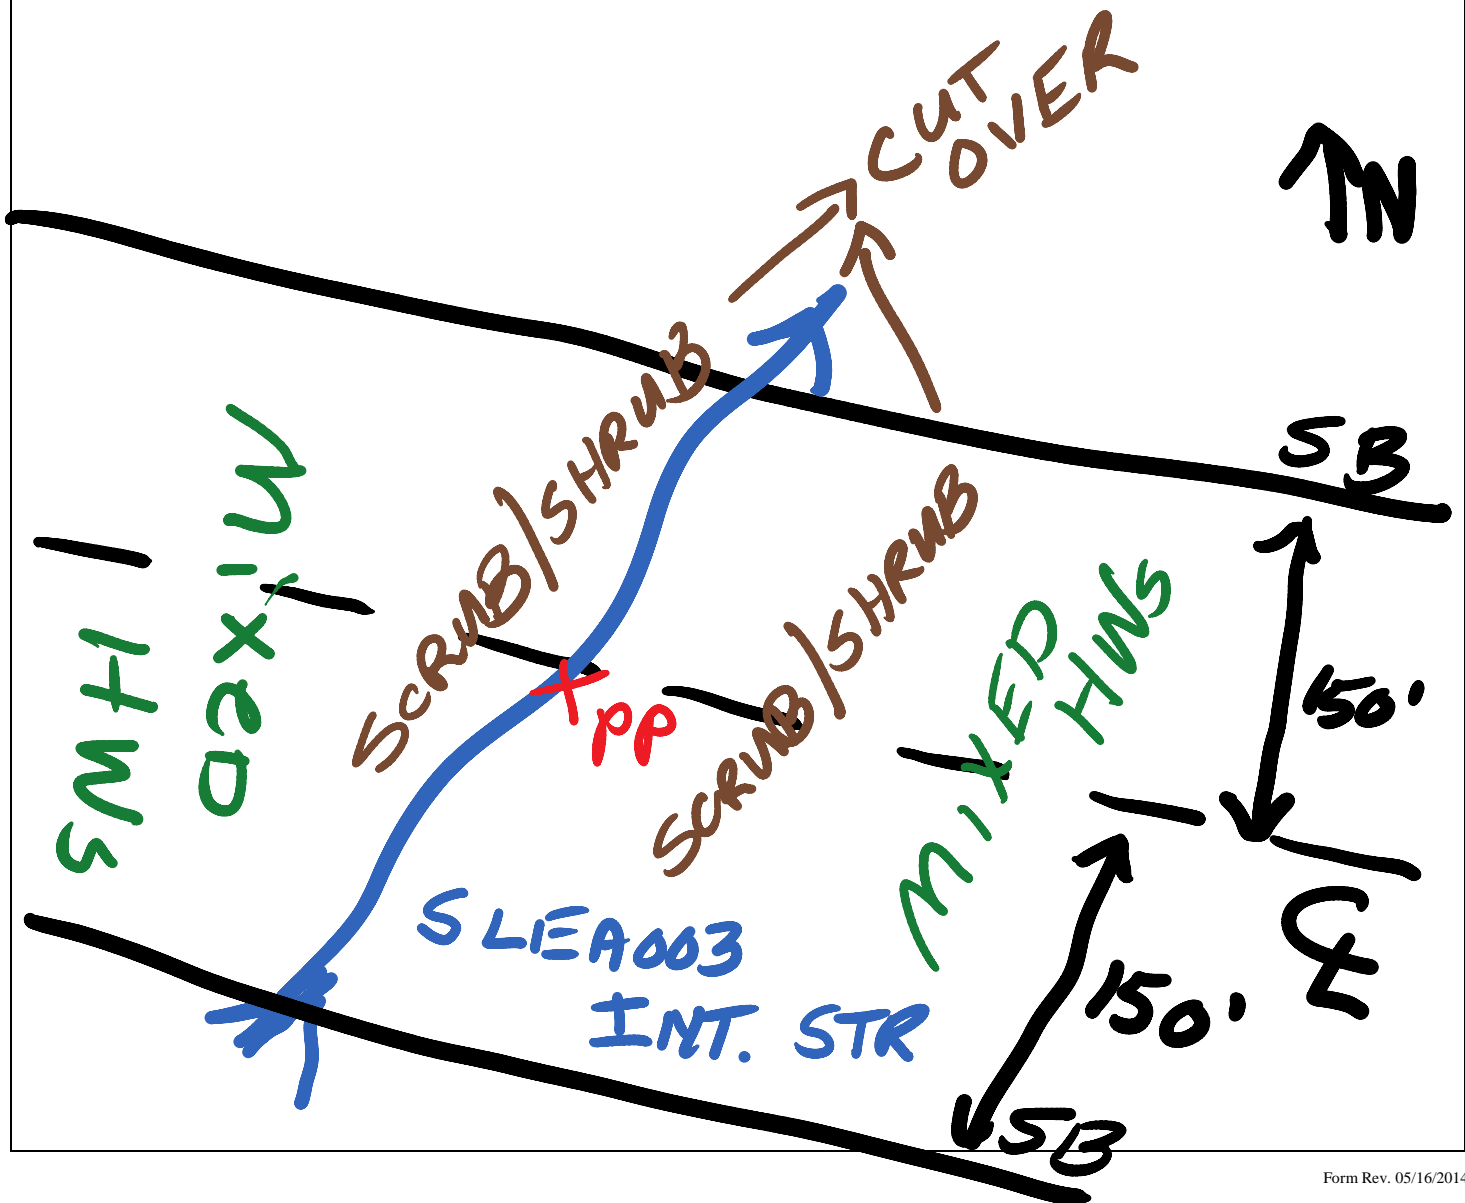
Waterbody Sketch (Include north arrow, centerline, distance from centerline, data point location, survey boundary, and IDs of associated features)

Corridor between toes of slope through which stream runs has been cleared of trees. Feature continues out of corridor in both directions.

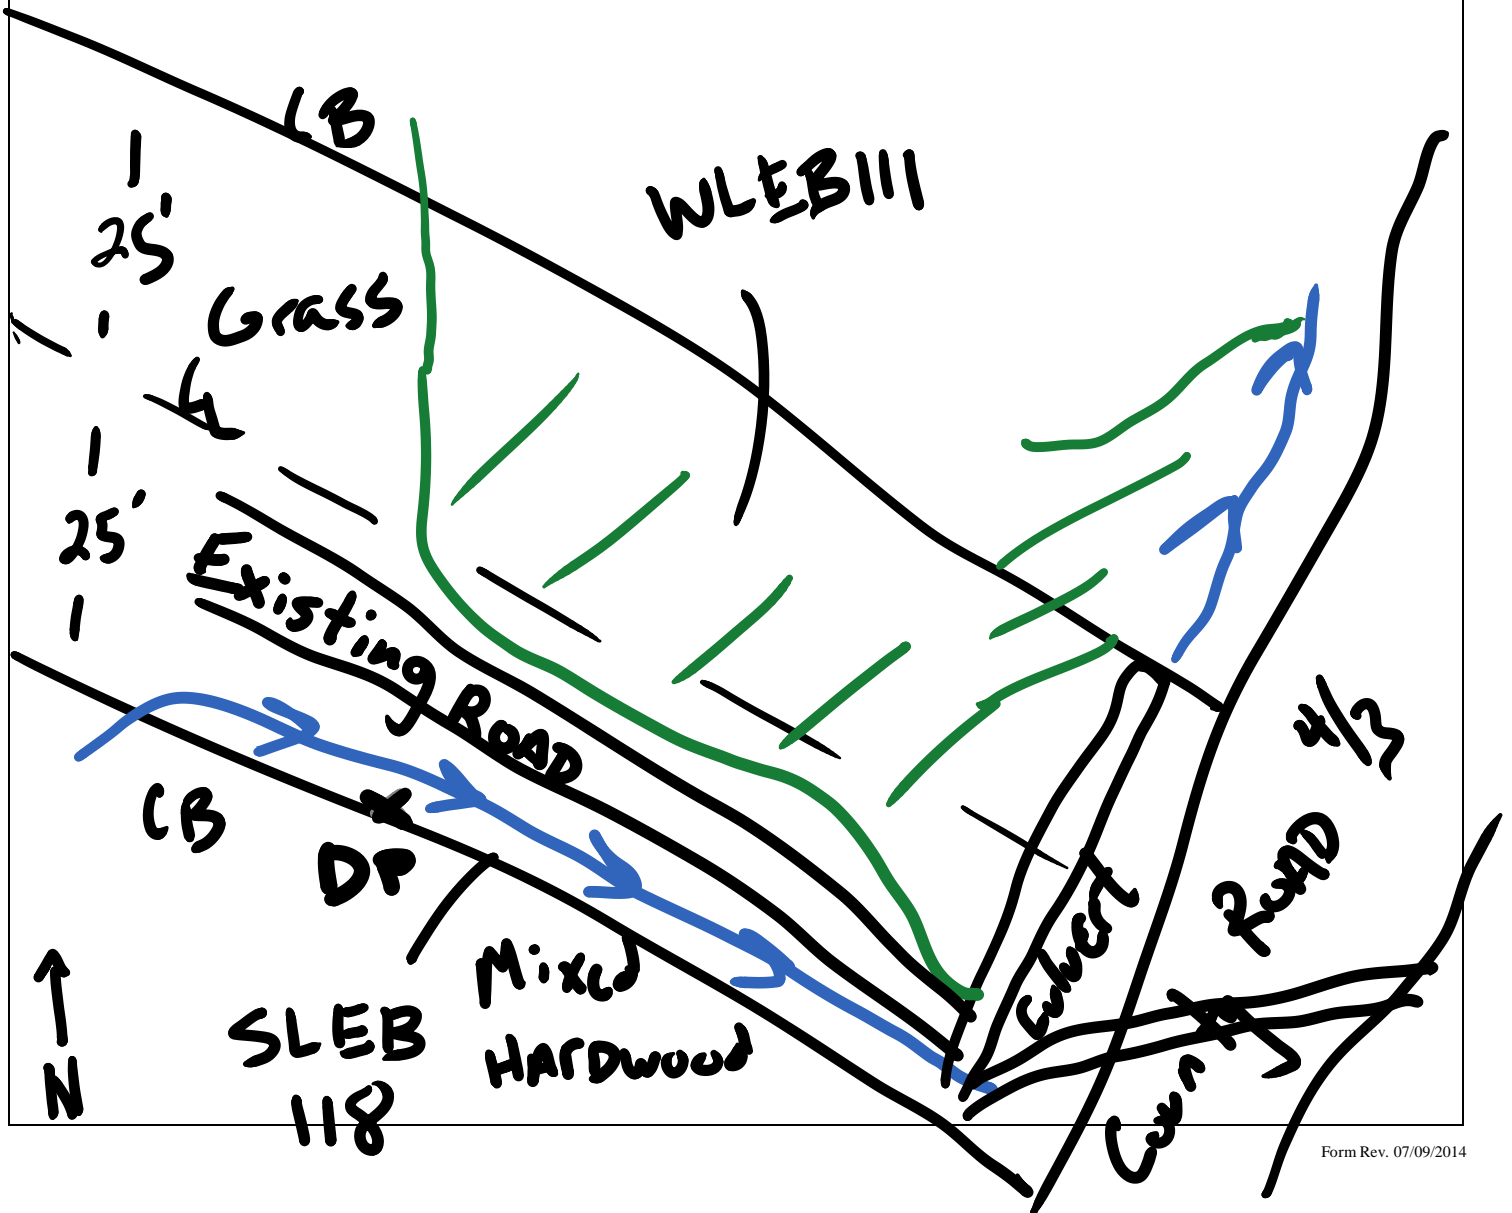
Waterbody Sketch (Include north arrow, centerline, distance from centerline, data point location, survey boundary, and IDs of associated features)

Perennial stream. Noted strong bars and benches, cobble, moderate sinuosity in thalweg of ditch, moderate grade control, debris piles, weak riffle pool sequence, and a few roots along bank. Stream appears slightly incised.

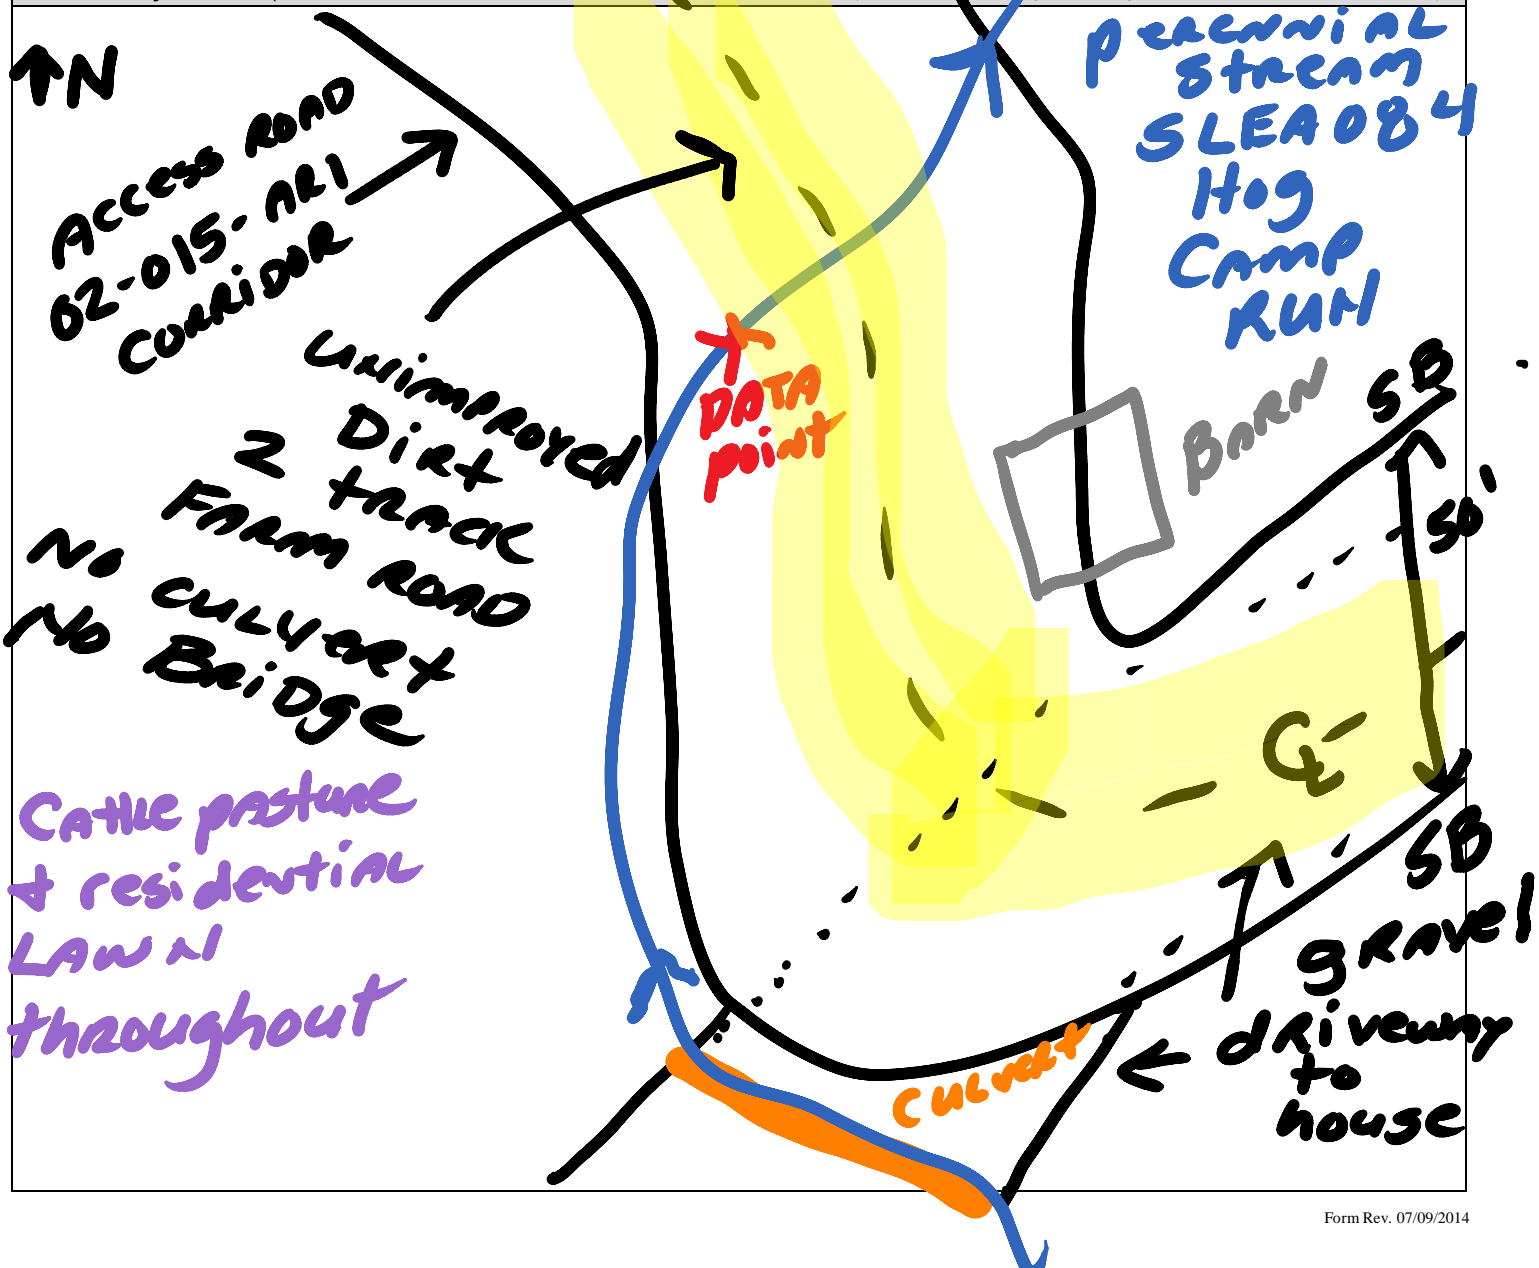
Waterbody Sketch (Include north arrow, centerline, distance from centerline, data point location, survey boundary, and IDs of associated features)

Continues out of access road corridor in both directions; livestock access has resulted in sporadic bank failures due to trampling; culvert crossing for driveway to house; there is no culvert or bridge at the proposed access road crossing, vehicles have been driving through stream.

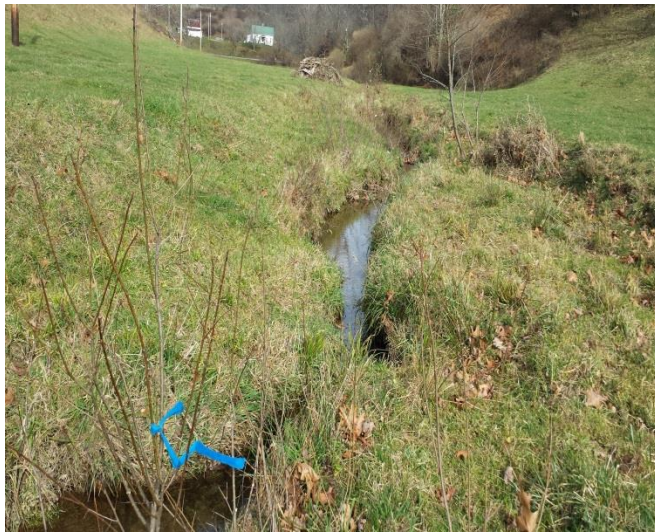
Waterbody SLEA084 facing northeast downstream

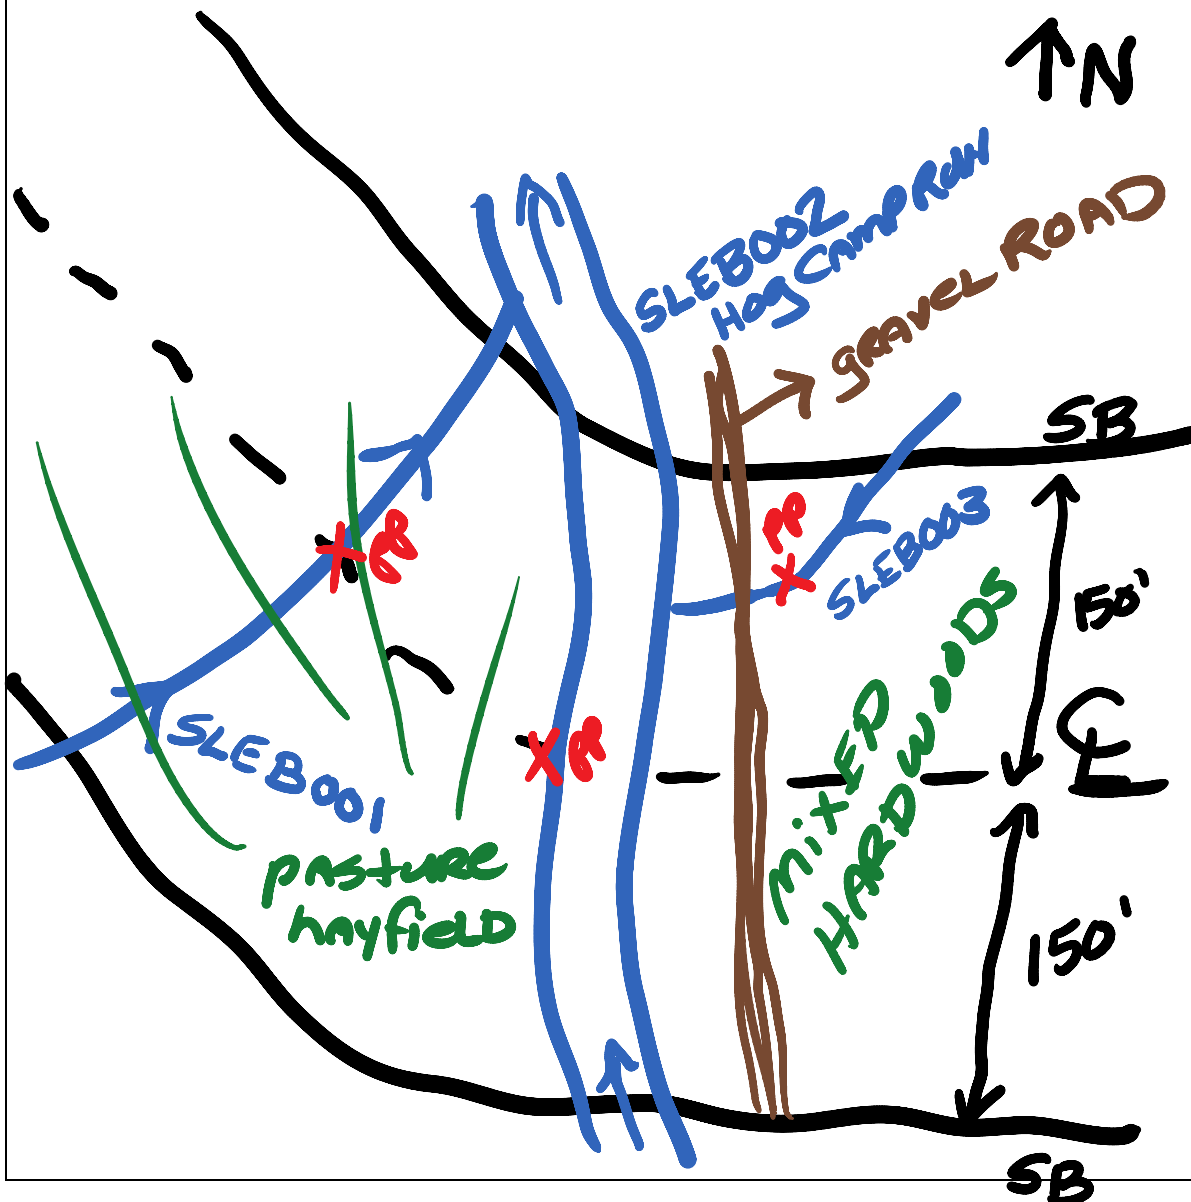
Waterbody Sketch (Include north arrow, centerline, distance from centerline, data point location, survey boundary, and IDs of associated features)

Tributary to Hog Camp Run; flows through the entire corridor; pasture on both sides of the creek

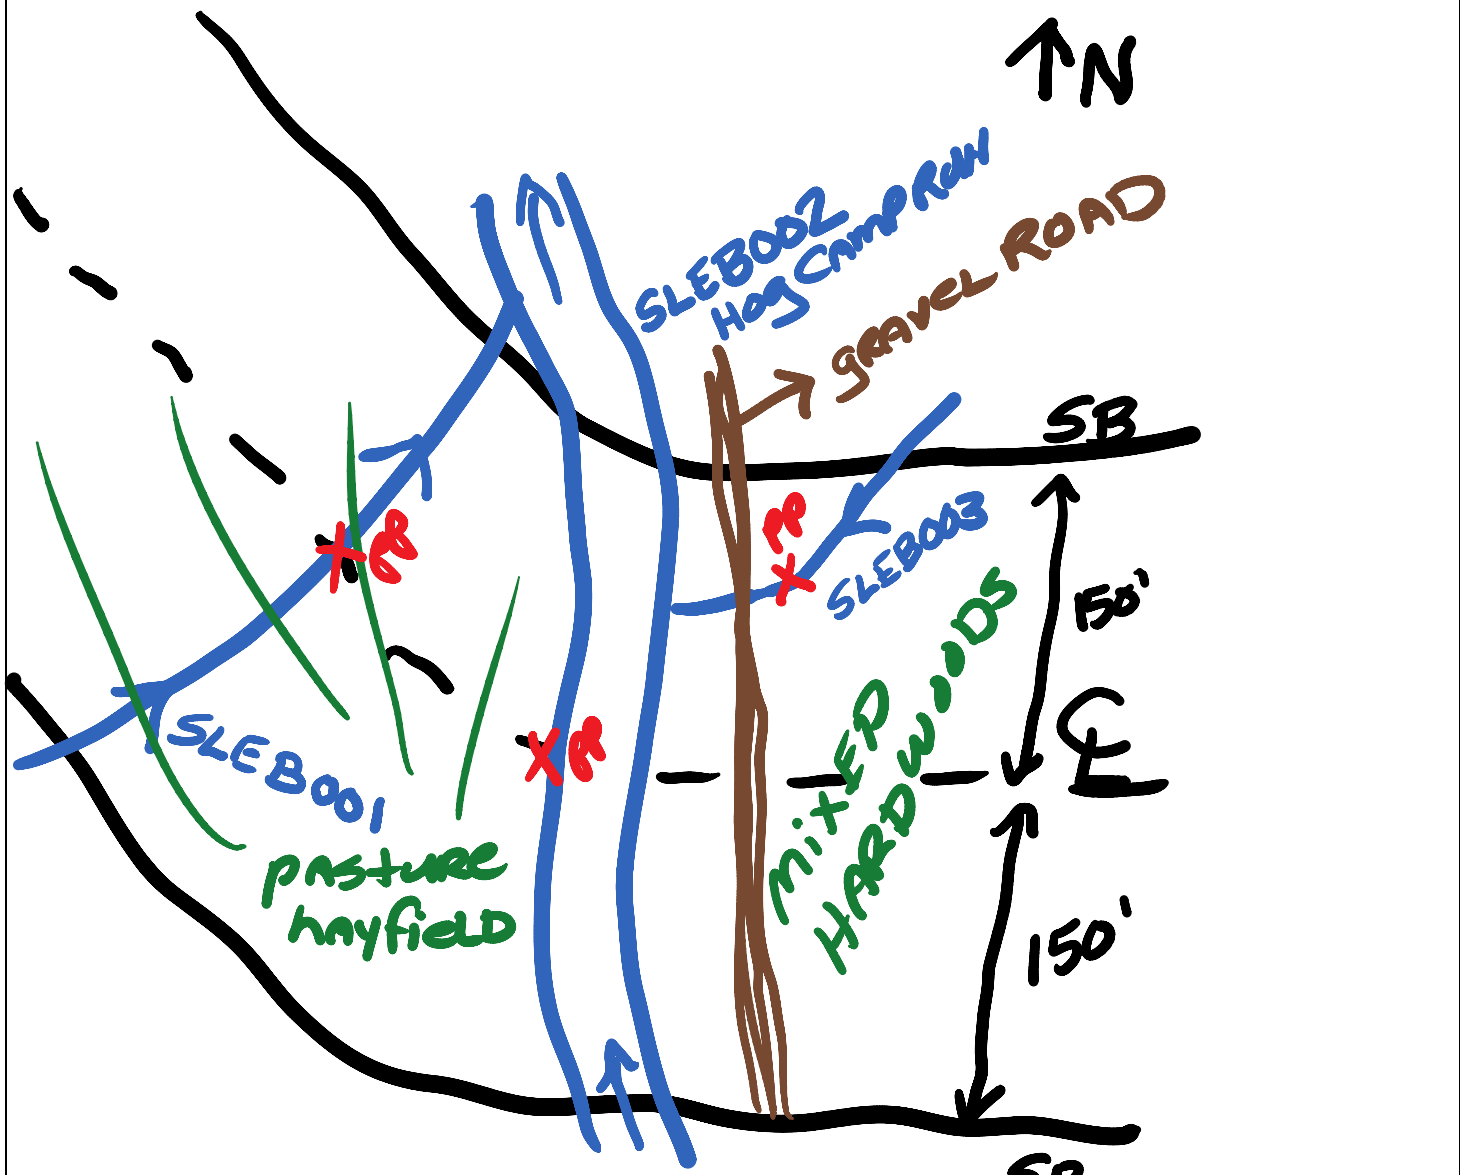
Waterbody Sketch (Include north arrow, centerline, distance from centerline, data point location, survey boundary, and IDs of associated features)

Pasture adjacent to creek

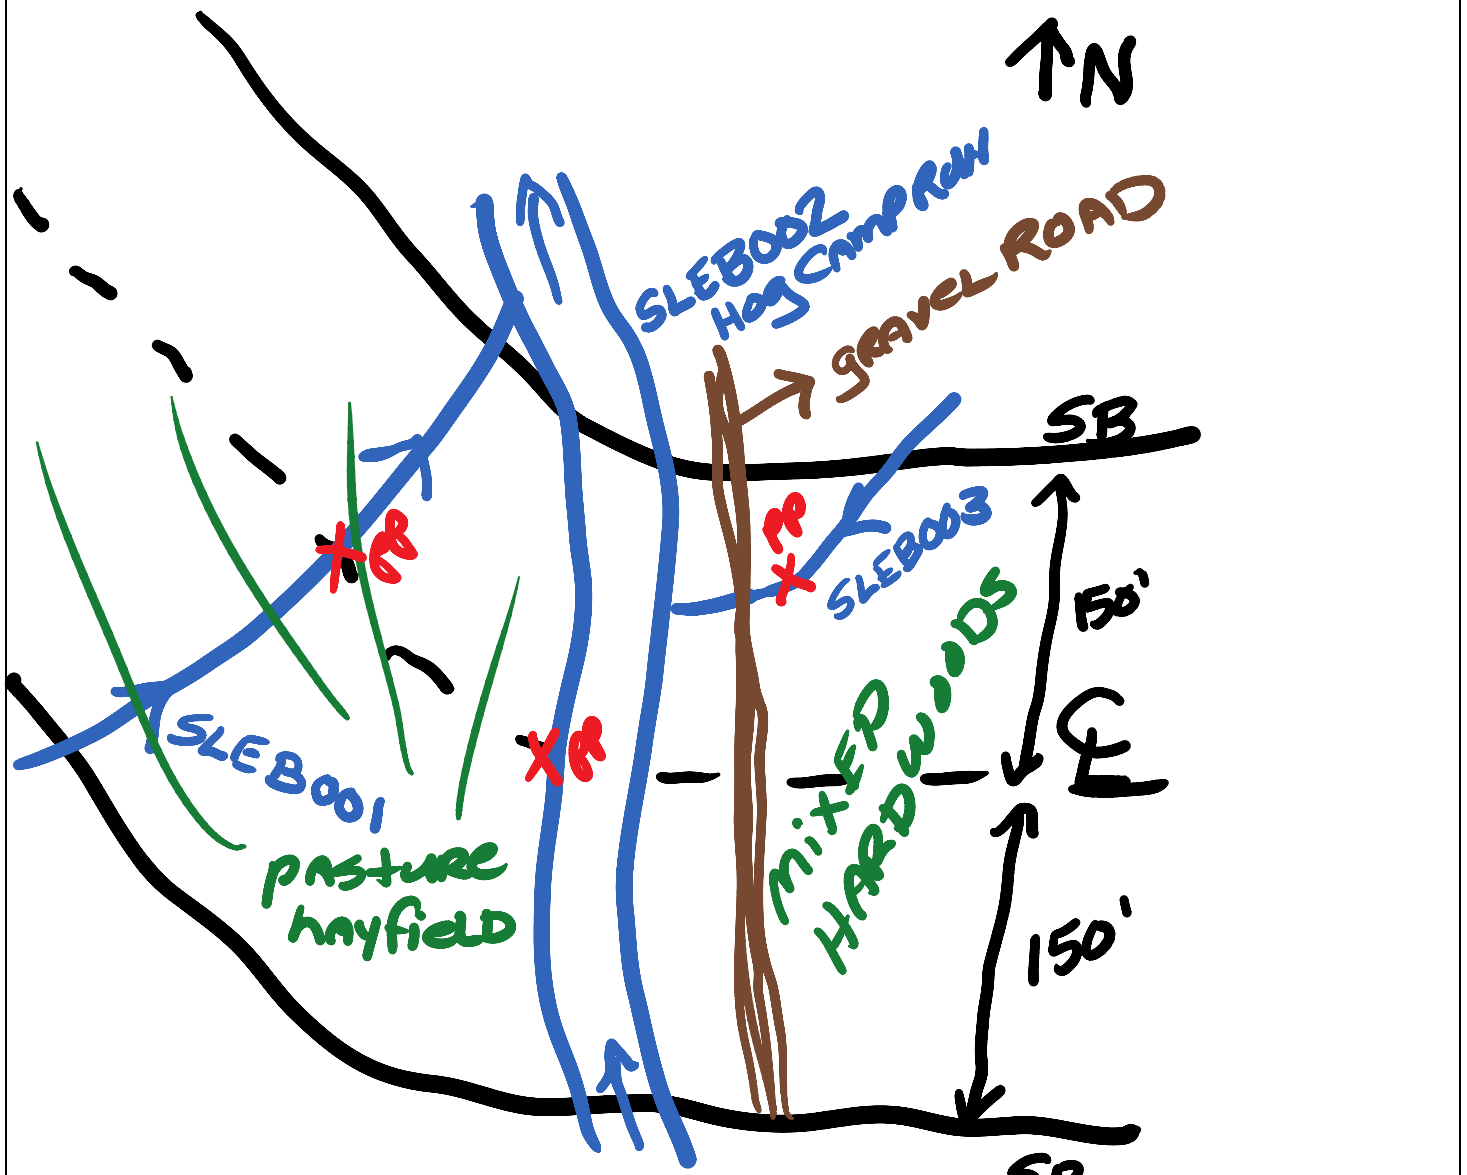
Waterbody Sketch (Include north arrow, centerline, distance from centerline, data point location, survey boundary, and IDs of associated features)

Crossed by road via culvert

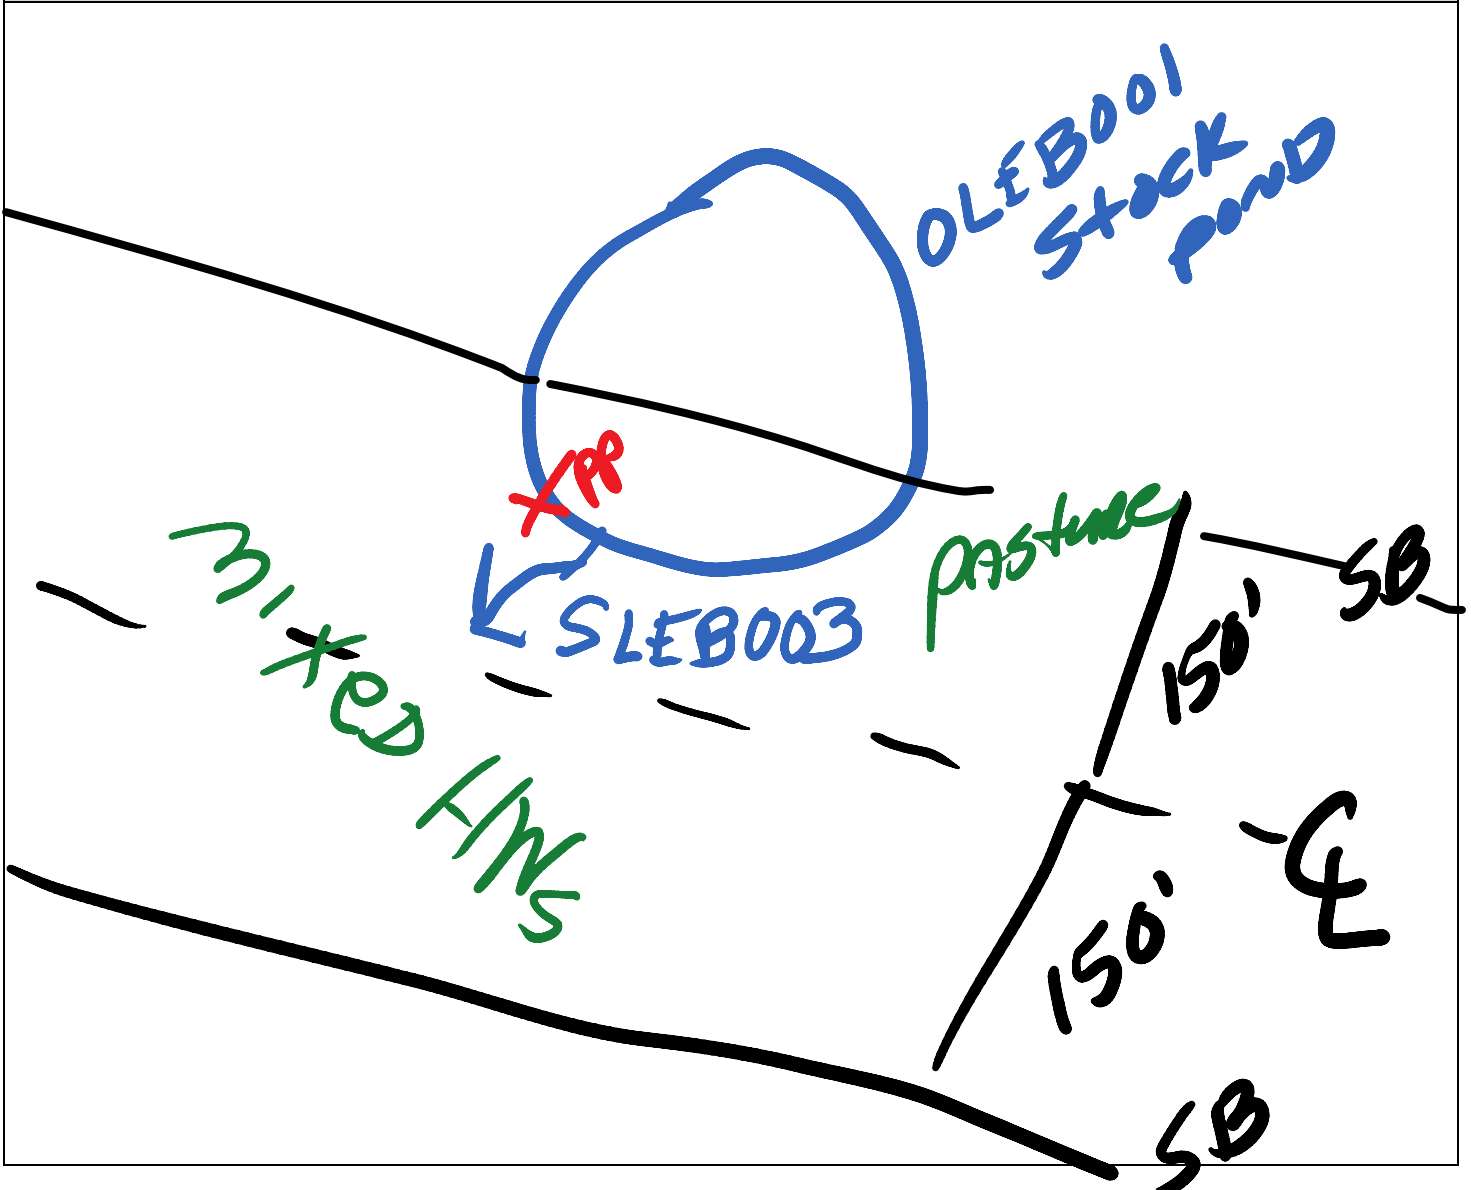
Waterbody Sketch (Include north arrow, centerline, distance from centerline, data point locations, survey boundary, and IDs of associated features)

Feature results from damming stream SLEB003

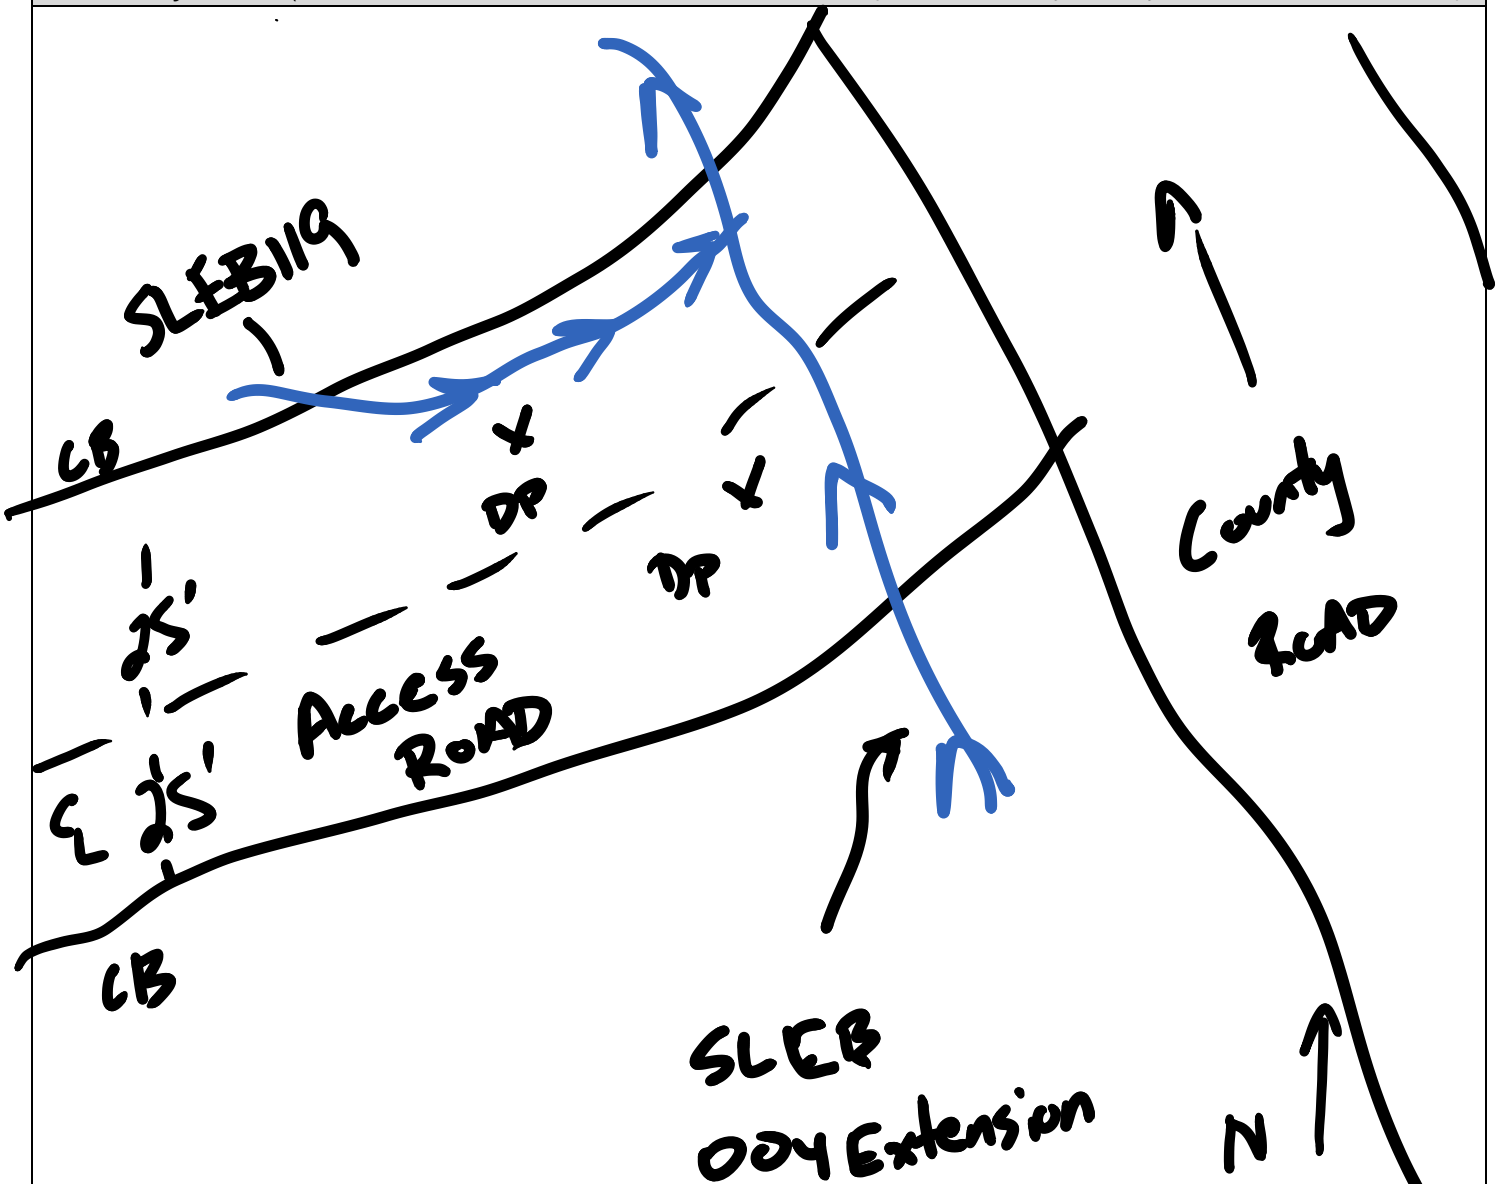
Intermittent stream. Noted weak bars and benches, weak sinuosity, good grade control, a few debris piles, no riffle pool sequence. Drains into SLEB004_extension..

Waterbody Sketch (Include north arrow, centerline, distance from centerline, data point location, survey boundary, and IDs of associated features)

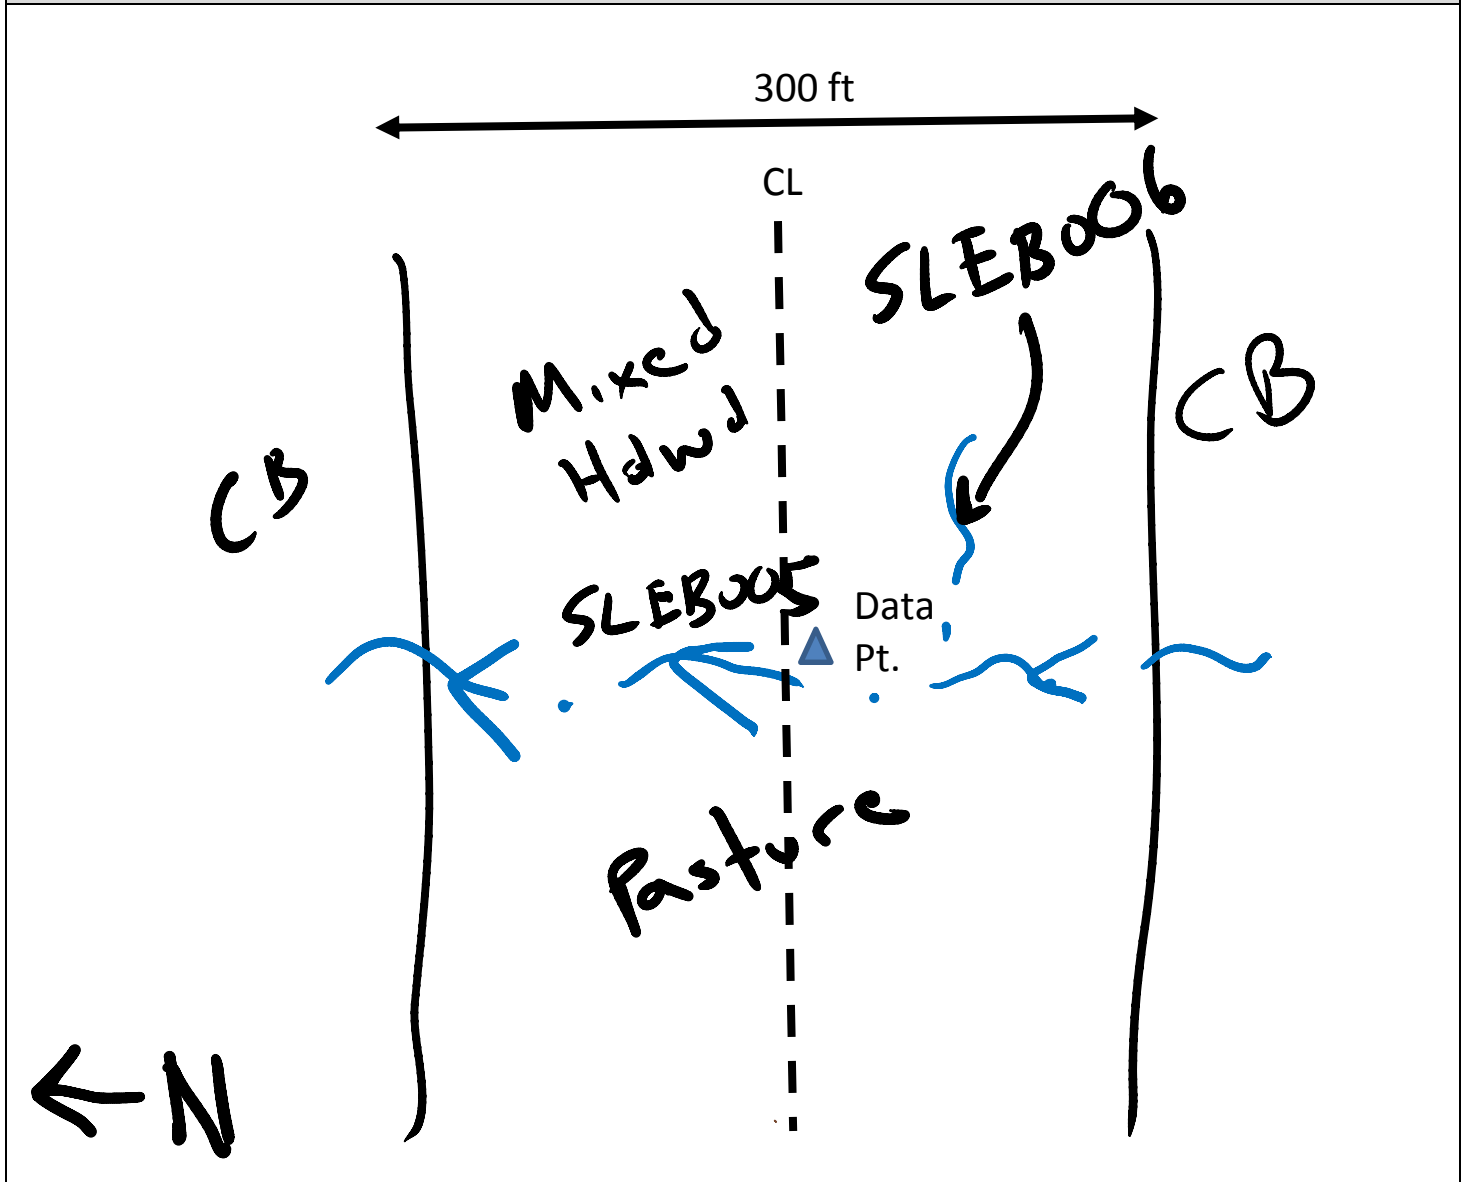
Pasture adjacent to creek

Waterbody Sketch (Include north arrow, centerline, distance from centerline, data point location, survey boundary, and IDs of associated features)

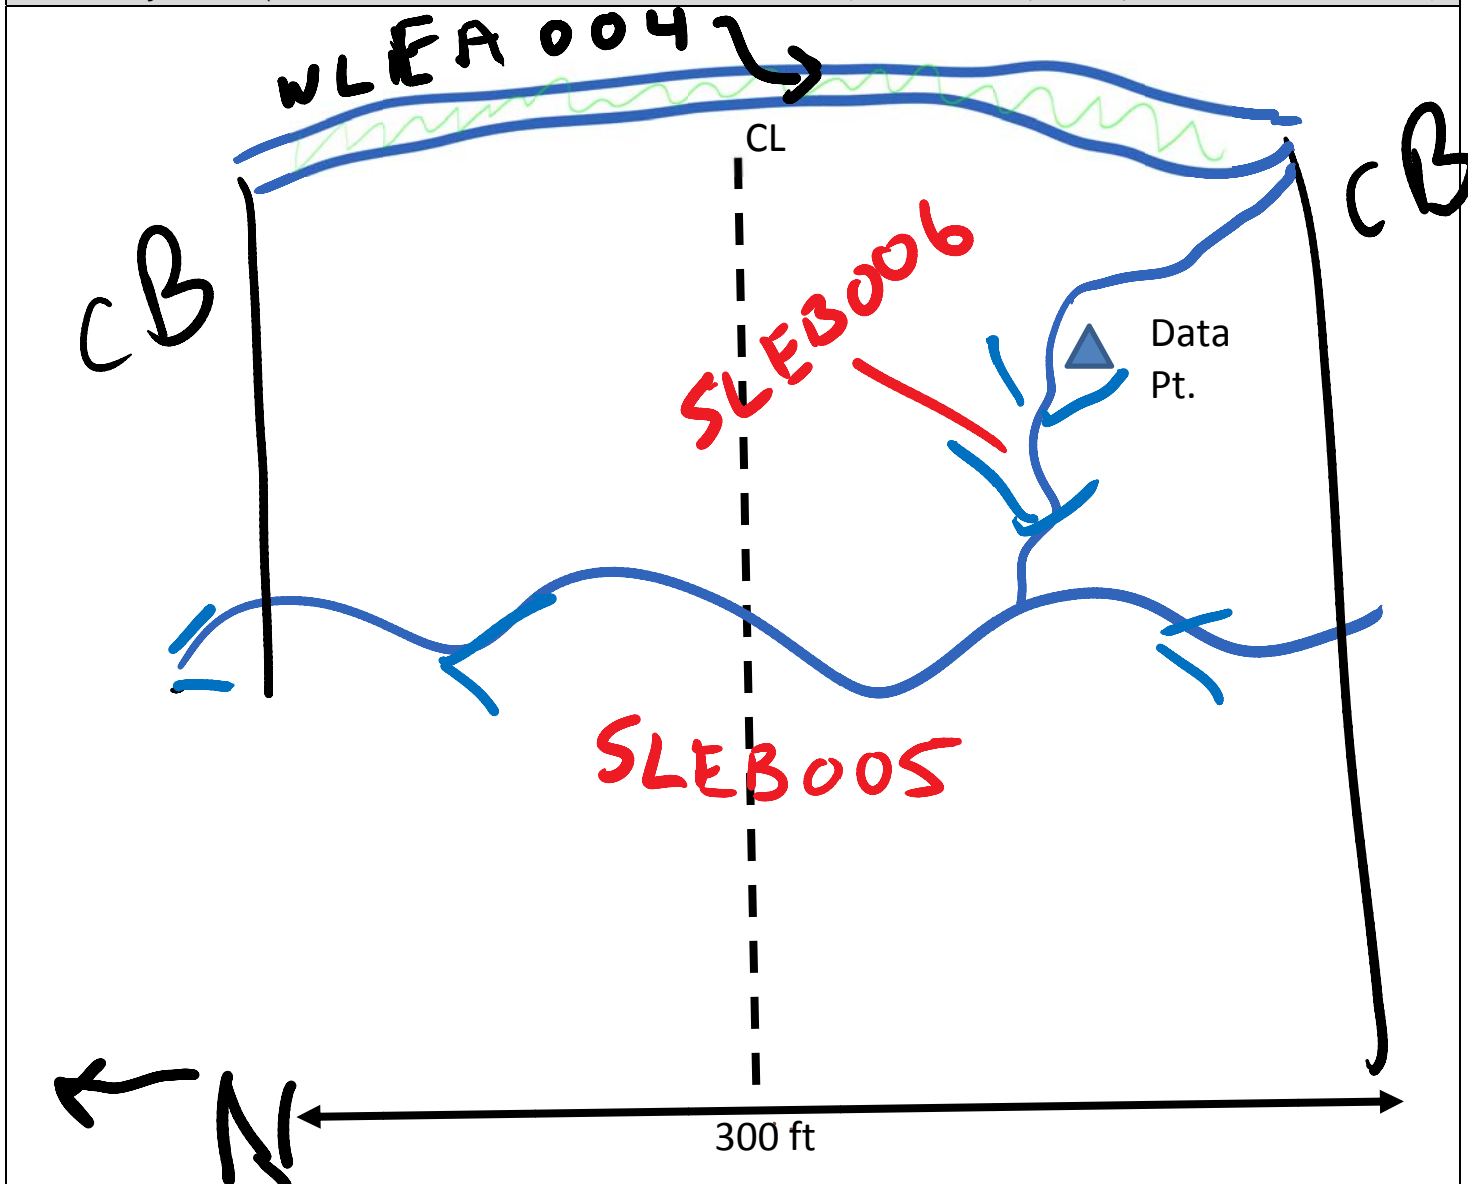
Fed by WLEB004

Waterbody Sketch (Include north arrow, centerline, distance from centerline, data point location, survey boundary, and IDs of associated features)
