Linear Waterbody Data Sheet

Survey Description			
Project Name: Southeast Reliability		Waterbody Name: Kincheloe Creek	
Waterbody ID: SLEA001		Date: 6/11/2014	
State: West Virginia	County/Parish: Lewis	Company: Natural Resource Group	Crew Member Initials: GB, SK, LE, TP
Photos: 3			
Tract Number(s): 01-016, 01-017		Nearest Milepost: 1.15	Associated Wetland ID(s): WLEB001
Survey Type: <i>(check one)</i> <input checked="" type="checkbox"/> Centerline <input type="checkbox"/> Re-Route <input type="checkbox"/> Access Road <input type="checkbox"/> Other:			
Physical Attributes			
Stream Classification: <i>(check one)</i> <input type="checkbox"/> Ephemeral <input type="checkbox"/> Intermittent <input checked="" type="checkbox"/> Perennial			
Waterbody Type: <i>(check one)</i> <input type="checkbox"/> River <input checked="" type="checkbox"/> Stream <input type="checkbox"/> Ditch <input type="checkbox"/> Canal <input type="checkbox"/> Other:

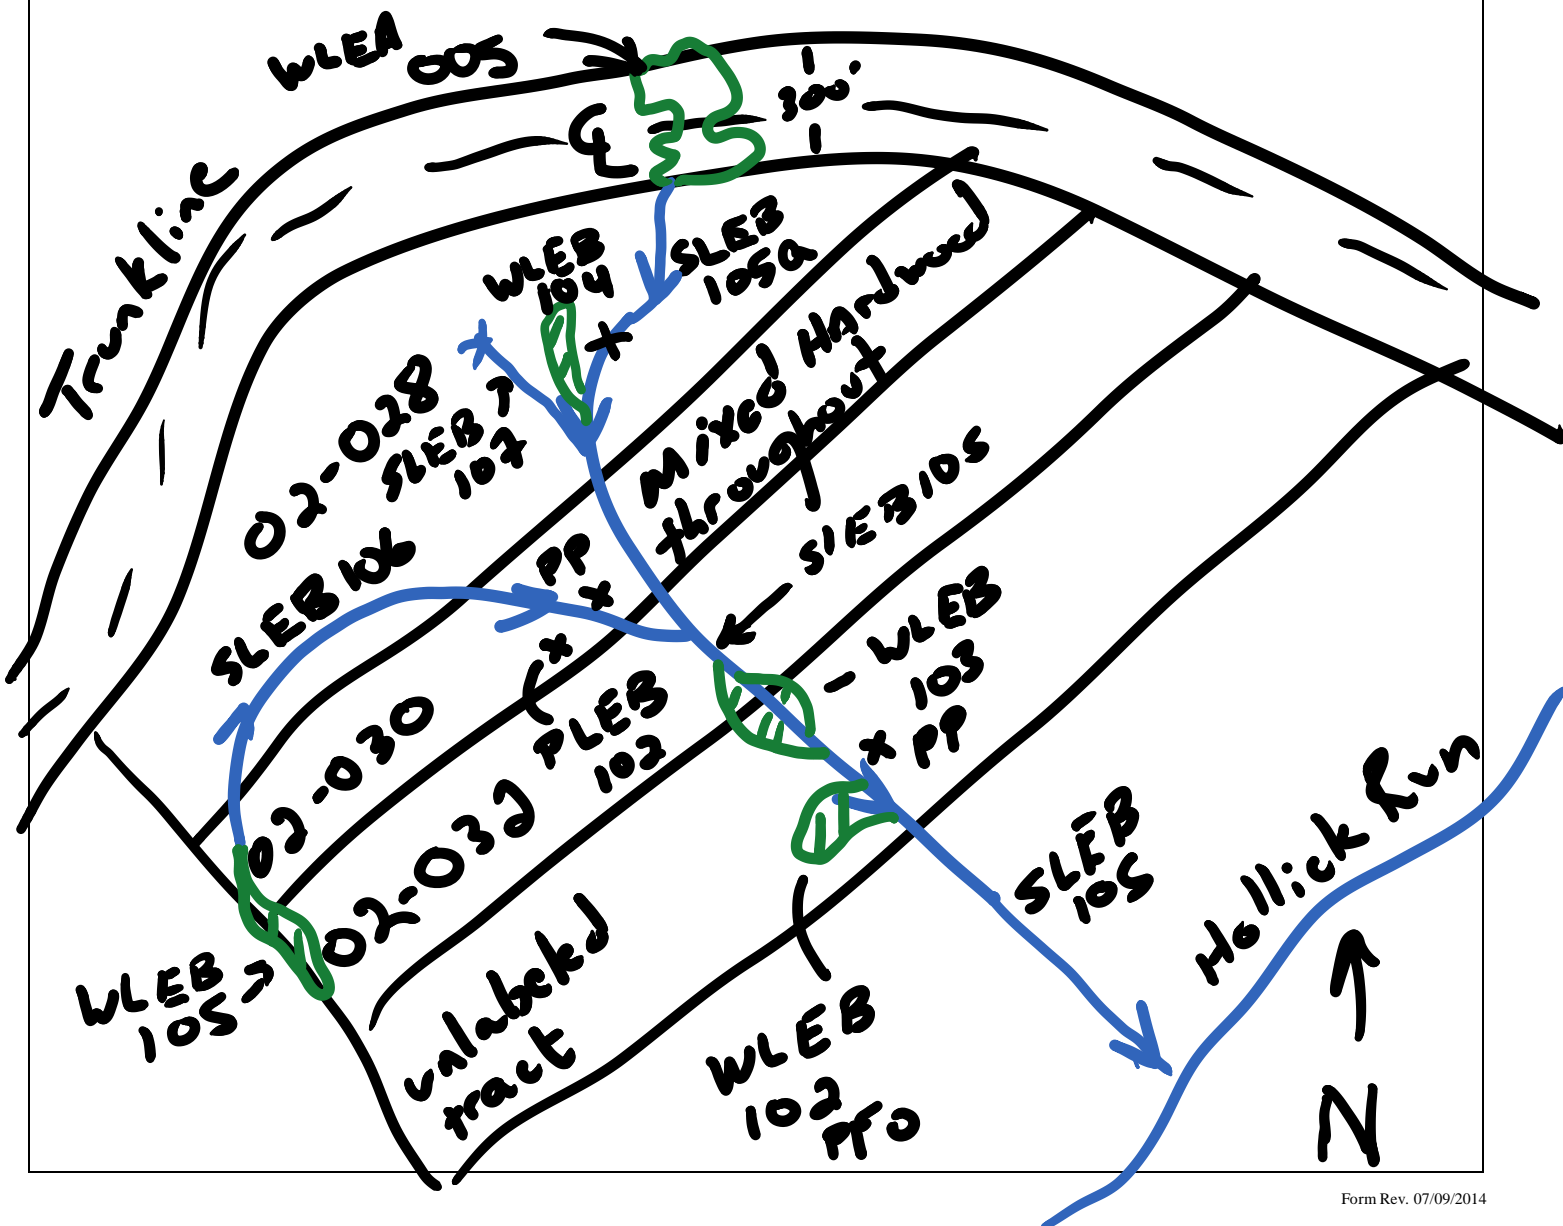
Noted strong sinuosity, good grade control, wrack lines/debris piles, some stretches with bedrock, well developed bars and benches, weak riffle pool sequence. Saw evidence of deer and raccoon use. .

Waterbody Sketch (Include north arrow, centerline, distance from centerline, data point location, survey boundary, and IDs of associated features)

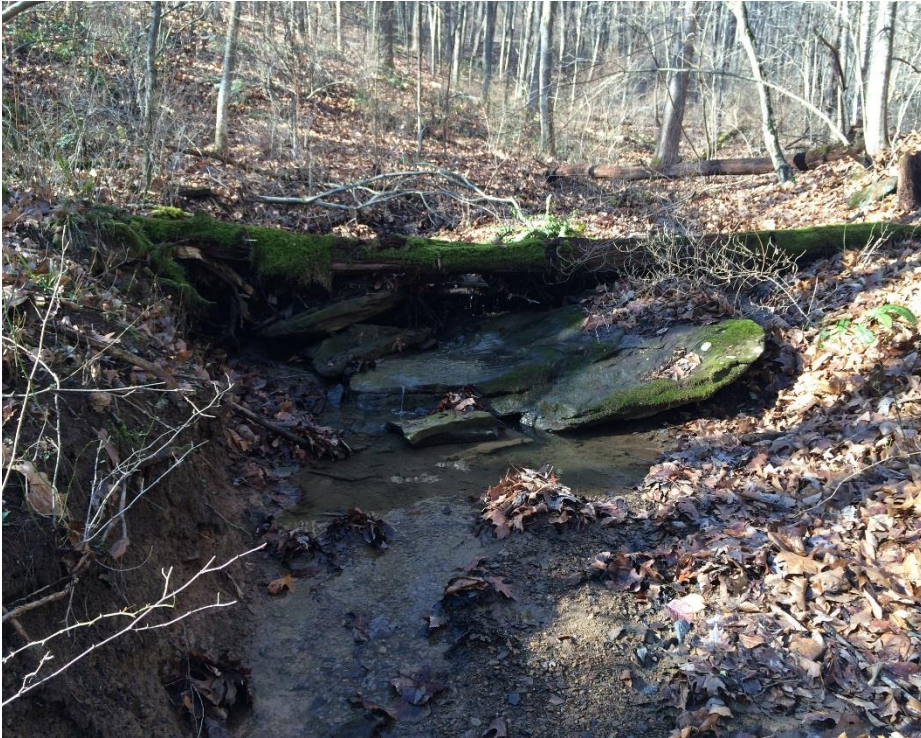
Waterbody SLEB105 facing west upstream

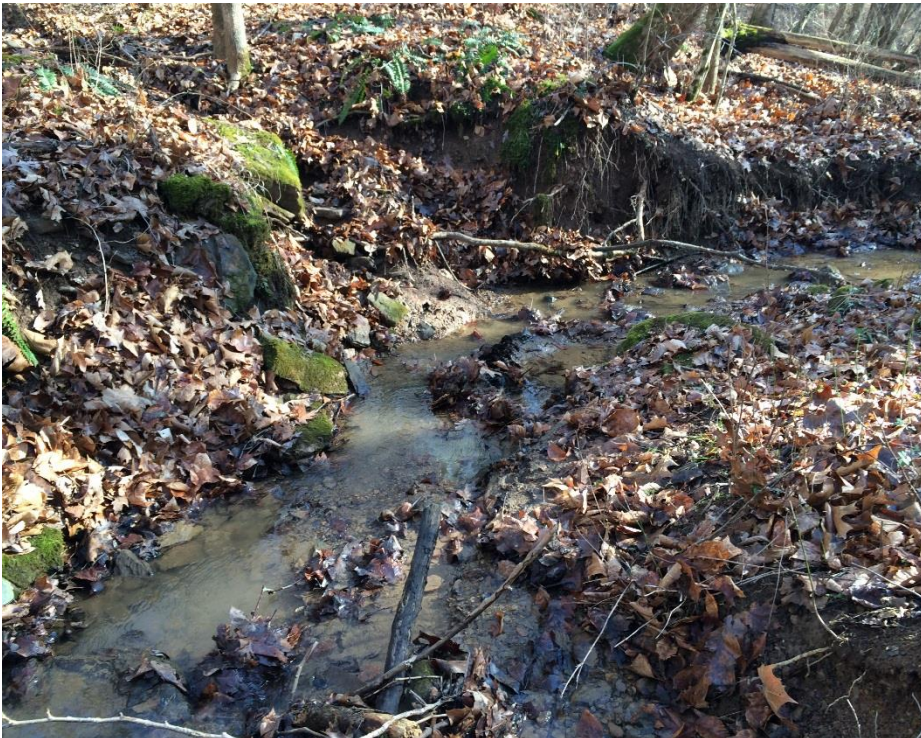
Waterbody SLEB105 facing east downstream

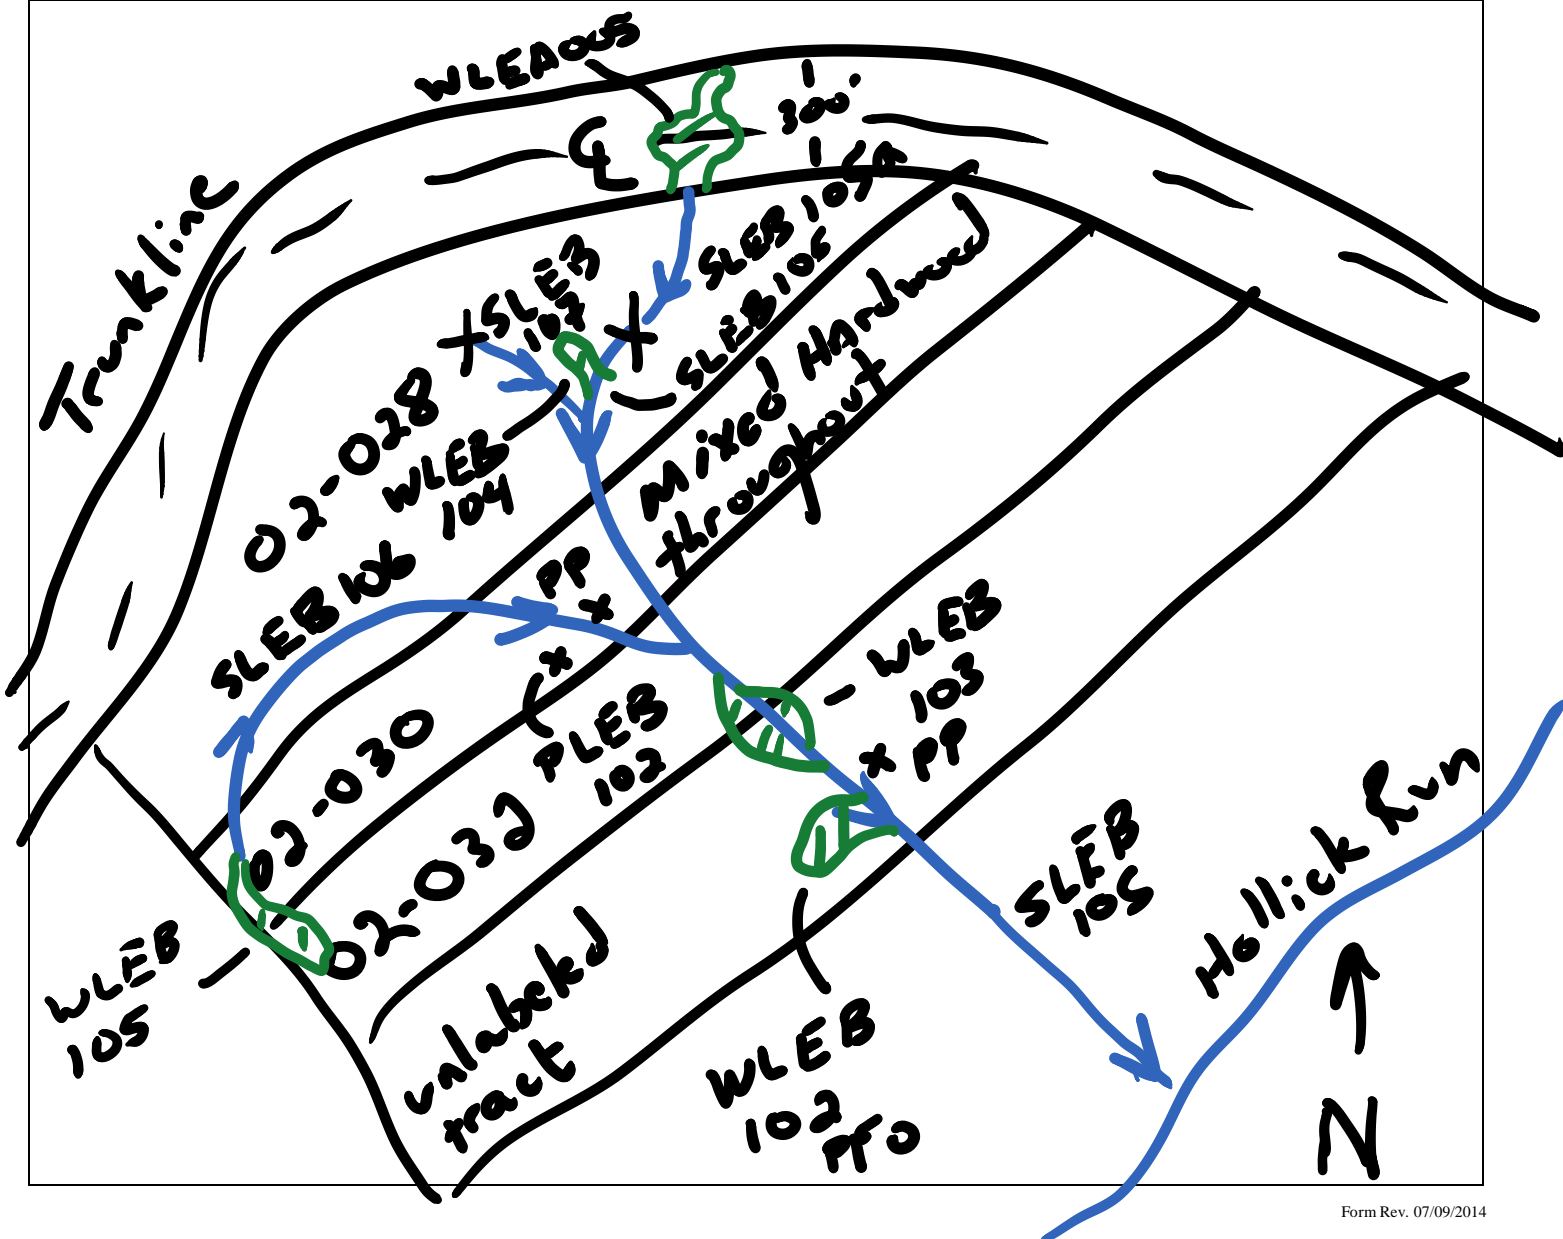
This is an ephemeral stream located in an erosional gully, with a weak to absent OHWM. Fed by WLEA005, becomes intermittent at SLEB105. Noted weak sinuosity, bank failures, good grade control, wrack lines/debris piles, weak riffle pool sequence. Flows into SLEB105. Note, heavy rains in the last 24 hours, water present at time of survey, but absent on 12/15. SLEB105a was changed to SLEB105e.

Waterbody Sketch (Include north arrow, centerline, distance from centerline, data point location, survey boundary, and IDs of associated features)

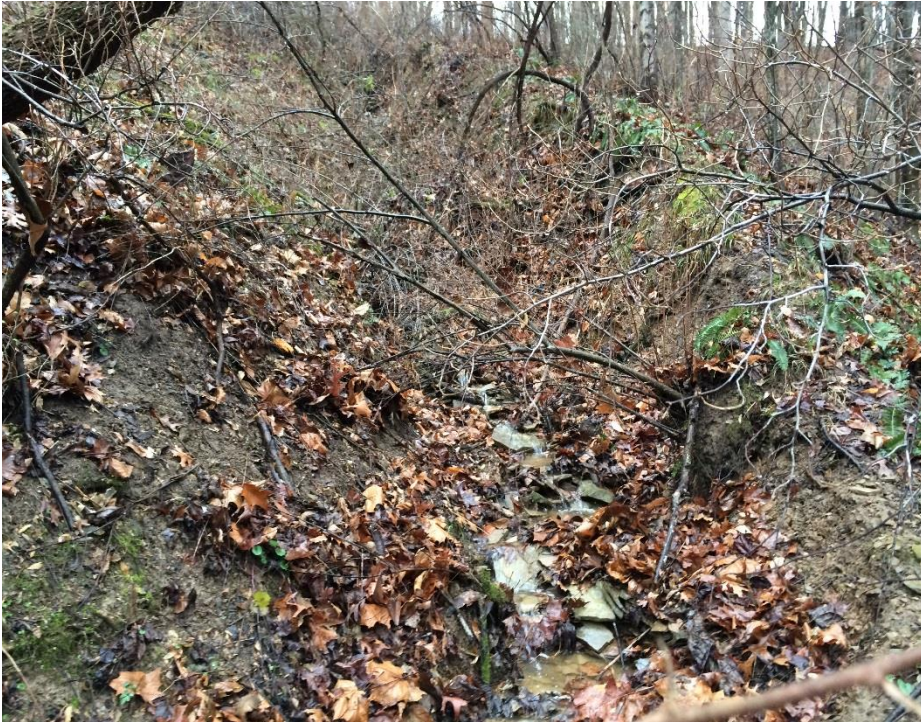
Stream SLEB105e facing north upstream

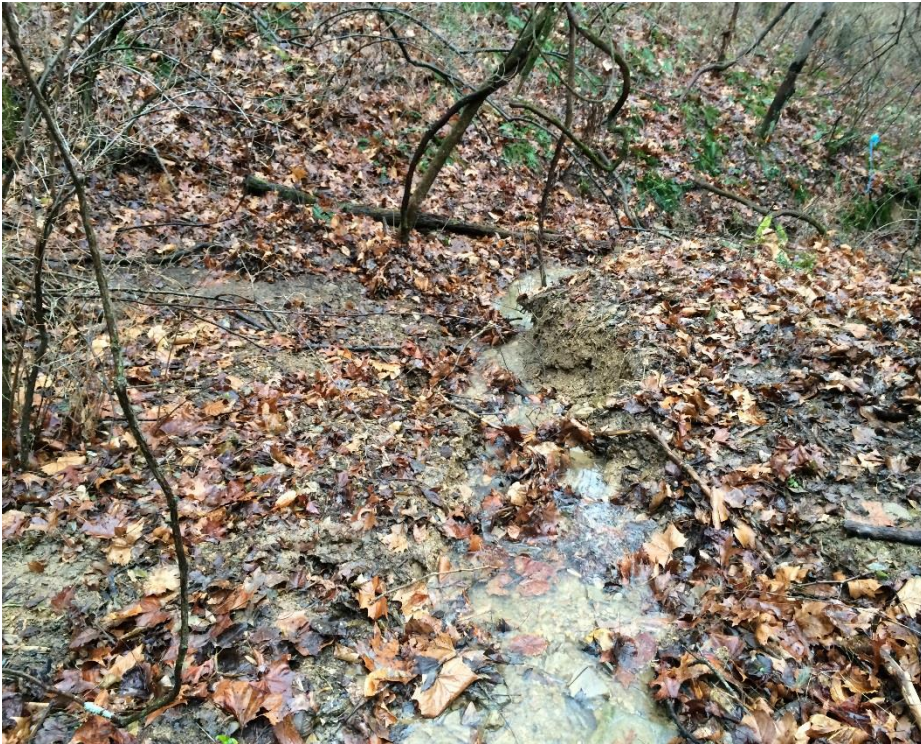
Stream SLEB105e facing south downstream

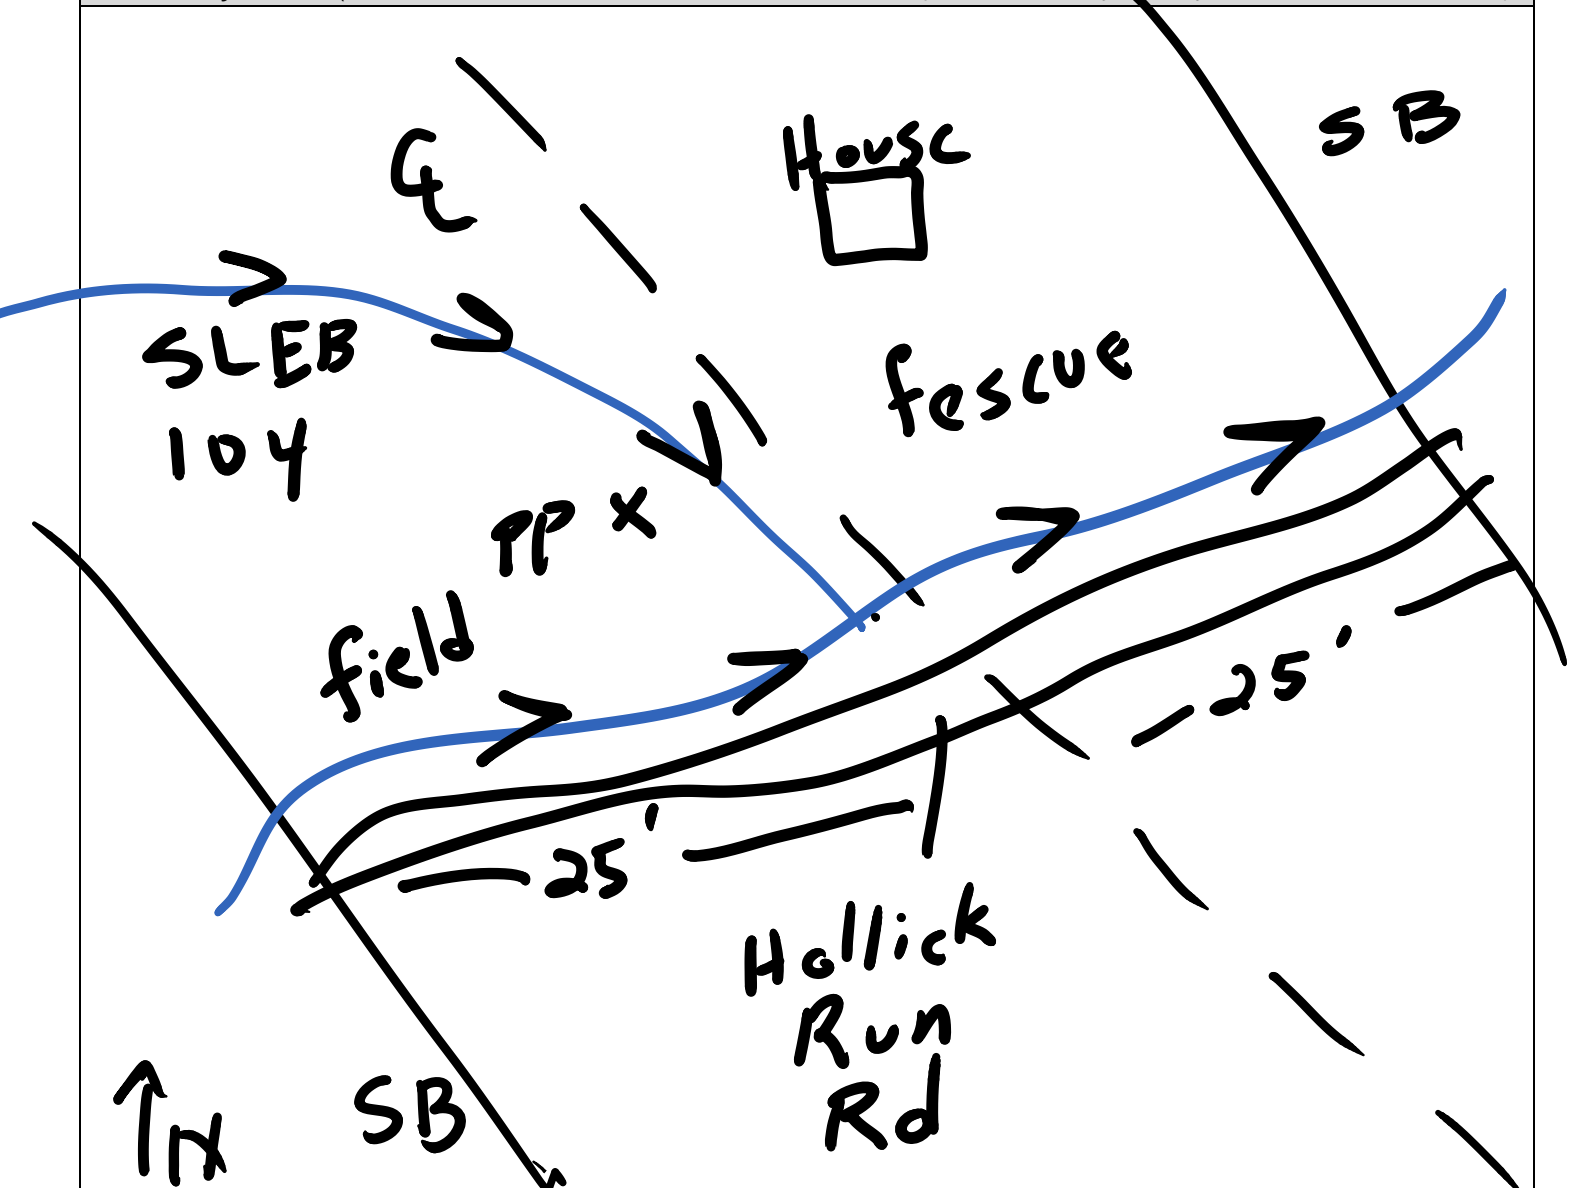
Stream originates just outside of corridor and has been diverted into ditch along the driveway.

Waterbody Sketch (Include north arrow, centerline, distance from centerline, data point location, survey boundary, and IDs of associated features)

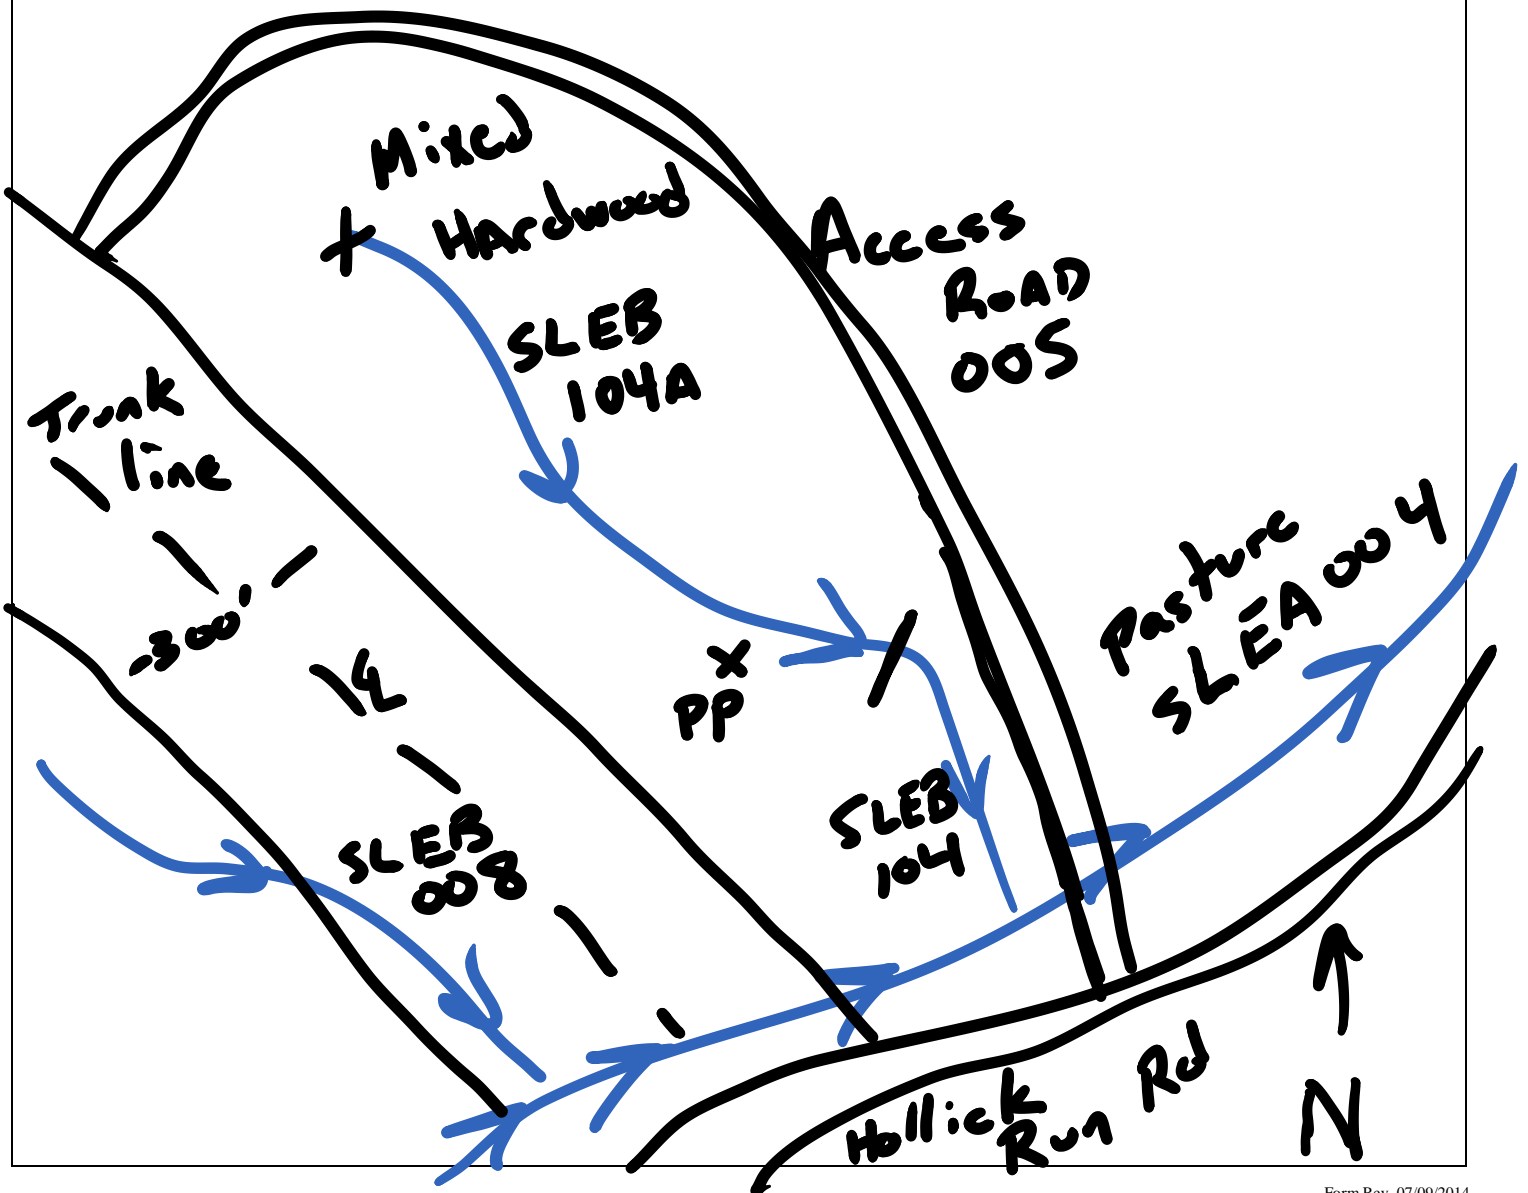
This is an extension of SLEB104. The original data point was taken along a driveway and the stream had been ditched. The extension includes an undisturbed reach. Noted moderate sinuosity, good grade control, wrack lines/debris piles, and some stretches with bedrock. SLEB104a was changed to SLEB104i.

Waterbody Sketch (Include north arrow, centerline, distance from centerline, data point location, survey boundary, and IDs of associated features)

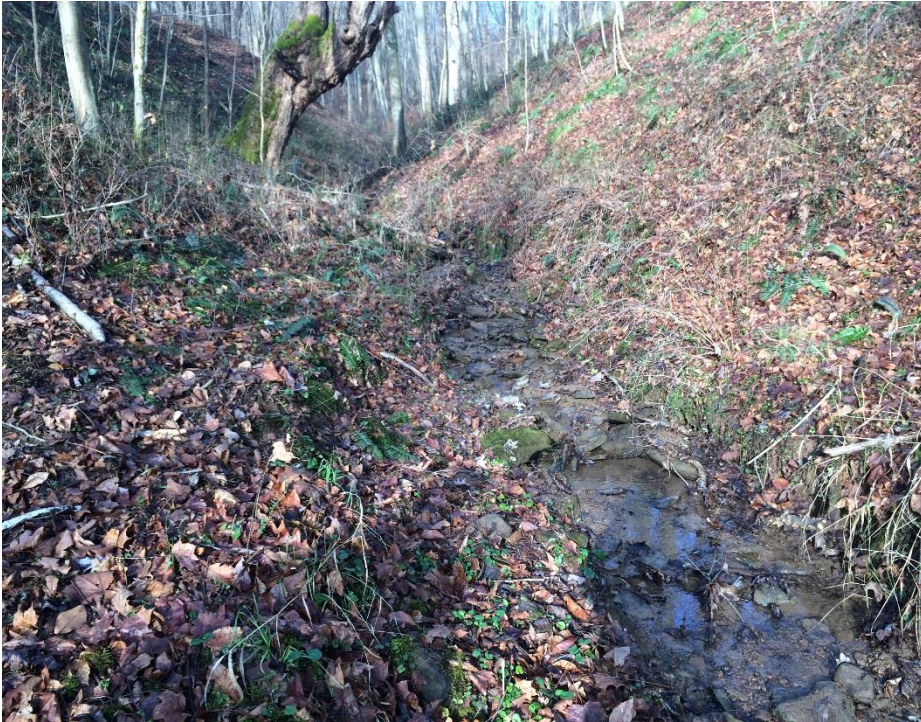
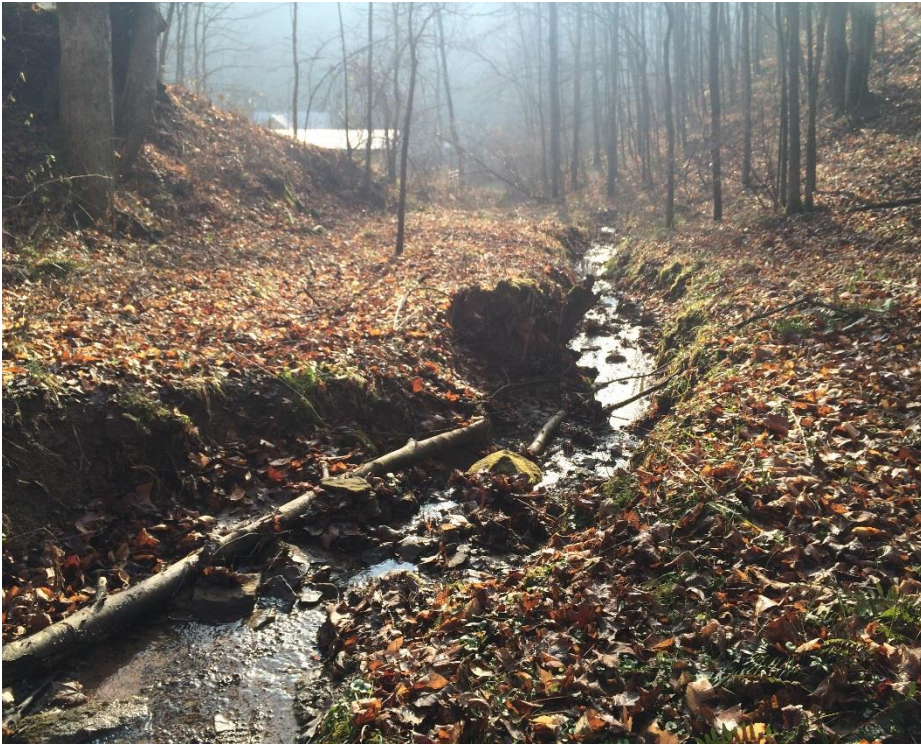
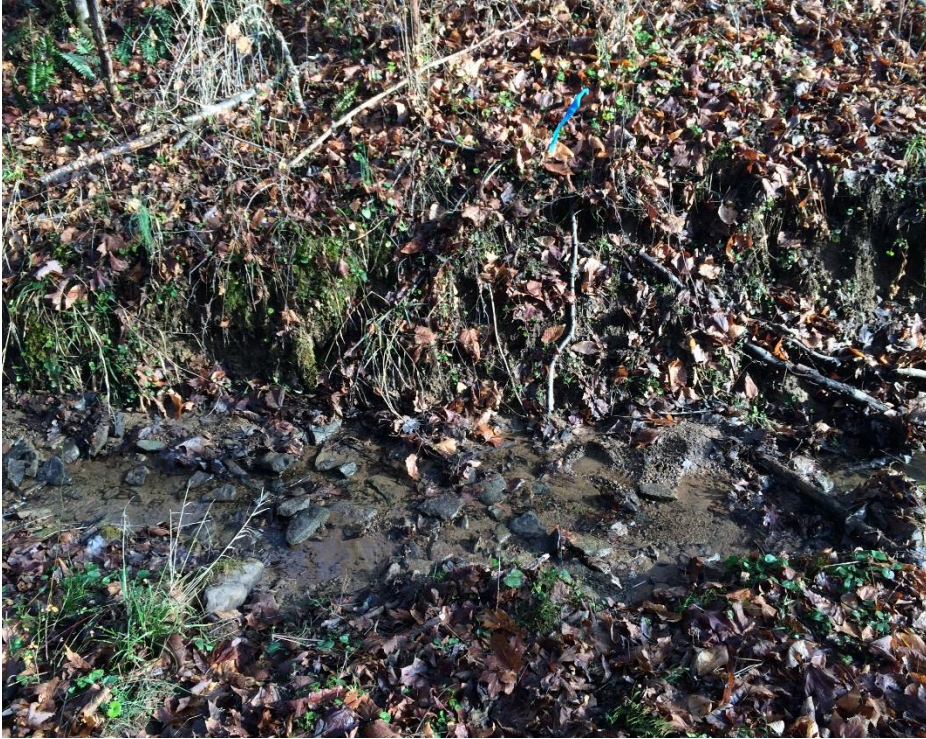
Stream SLEB104i facing north upstream

Stream SLEB104i facing south downstream

Stream SLEB104i facing east across

This is an extension of SLEB104. The original data point was taken along a driveway and the stream had been ditched. The extension includes an undisturbed reach. Noted moderate sinuosity, good grade control, wrack lines/debris piles, and some stretches with bedrock. SLEB104a was changed to SLEB104i.

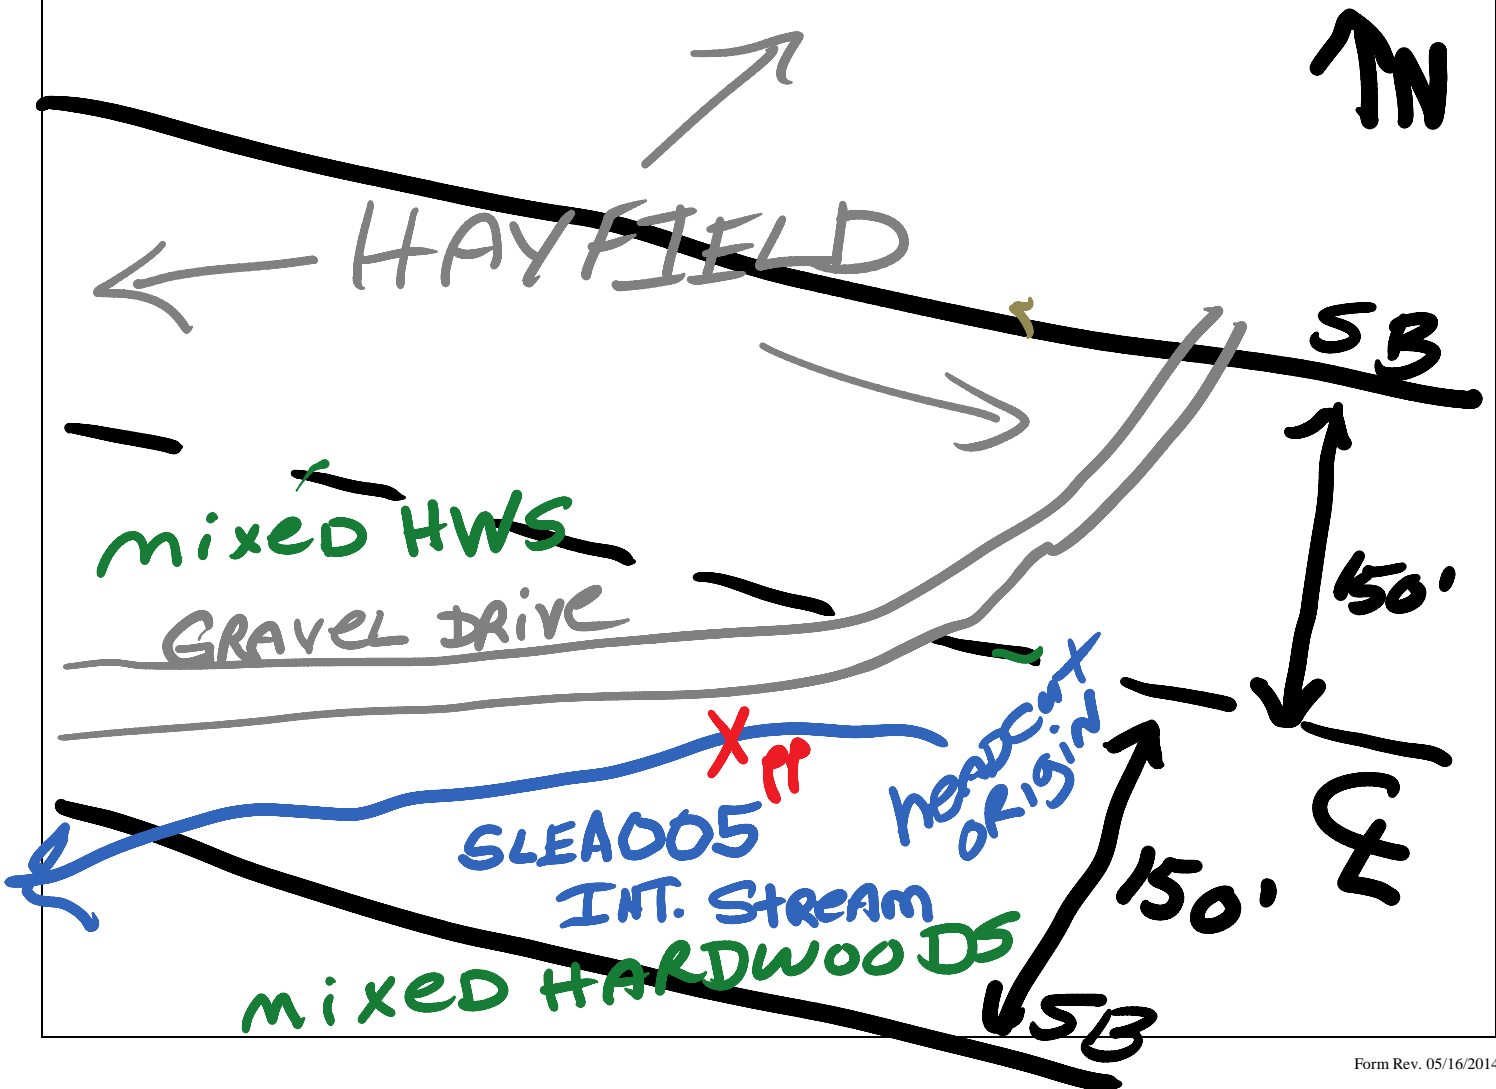
Waterbody Sketch (Include north arrow, centerline, distance from centerline, data point location, survey boundary, and IDs of associated features)

Feature begins at a headcount within the corridor; flows into Hollick Run outside the corridor.

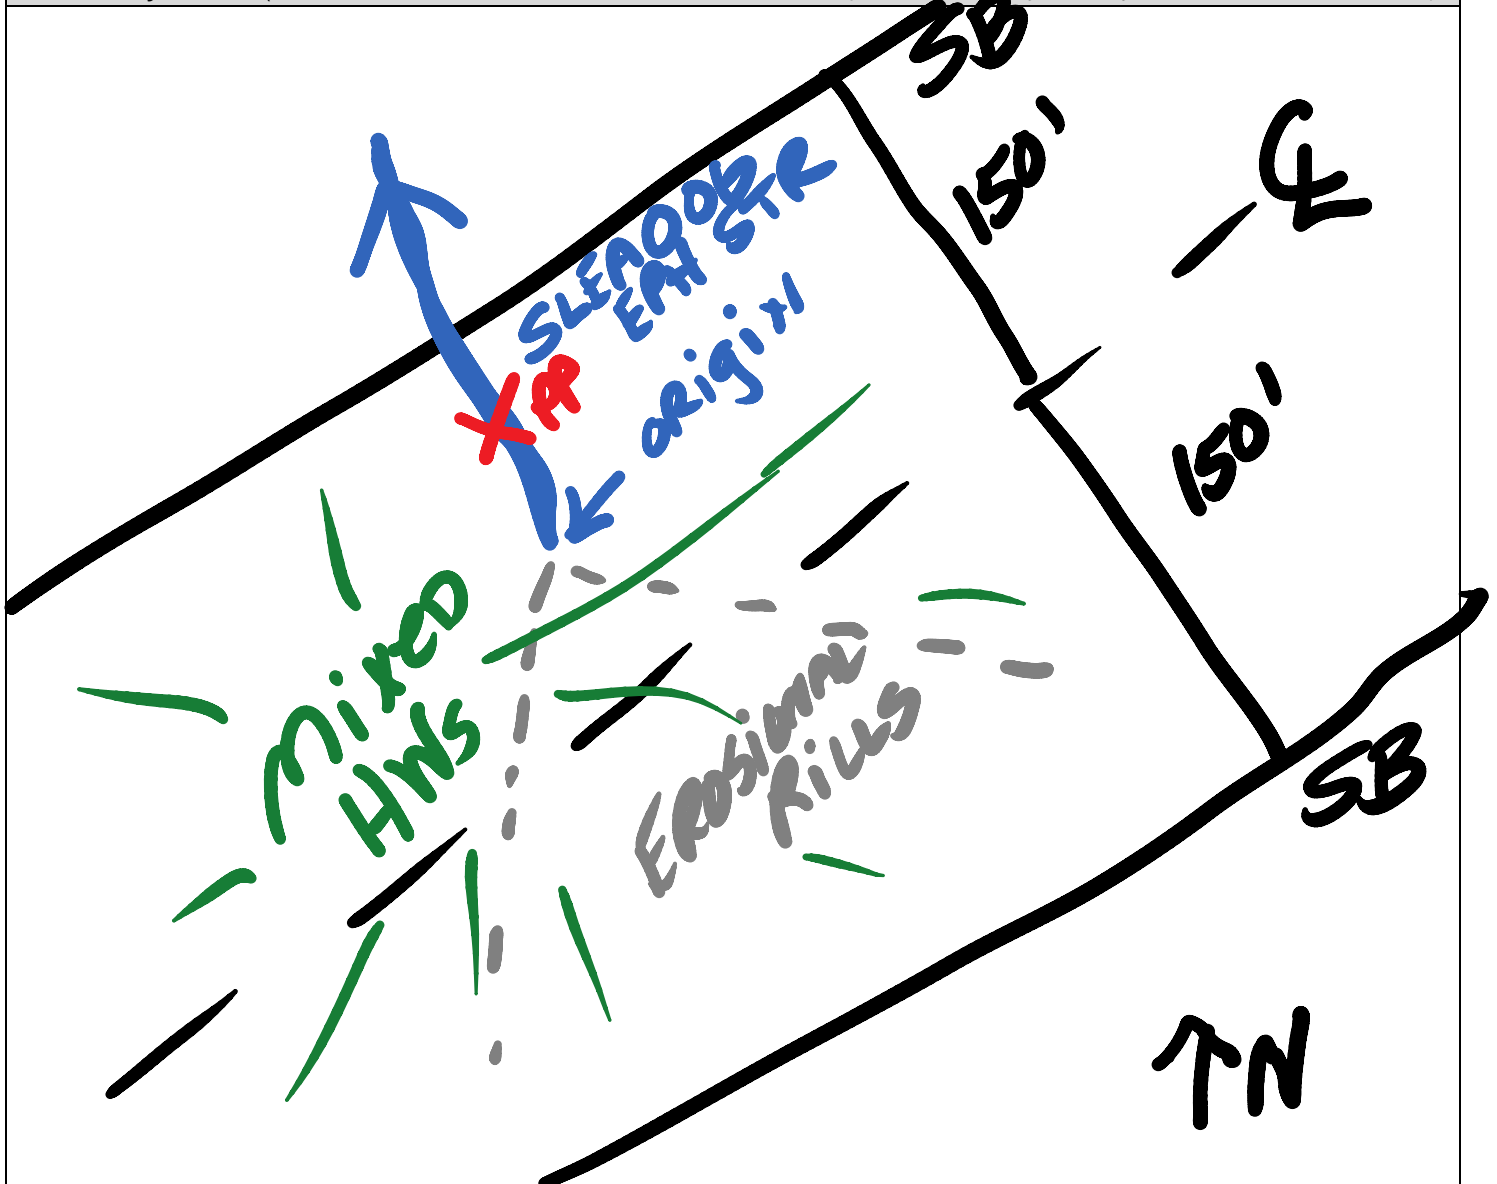
Waterbody Sketch (Include north arrow, centerline, distance from centerline, data point location, survey boundary, and IDs of associated features)

Begins within corridor where two erosional rills converge; downstream continues out of corridor where it is a tributary to West Fork River

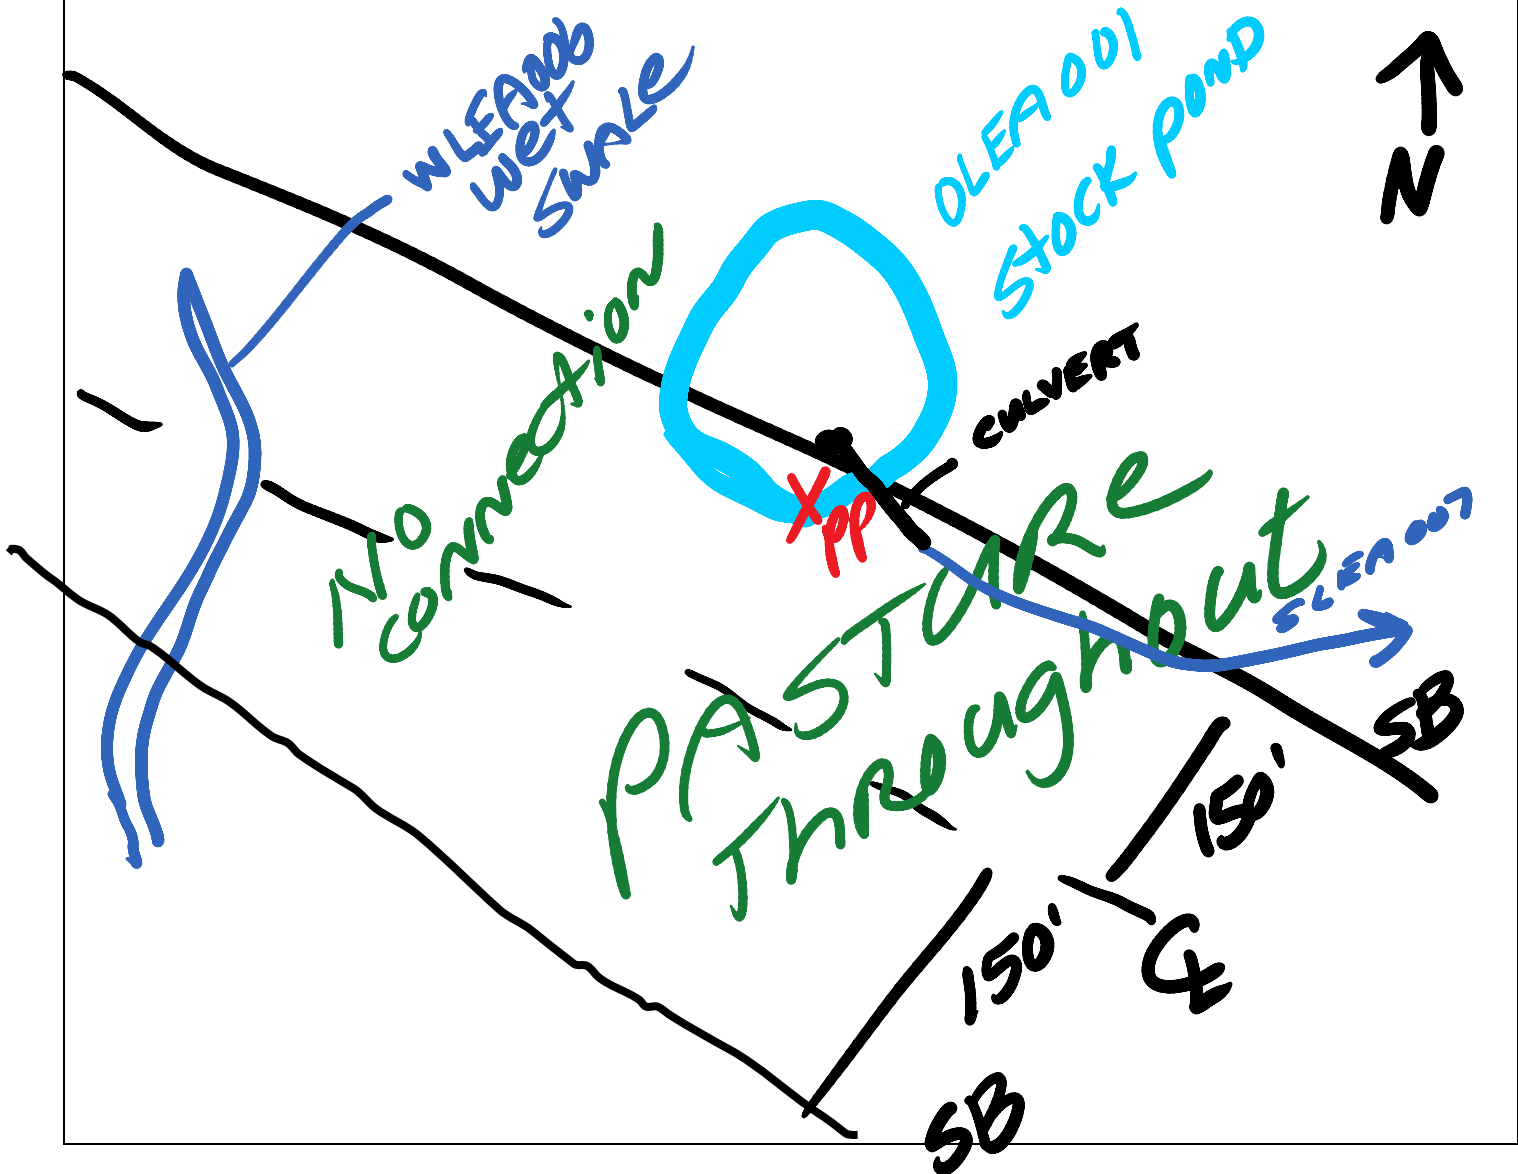
Waterbody Sketch (Include north arrow, centerline, distance from centerline, data point locations, survey boundary, and IDs of associated features)

Intermittent stream (SLEA007) is outflow from pond via culvert

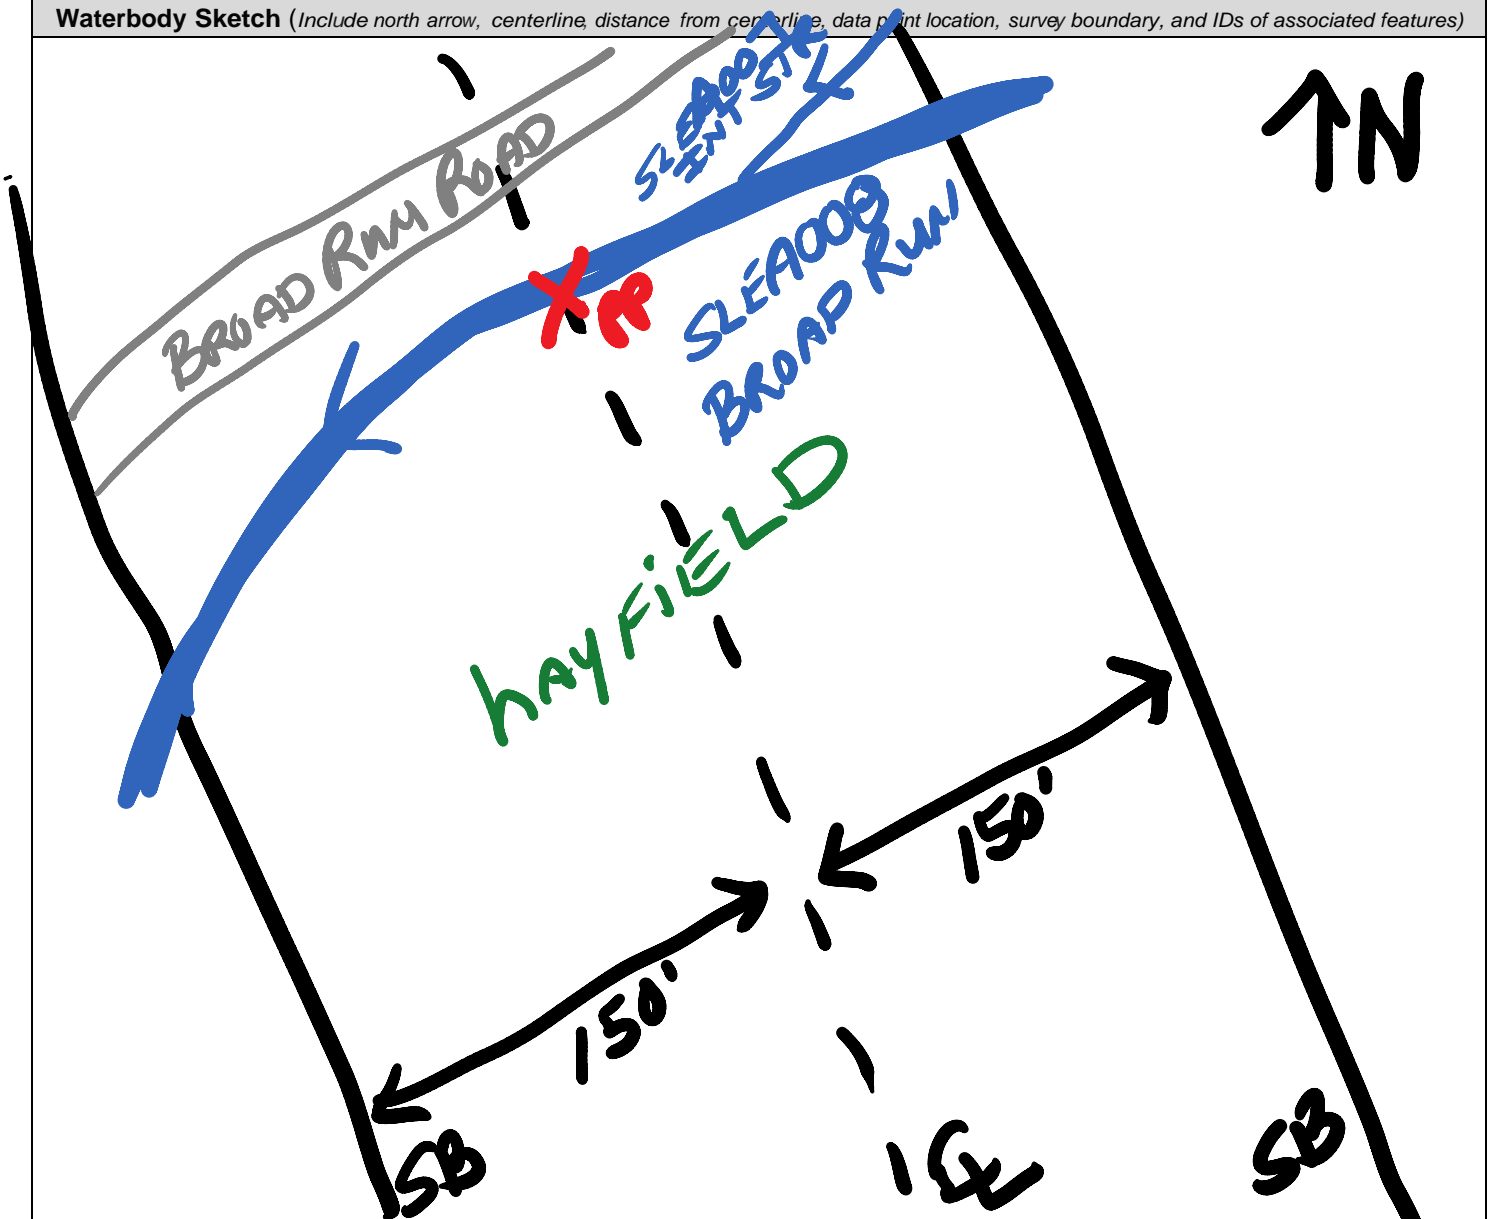
Waterbody Sketch (Include north arrow, centerline, distance from centerline, data point location, survey boundary, and IDs of associated features)

We were asked to leave the property before stream GPS mapping could be completed. Mapping finished in the office.

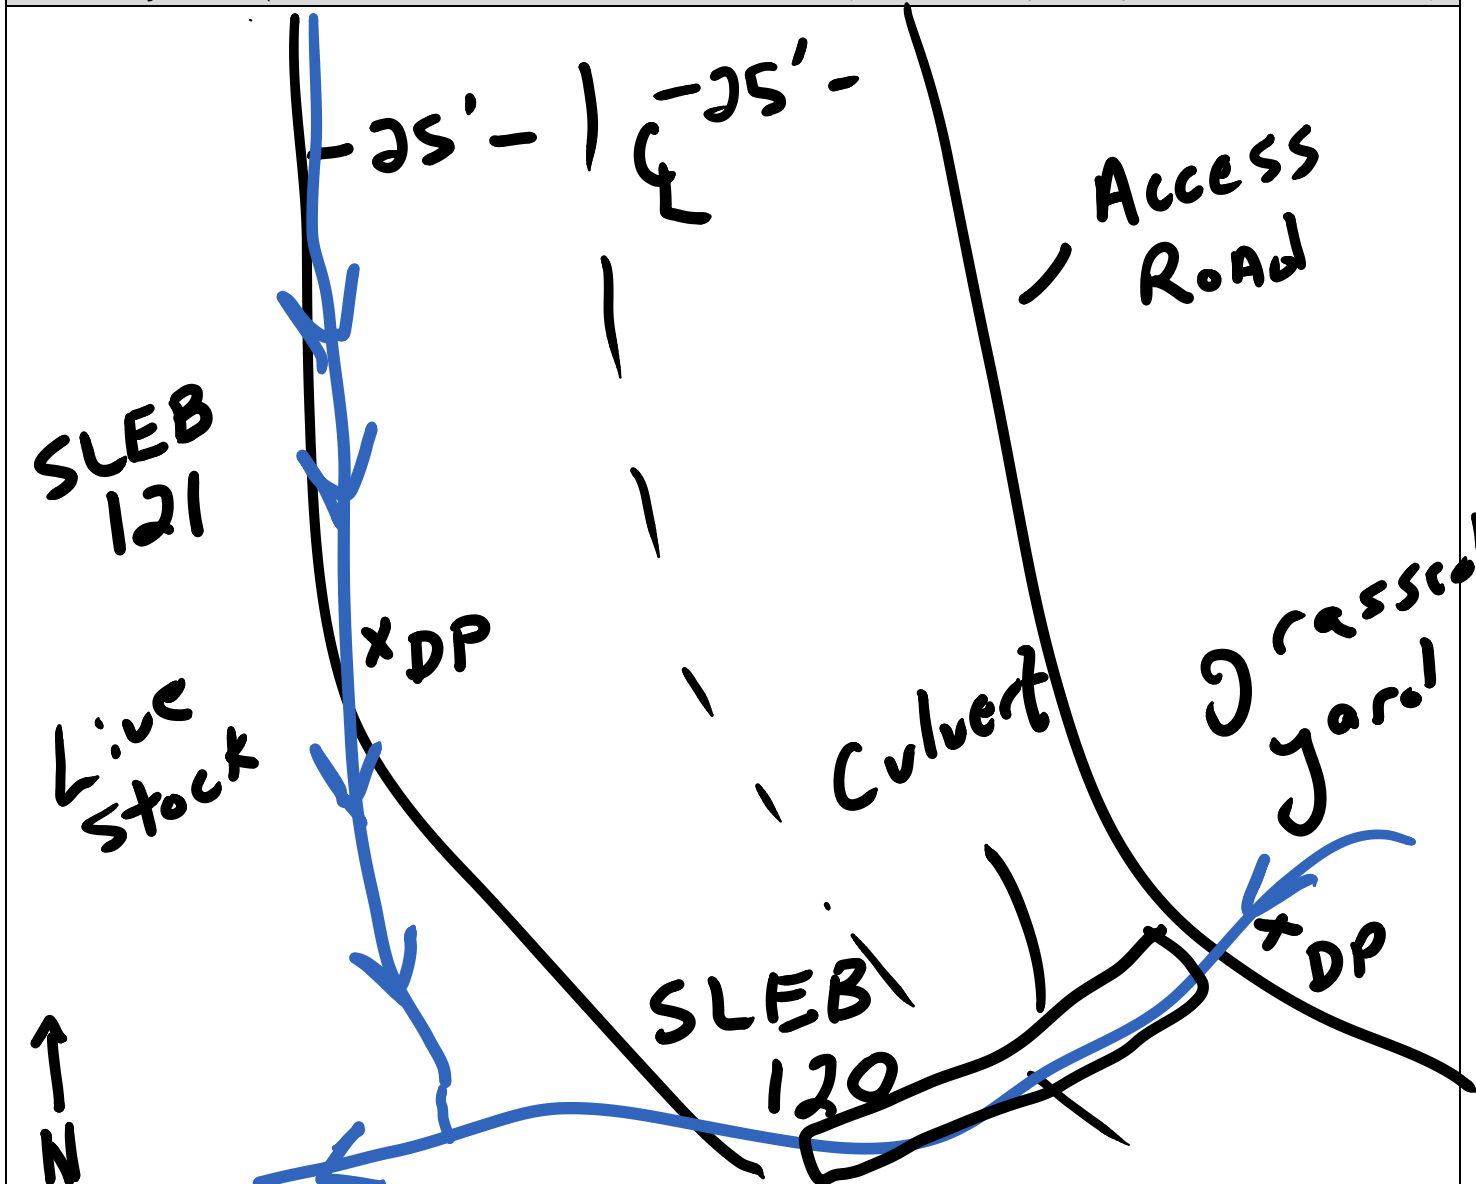
Waterbody Sketch (Include north arrow, centerline, distance from centerline, data point location, survey boundary, and IDs of associated features)

Degraded intermittent stream in livestock pasture. Noted bank failures, week grade control, no sinuosity, and no macrobenthos. Conveys storm water from county road.
