Linear Waterbody Data Sheet

Survey Description			
Project Name: Southeast Reliability		Waterbody Name: Kincheloe Creek	
Waterbody ID: SLEA001		Date: 6/11/2014	
State: West Virginia	County/Parish: Lewis	Company: Natural Resource Group	Crew Member Initials: GB, SK, LE, TP
Photos: 3			
Tract Number(s): 01-016, 01-017		Nearest Milepost: 1.15	Associated Wetland ID(s): WLEB001
Survey Type: <i>(check one)</i> <input checked="" type="checkbox"/> Centerline <input type="checkbox"/> Re-Route <input type="checkbox"/> Access Road <input type="checkbox"/> Other:			
Physical Attributes			
Stream Classification: <i>(check one)</i> <input type="checkbox"/> Ephemeral <input type="checkbox"/> Intermittent <input checked="" type="checkbox"/> Perennial			
Waterbody Type: <i>(check one)</i> <input type="checkbox"/> River <input checked="" type="checkbox"/> Stream <input type="checkbox"/> Ditch <input type="checkbox"/> Canal <input type="checkbox"/> Other:

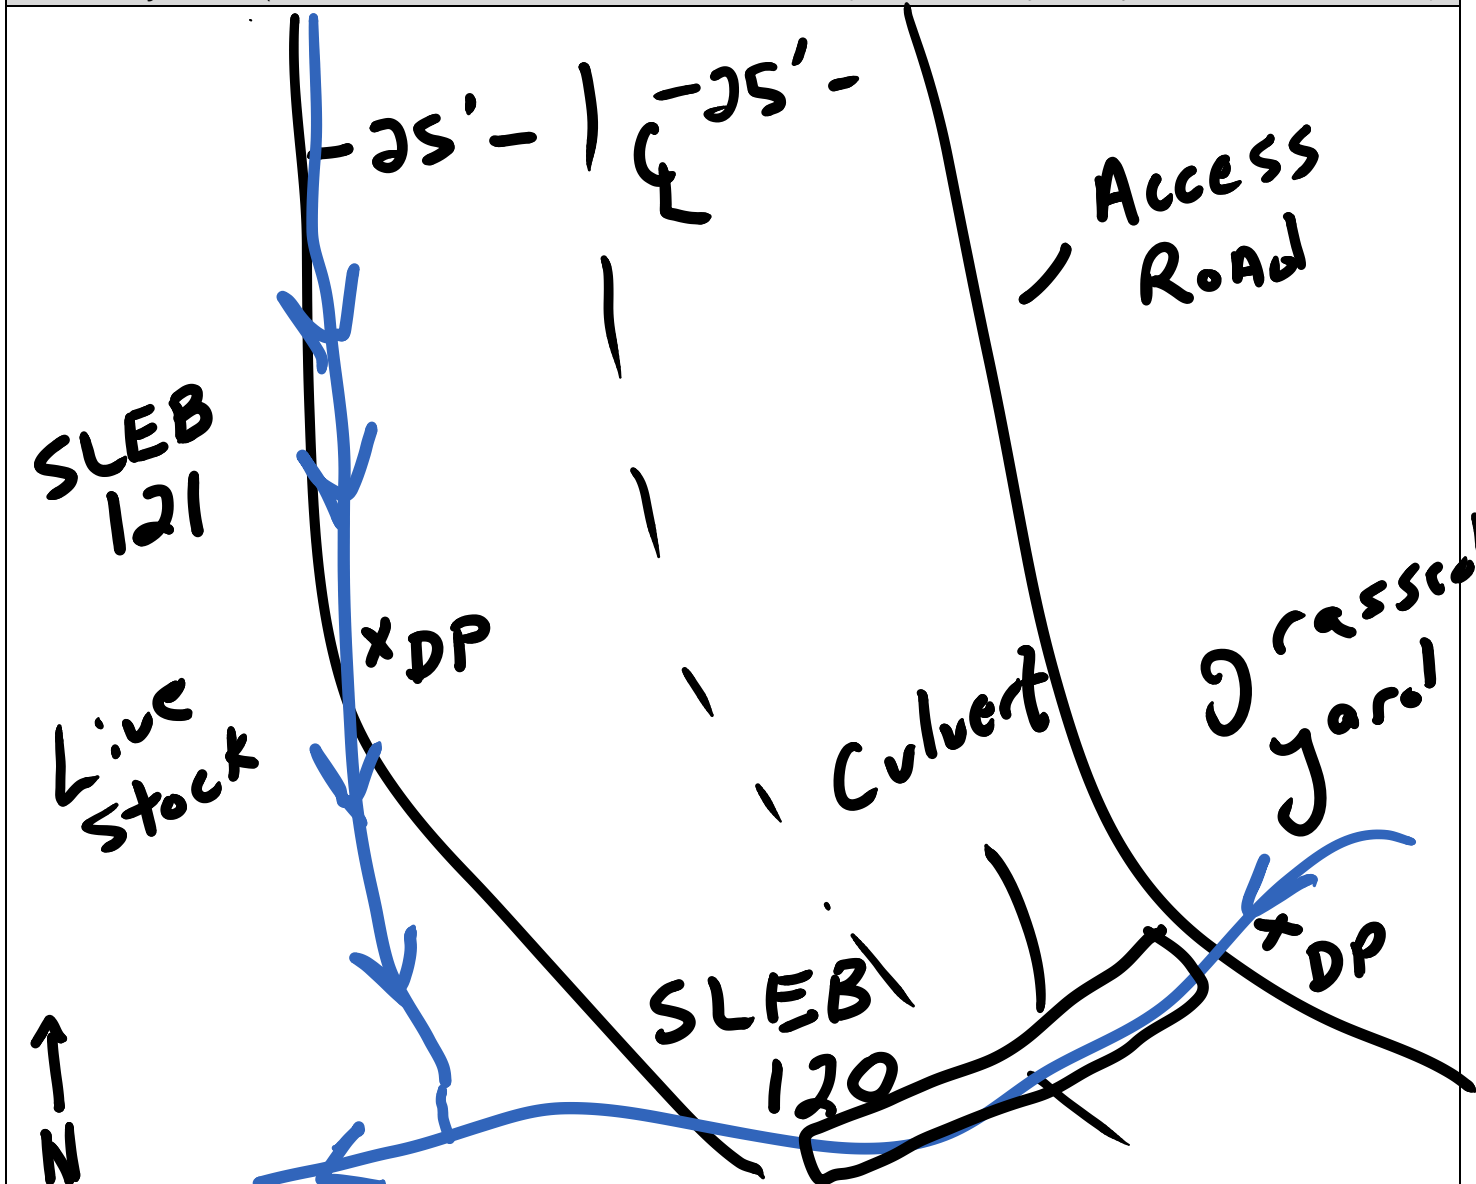
Waterbody Sketch (Include north arrow, centerline, distance from centerline, data point location, survey boundary, and IDs of associated features)

Degraded perennial stream in livestock pasture. Noted bank failures, weak grade control, weak sinuosity, moderate bars and benches, and no macrobenthos.

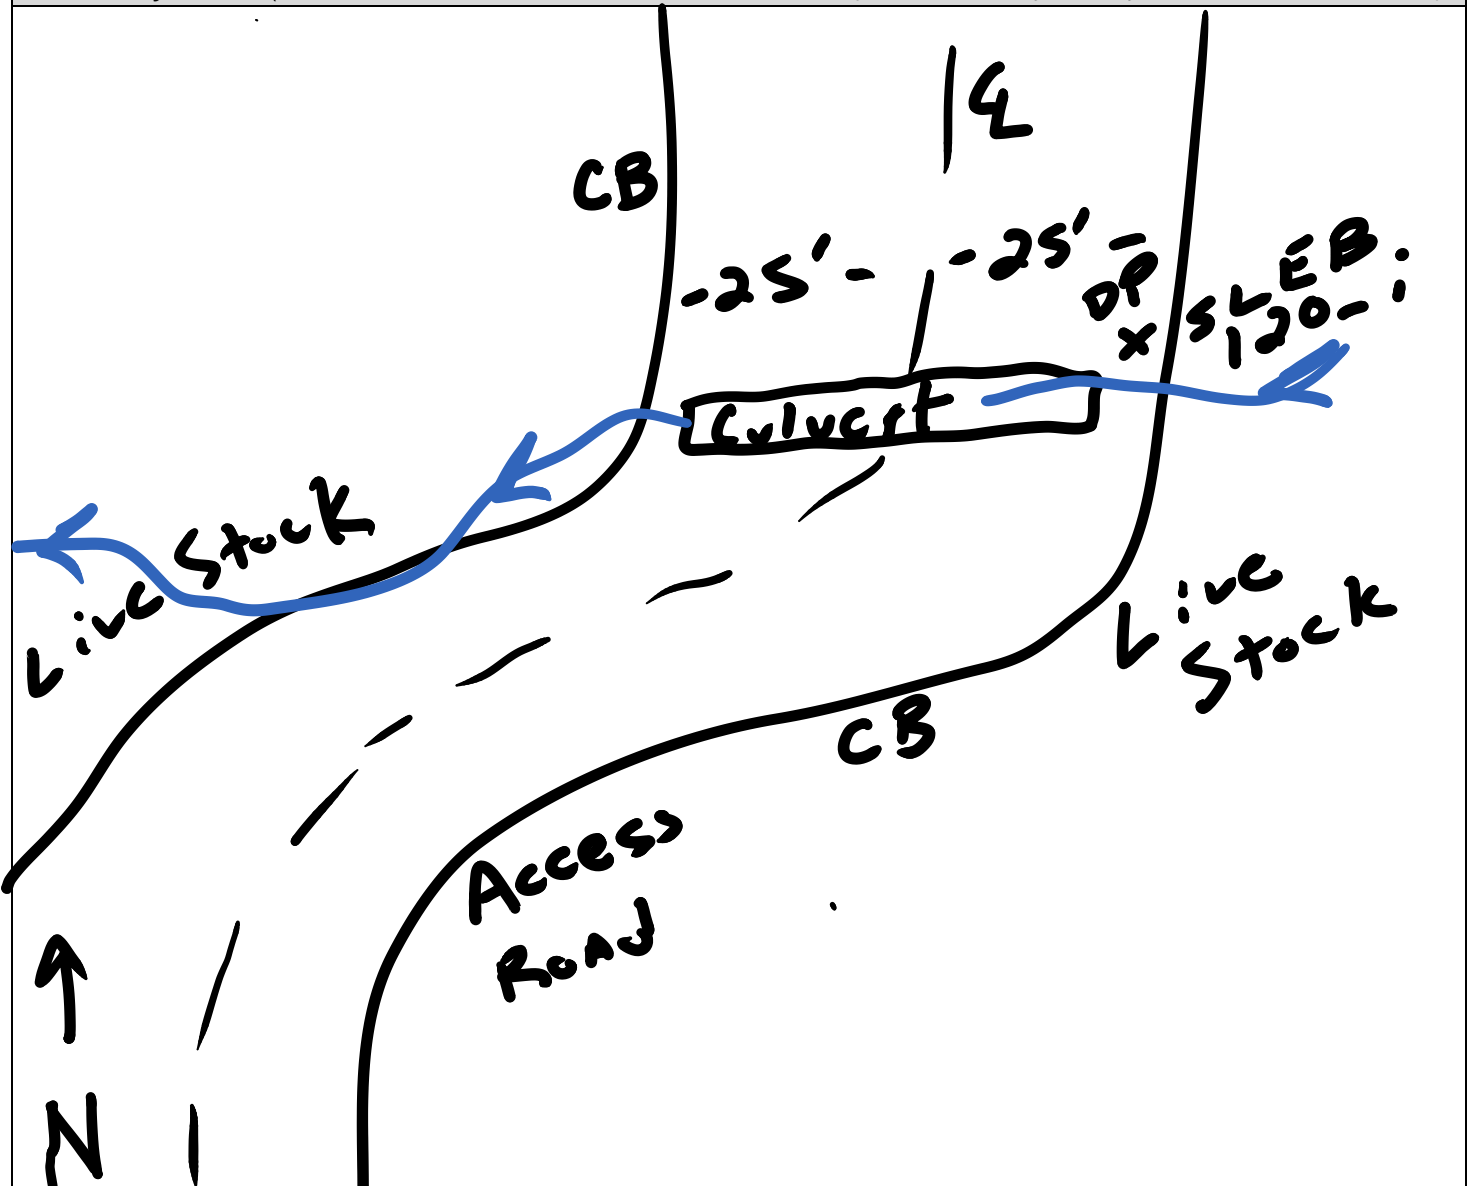
Waterbody Sketch (Include north arrow, centerline, distance from centerline, data point location, survey boundary, and IDs of associated features)

Degraded perennial stream in livestock pasture. Part of stream is intermittent. Noted bank failures, moderate grade control, weak sinuosity, weak bars and benches, rooted wetland plants in channel, and no macrobenthos.

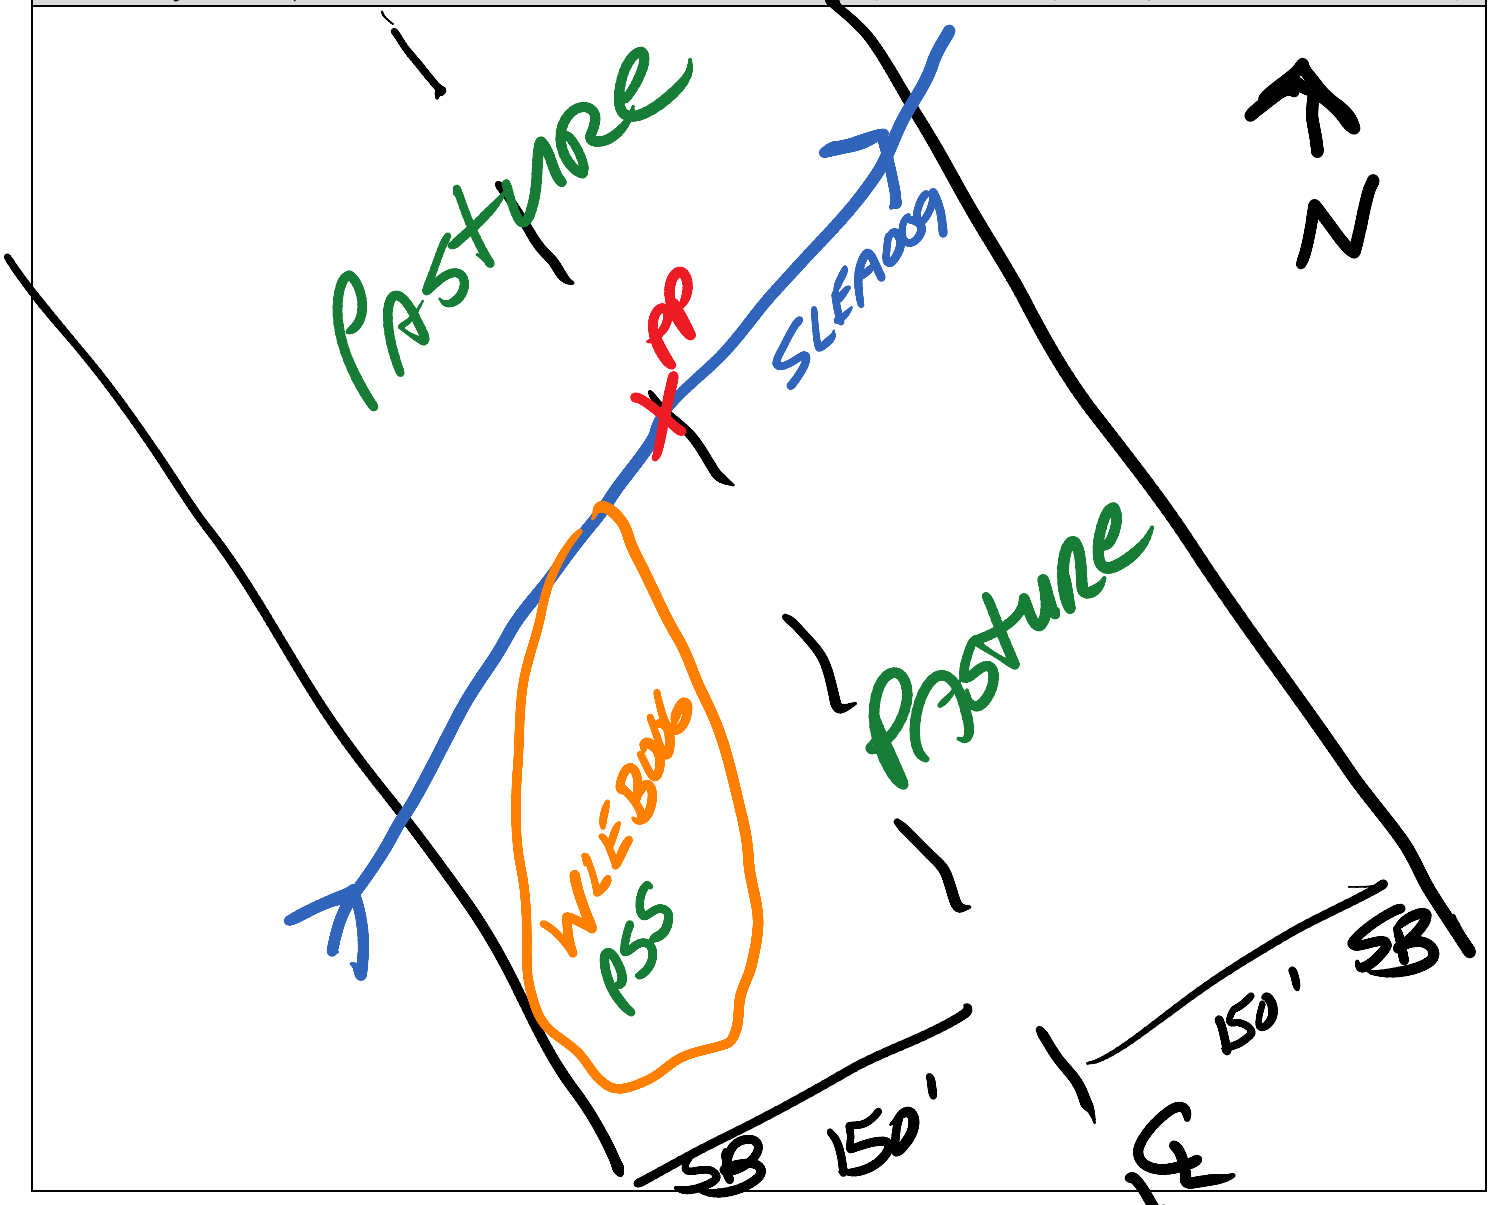
Waterbody Sketch (Include north arrow, centerline, distance from centerline, data point location, survey boundary, and IDs of associated features)

Stream is severely impacted by cattle trampling; NDH int. stream which is a tributary to Broad Run.

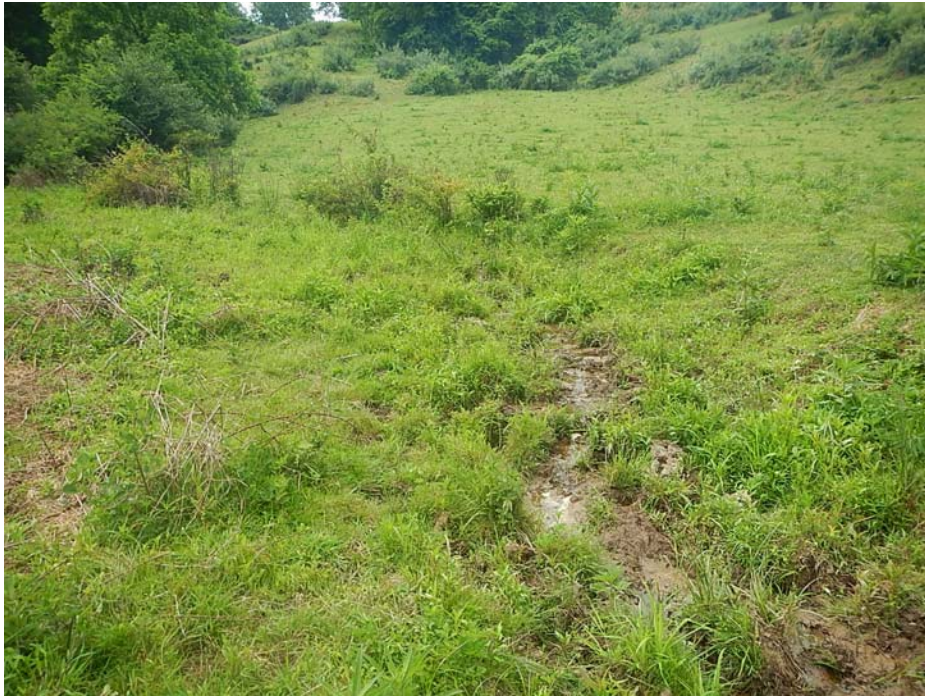
Waterbody SLEA009 facing west upstream

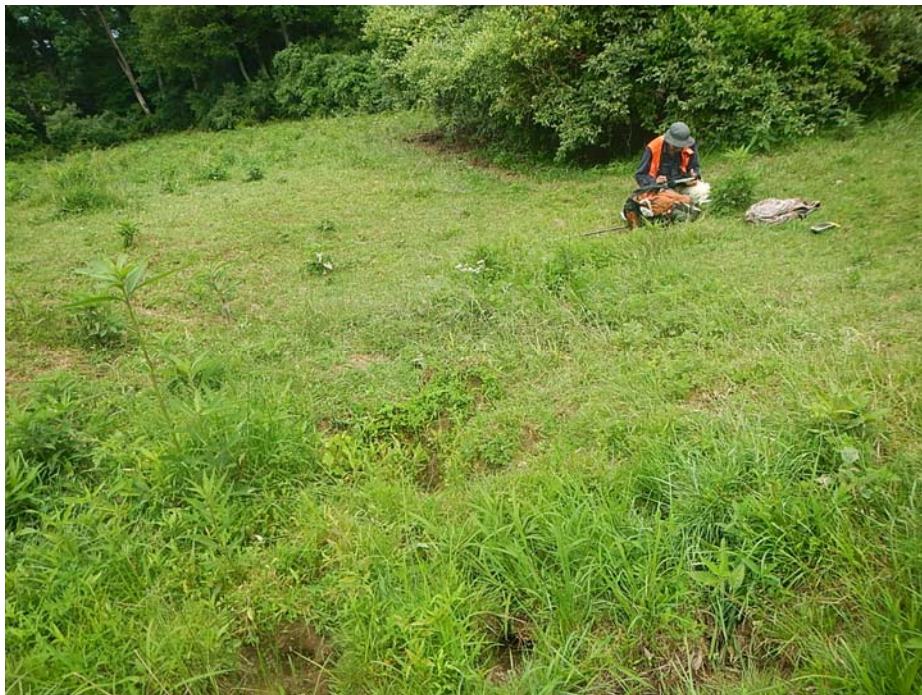
Waterbody SLEA009 facing east downstream

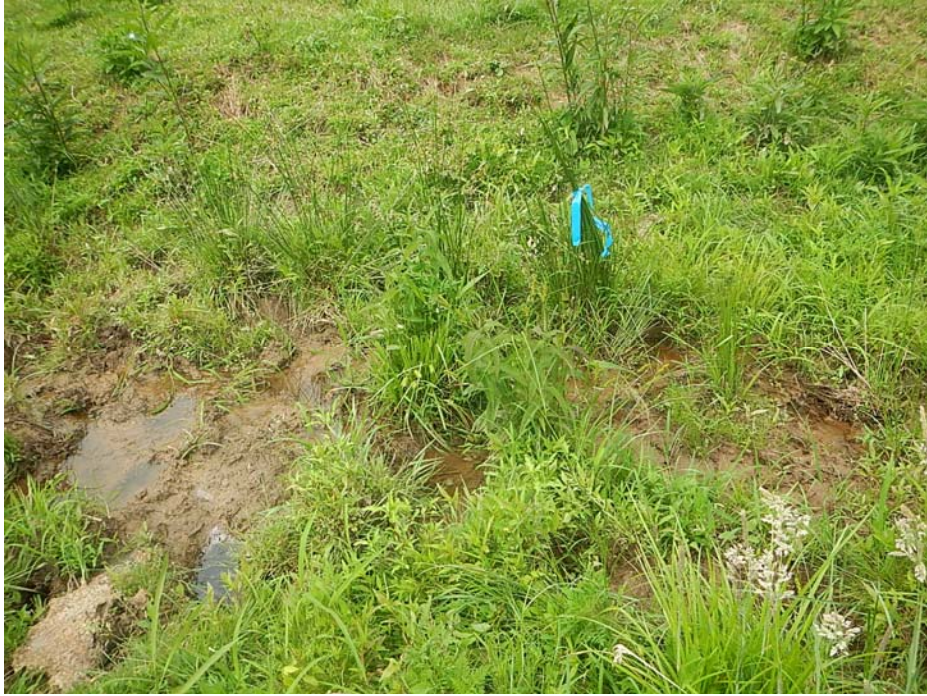
Waterbody SLEA009 facing north across

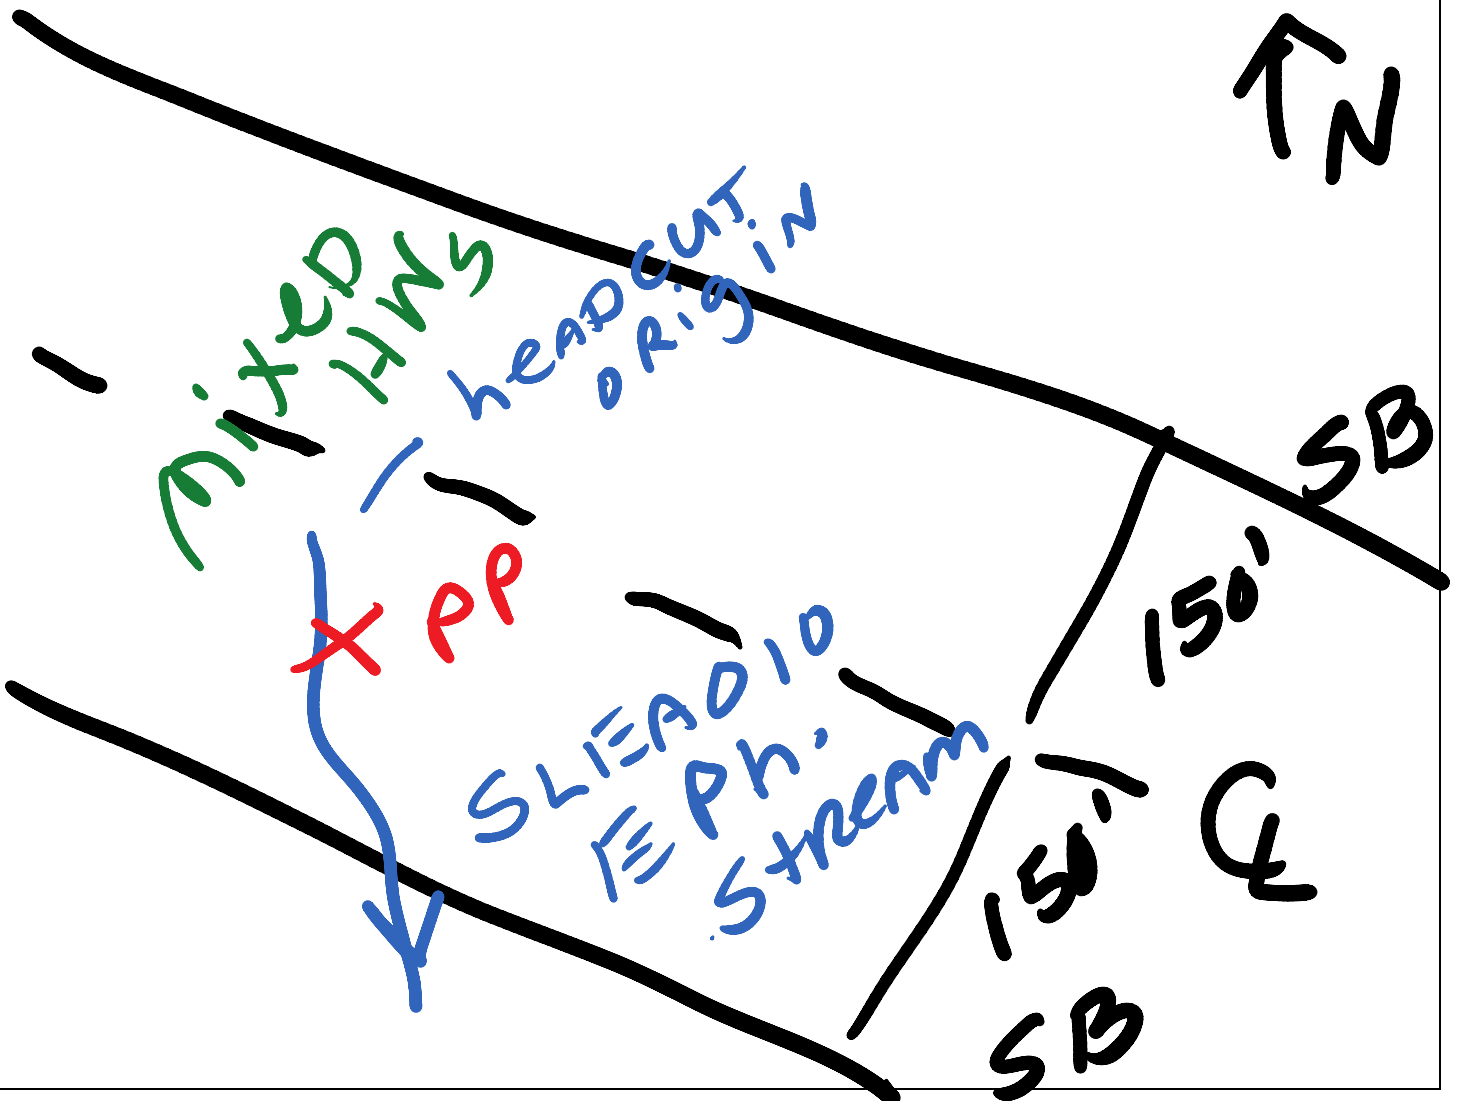
Waterbody Sketch (Include north arrow, centerline, distance from centerline, data point location, survey boundary, and IDs of associated features)

Begins within corridor at headcut; downstream continues out of corridor where it is a tributary to Sycamore Lick

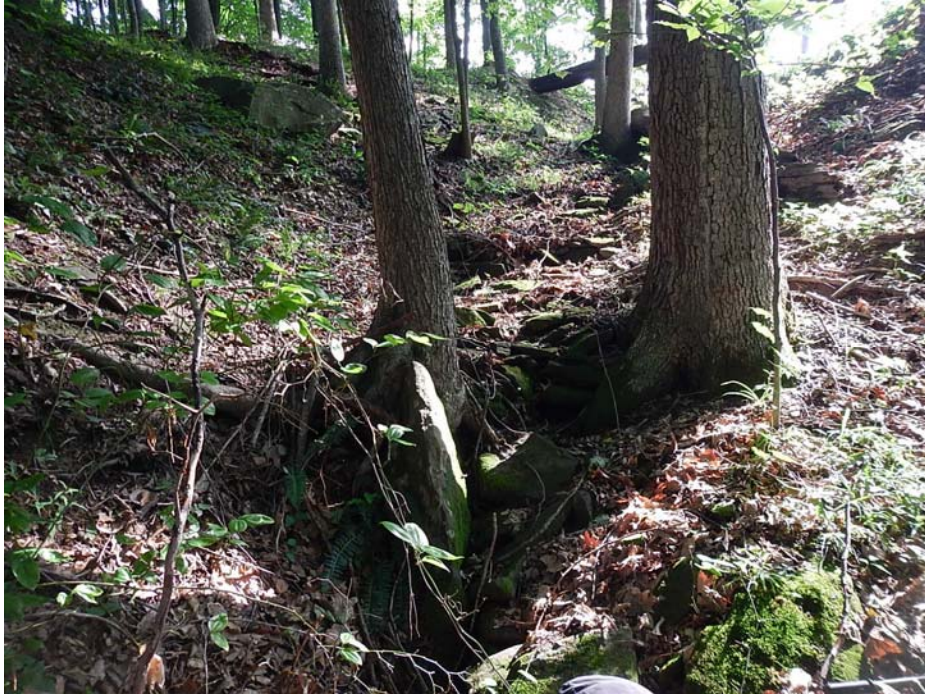
Waterbody SLEA010 facing north upstream

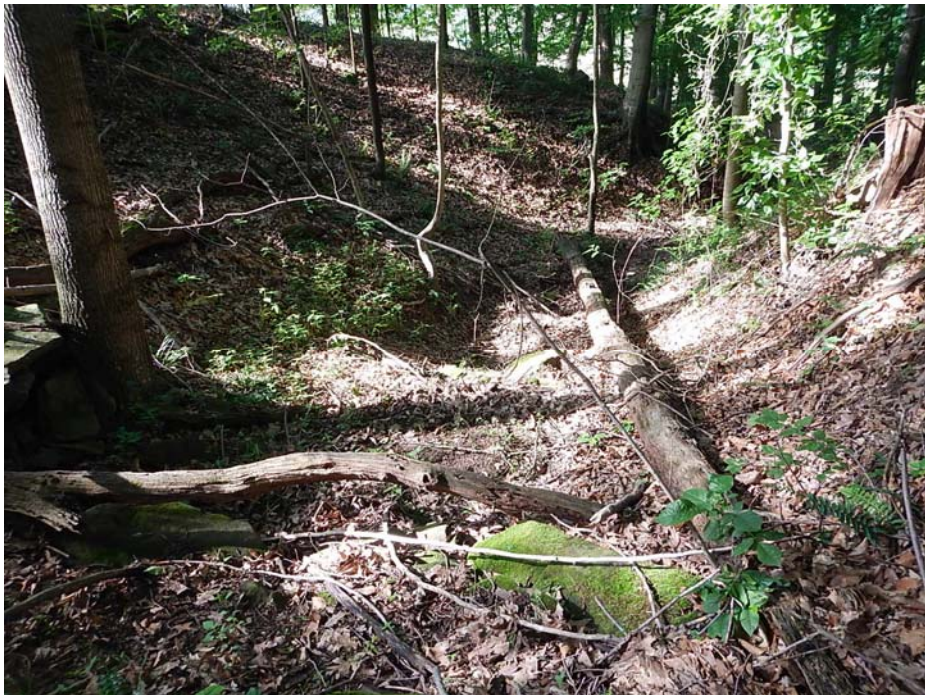
Waterbody SLEA010 facing south downstream

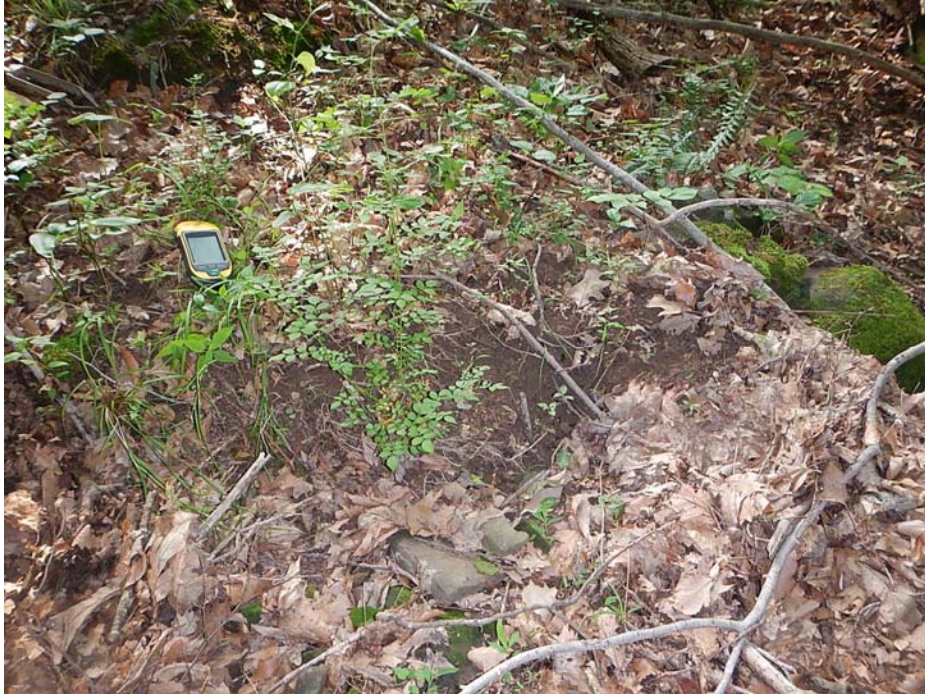
Waterbody SLEA010 facing east across

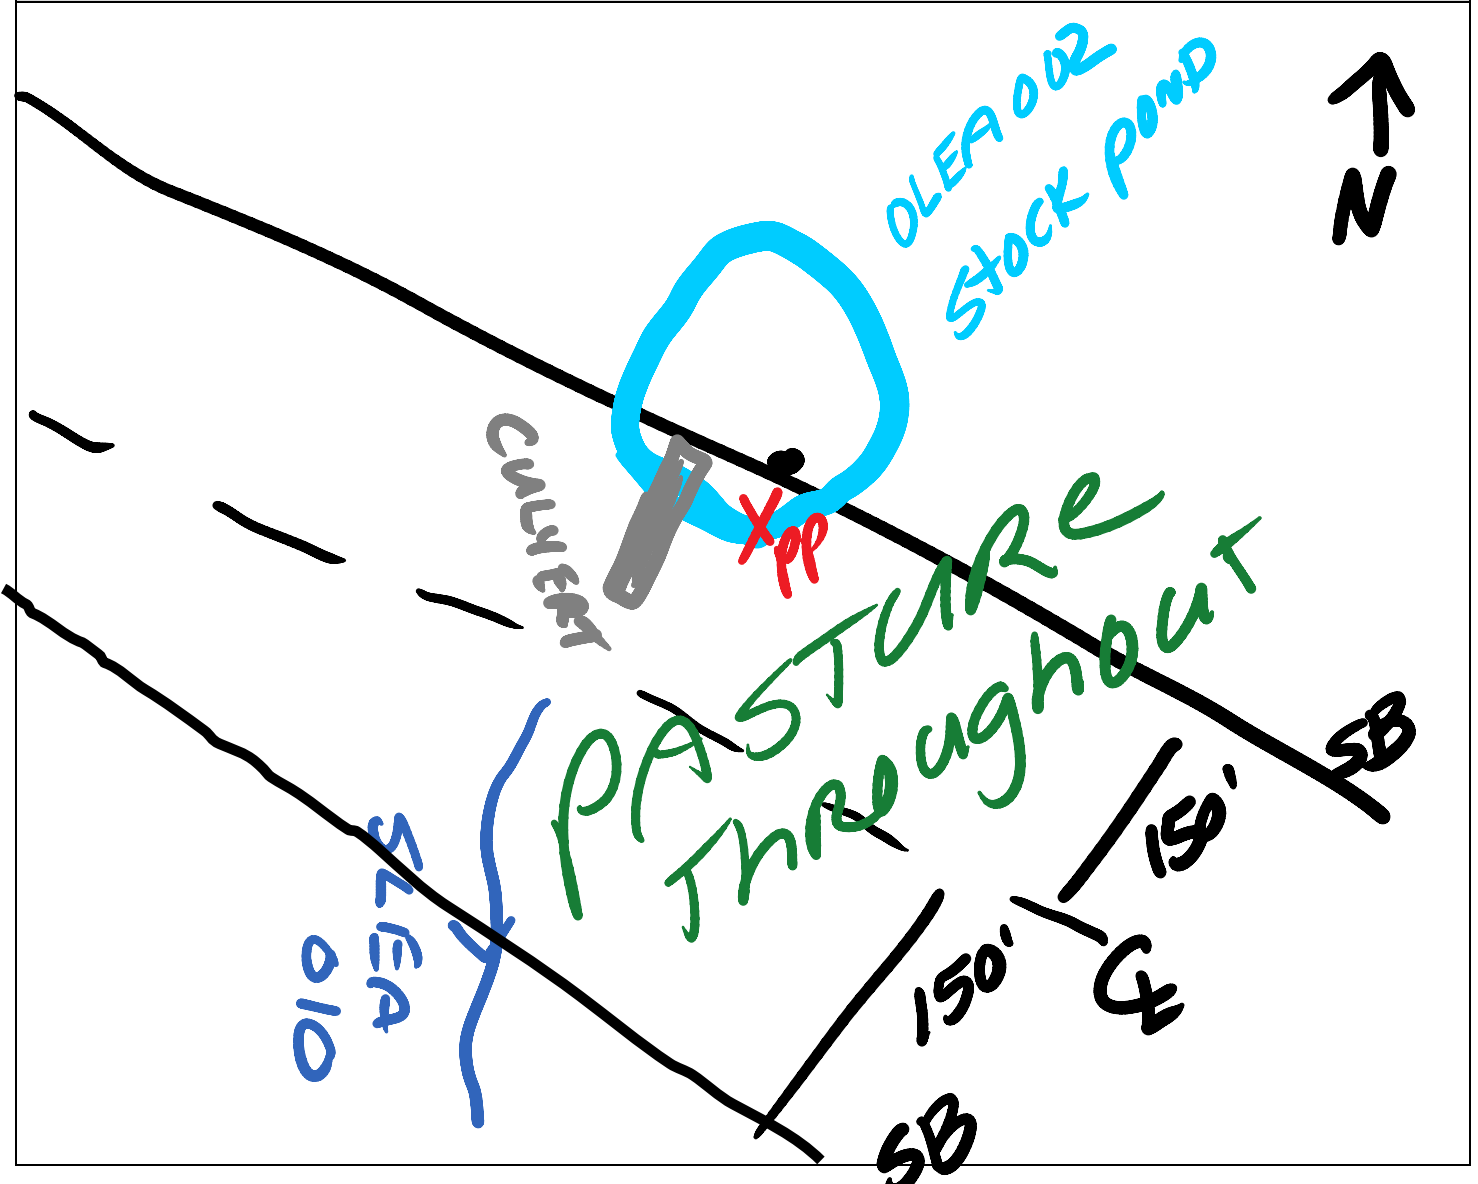
Waterbody Sketch (Include north arrow, centerline, distance from centerline, data point locations, survey boundary, and IDs of associated features)

Ephemeral stream (SLEA010) is outflow from pond via culvert

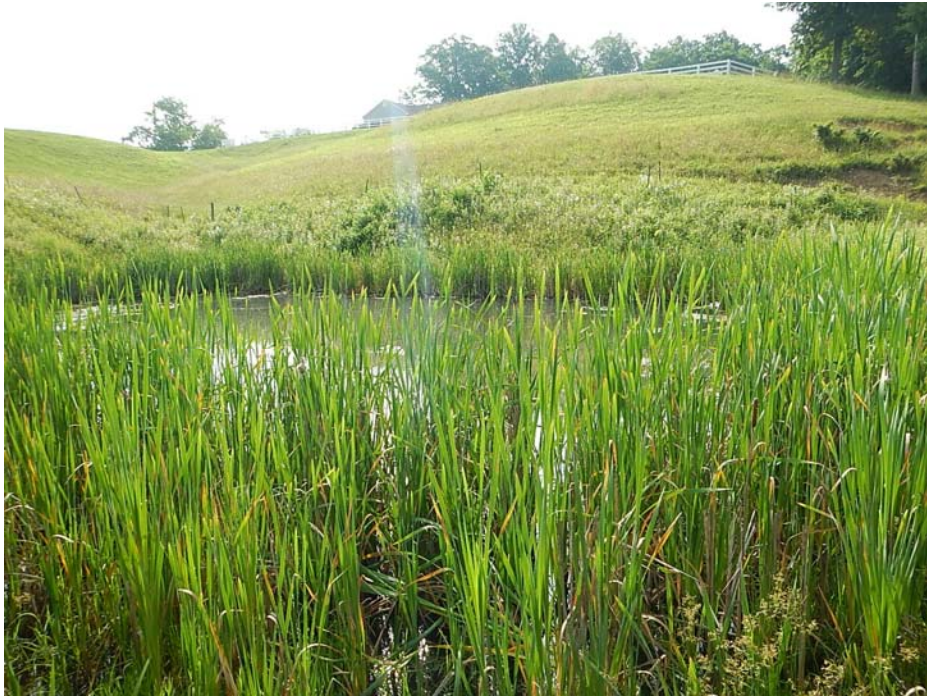
Waterbody OLEA002 facing east

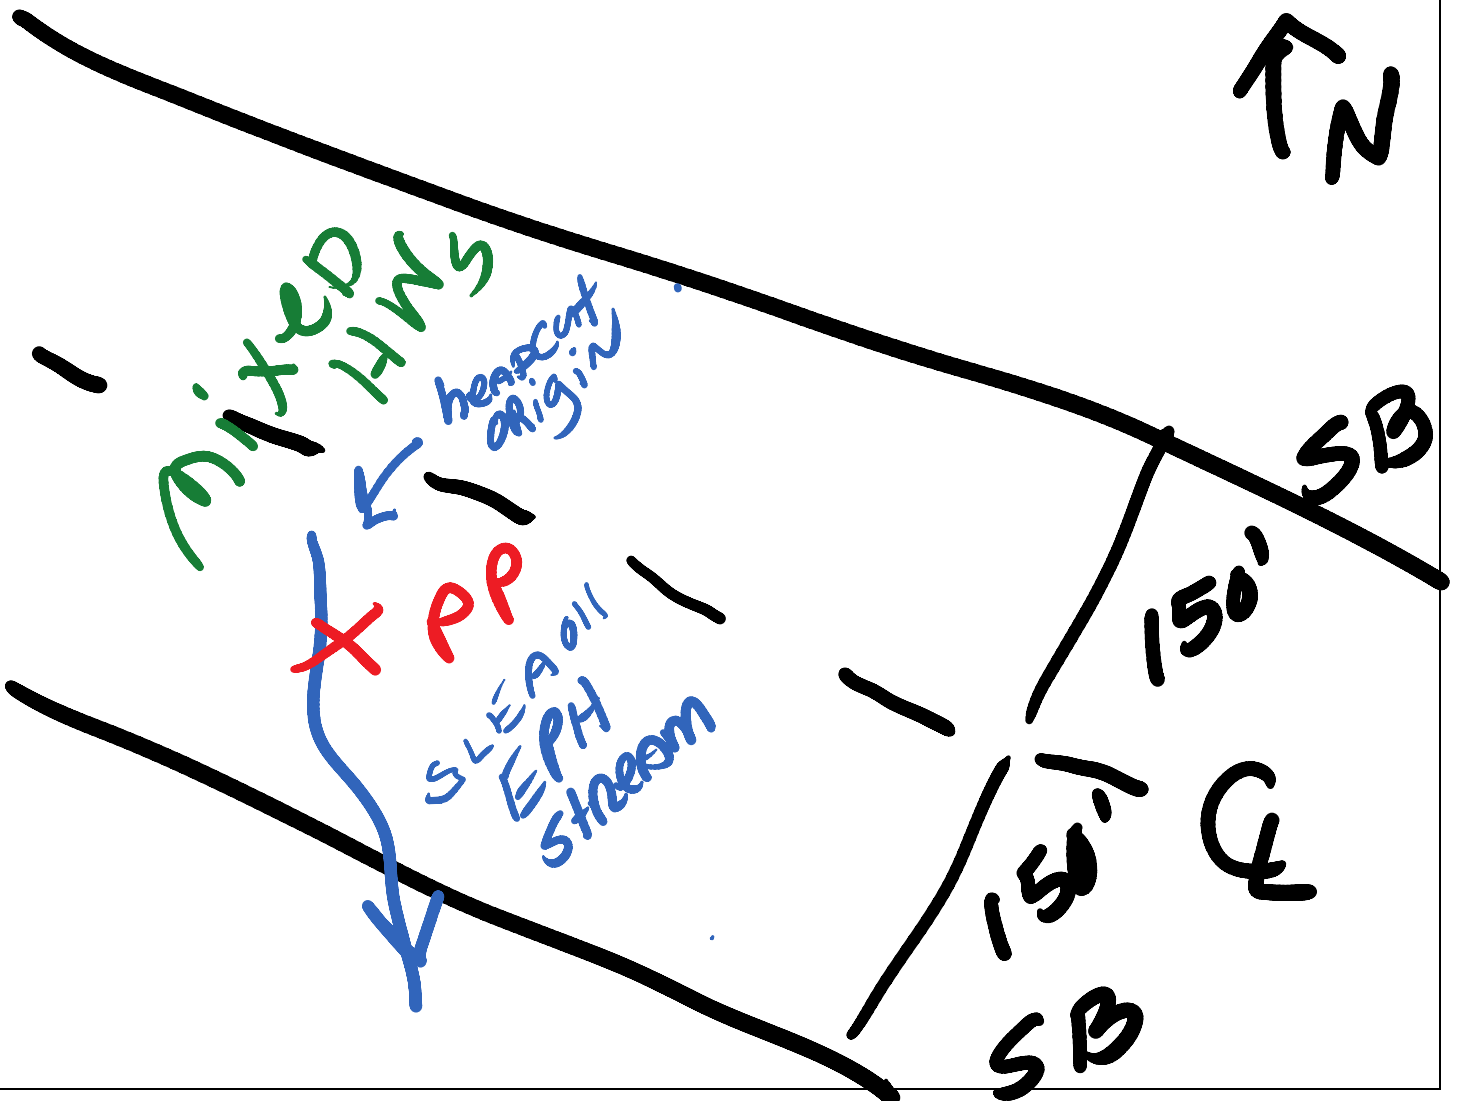
Waterbody Sketch (Include north arrow, centerline, distance from centerline, data point location, survey boundary, and IDs of associated features)

Begins within corridor at a headcut; downstream continues out of corridor where it is a tributary to Sycamore Lick

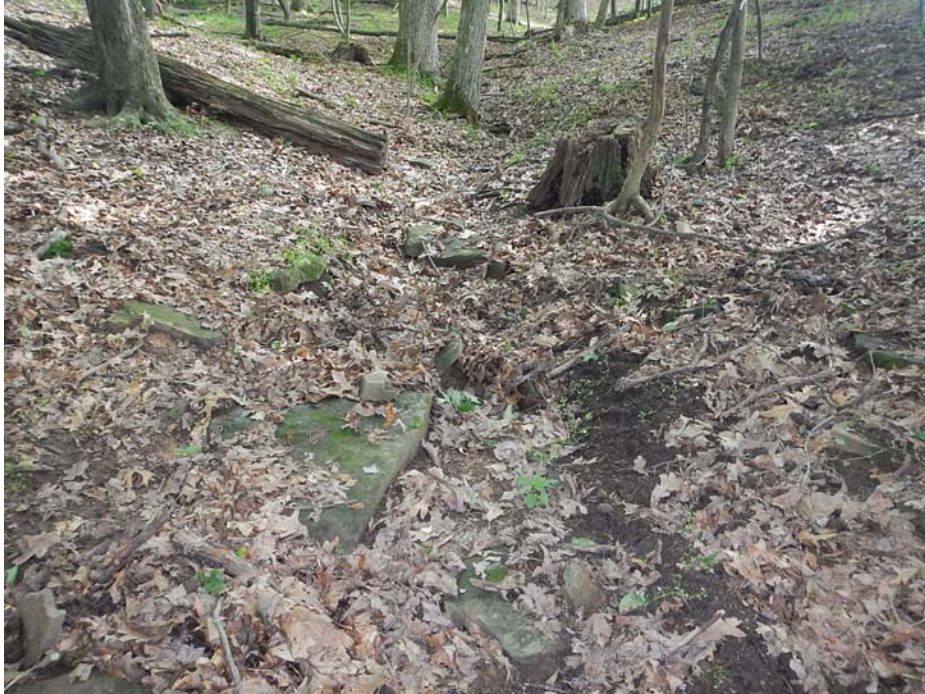
Waterbody SLEA011 facing north upstream

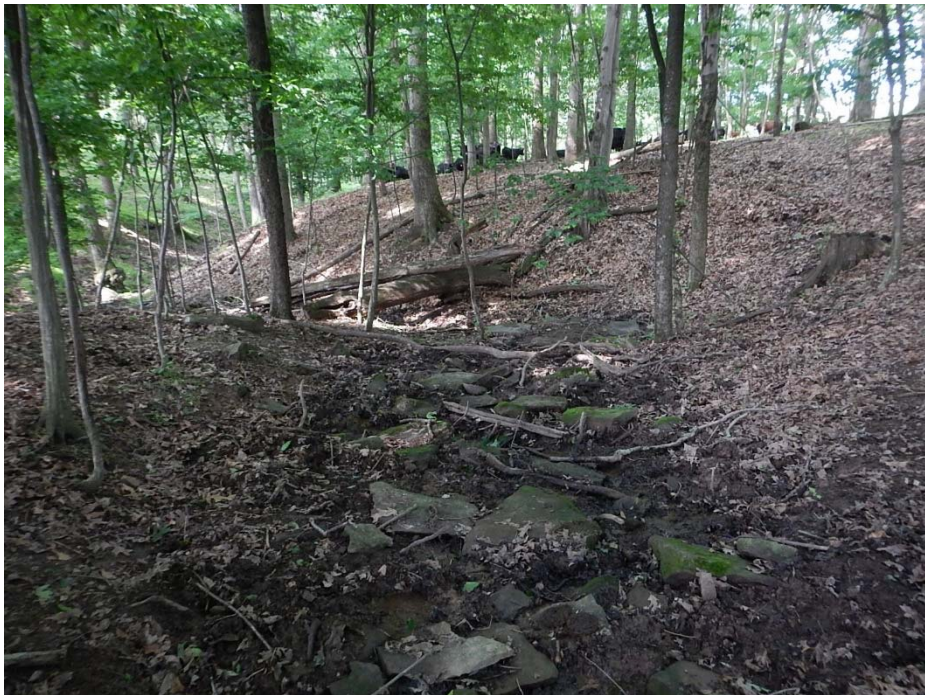
Waterbody SLEA011 facing south downstream

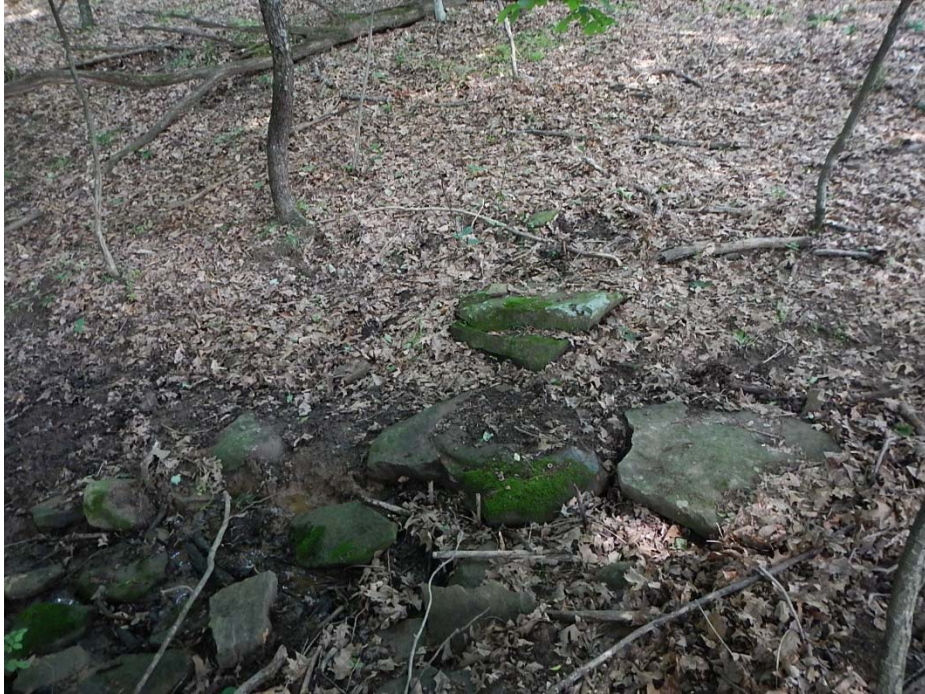
Waterbody SLEA011 facing east across
