Linear Waterbody Data Sheet

Survey Description			
Project Name: Southeast Reliability		Waterbody Name: Unnamed Tributary to Trubie Run	
Waterbody ID: SUPB009		Date: 6/27/2014	
State: West Virginia	County/Parish: Upshur	Company: Natural Resource Group	Crew Member Initials: TP
Photos: 3			
Tract Number(s): 03-107		Nearest Milepost: 31.27	Associated Wetland ID(s): none
Survey Type: <i>(check one)</i> <input checked="" type="checkbox"/> Centerline <input type="checkbox"/> Re-Route <input type="checkbox"/> Access Road <input type="checkbox"/> Other:			
Physical Attributes			
Stream Classification: <i>(check one)</i> <input type="checkbox"/> Ephemeral <input type="checkbox"/> Intermittent <input checked="" type="checkbox"/> Perennial			
Waterbody Type: <i>(check one)</i> <input type="checkbox"/> River <input checked="" type="checkbox"/> Stream <input type="checkbox"/> Ditch <input type="checkbox"/> Canal <input type="checkbox"/> Other:

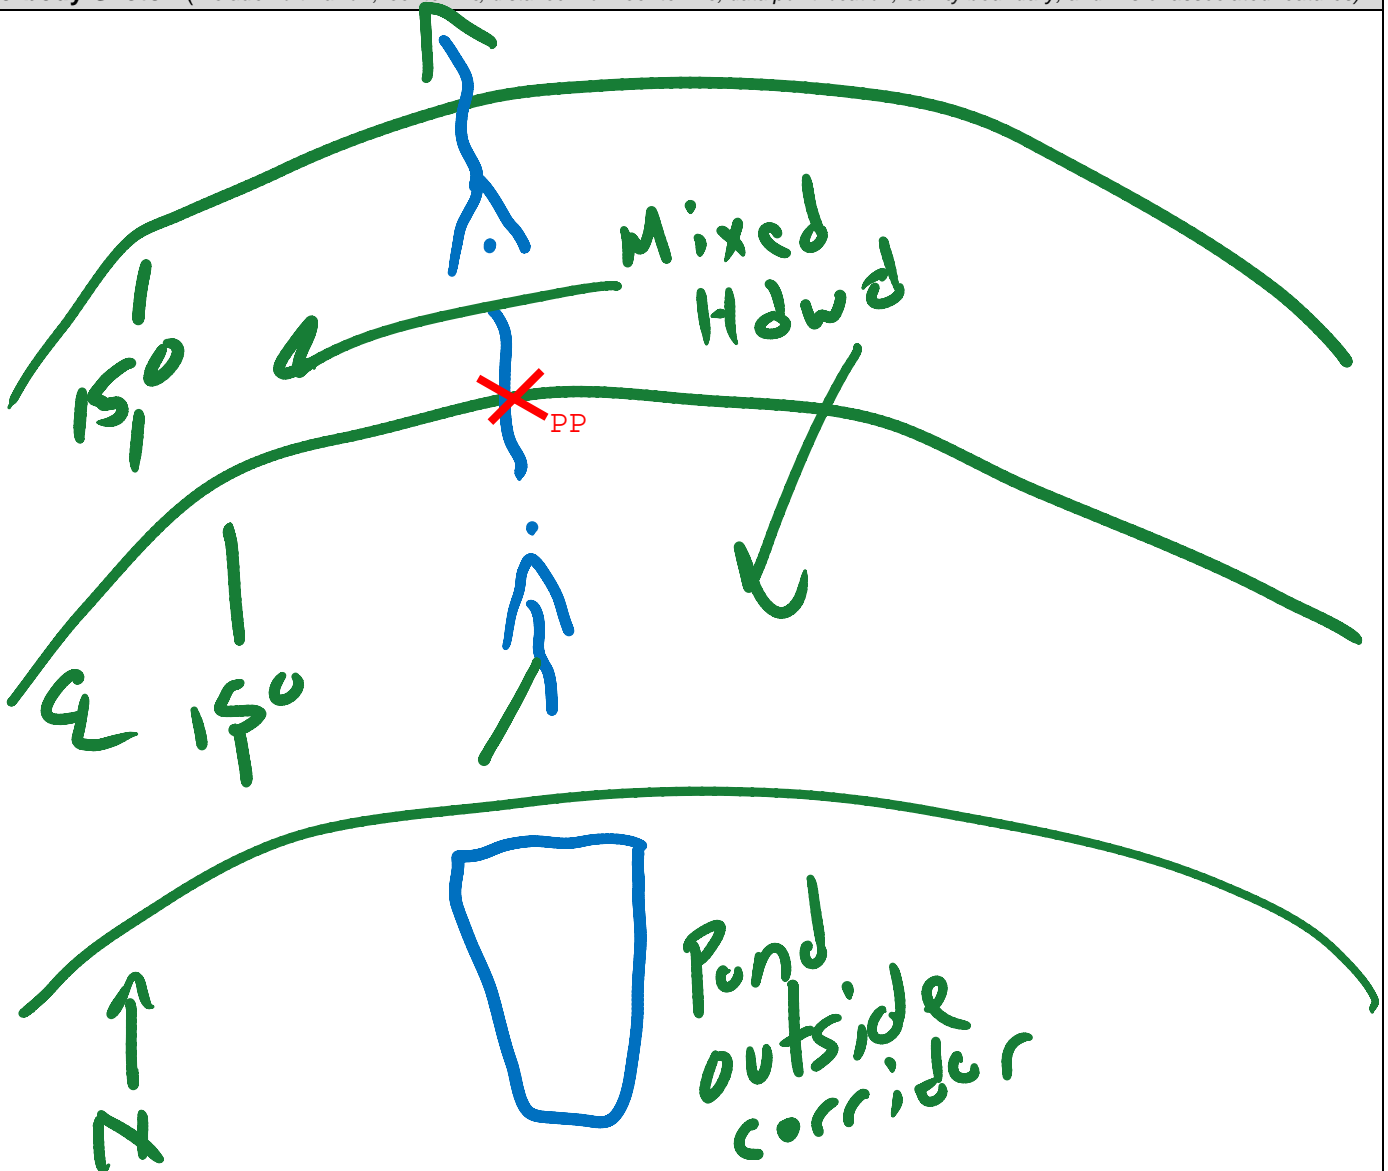
Waterbody Sketch (Include north arrow, centerline, distance from centerline, data point location, survey boundary, and IDs of associated features)

Clear flowing mountain stream, lots of bars and benches, cobble, rock, caddisfly, stonefly, mayfly observed

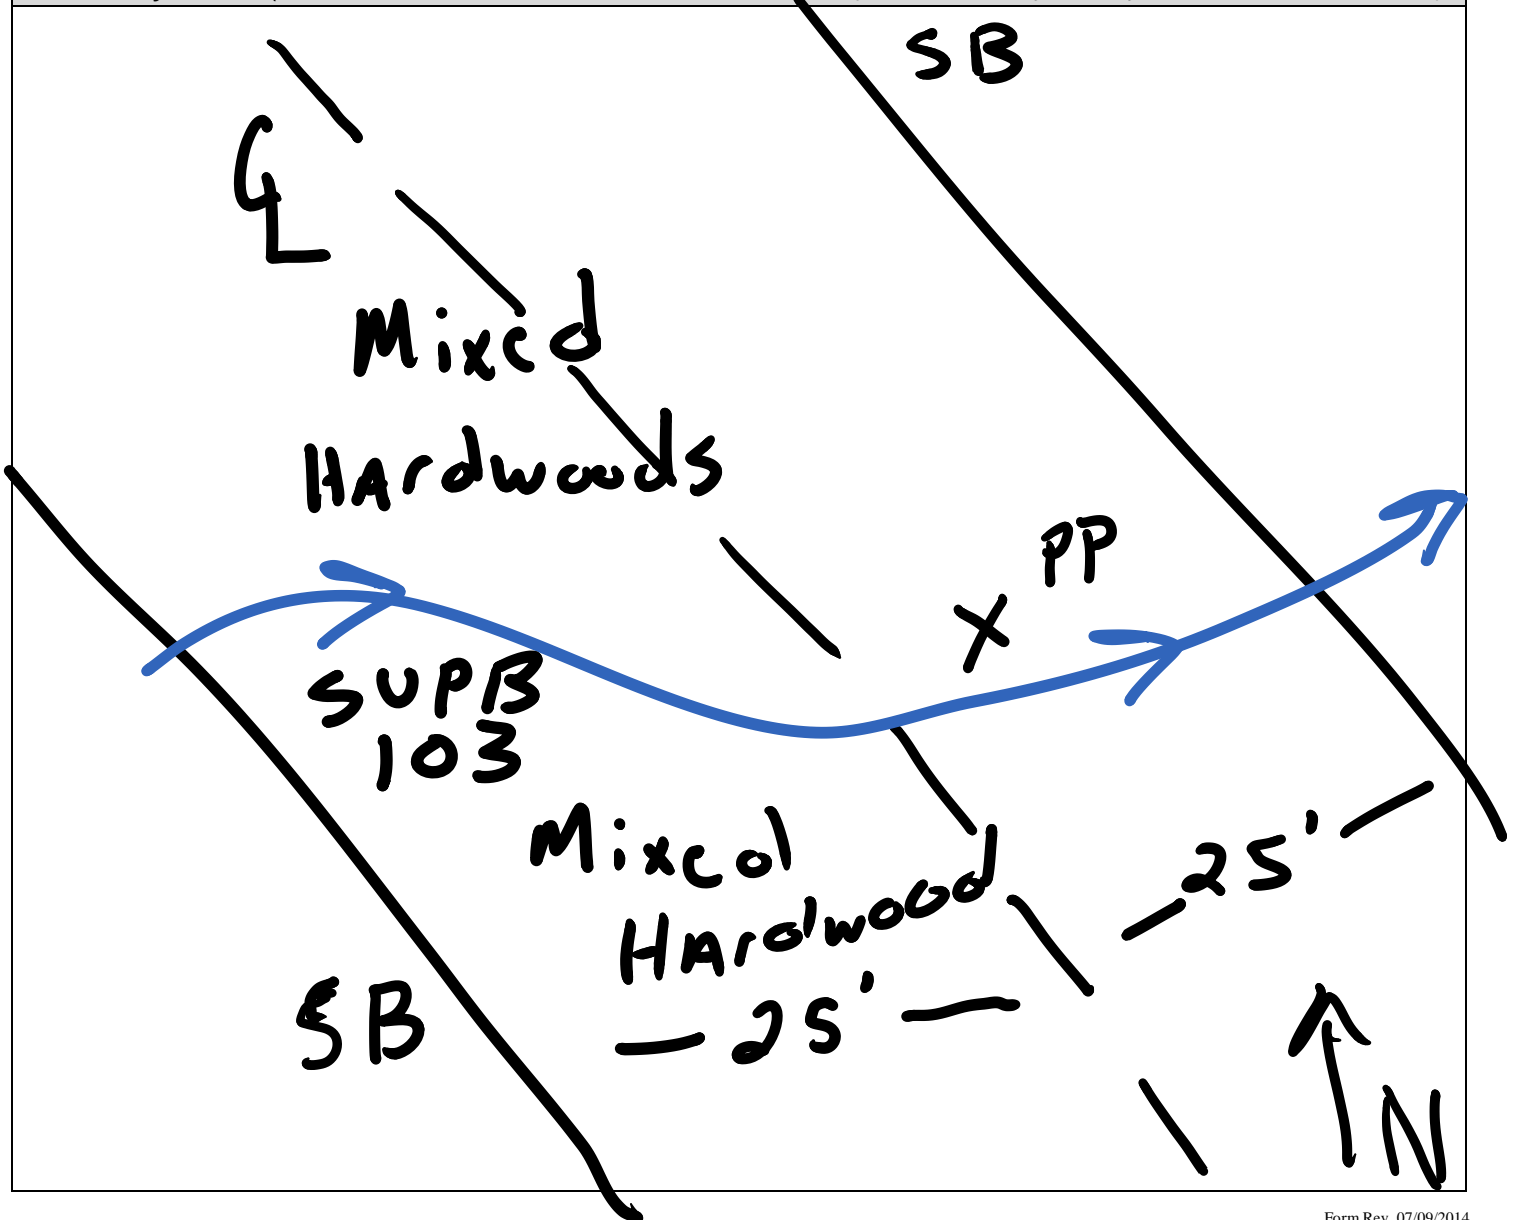
Waterbody Sketch (Include north arrow, centerline, distance from centerline, data point location, survey boundary, and IDs of associated features)

Typical mountain stream. Thalweg meanders back and forth in stream bed and varies from 5 to 20 feet wide.

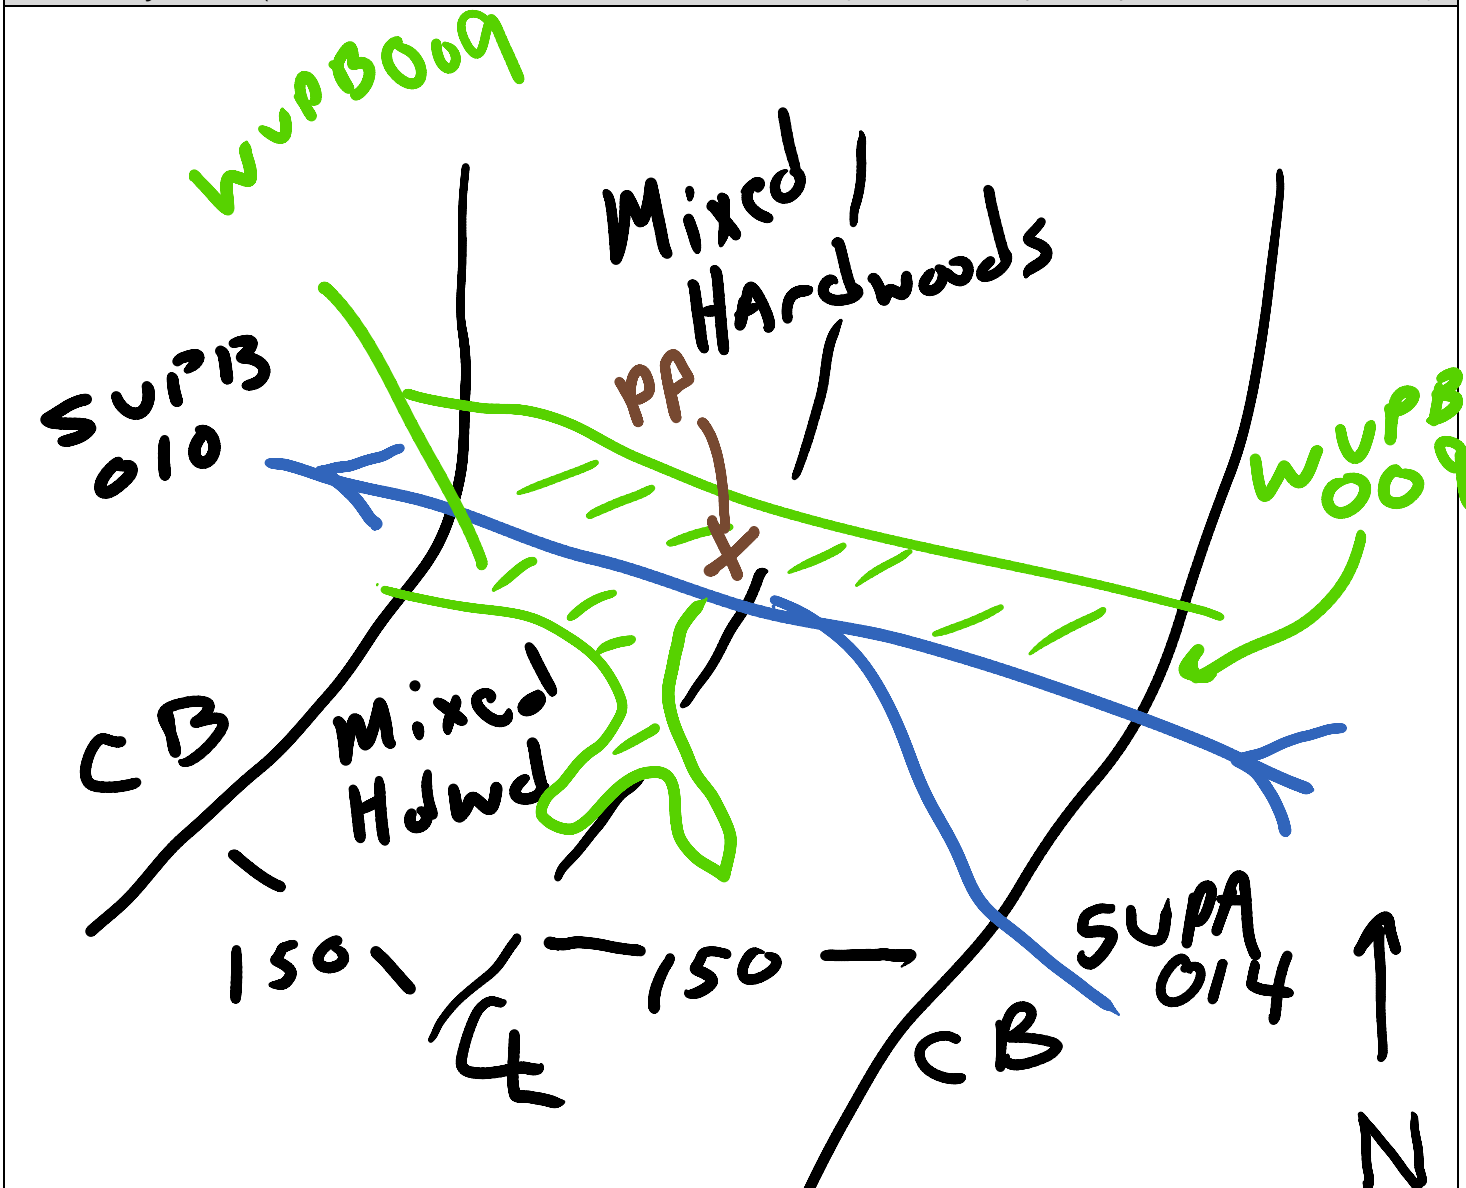
Waterbody Sketch (Include north arrow, centerline, distance from centerline, data point location, survey boundary, and IDs of associated features)

Clear flowing mountain stream, lots of bars and benches, cobble, rock, caddisfly, broad/flat

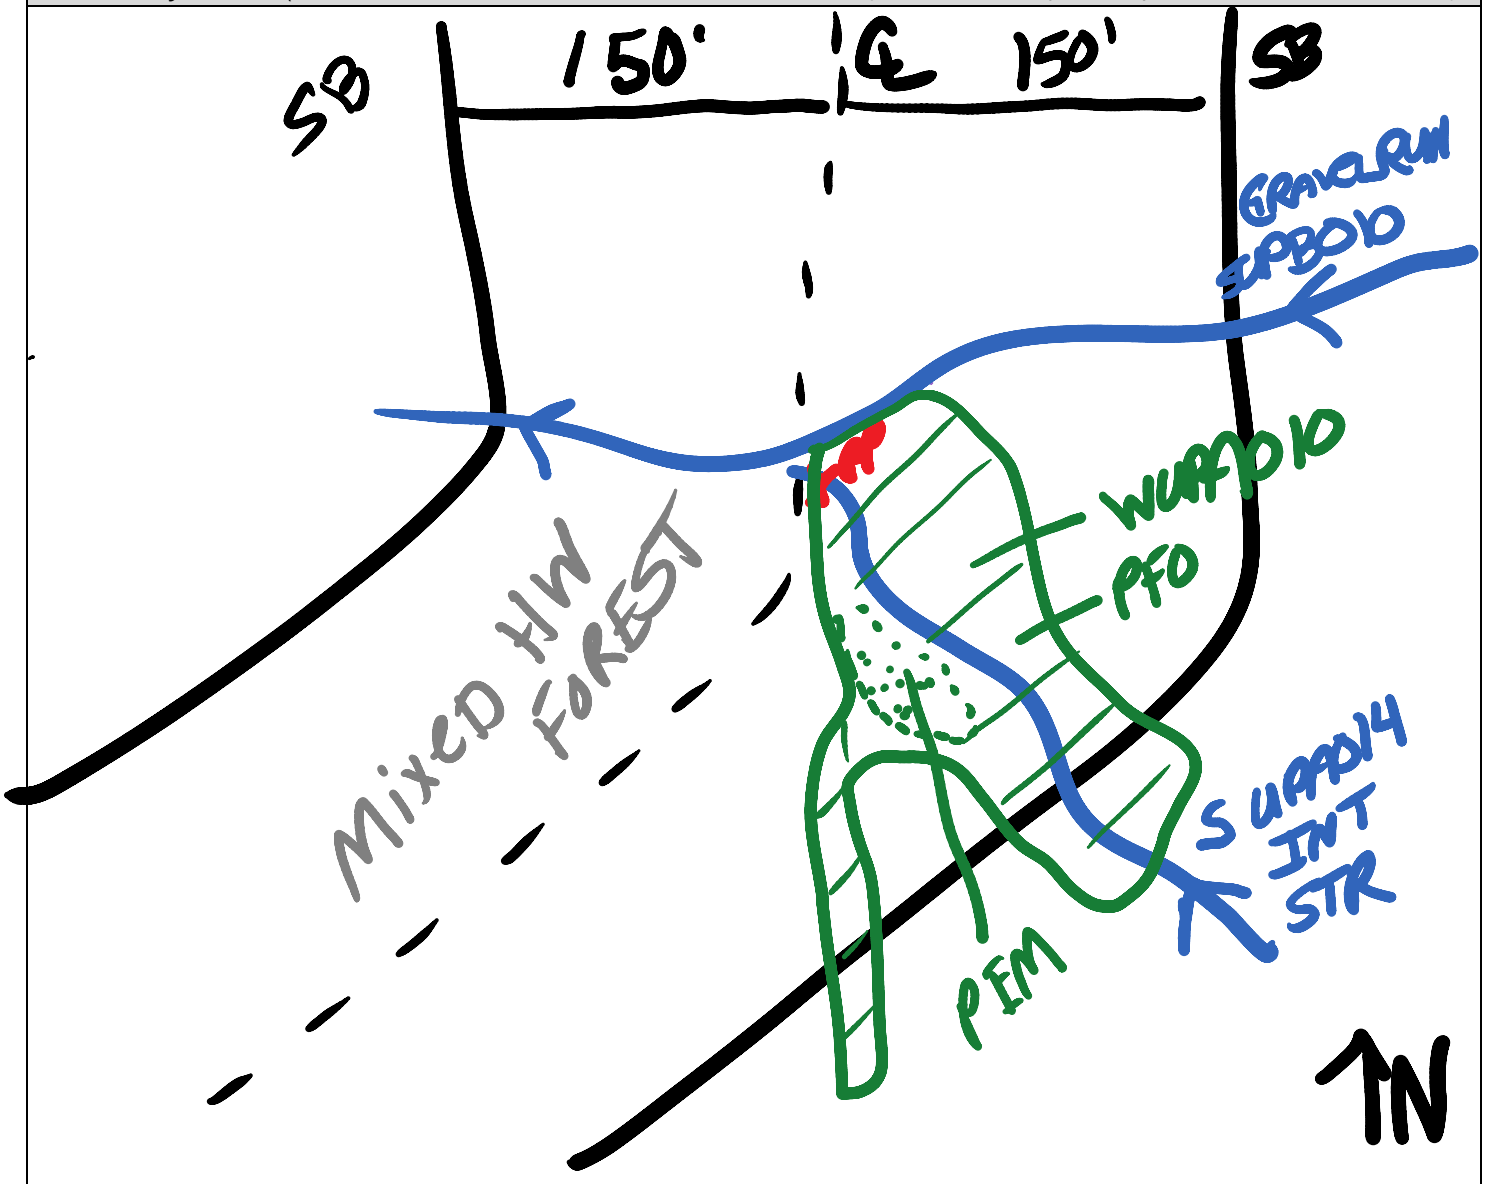
Waterbody Sketch (Include north arrow, centerline, distance from centerline, data point location, survey boundary, and IDs of associated features)

Unnamed Tributary to Gravel Run, confluence at centerline, upstream continues out, connected to PFO/PEM wetland WUPA010.

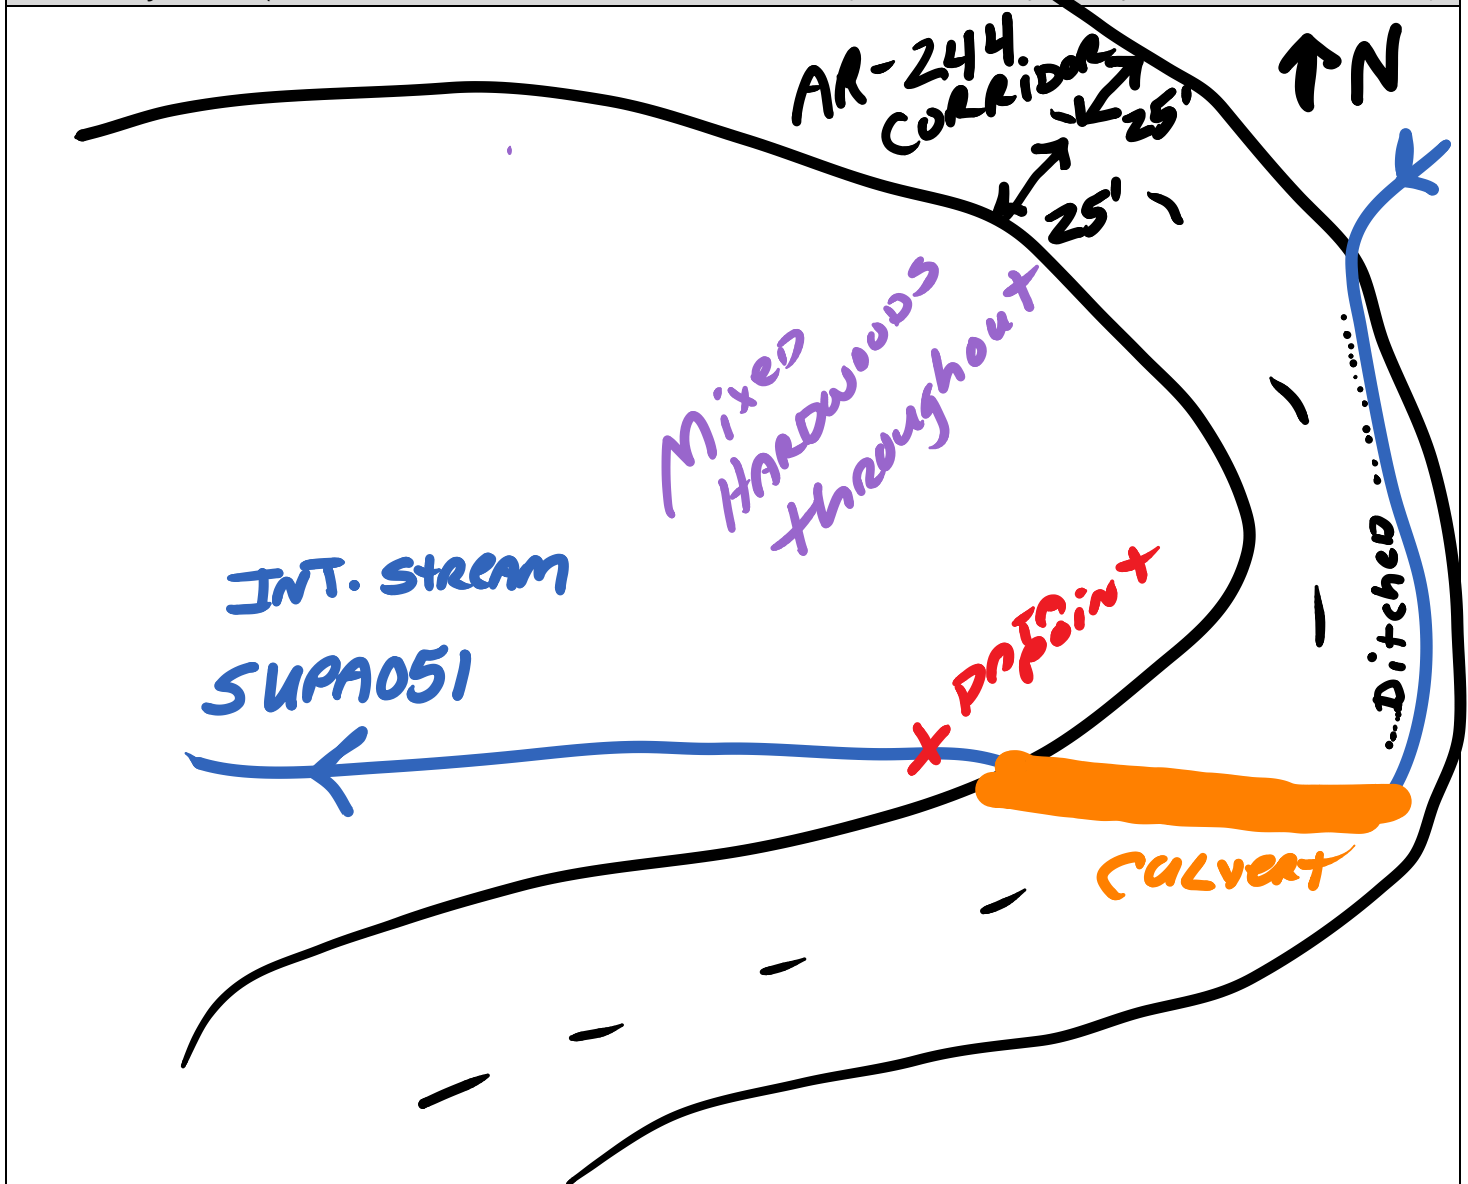
Waterbody Sketch (Include north arrow, centerline, distance from centerline, data point location, survey boundary, and IDs of associated features)

Continues out of access road corridor in both directions

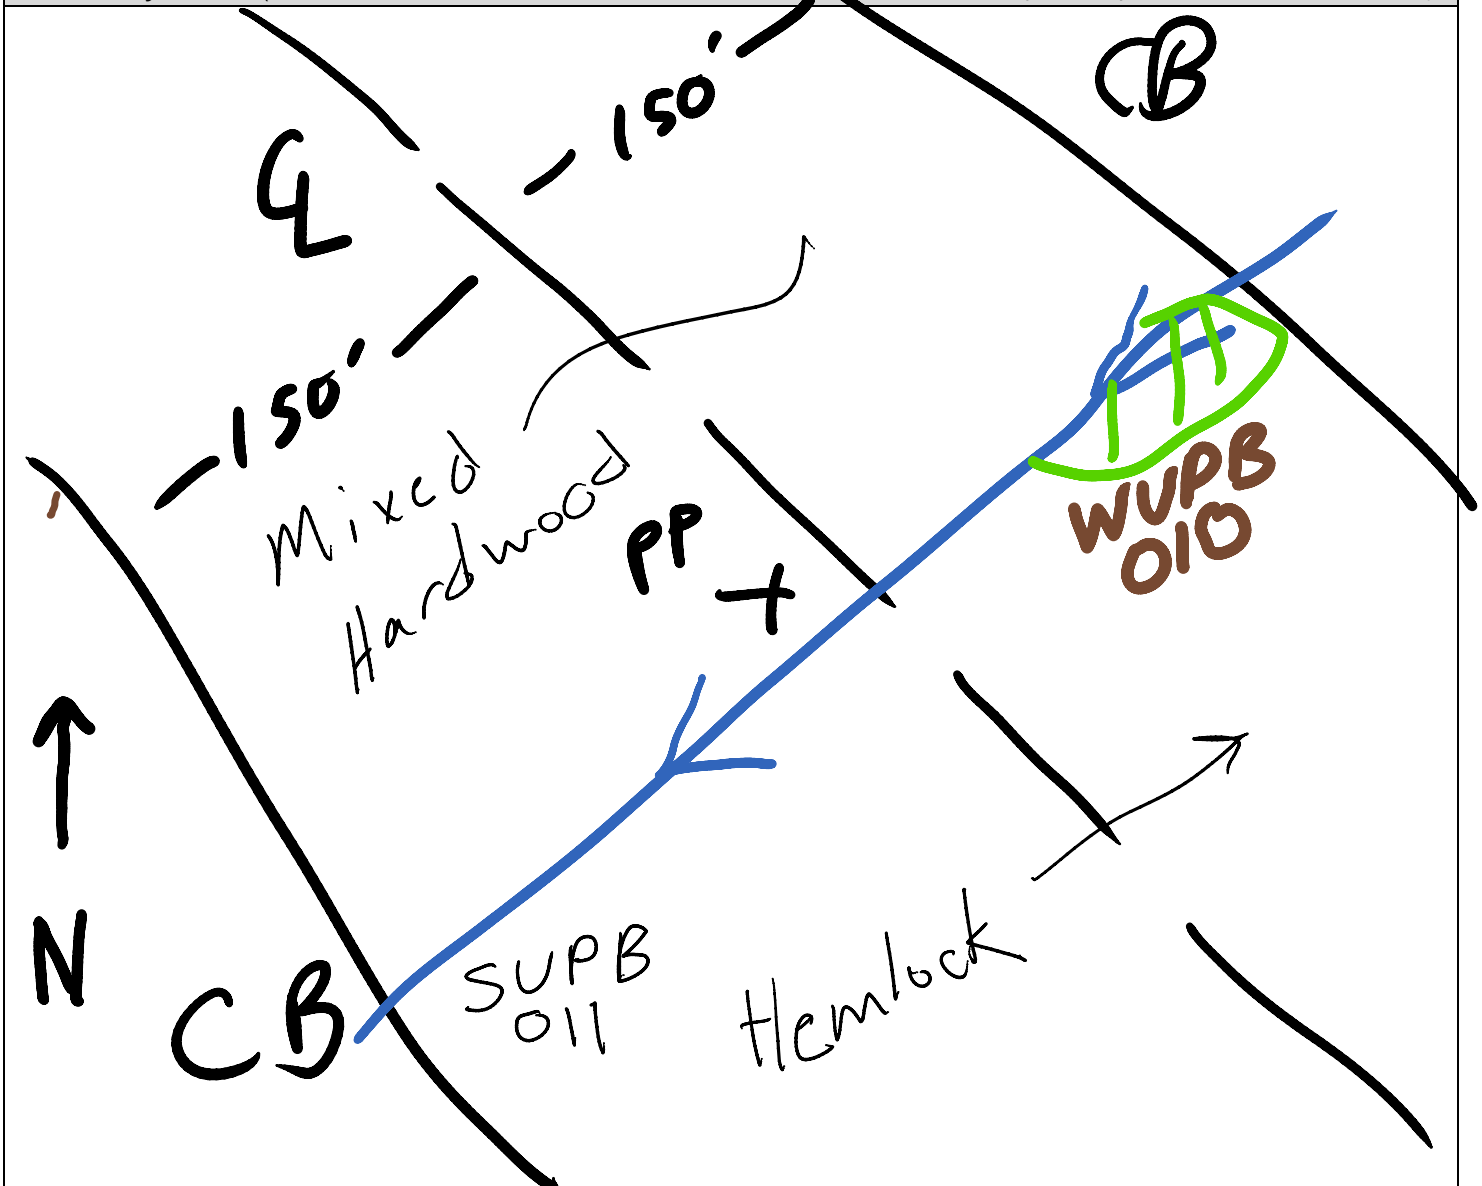
Waterbody Sketch (Include north arrow, centerline, distance from centerline, data point location, survey boundary, and IDs of associated features)

Clear flowing stream, lots of bars and benches, cobble, rock, caddisfly, broad/flat

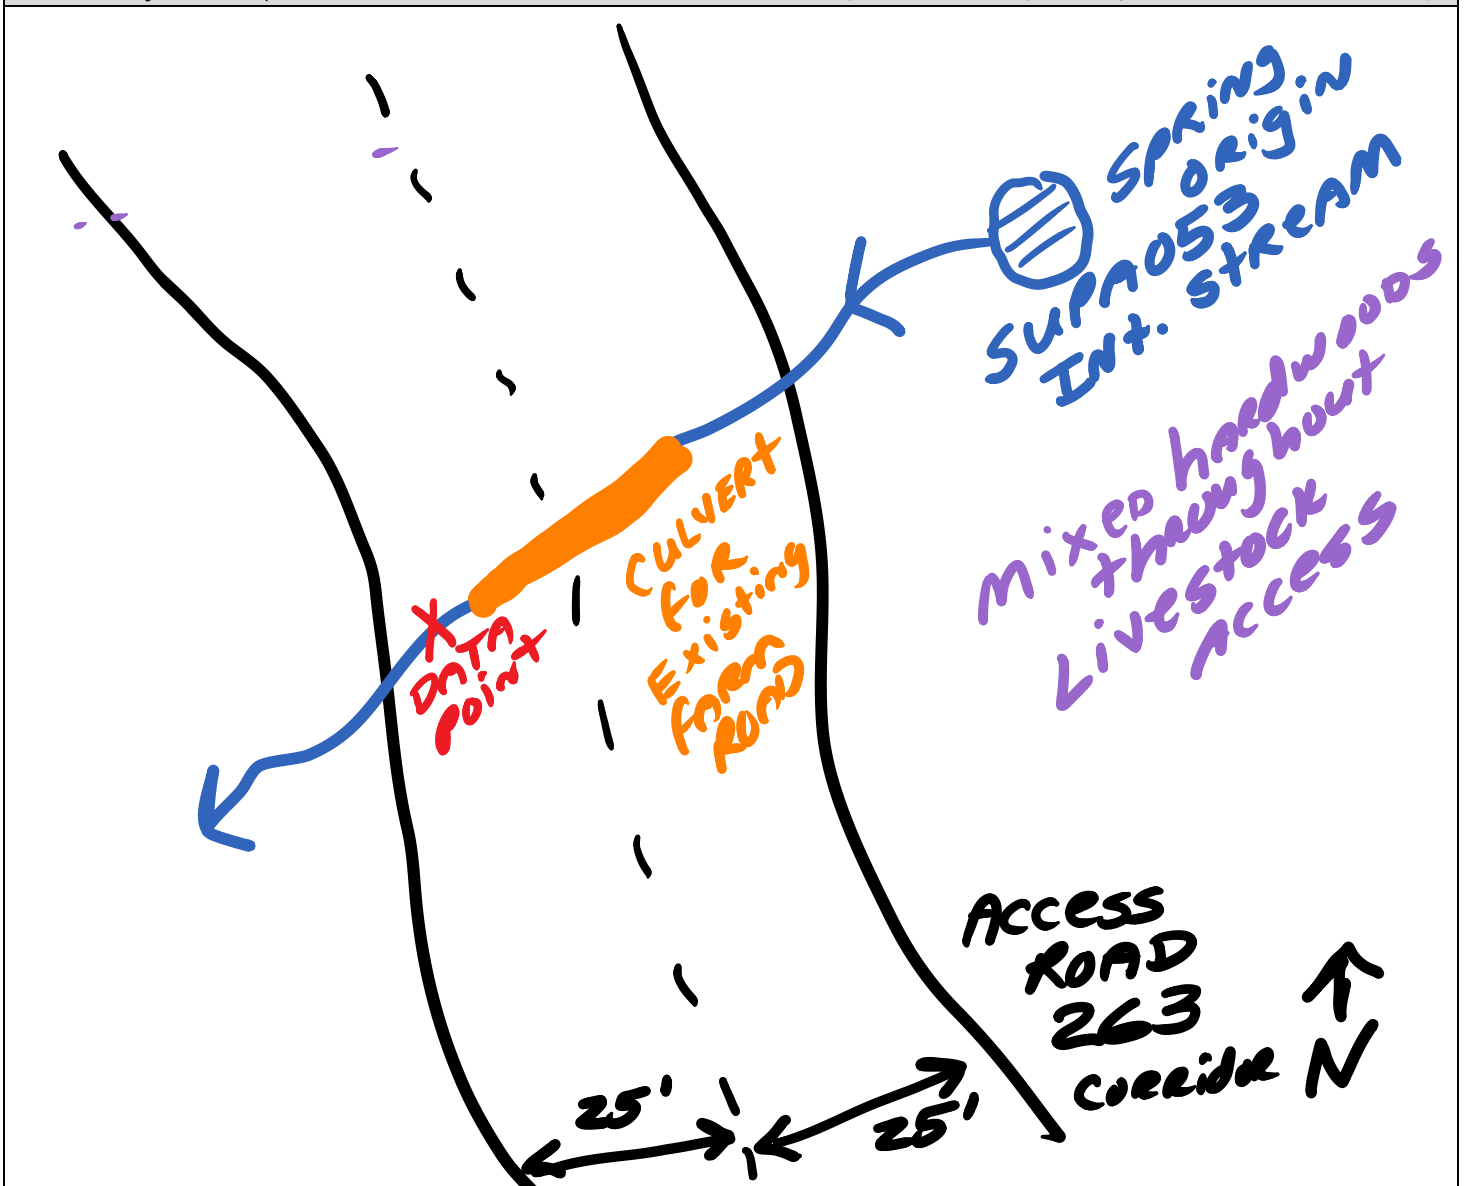
Waterbody Sketch (Include north arrow, centerline, distance from centerline, data point location, survey boundary, and IDs of associated features)

Small spring fed stream, severely degraded, continues out of access road corridor in both directions

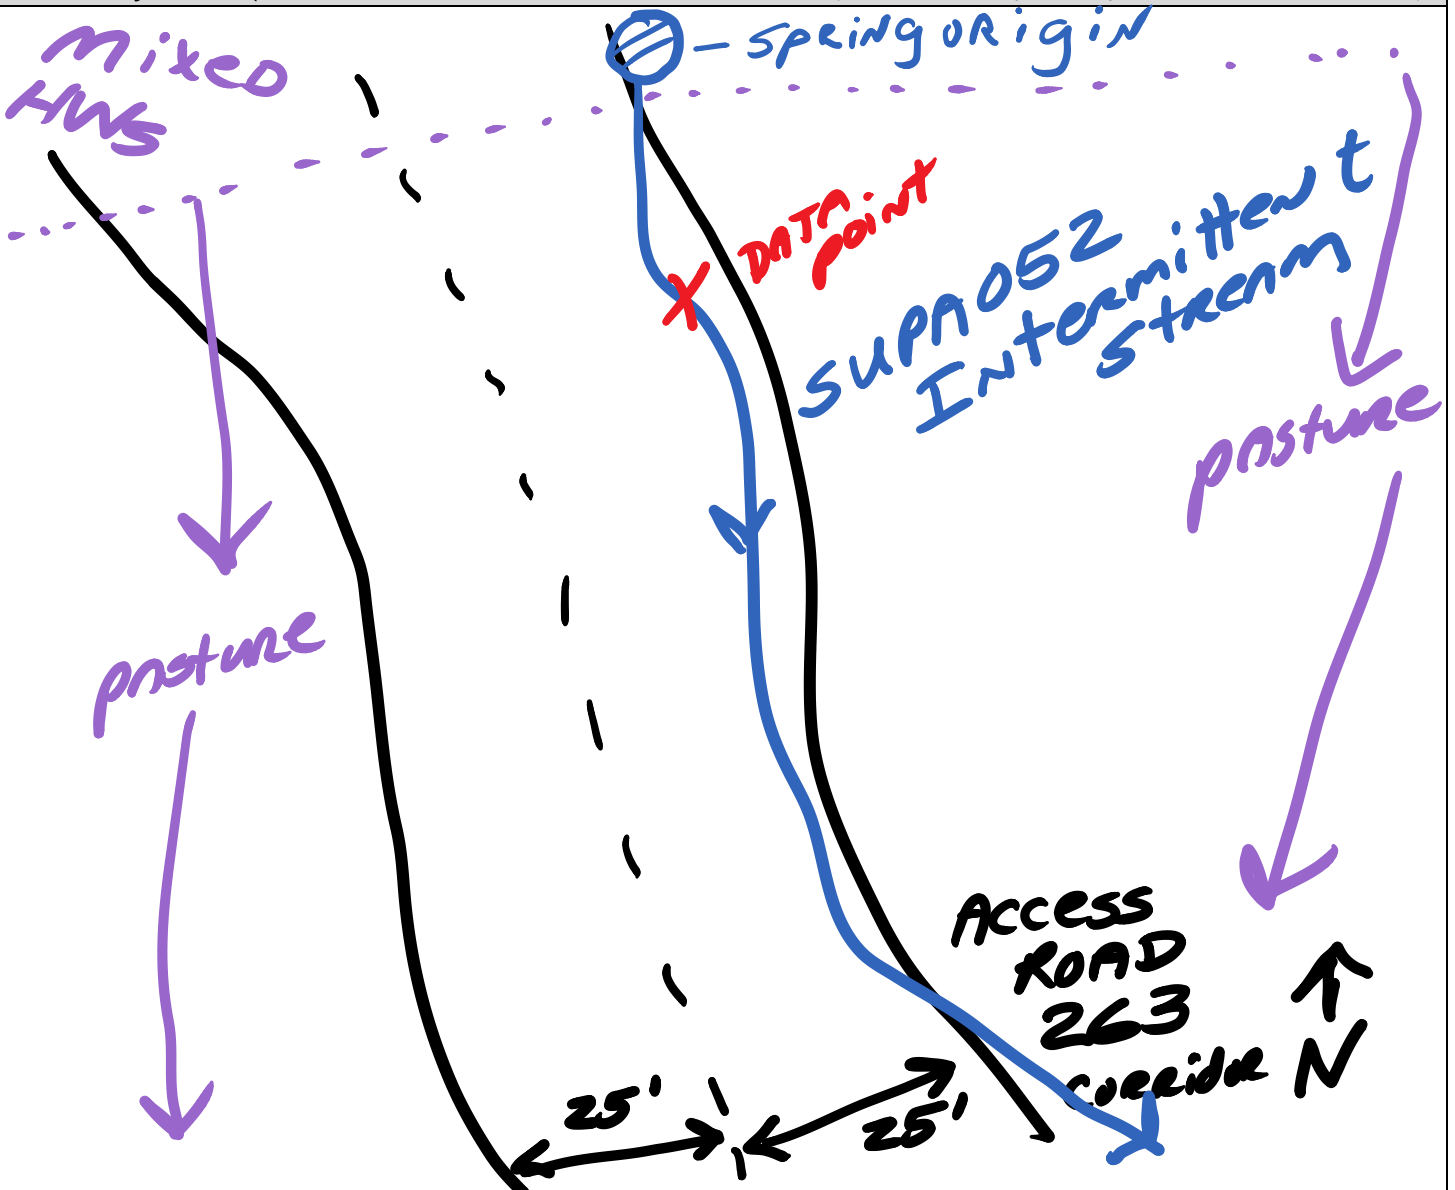
Waterbody Sketch (Include north arrow, centerline, distance from centerline, data point location, survey boundary, and IDs of associated features)

Small spring fed channelized stream in an active pasture, severely degraded, continues out of access road corridor in both directions, spring origin just outside access road corridor.

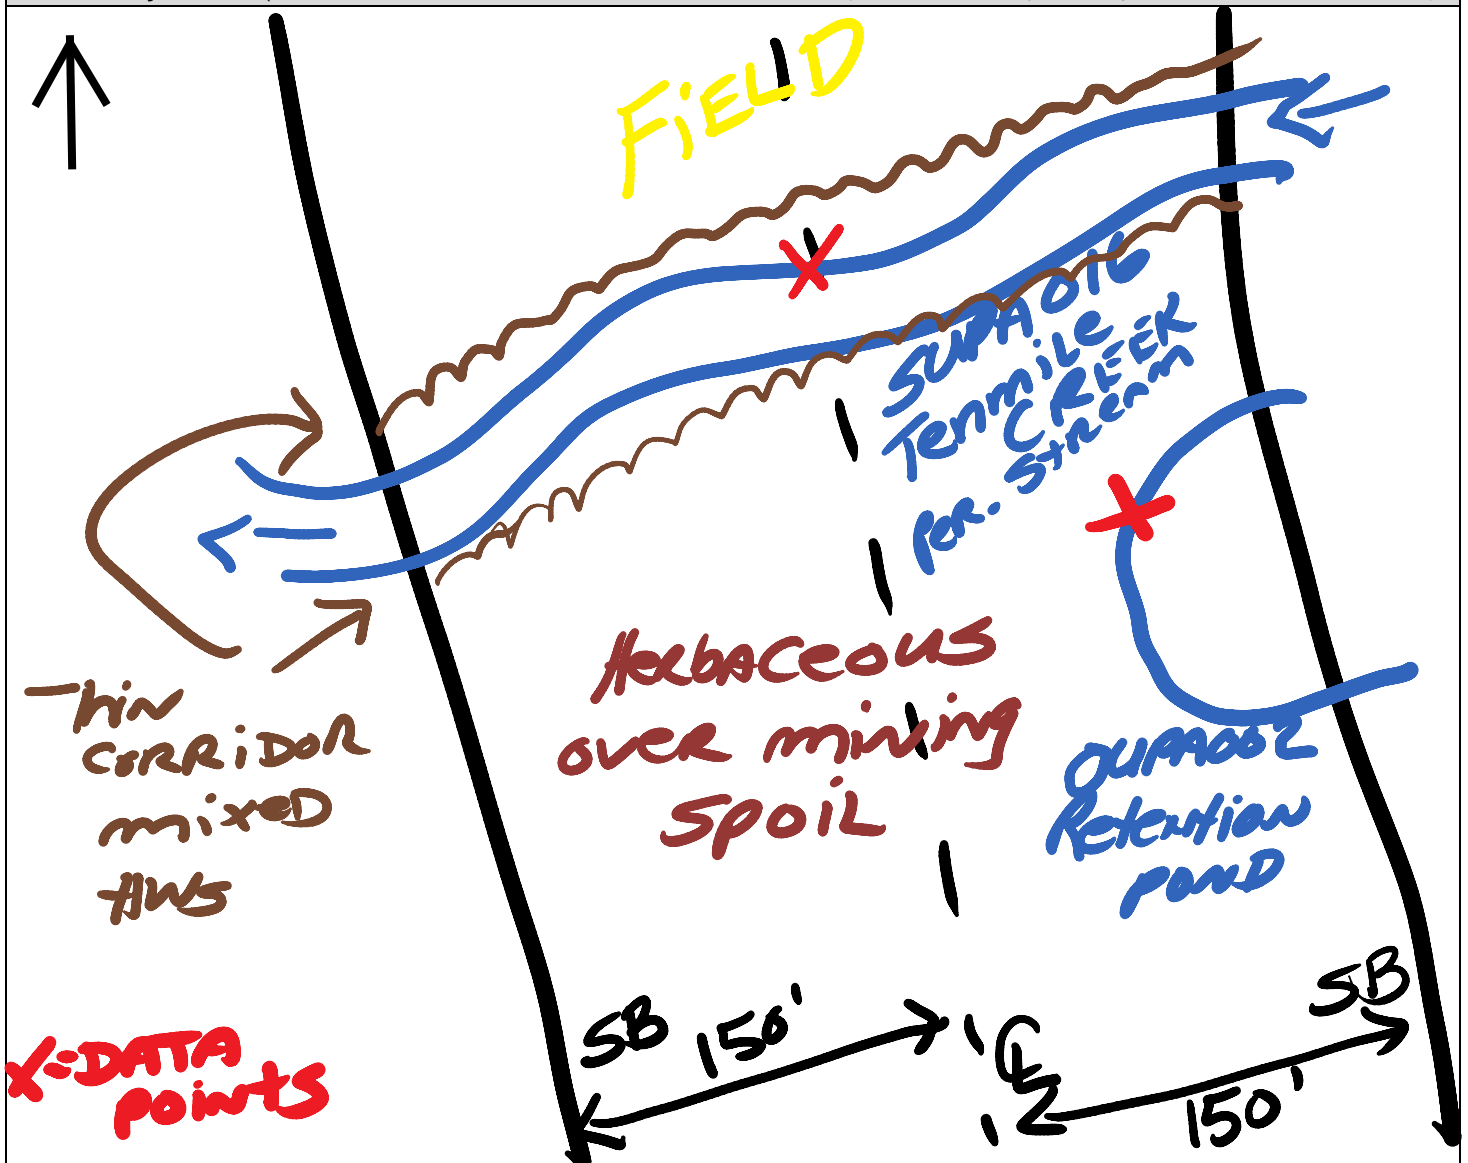
Waterbody Sketch (Include north arrow, centerline, distance from centerline, data point location, survey boundary, and IDs of associated features)

Continues out of corridor both directions, upline and downline taken

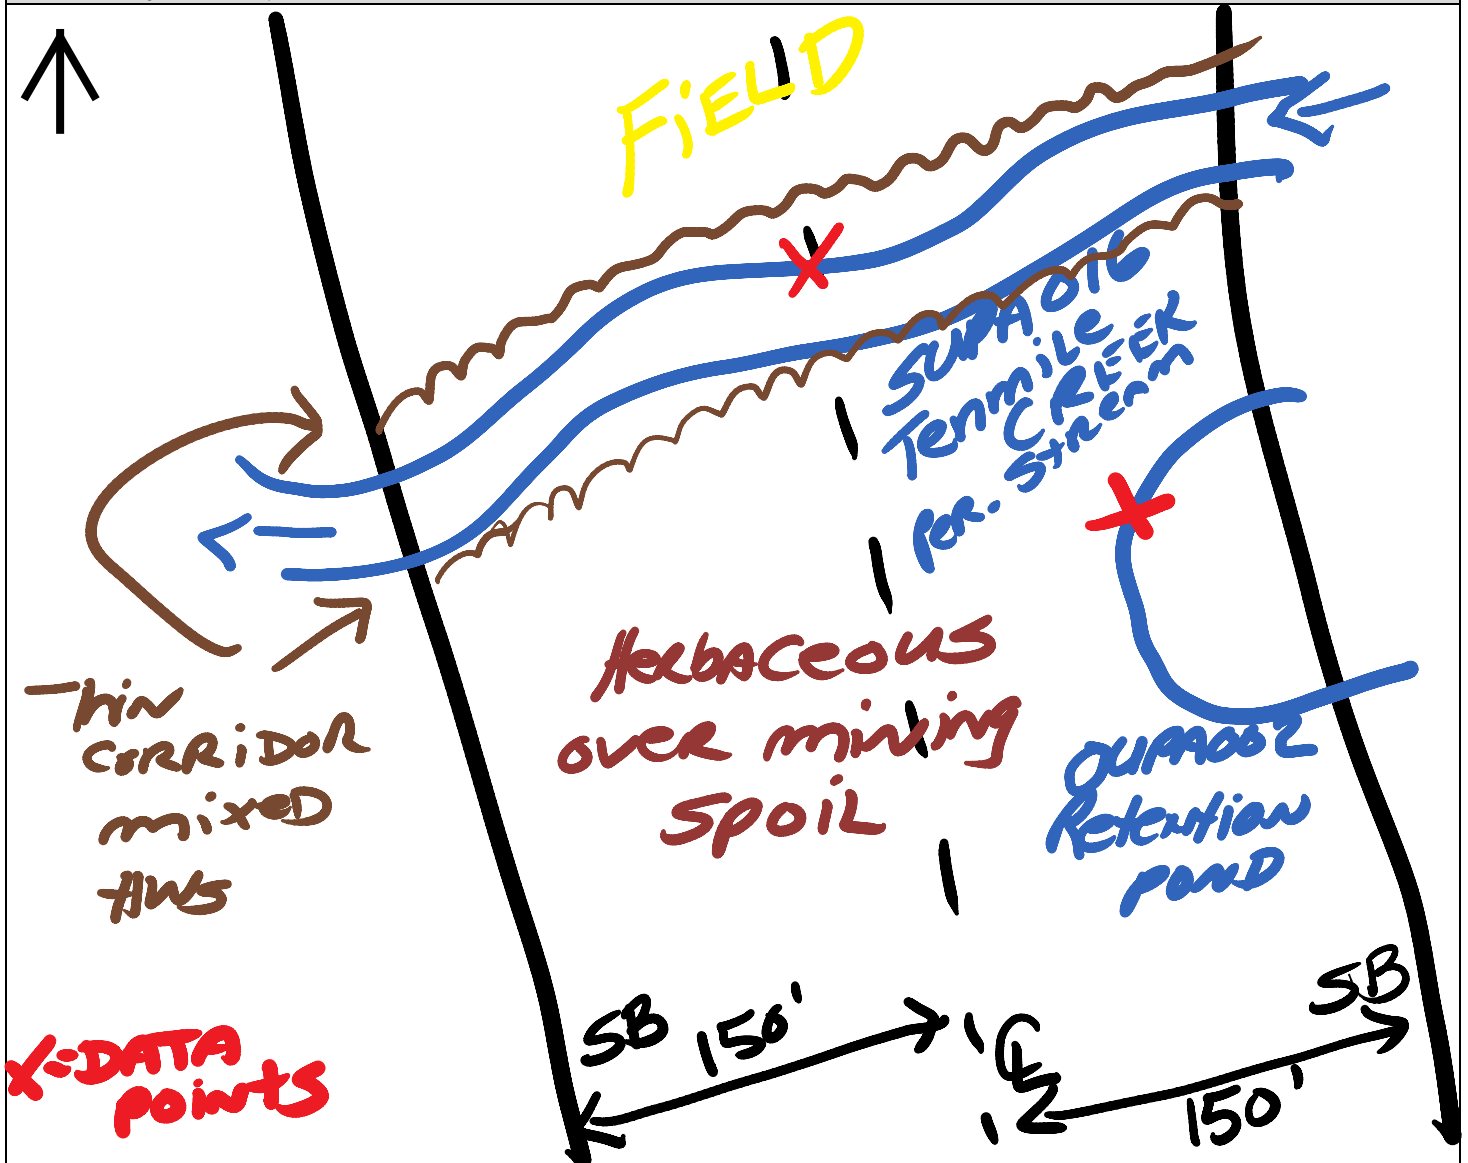
Waterbody Sketch (Include north arrow, centerline, distance from centerline, data point locations, survey boundary, and IDs of associated features)

Retention pond for run-off and sediment associated with strip mine

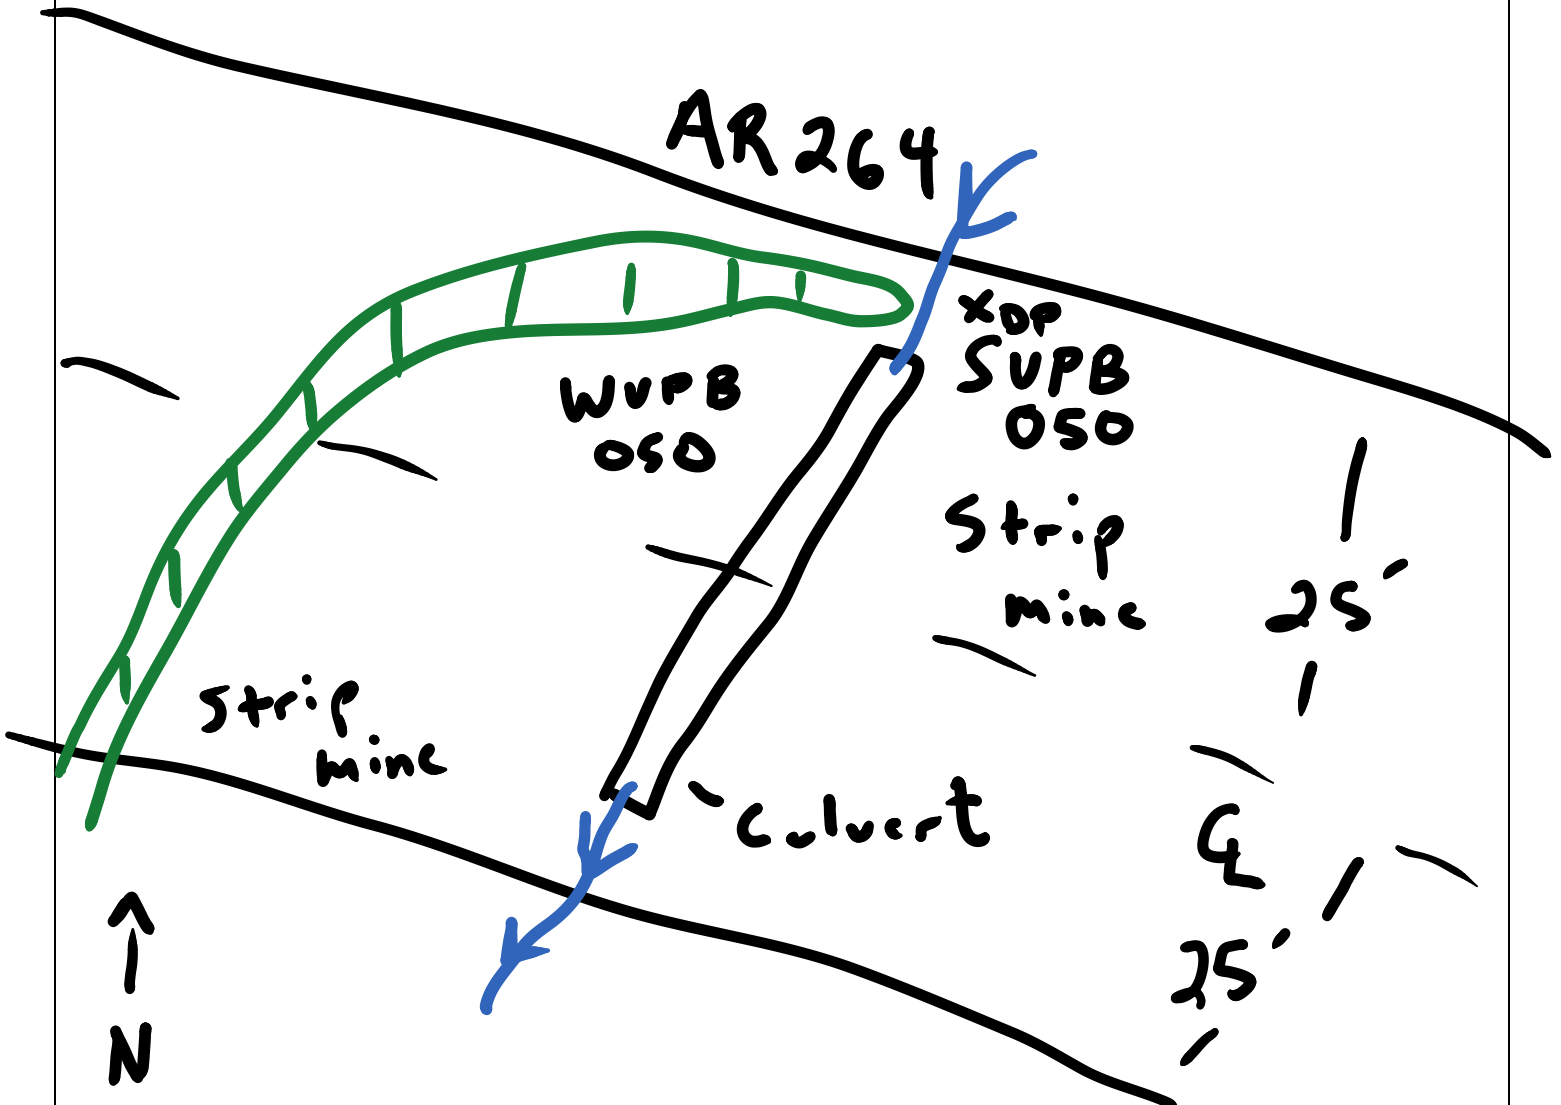
Waterbody Sketch (Include north arrow, centerline, distance from centerline, data point location, survey boundary, and IDs of associated features)

Degraded perennial stream in strip mine. Strong grade control, weak sinuosity. Please note, heavy rains in last 24 hours, stream appears to be perennial, based on today's observations.

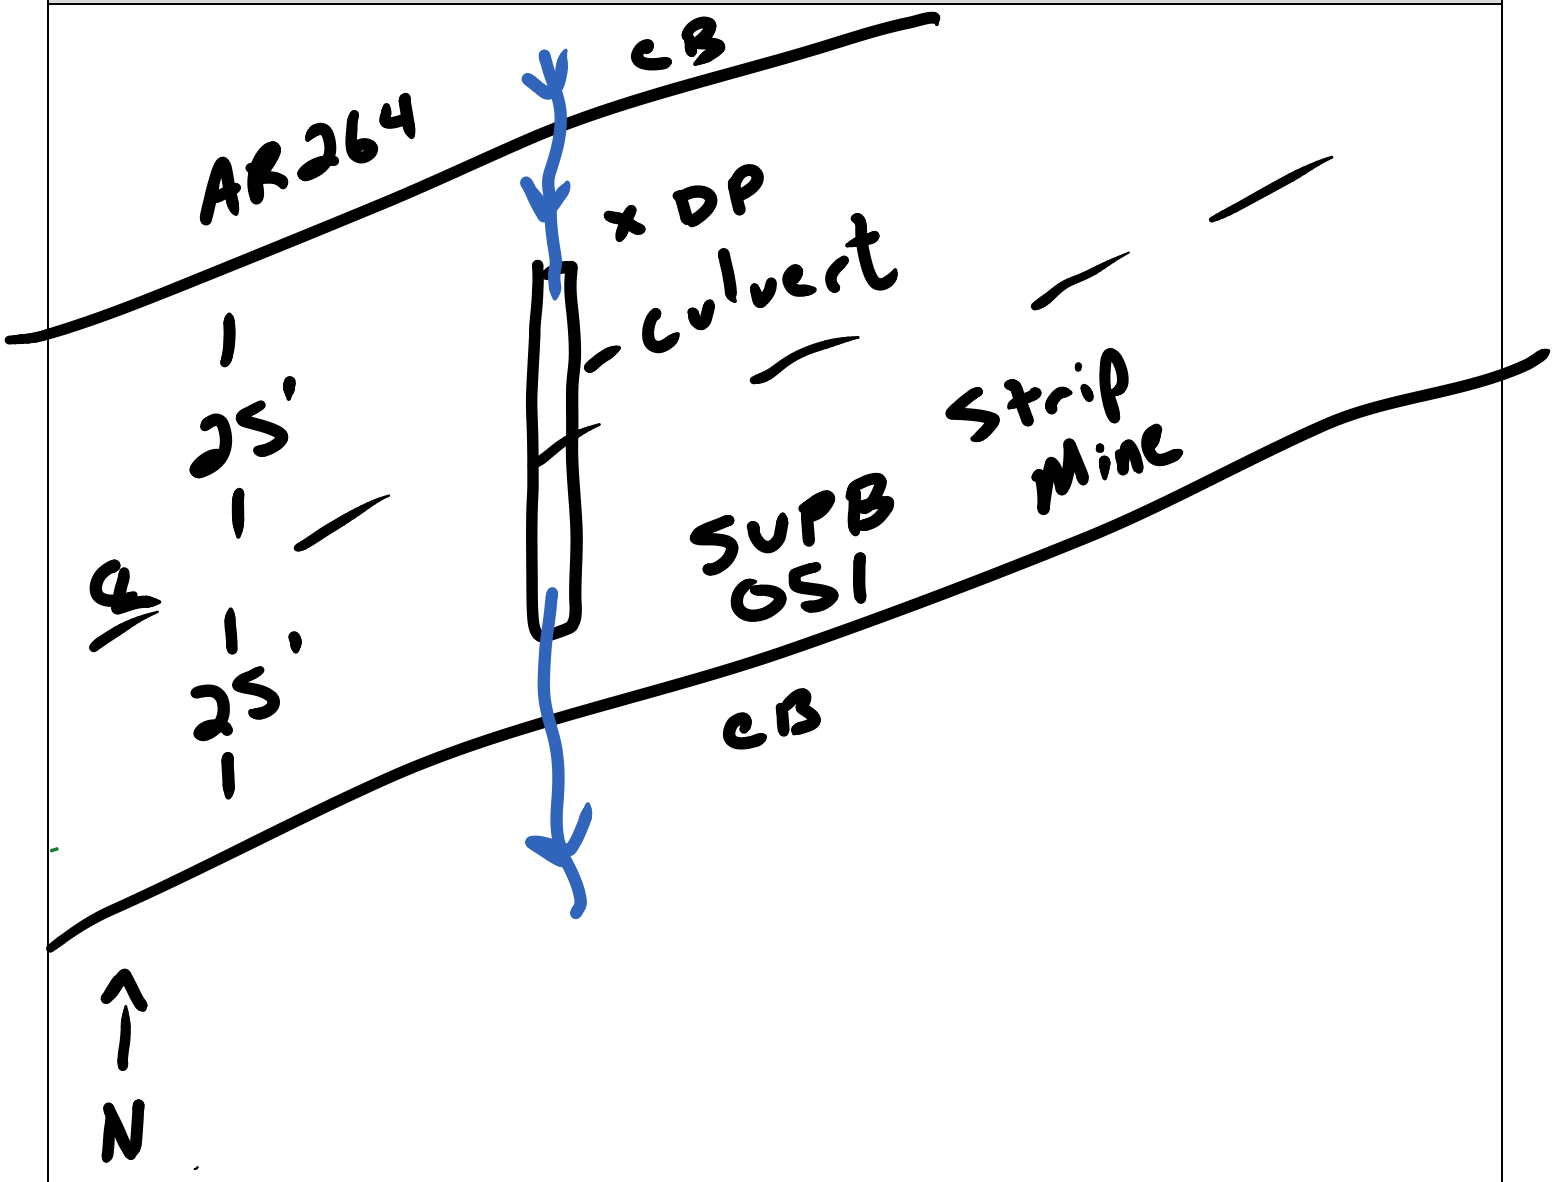
Waterbody Sketch (Include north arrow, centerline, distance from centerline, data point location, survey boundary, and IDs of associated features)

Degraded perennial stream in strip mine, deeply incised. Strong grade control, weak sinuosity. Please note, heavy rains in last 24 hours, stream appears to be perennial, based on today's observations.
