Linear Waterbody Data Sheet

Survey Description			
Project Name: Southeast Reliability		Waterbody Name: Unnamed Tributary to Trubie Run	
Waterbody ID: SUPB009		Date: 6/27/2014	
State: West Virginia	County/Parish: Upshur	Company: Natural Resource Group	Crew Member Initials: TP
Photos: 3			
Tract Number(s): 03-107		Nearest Milepost: 31.27	Associated Wetland ID(s): none
Survey Type: <i>(check one)</i> <input checked="" type="checkbox"/> Centerline <input type="checkbox"/> Re-Route <input type="checkbox"/> Access Road <input type="checkbox"/> Other:			
Physical Attributes			
Stream Classification: <i>(check one)</i> <input type="checkbox"/> Ephemeral <input type="checkbox"/> Intermittent <input checked="" type="checkbox"/> Perennial			
Waterbody Type: <i>(check one)</i> <input type="checkbox"/> River <input checked="" type="checkbox"/> Stream <input type="checkbox"/> Ditch <input type="checkbox"/> Canal <input type="checkbox"/> Other:

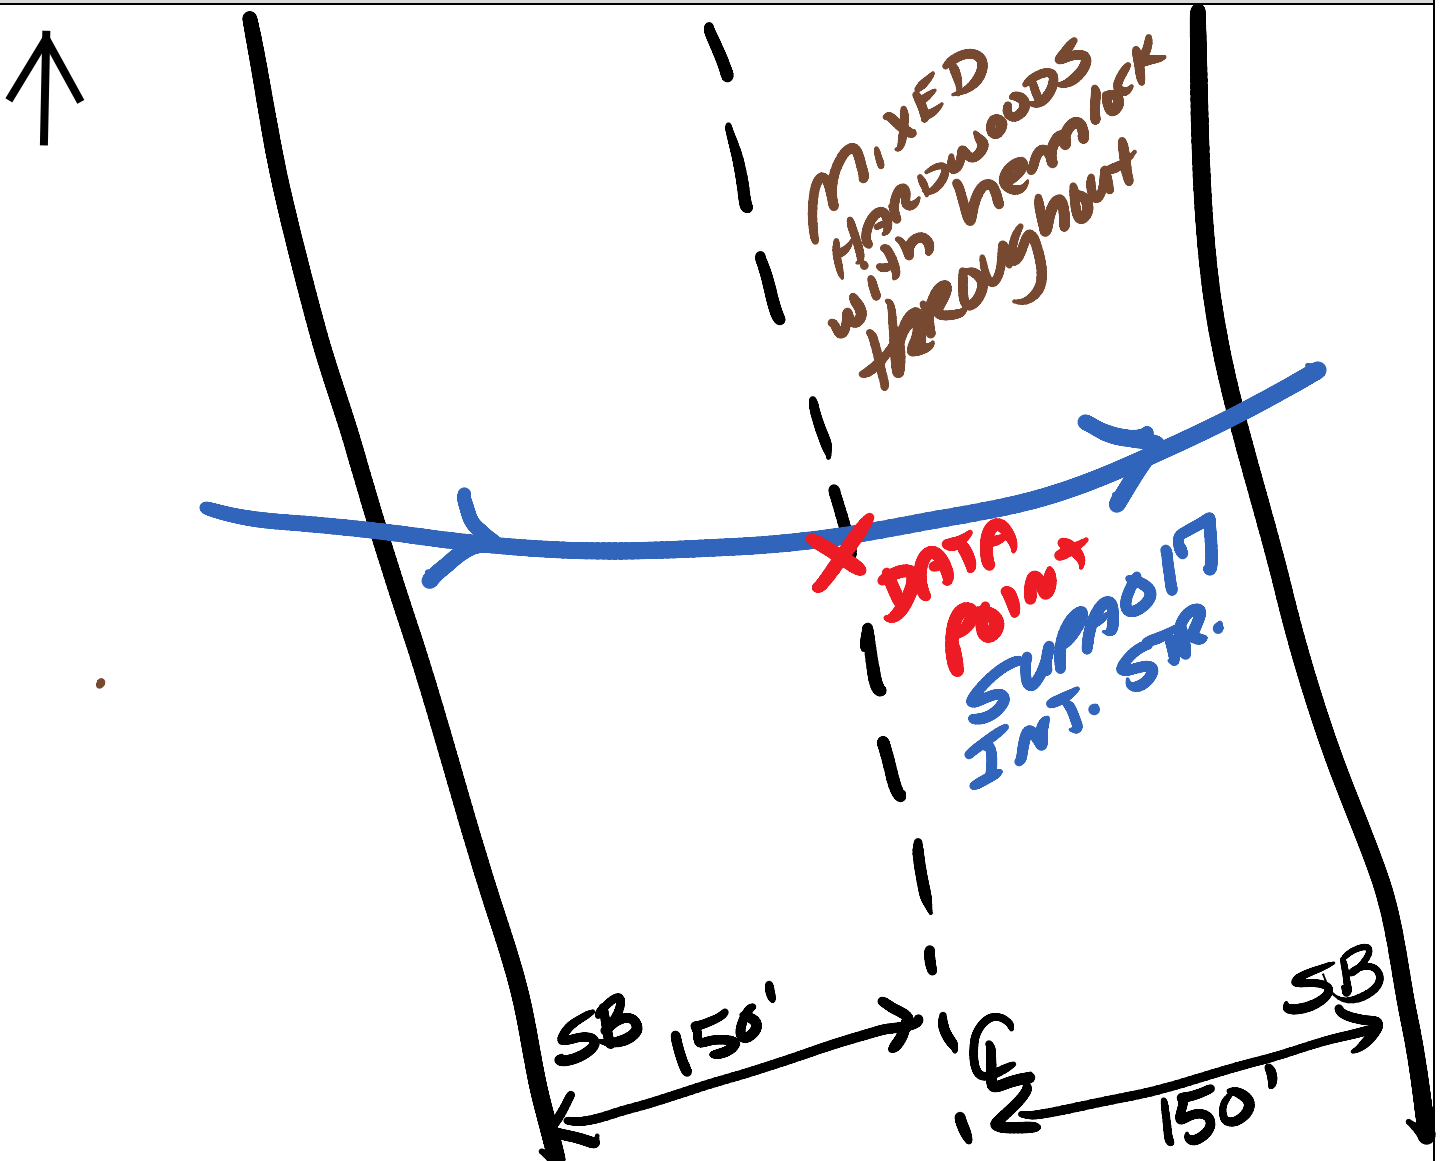
Waterbody Sketch (Include north arrow, centerline, distance from centerline, data point location, survey boundary, and IDs of associated features)

Continues out of corridor both directions

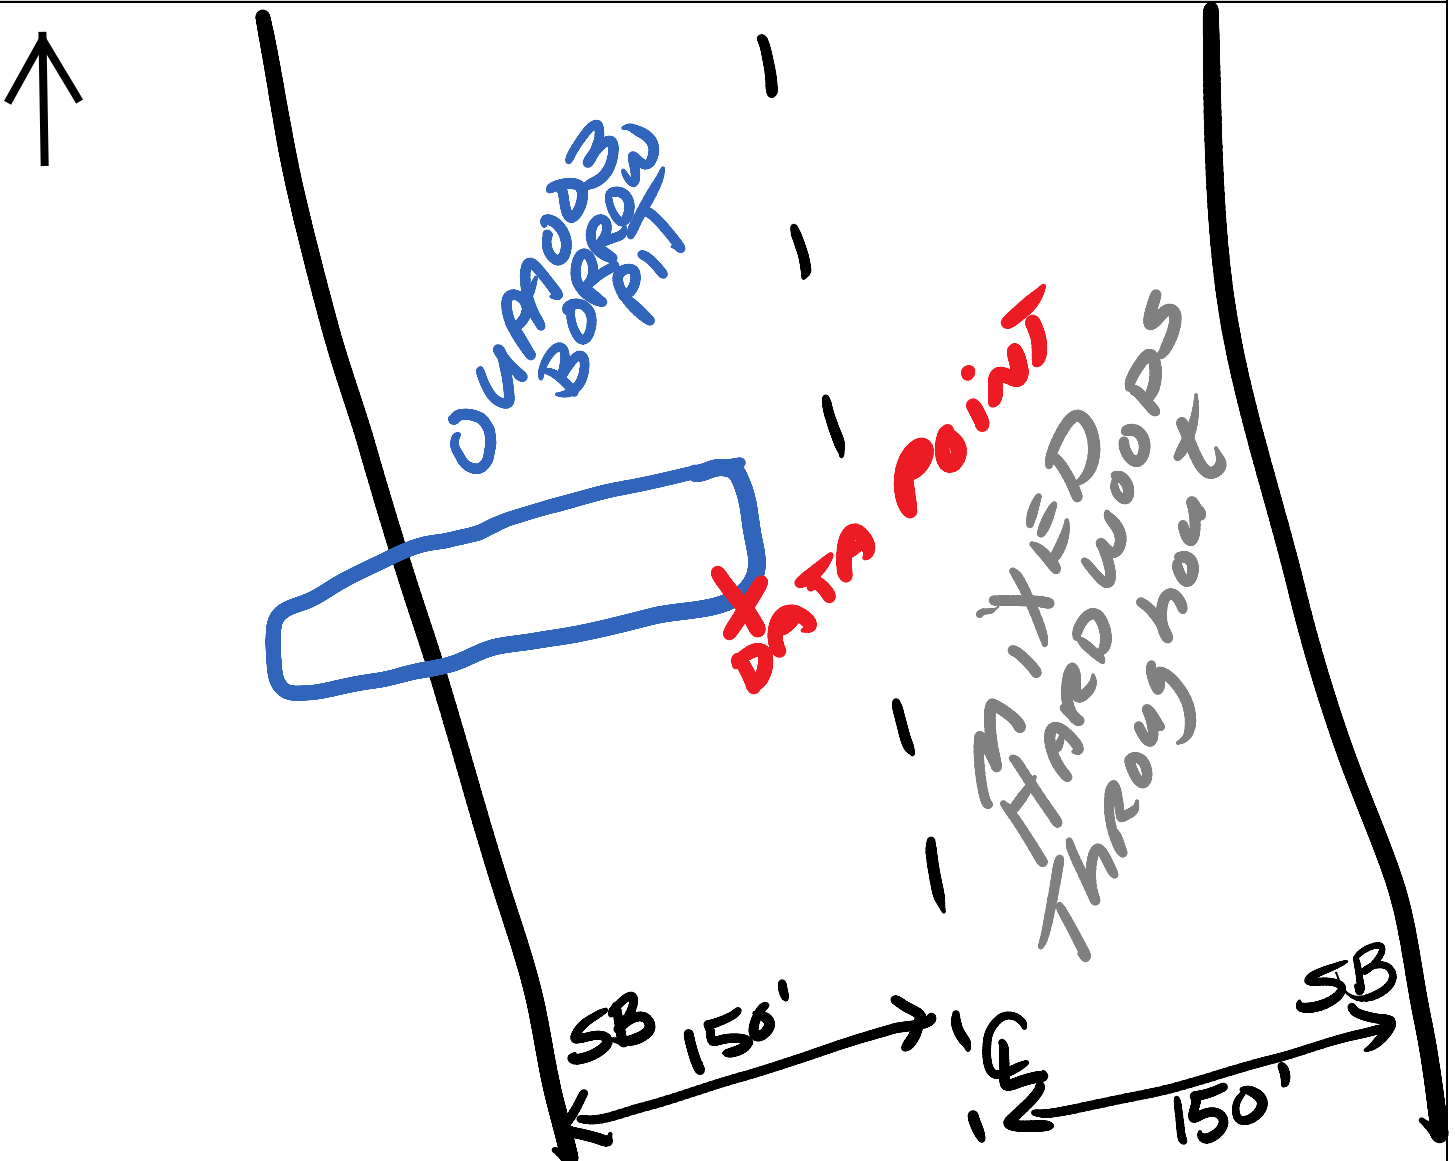
Waterbody Sketch (Include north arrow, centerline, distance from centerline, data point locations, survey boundary, and IDs of associated features)

Borrow pit on a strip mine terrace cut

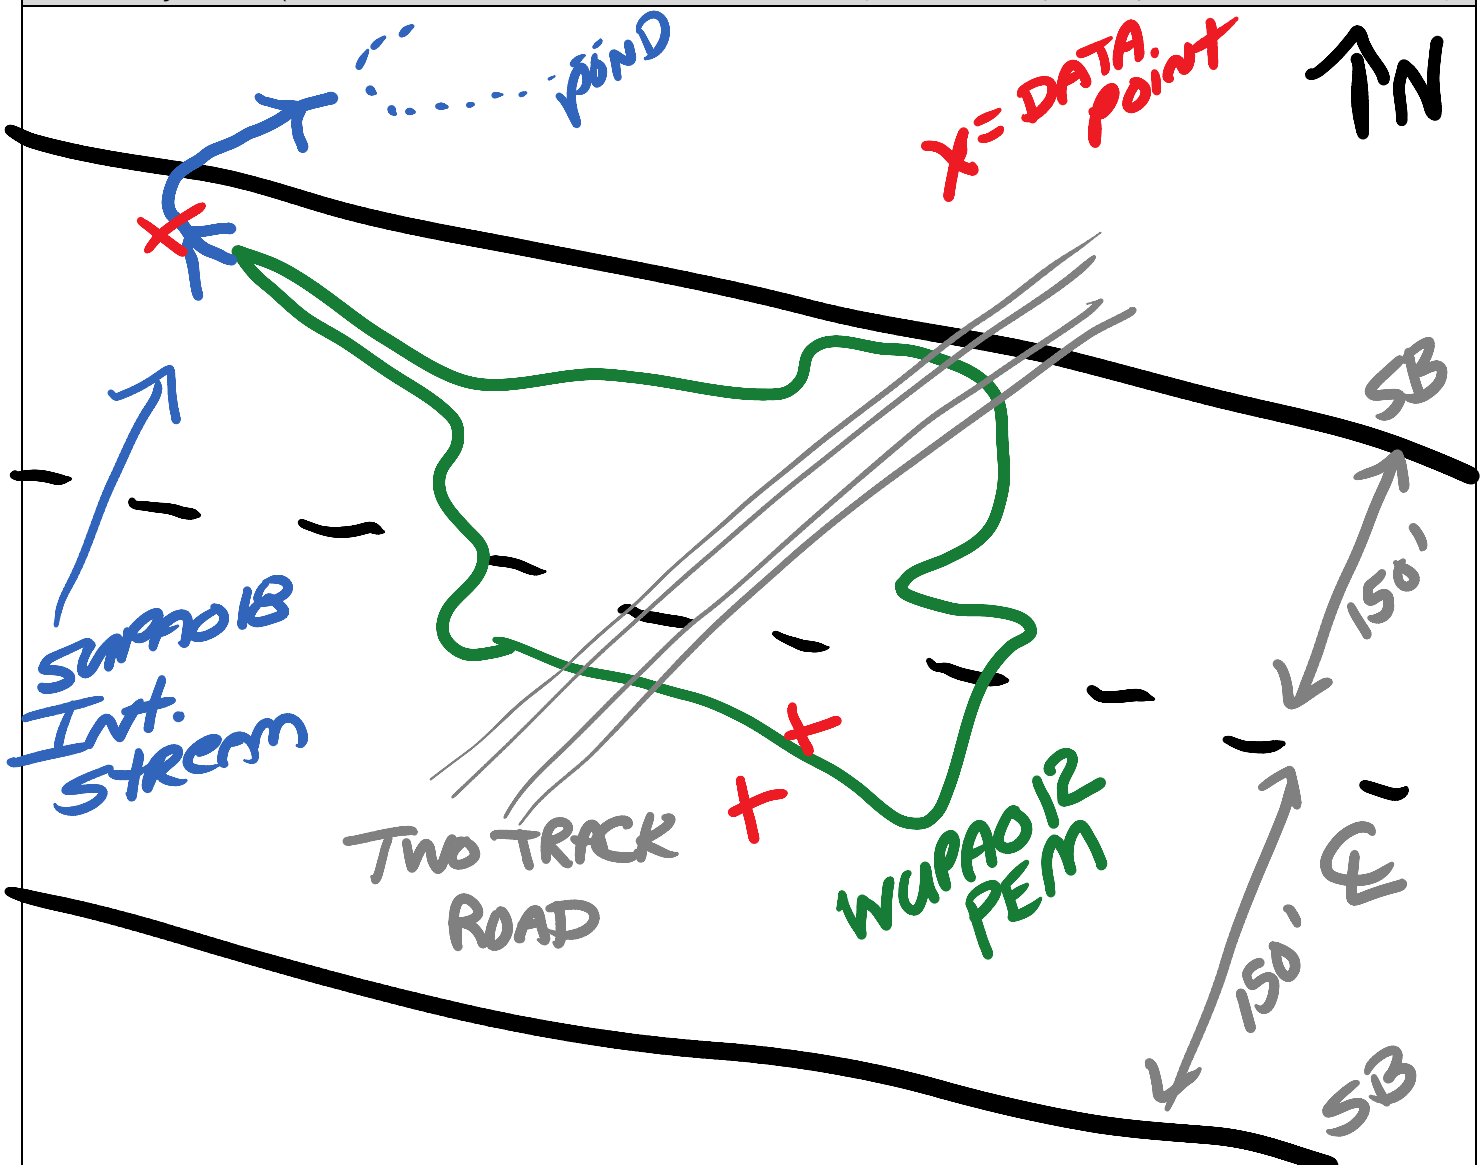
Waterbody Sketch (Include north arrow, centerline, distance from centerline, data point location, survey boundary, and IDs of associated features)

Begins at a headcut as outflow from wetland WUPA012, downstream continues out of corridor and flows into a pond.

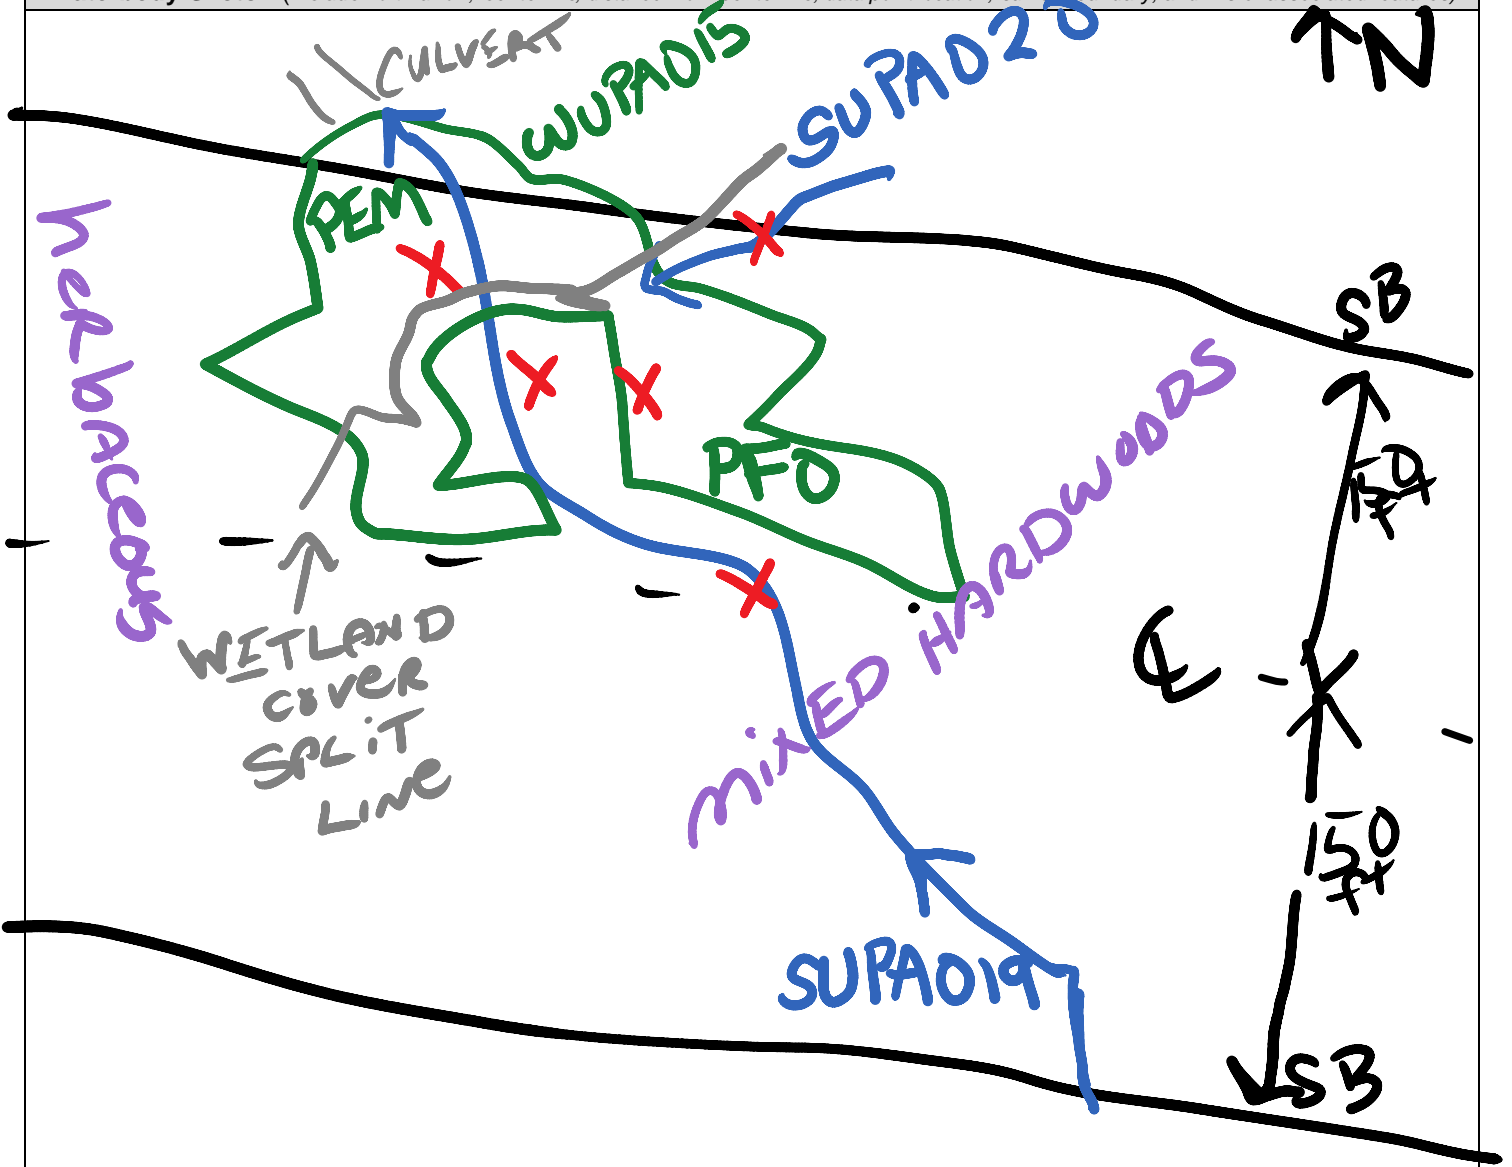
Waterbody Sketch (Include north arrow, centerline, distance from centerline, data point location, survey boundary, and IDs of associated features)

Unnamed tribe to ten mile creek, continues out both directions, runs through wupa015, flows into culvert into a hillside just out of corridor

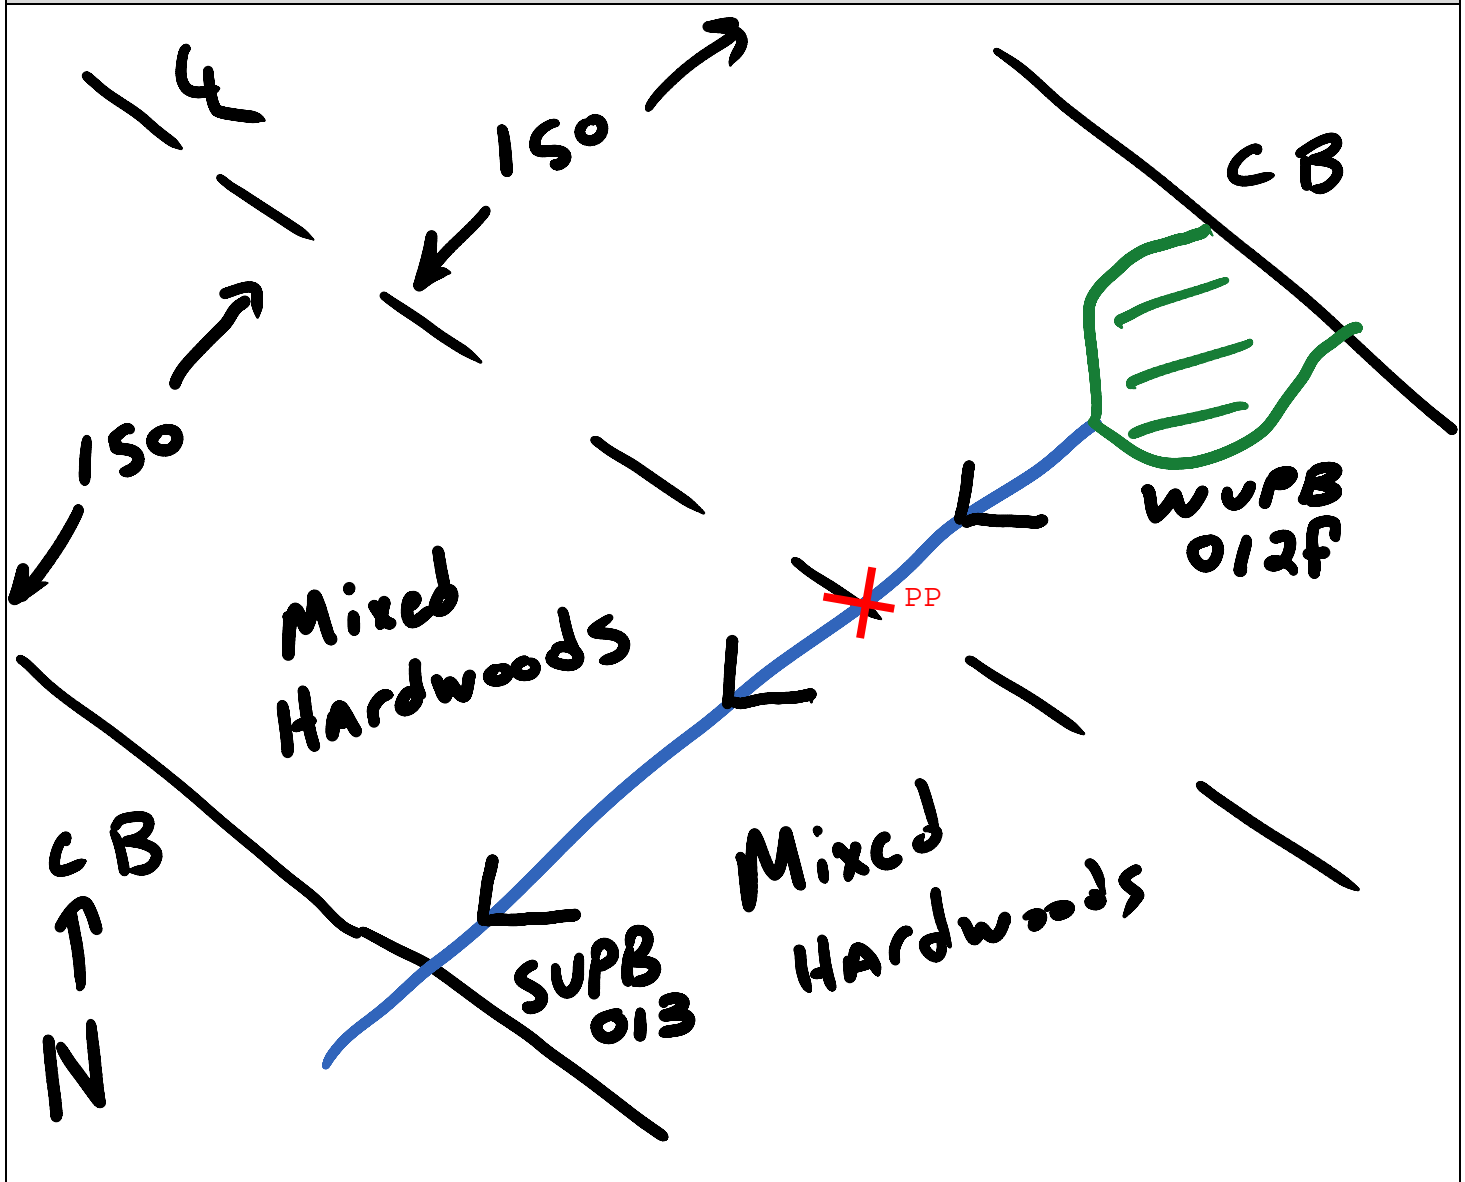
Waterbody Sketch (Include north arrow, centerline, distance from centerline, data point location, survey boundary, and IDs of associated features)

Stream originates below headwater forest wetland. Water present, but rain in last 24 hours. Lots of nick points and grade control, sediment transport, good bars and benches.

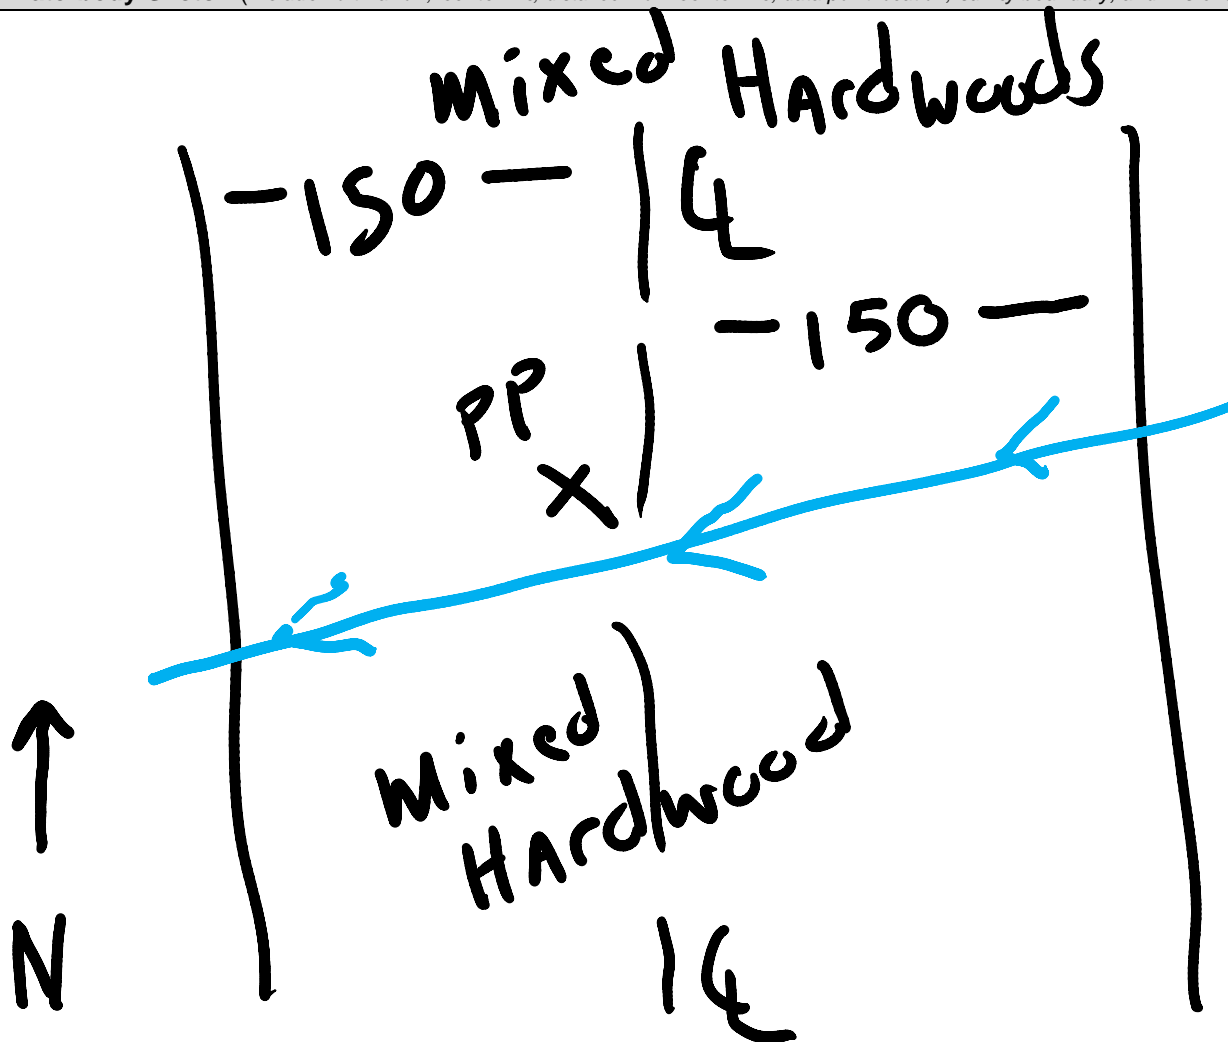
Waterbody Sketch (Include north arrow, centerline, distance from centerline, data point location, survey boundary, and IDs of associated features)

Cattle have trampled in the stream

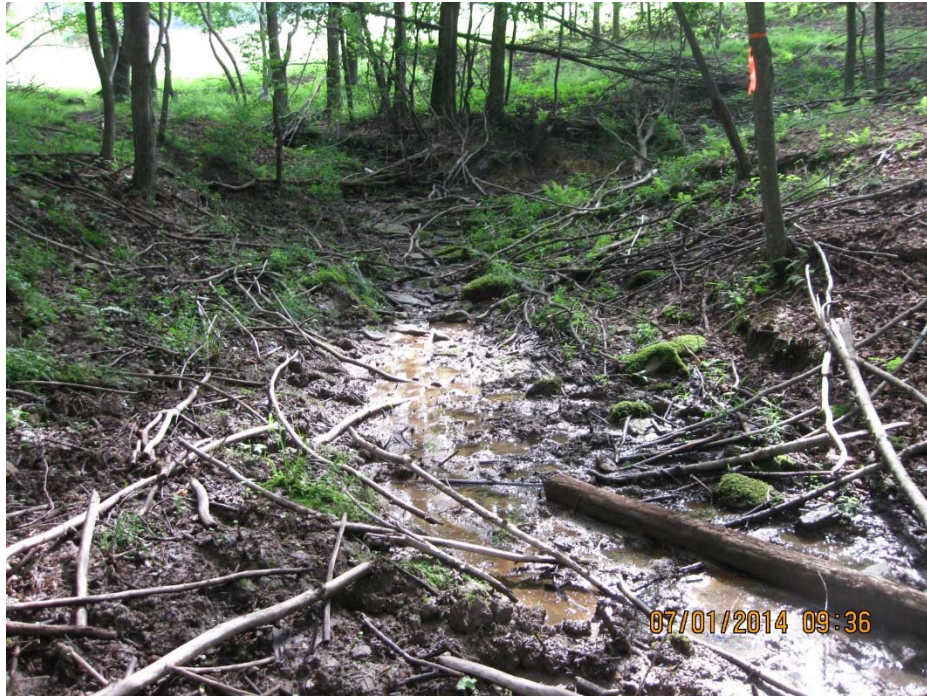
Waterbody SUPB012 facing east upstream

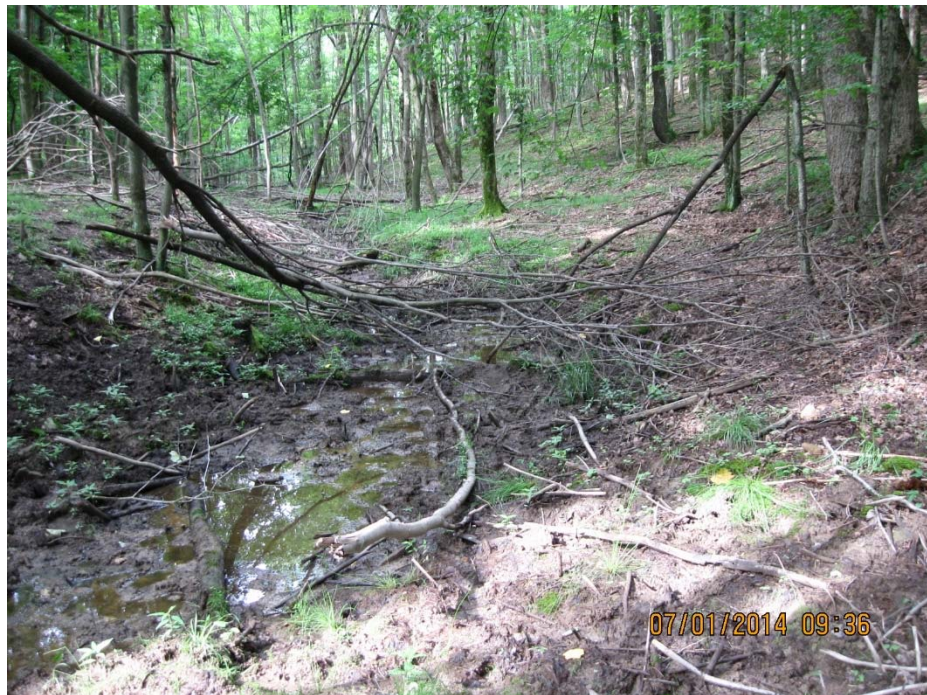
Waterbody SUPB012 facing west downstream

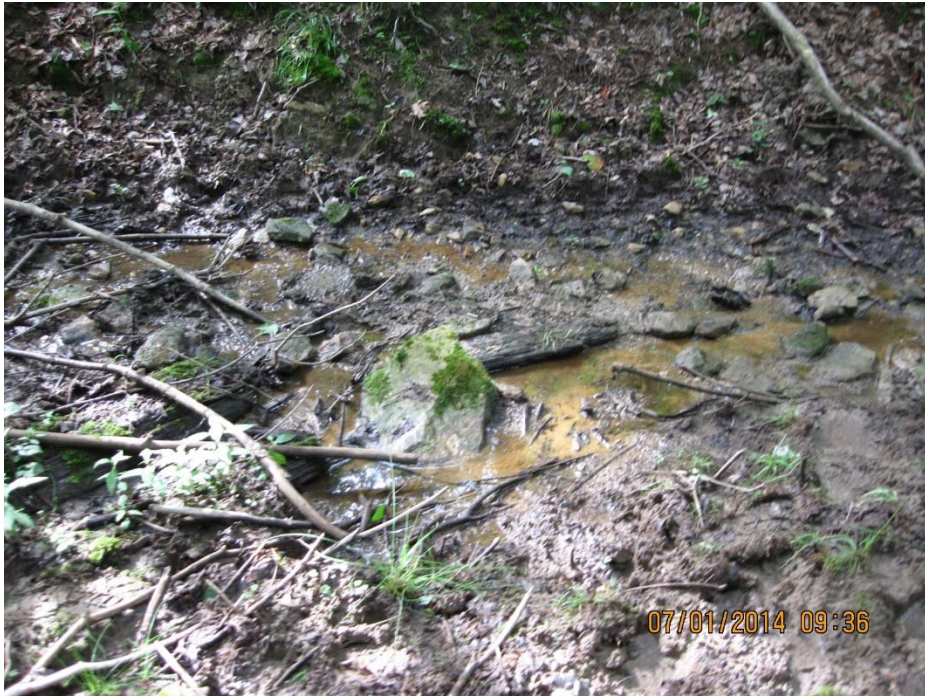
Waterbody SUPB012 facing south across

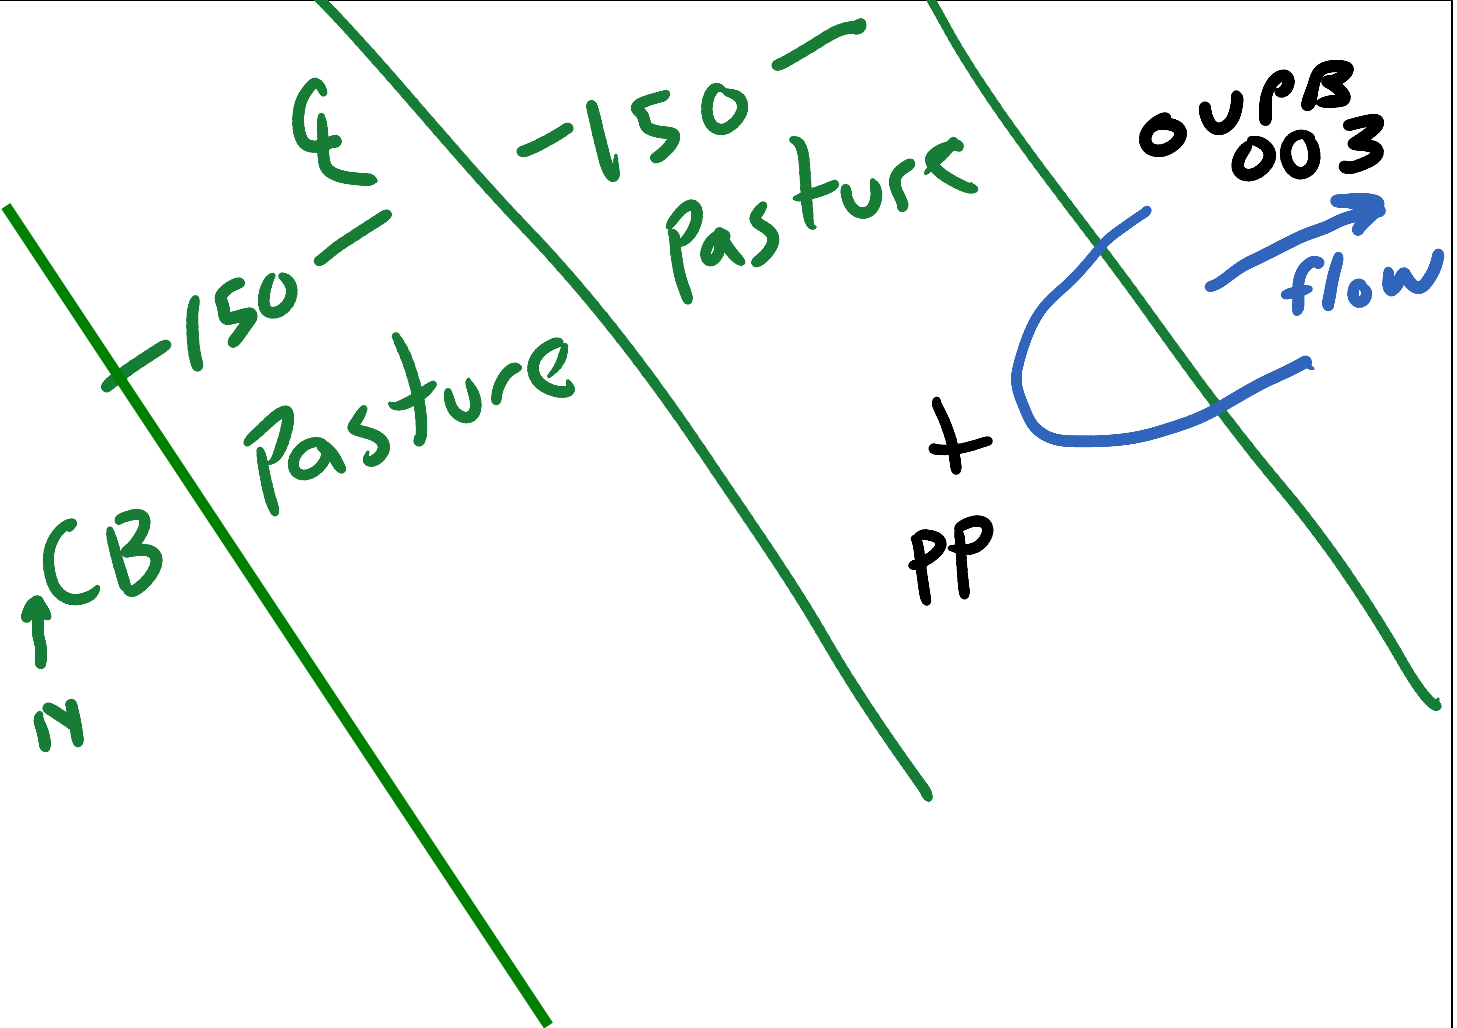
Waterbody Sketch (Include north arrow, centerline, distance from centerline, data point locations, survey boundary, and IDs of associated features)

Stock pond in cattle pasture

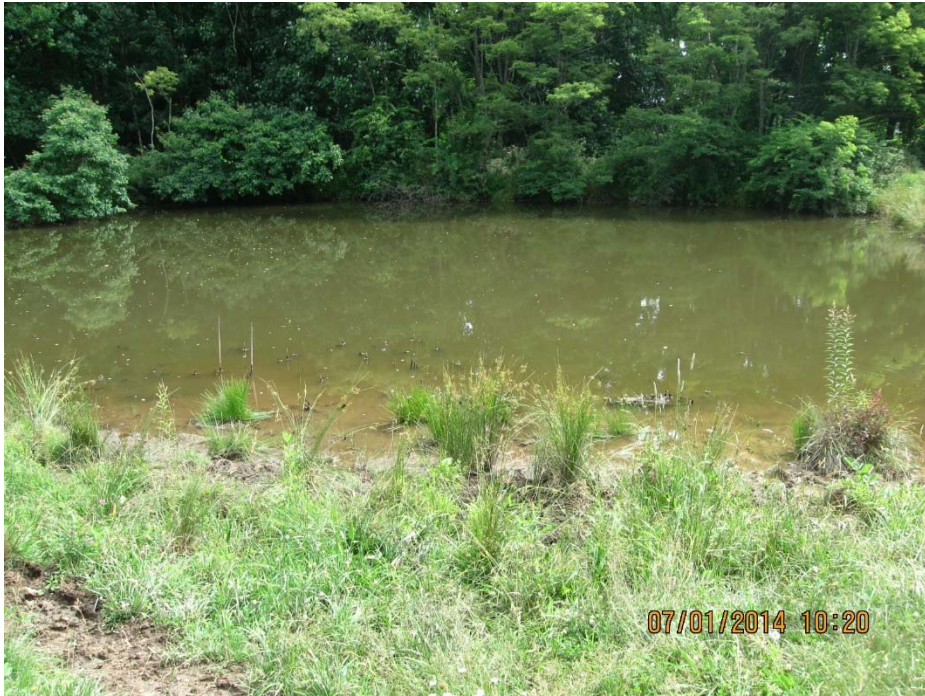
Waterbody OUPB003 facing north

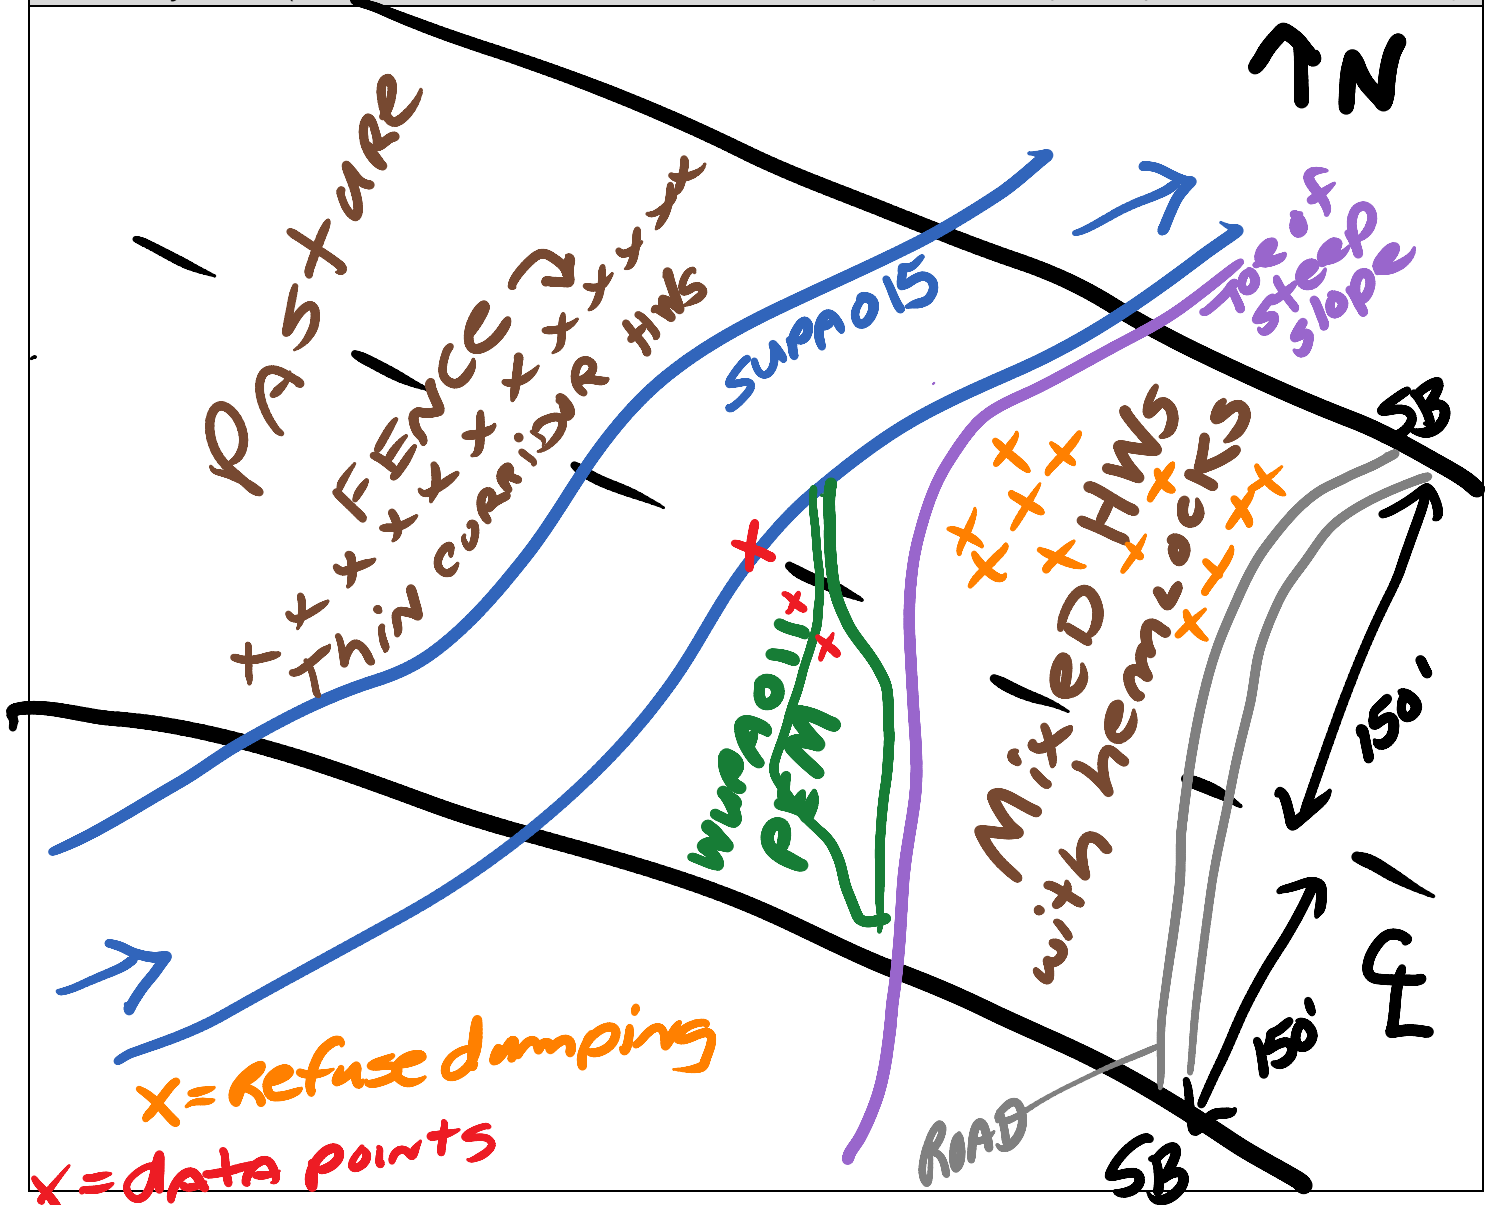
Waterbody Sketch (Include north arrow, centerline, distance from centerline, data point location, survey boundary, and IDs of associated features)

Continues out of corridor in both directions, connected to PEM wetland WUPA011.

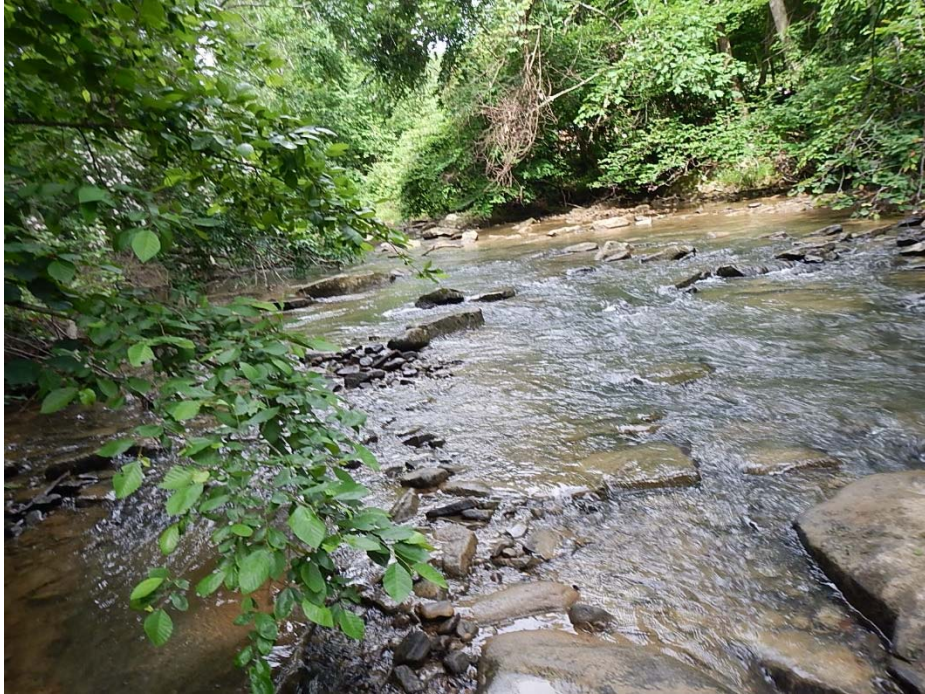
Waterbody SUPA015 facing west upstream

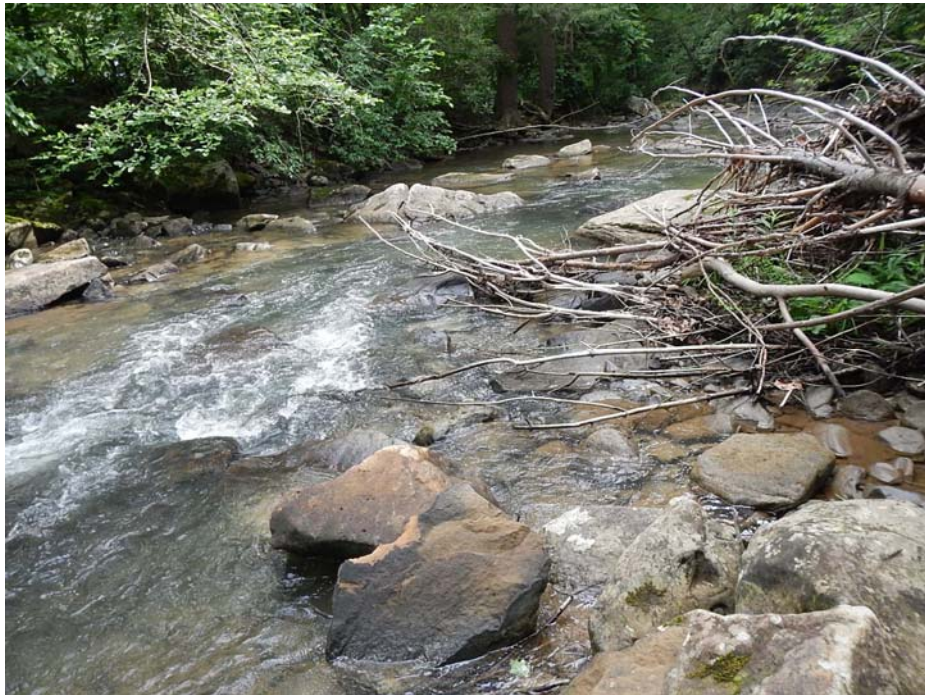
Waterbody SUPA015 facing east downstream

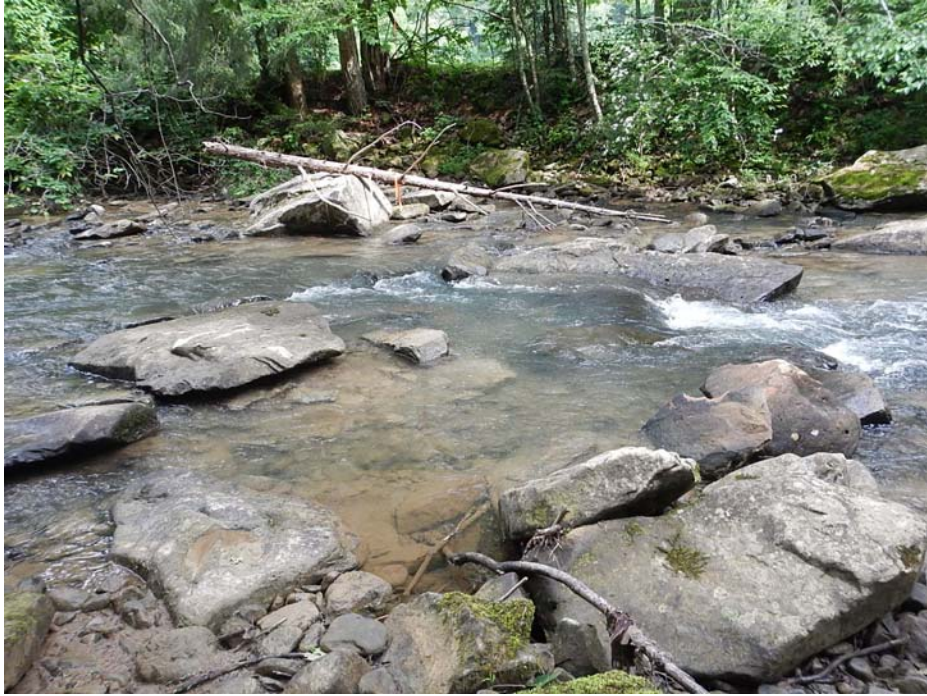
Waterbody SUPA015 facing north across

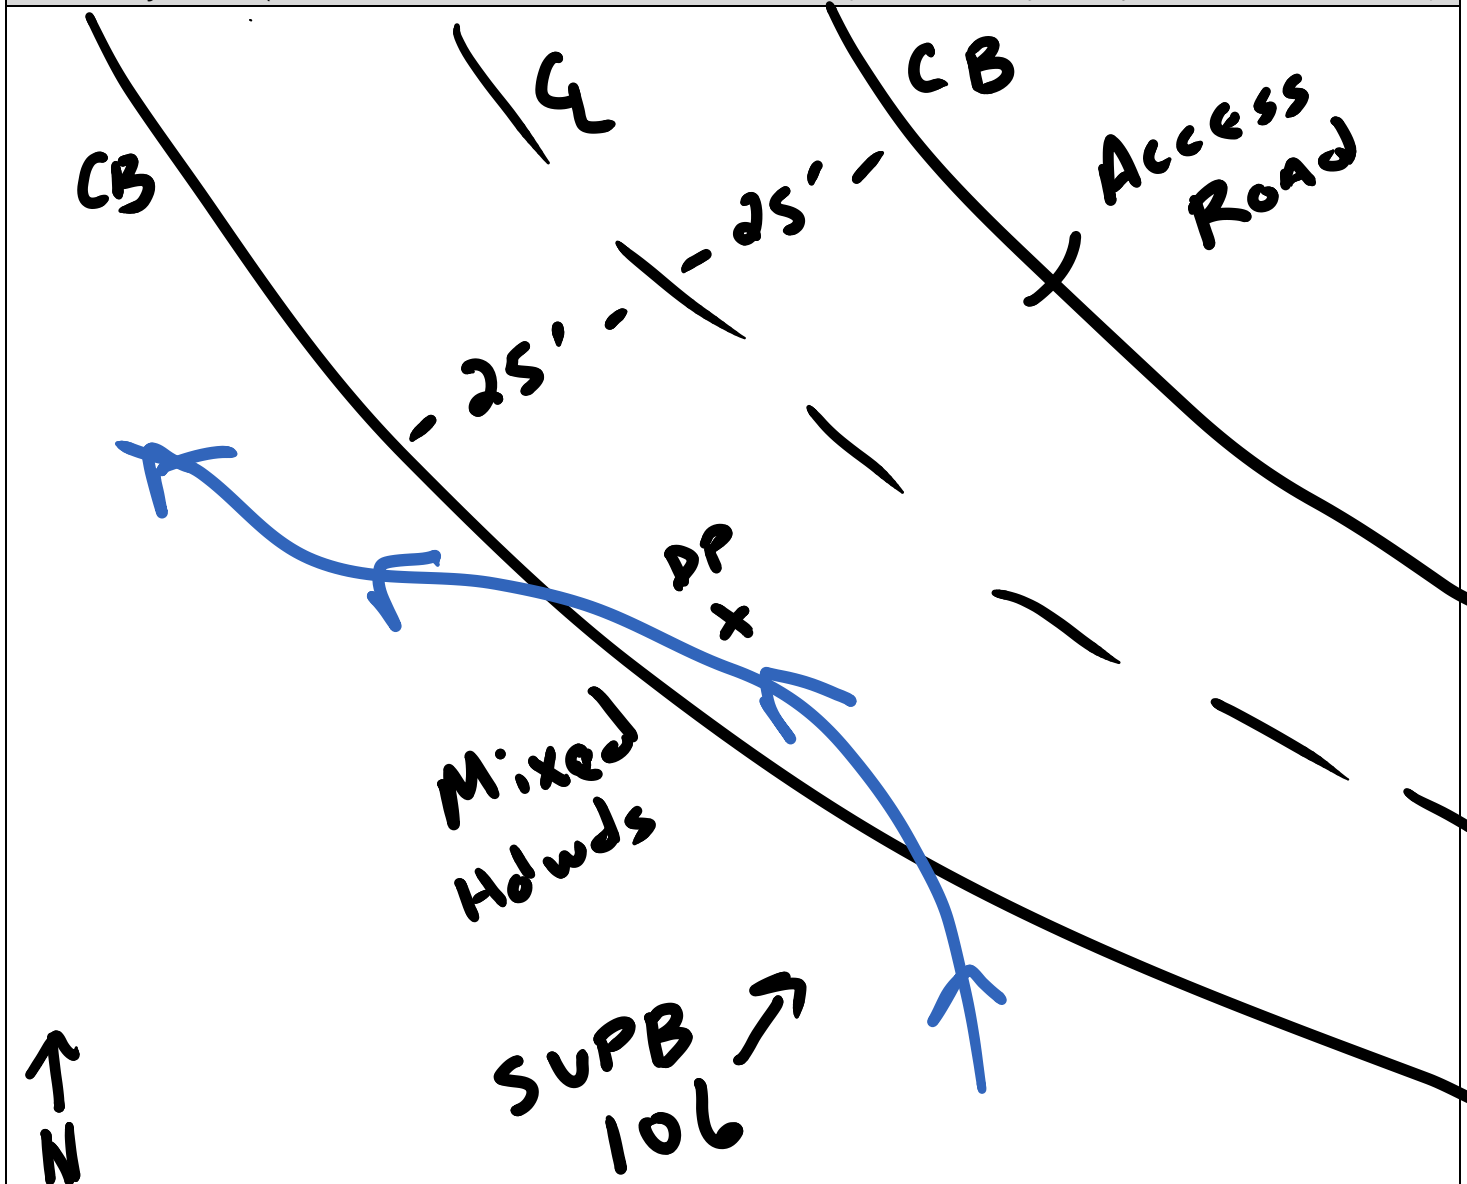
Waterbody Sketch (Include north arrow, centerline, distance from centerline, data point location, survey boundary, and IDs of associated features)

Intermittent stream/seep. Weak bed/banks, strong grade control, a few leaf packs, weak to moderate head cuts, no riffle pool complex. Probably only flowing because of recent rainfall.

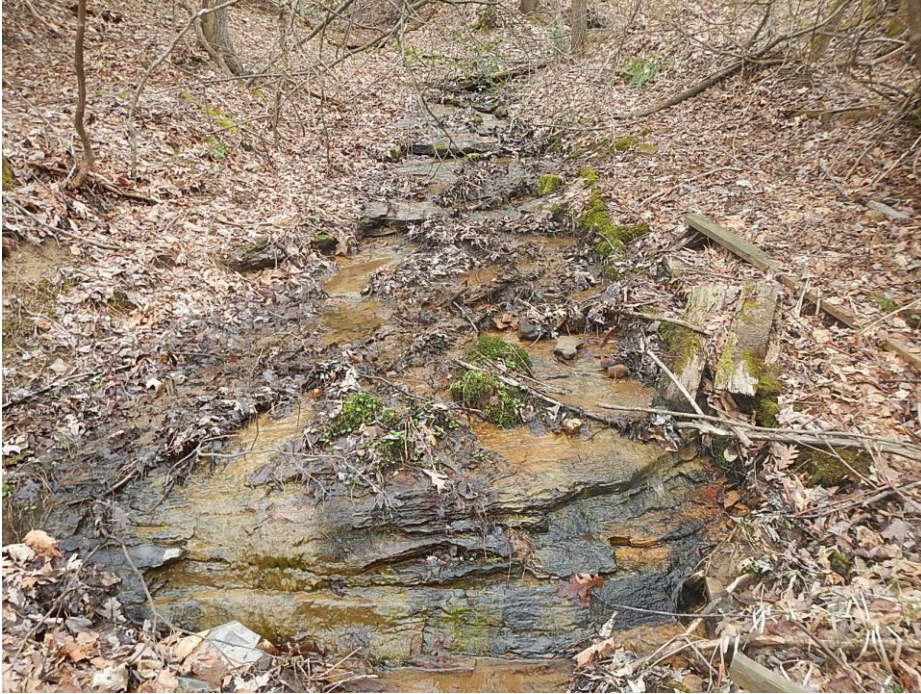
Waterbody SUPB106 facing southeast upstream

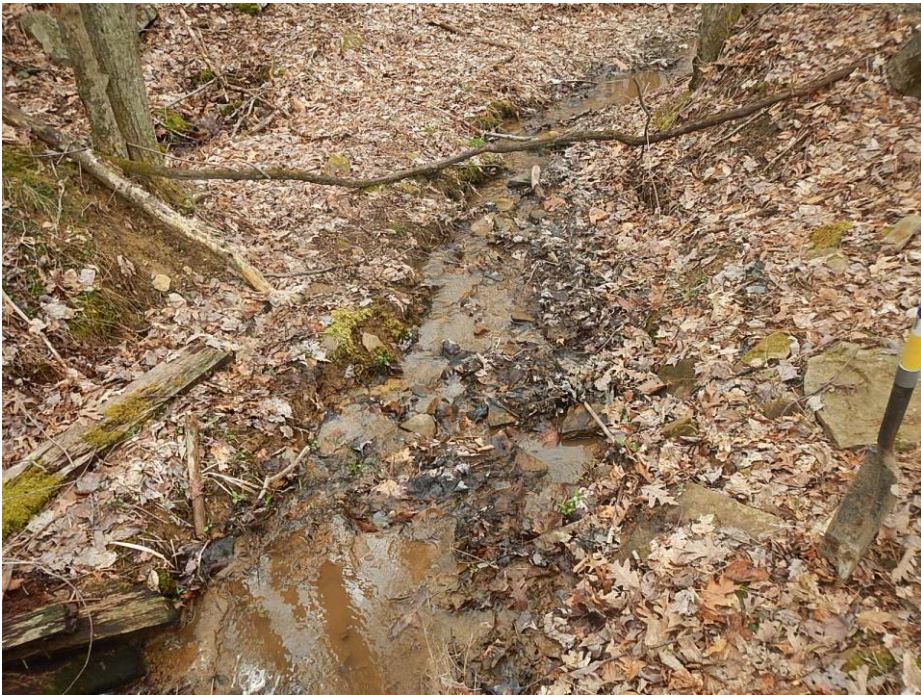
Waterbody SUPB106 facing southwest downstream

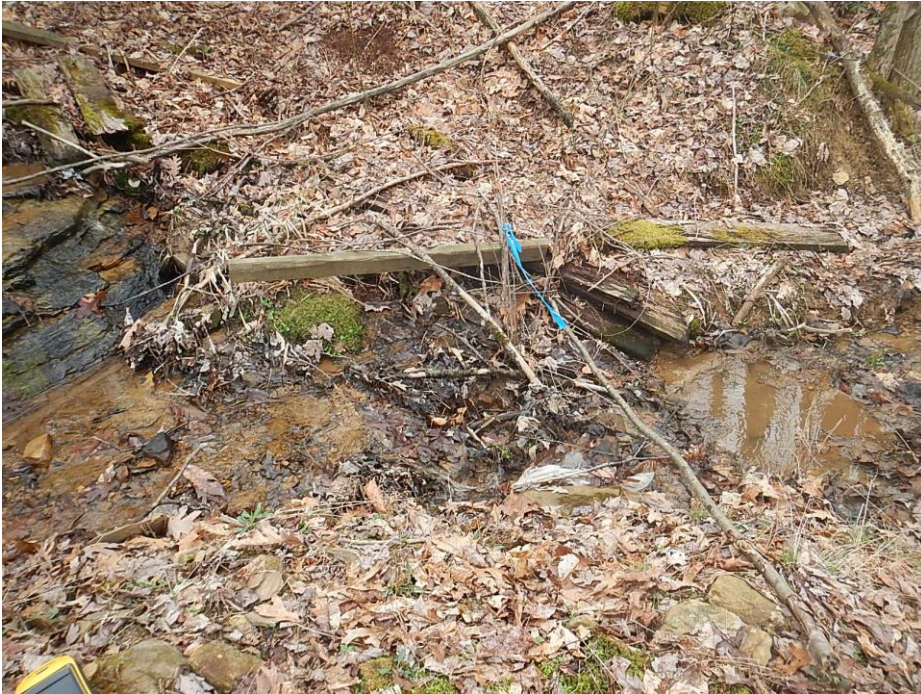
Waterbody SUPB106 facing south across
