Linear Waterbody Data Sheet

Survey Description			
Project Name: Southeast Reliability		Waterbody Name: Unnamed Tributary to Trubie Run	
Waterbody ID: SUPB009		Date: 6/27/2014	
State: West Virginia	County/Parish: Upshur	Company: Natural Resource Group	Crew Member Initials: TP
Photos: 3			
Tract Number(s): 03-107		Nearest Milepost: 31.27	Associated Wetland ID(s): none
Survey Type: <i>(check one)</i> <input checked="" type="checkbox"/> Centerline <input type="checkbox"/> Re-Route <input type="checkbox"/> Access Road <input type="checkbox"/> Other:			
Physical Attributes			
Stream Classification: <i>(check one)</i> <input type="checkbox"/> Ephemeral <input type="checkbox"/> Intermittent <input checked="" type="checkbox"/> Perennial			
Waterbody Type: <i>(check one)</i> <input type="checkbox"/> River <input checked="" type="checkbox"/> Stream <input type="checkbox"/> Ditch <input type="checkbox"/> Canal <input type="checkbox"/> Other:

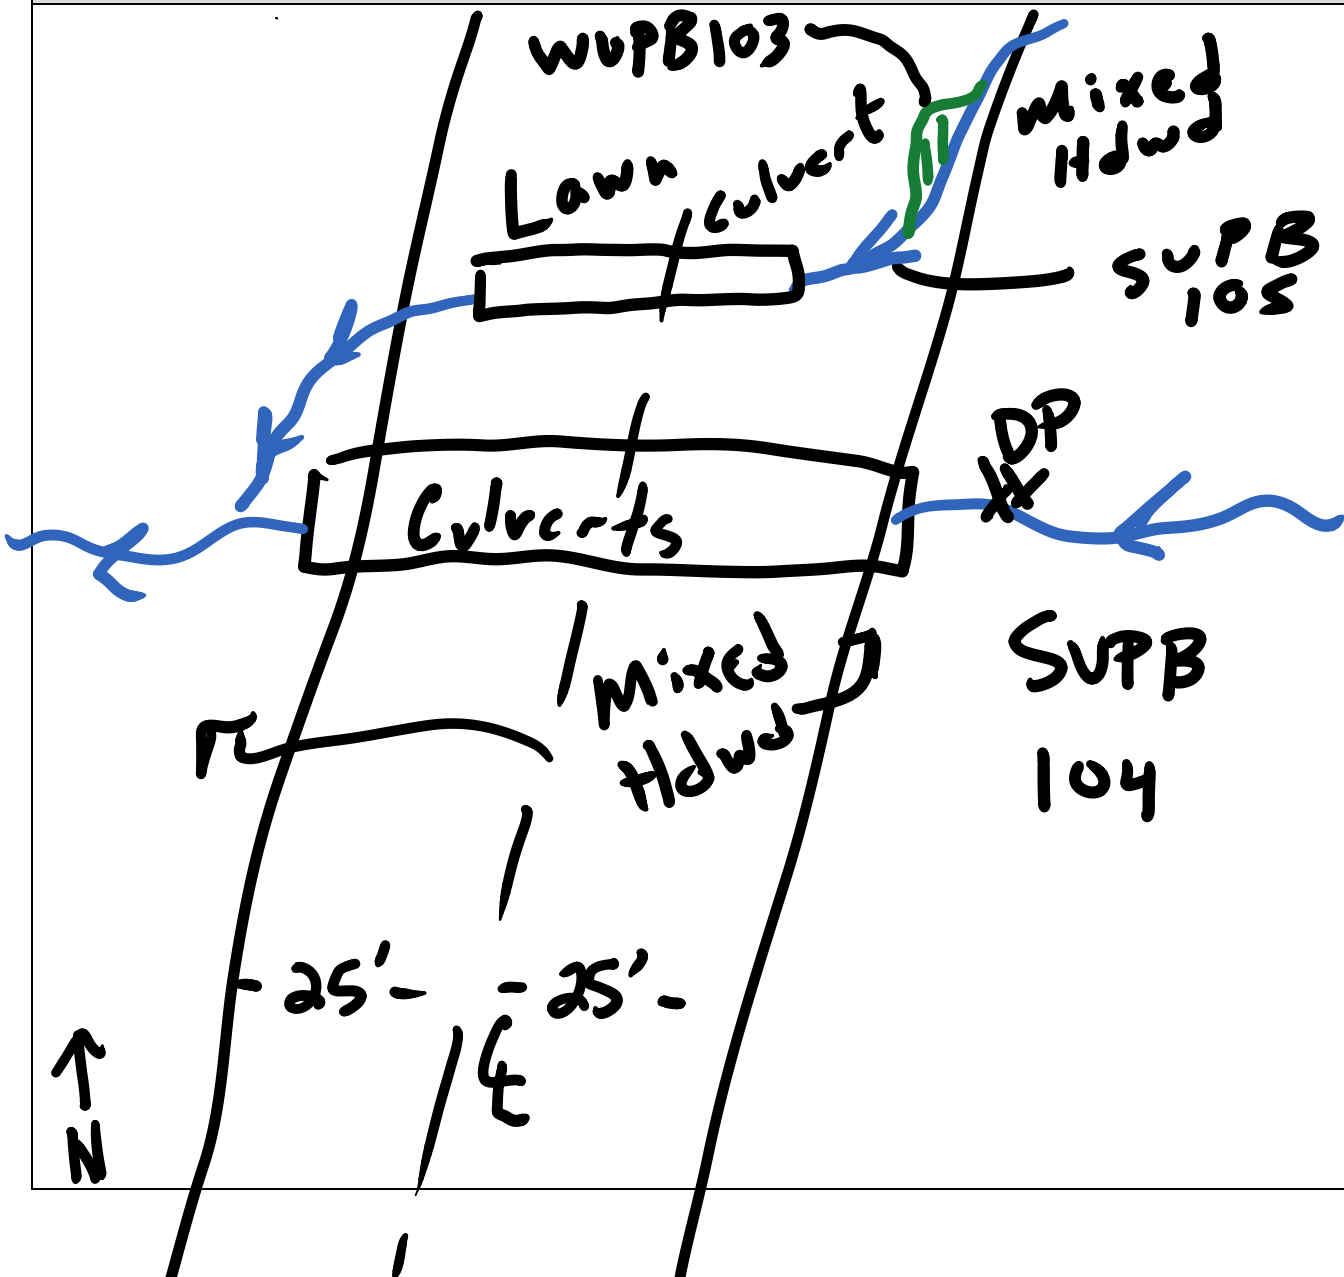
Waterbody Sketch (Include north arrow, centerline, distance from centerline, data point location, survey boundary, and IDs of associated features)

Ephemeral stream conveying roadside drainage. Weak sinuosity, weak grade control. Probably only flowing because of recent rainfall.

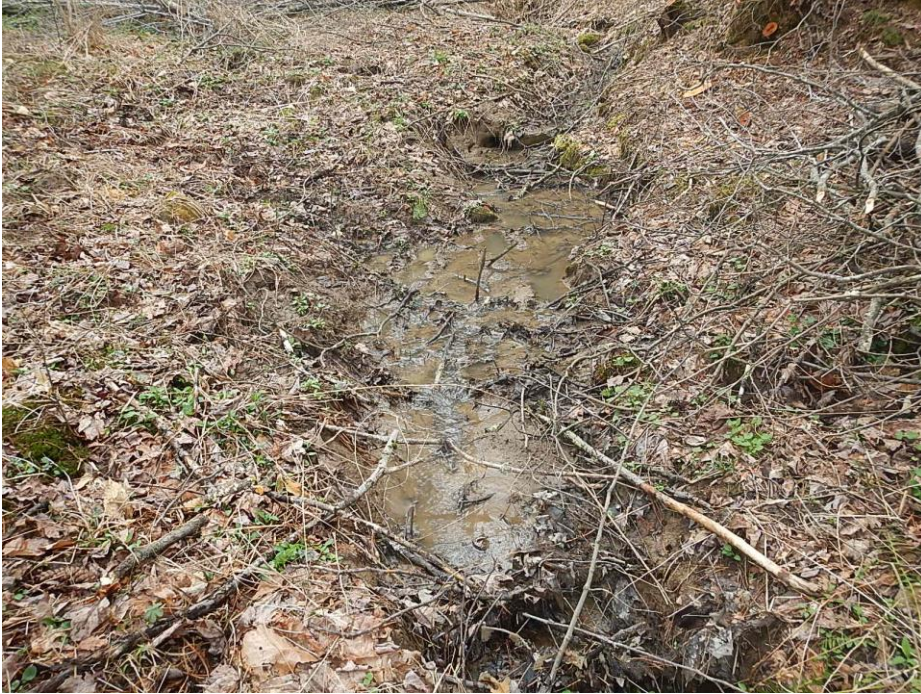
Waterbody SUPB105 facing east upstream

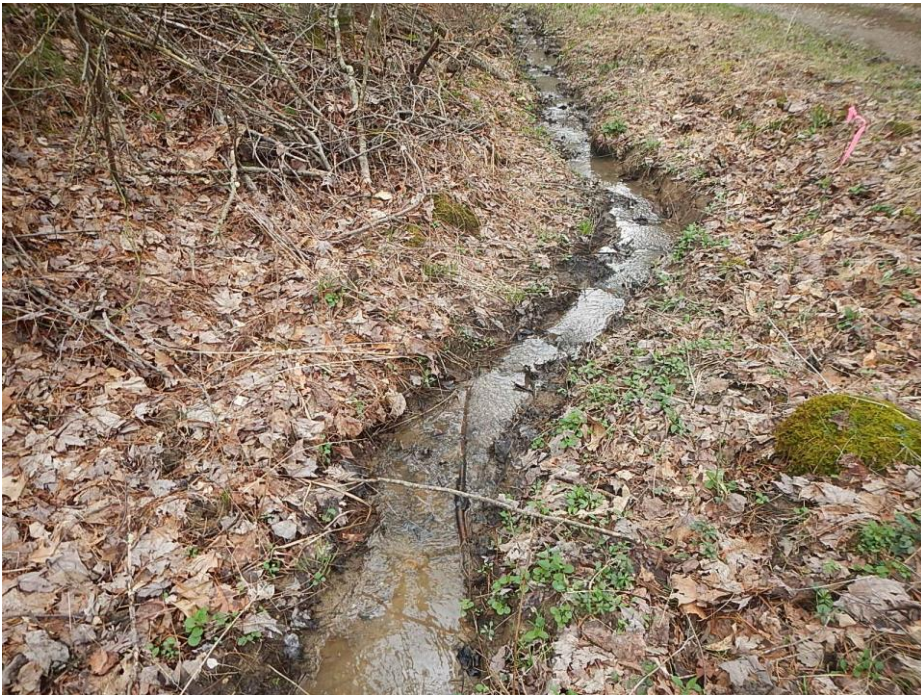
Waterbody SUPB105 facing west downstream

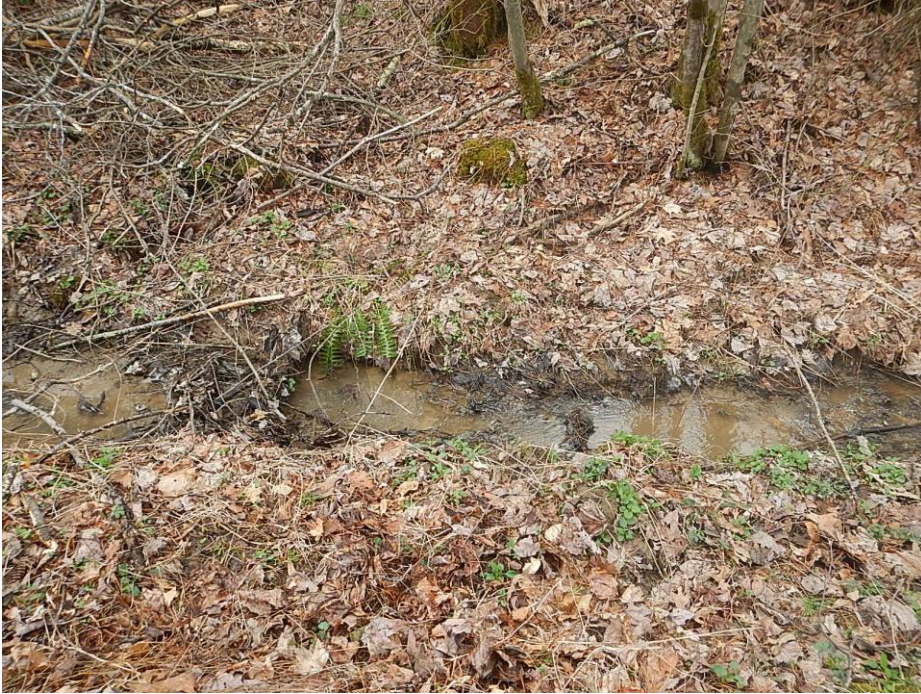
Waterbody SUPB105 facing south across

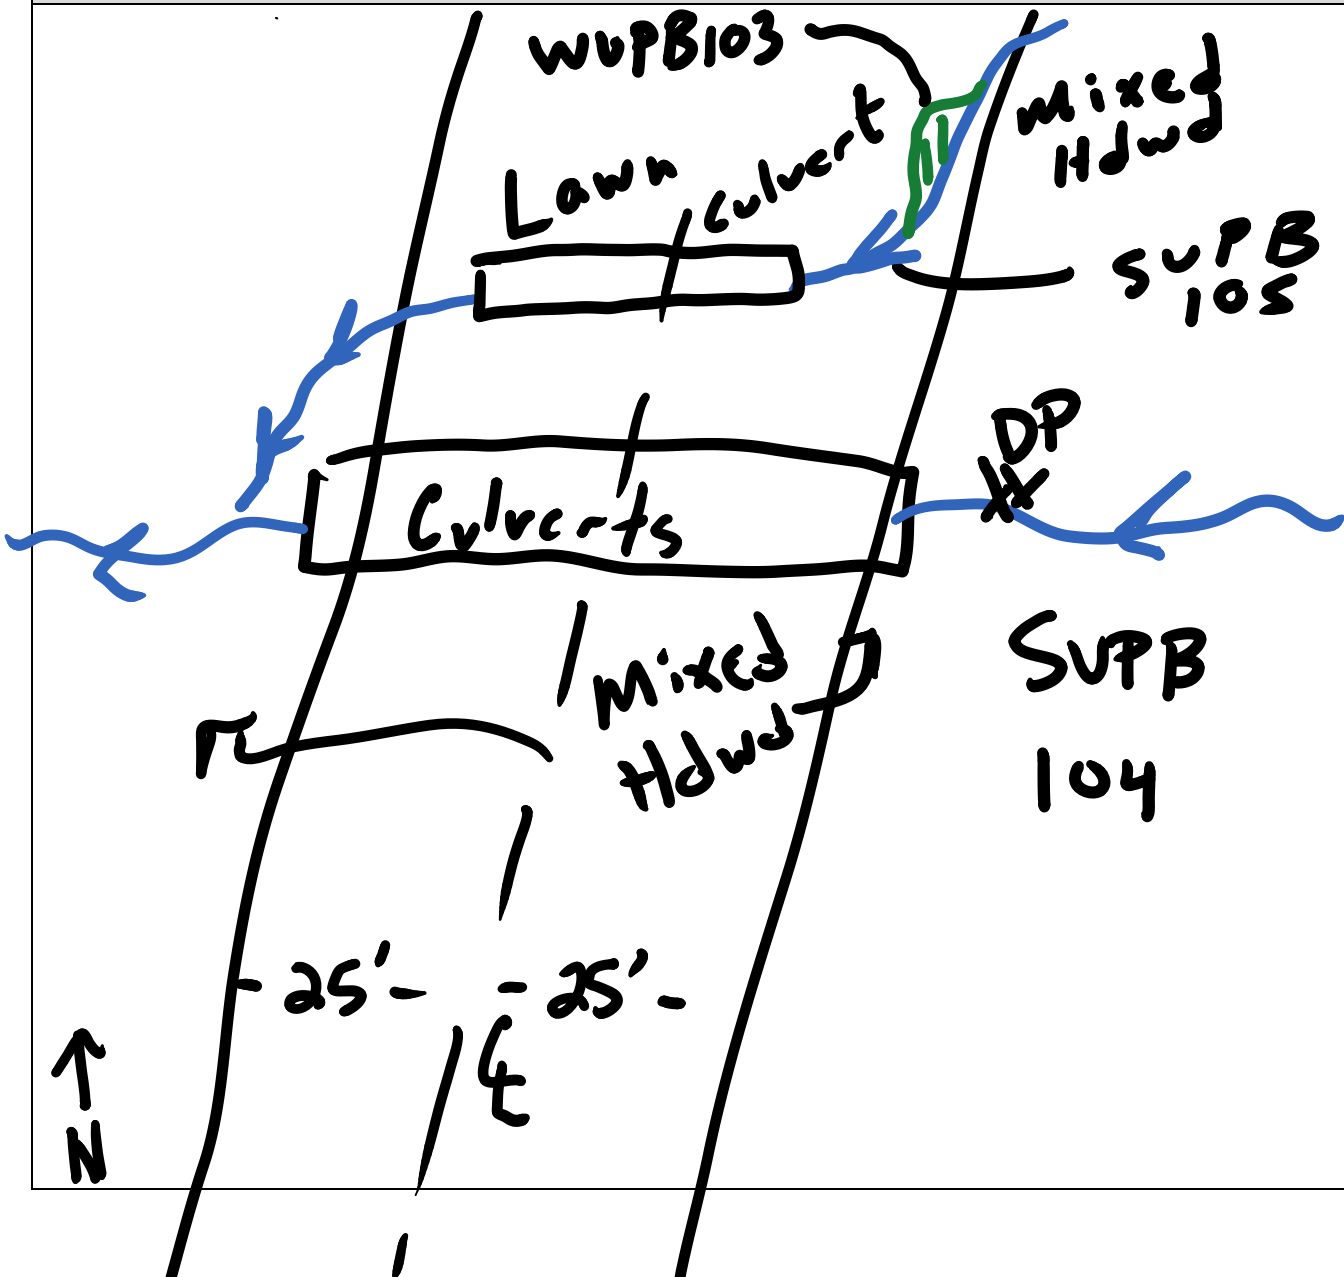
Waterbody Sketch (Include north arrow, centerline, distance from centerline, data point location, survey boundary, and IDs of associated features)

Typical mountain stream. Fast flowing stream strewn with boulders and cobble. Locals state that brook trout are present. Noted strong bars and benches, cobble, strong sinuosity in thalweg, strong grade control, debris piles, moderate to strong riffle pool sequence, roots along bank.

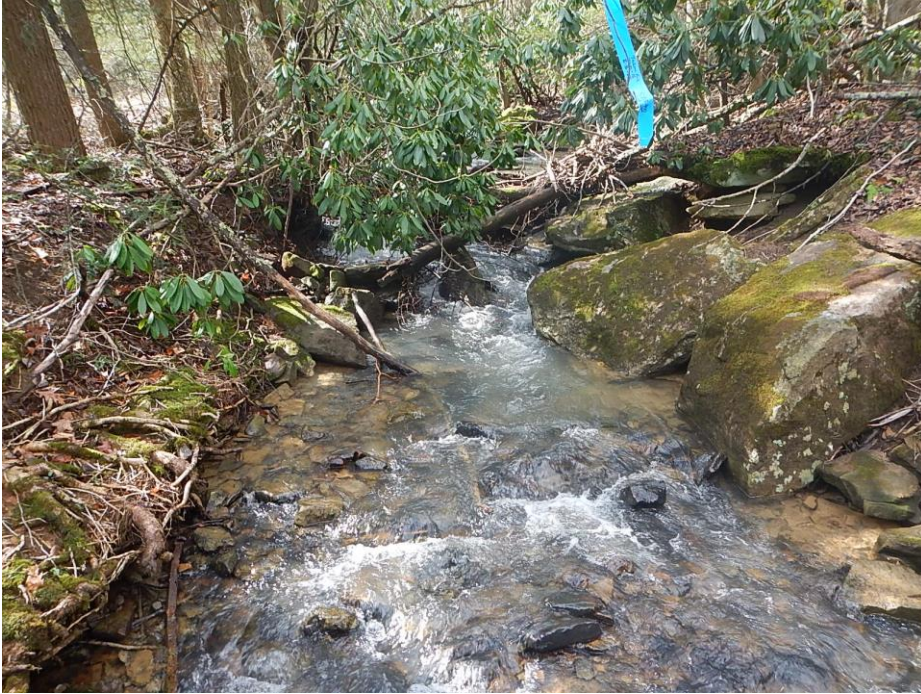
Waterbody SUPB104 facing south upstream

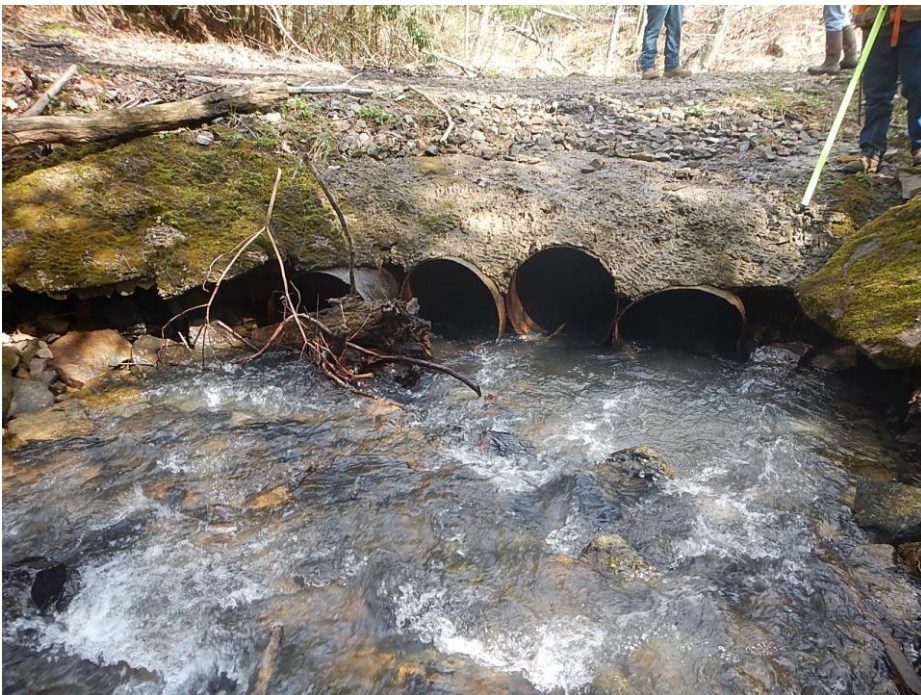
Waterbody SUPB104 facing north downstream

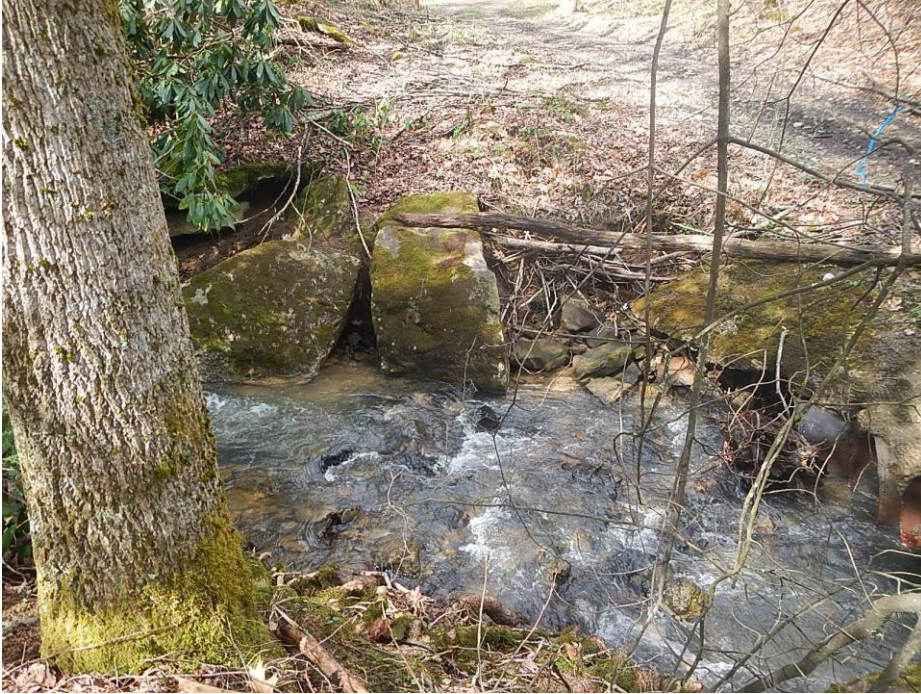
Waterbody SUPB104 facing west across
