**Atlantic Coast Pipeline**

Visual Impact Assessment for Pipeline Segments in Monongahela and George Washington National Forests, and National Park Service Lands, including the Appalachian National Scenic Trail and Seneca State Forest

January 2017

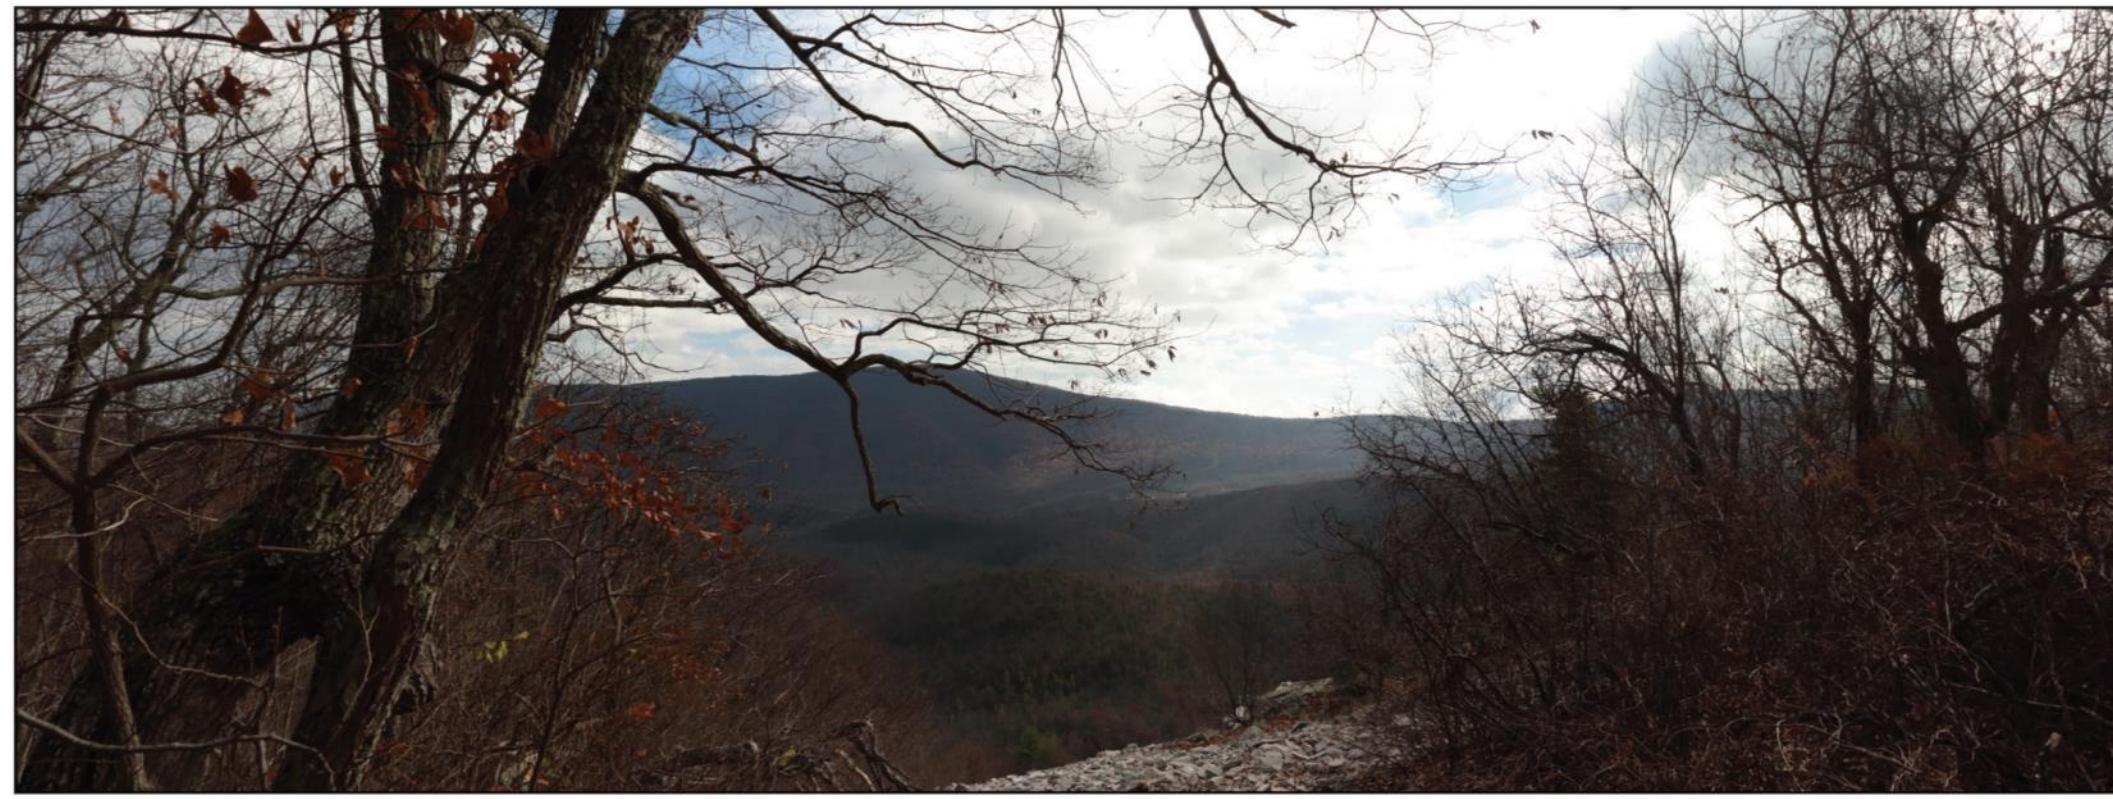
Figure 2-3: Full Simulation, KOP 34, Regrowth Following Construction

KOP34 - Torry Ridge Trail 1, Looking Southeast - Following Construction

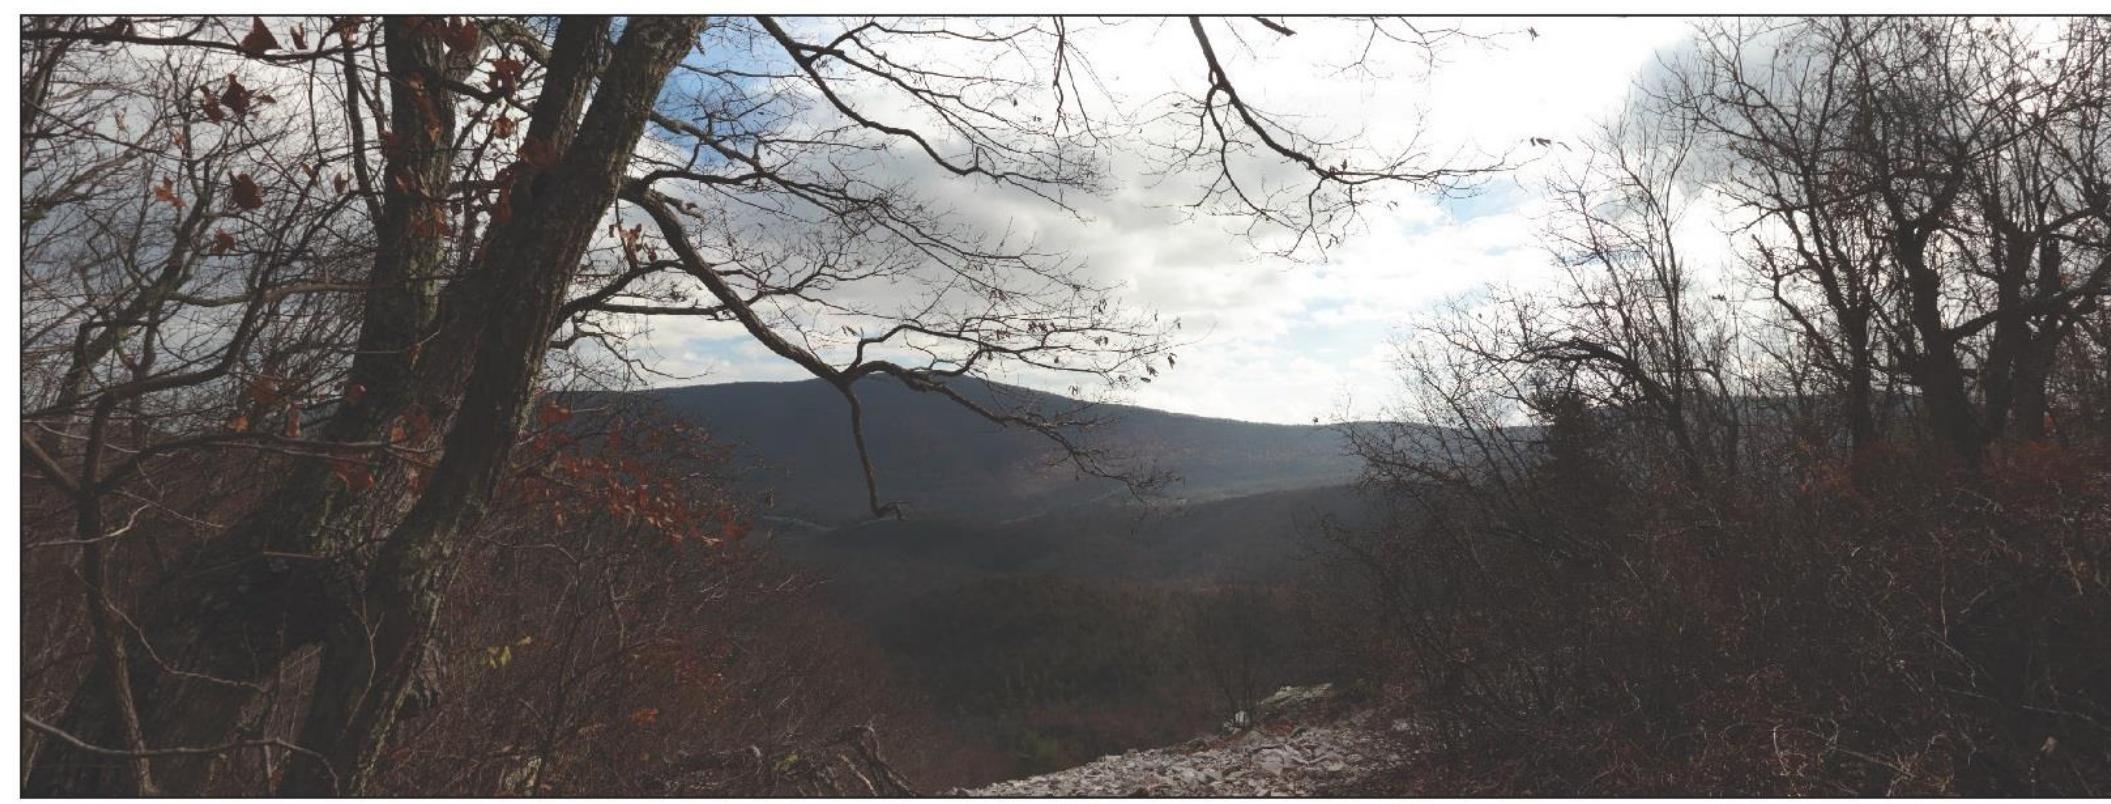
KOP34 - Torry Ridge Trail 1, Looking Southeast - Proposed View 75' Permanent ROW (5 Year Tree Growth)

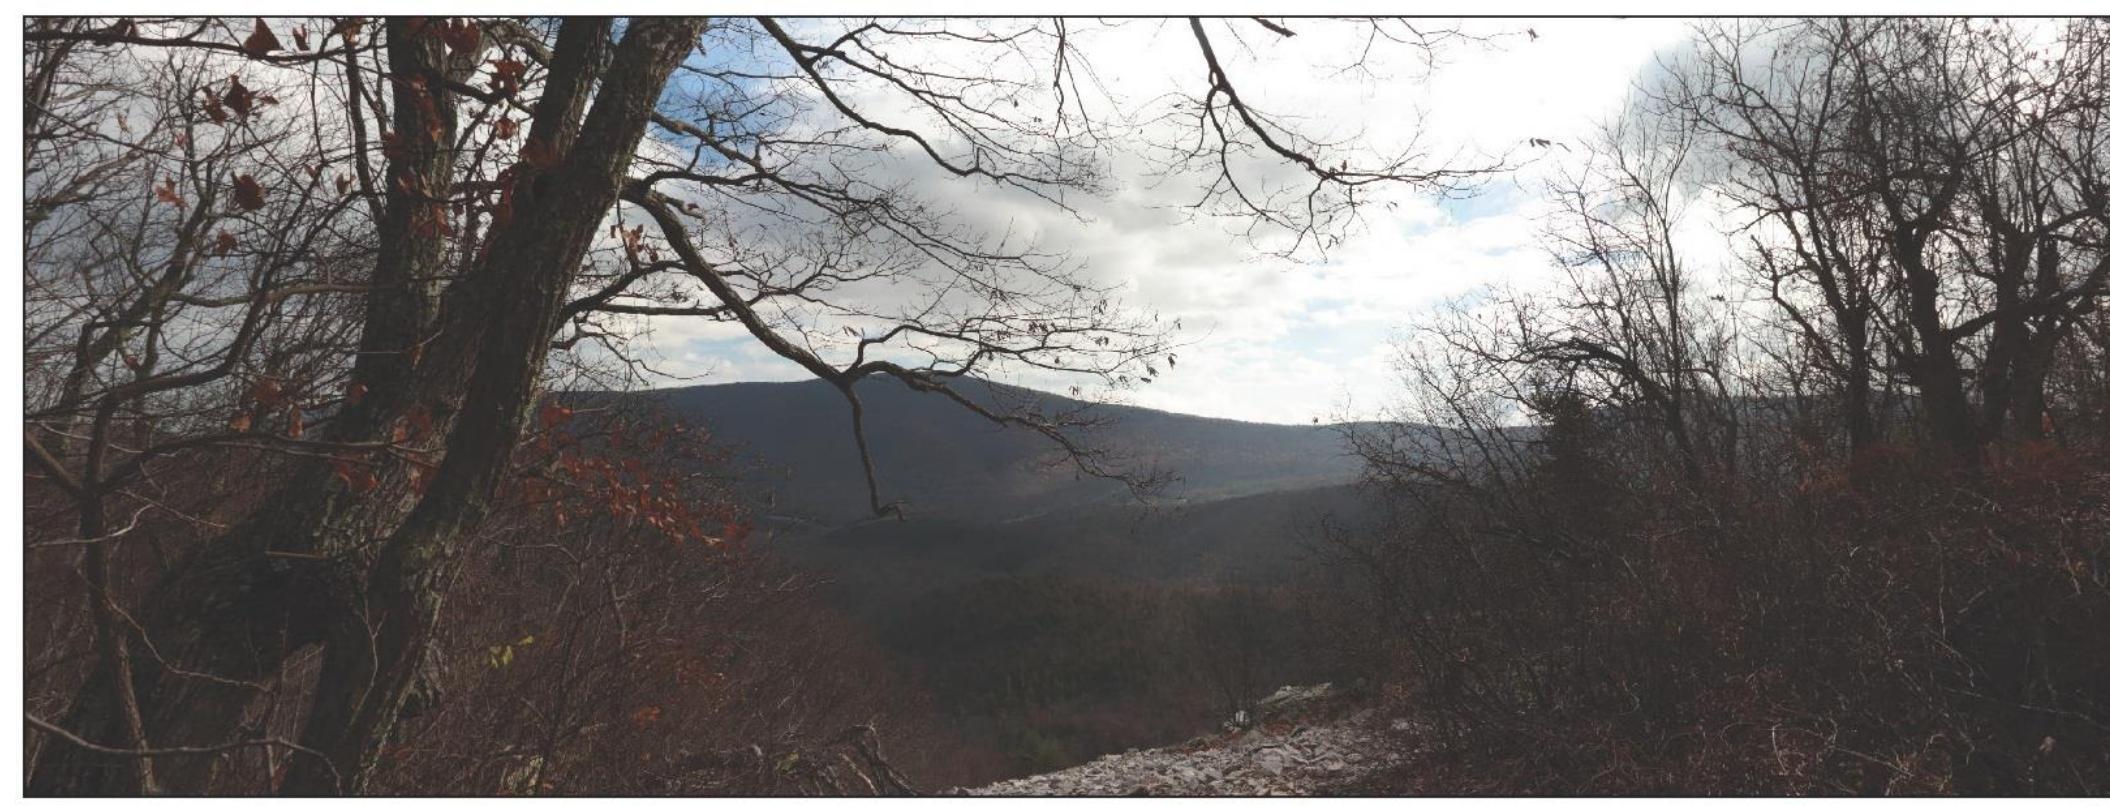
KOP34 - Torry Ridge Trail 1, Looking Southeast - Proposed View 75' Permanent ROW (15/20 Year Tree Growth)

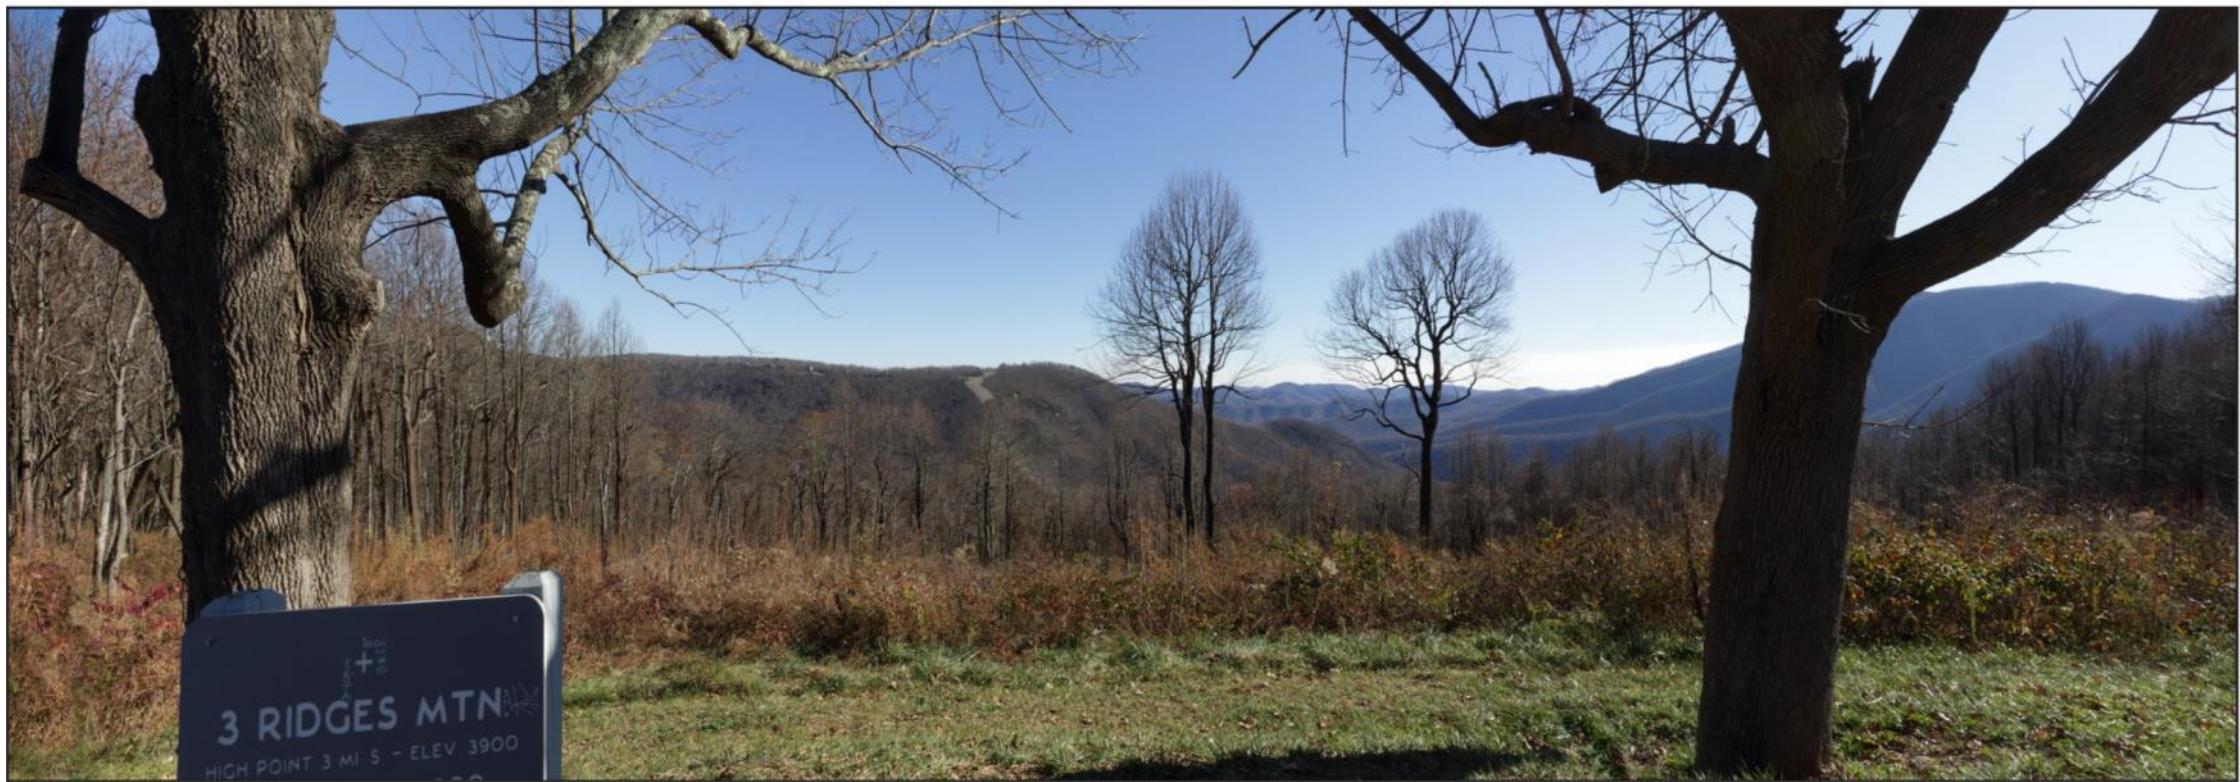
KOP 39 (REVISED) - Three Ridges Overlook (REVISED), Looking Southeast - Proposed View: 75' Permanent ROW, 50' Temp. ROW

Figures 3-11, 3-12, 3-13, and 3-14 show the full simulation images for KOP 39. From this KOP, viewers would have an axial view (facing southeast) of the ACP corridor at approximately MP 159 as it climbs over Piney Mountain, just south of Atlantic's proposed HDD entry point. This segment of the corridor would be approximately 0.75 to 1.0 mile from the viewer, in the middleground, as defined by the USFS. As shown in the simulation images, the bottom (closer) portion of the corridor is partially obscured by trees during leaf-off conditions. During leaf-on conditions, this portion of the corridor would likely not be visible at all, although the upper portion of the corridor would remain visible as a vegetated (but not forested) strip. The width of the corridor would become narrower, and the contrast with surrounding areas less prominent, as trees and other vegetation reclaim the temporary right-of-way over time.

The simulations in Figures 3-11, 3-12, and 3-13 show the likely conditions after construction, with no visual mitigation incorporated. Figure 3-14 shows the right-of-way at this location, approximately 15-20 years after construction, with the incorporation of shallow-rooted perennial shrubs within the right-of-way, planted as visual mitigation to break up the linear nature of the gap in forest. With the incorporation of this mitigation, the corridor would remain visible, but would have less contrast with surrounding forested areas.

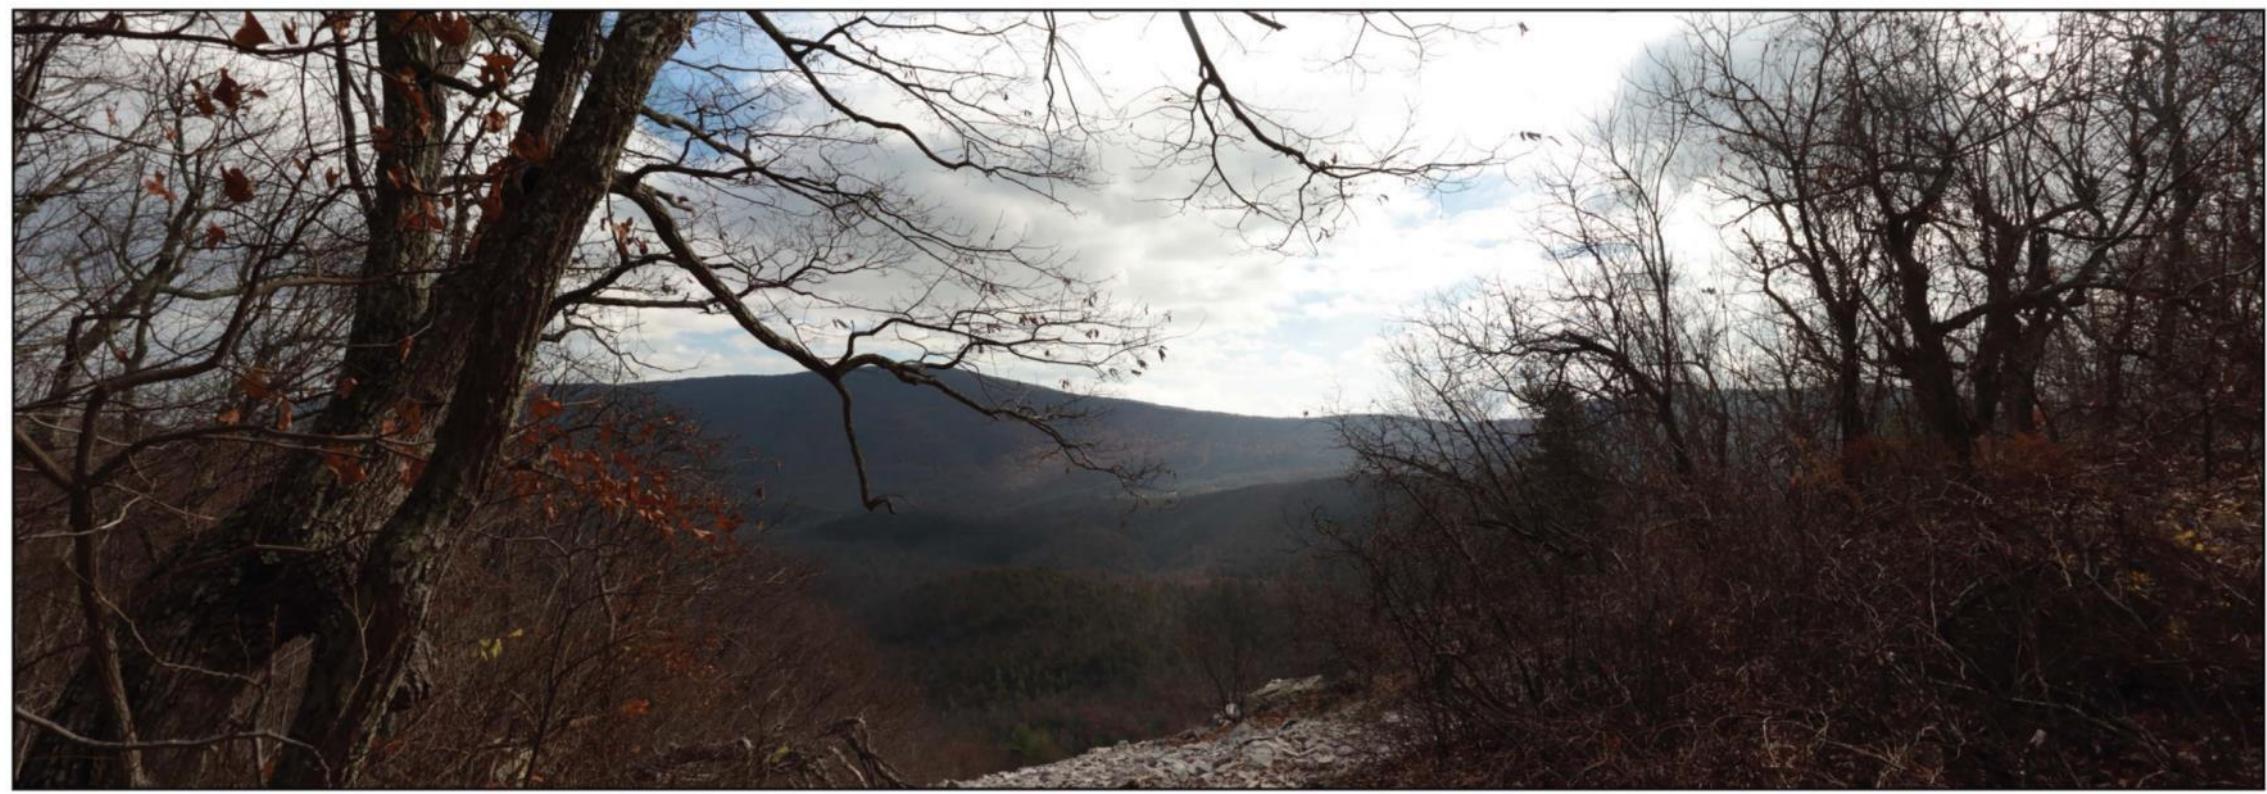
Figure 3-19: Full Simulation, KOP 34, Contingency Plan

Viewpoint KOP34 - Torry Ridge Trail 1, Looking Southeast - Proposed View

KOP 34 presents potential views of the BRP HDD contingency corridor from the west. Figure 3-19 shows the full simulation image of the BRP HDD contingency corridor at KOP 34, 15 to 20 years after construction. Figure 3-20 shows this simulation with the permanent right-ofway outlined in yellow, for viewer clarity due to the relatively dark atmospheric conditions during baseline photography and presence of shade at the KOP. From this KOP, the ACP contingency corridor from approximately MP 157 to MP 158 would be visible as a narrow vegetated (but not forested) band on the far side of the Back Creek valley, approximately 1.2 to 2.0 miles to the southeast. The width of the corridor would become narrower, and the contrast with surrounding areas less prominent, as trees and other vegetation reclaim the temporary rightof-way over time. Both of these views are in the middleground, as defined by the USFS.

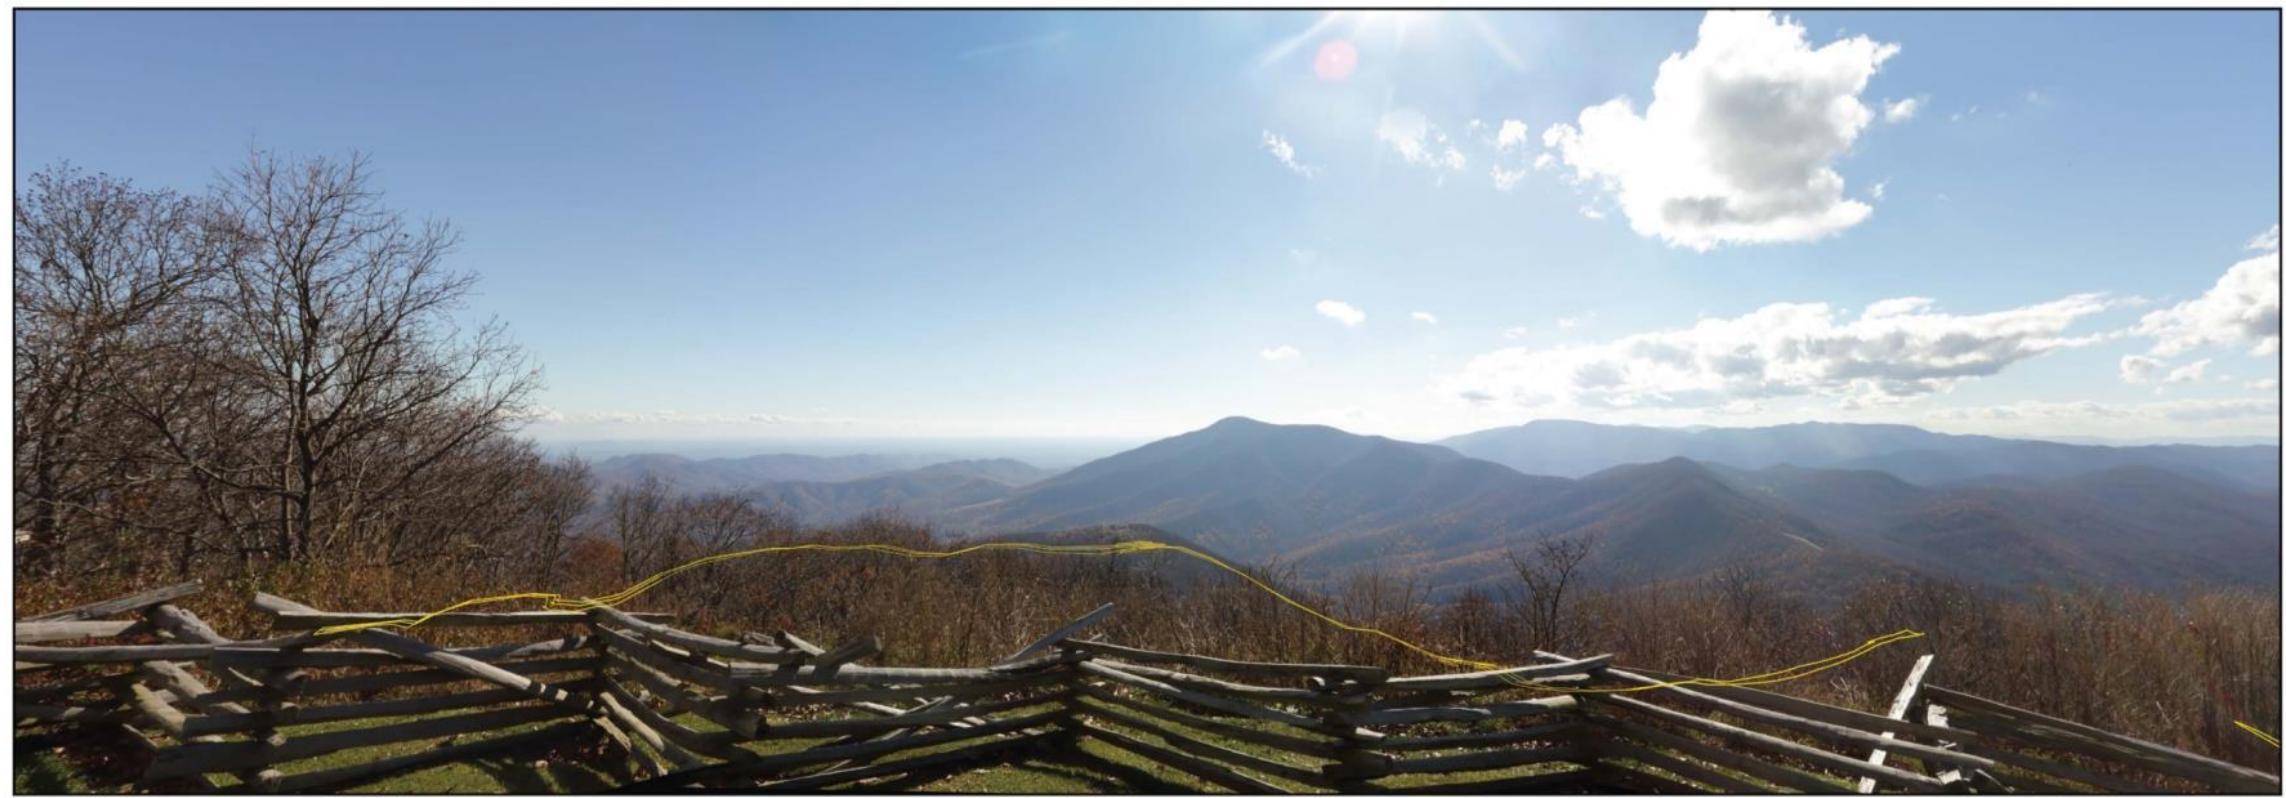
Viewpoint KOP65 - Devil's Knob, Looking South - Proposed View (Right Of Way Overlayed)

Figure 3-23 shows the full simulation image of the ACP contingency corridor at KOP 65, 15 to 20 years after construction, with the permanent right-of-way outlined in yellow, for viewer clarity. (The fencing shown here has since been replaced.) From this KOP, the corridor, approximately 1.0 mile away, would be blocked by vegetation at the edge of the Devils Knob Overlook. Individual viewers could potentially obtain a view of the contingency corridor by standing at the extreme edge of the overlook (i.e., at the edge of the vegetation, where the slope begins to drop off); however, the typical viewer, standing in the designated overlook area, would not be able to see the contingency corridor (if used) as it would exit the potential directional bore crossing of the BRP on the east side of the Blue Ridge Mountains.

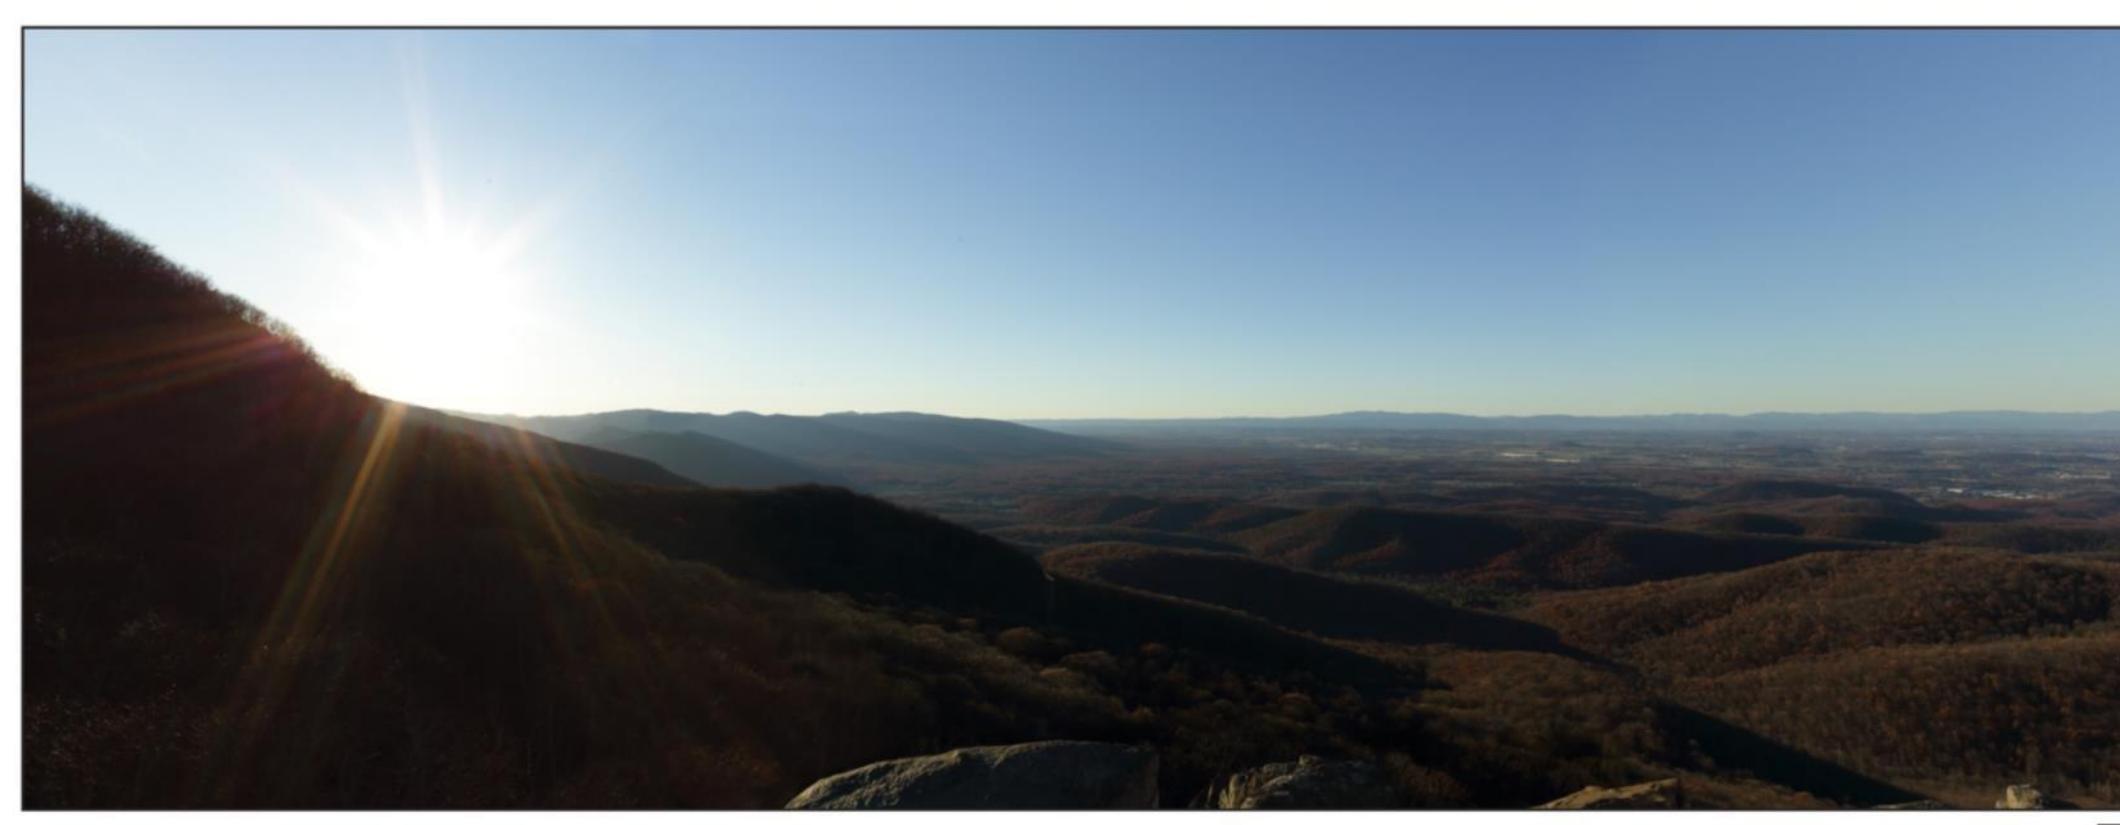
ANST 02 - Humpback Rocks, Looking Northwest - Proposed View: 75' Permanent ROW, 50' Temp. ROW

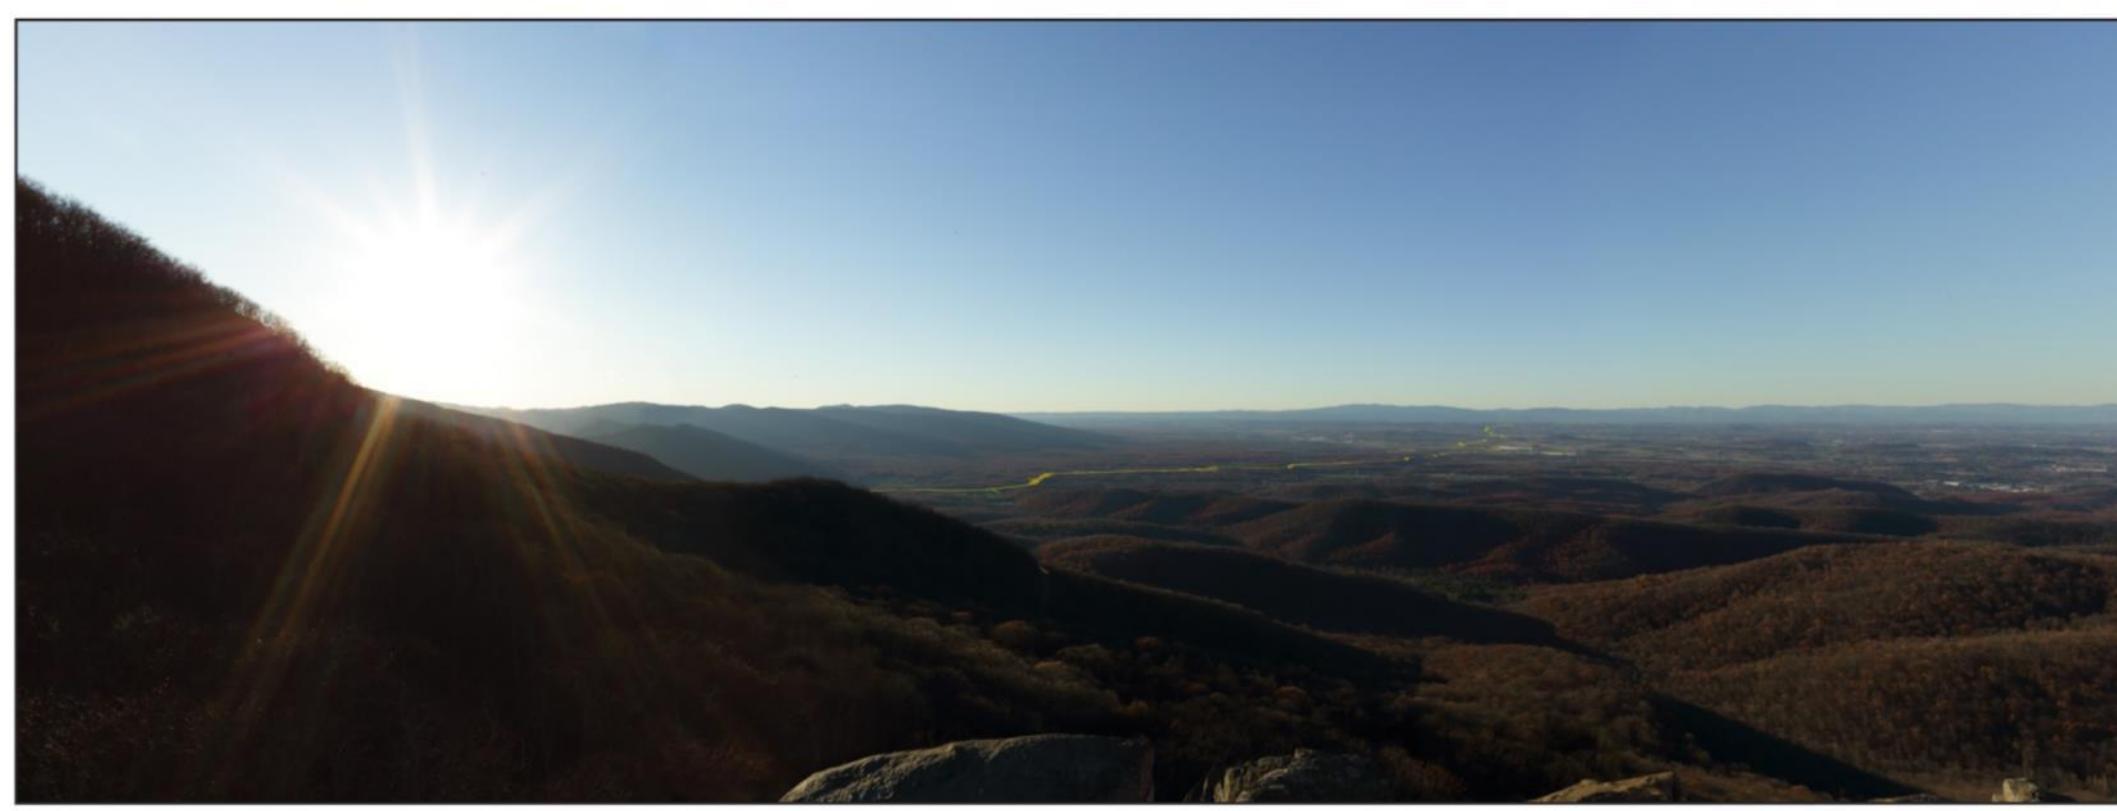
Figure 3-25: Full Simulation, KOP ANST 02, Regrowth Following Construction, Permanent ROW Outlined

ANST 02 - Humpback Rocks, Looking Northwest - Indicative Overlay: 75' Permanent ROW, 50' Temp. ROW

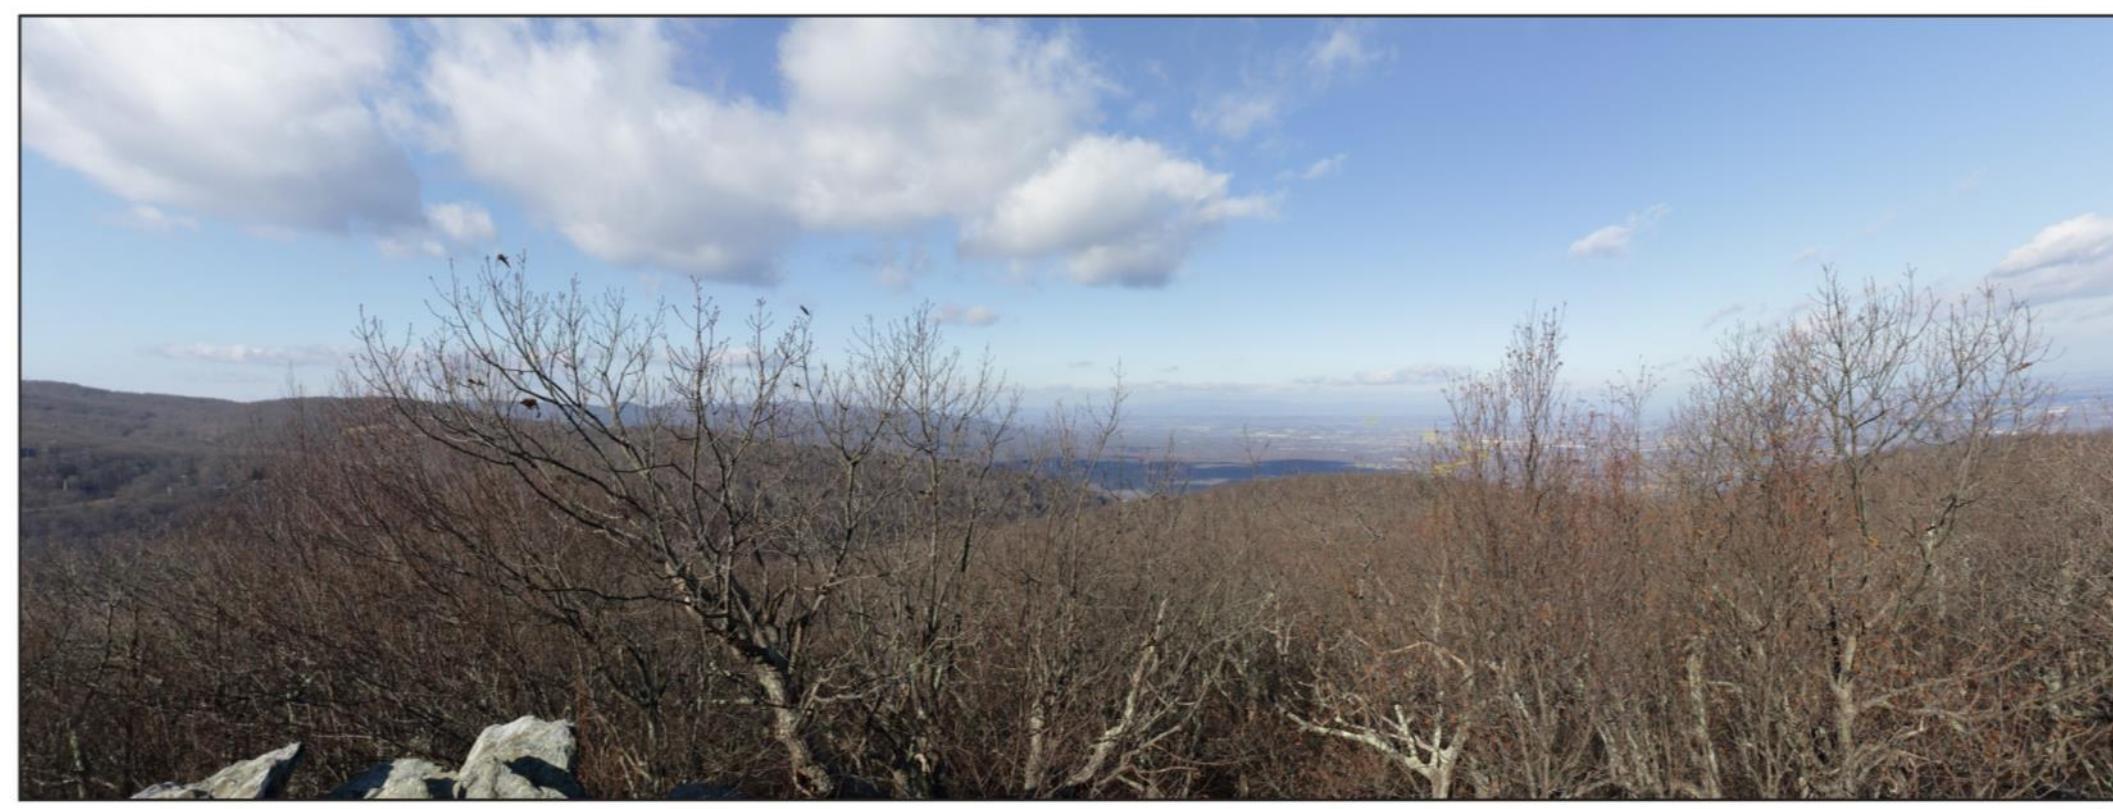
ANST 04 - Laurel Springs, Looking Northwest - Indicative Overlay: 75' Permanent ROW, 50' Temp. ROW

Figures 3-32, 3-33, 3-34, and 3-35 show the full simulation images for KOP ANST 04. Figure 3-33 shows this simulation with the permanent right-of-way outlined in yellow, for viewer clarity. From this KOP, the segment of the ACP corridor within the "seen area" (see Section 2.1) is approximately MP 152-154, and located approximately 2 to 4 miles from the KOP. As demonstrated by the yellow "indicative overlay" in Figure 3-32, the view of the rightof-way from this KOP would be blocked by vegetation, particularly during leaf-on conditions. A viewer standing slightly to the left of the location depicted in the Figures could see more of the right-of-way, but generally only during leaf off conditions. From such a view, project-related changes in color, line, texture, and other visual characteristics would be minimally perceptible from this KOP, and would be indistinguishable from other development and evidence of human activity already within the view.

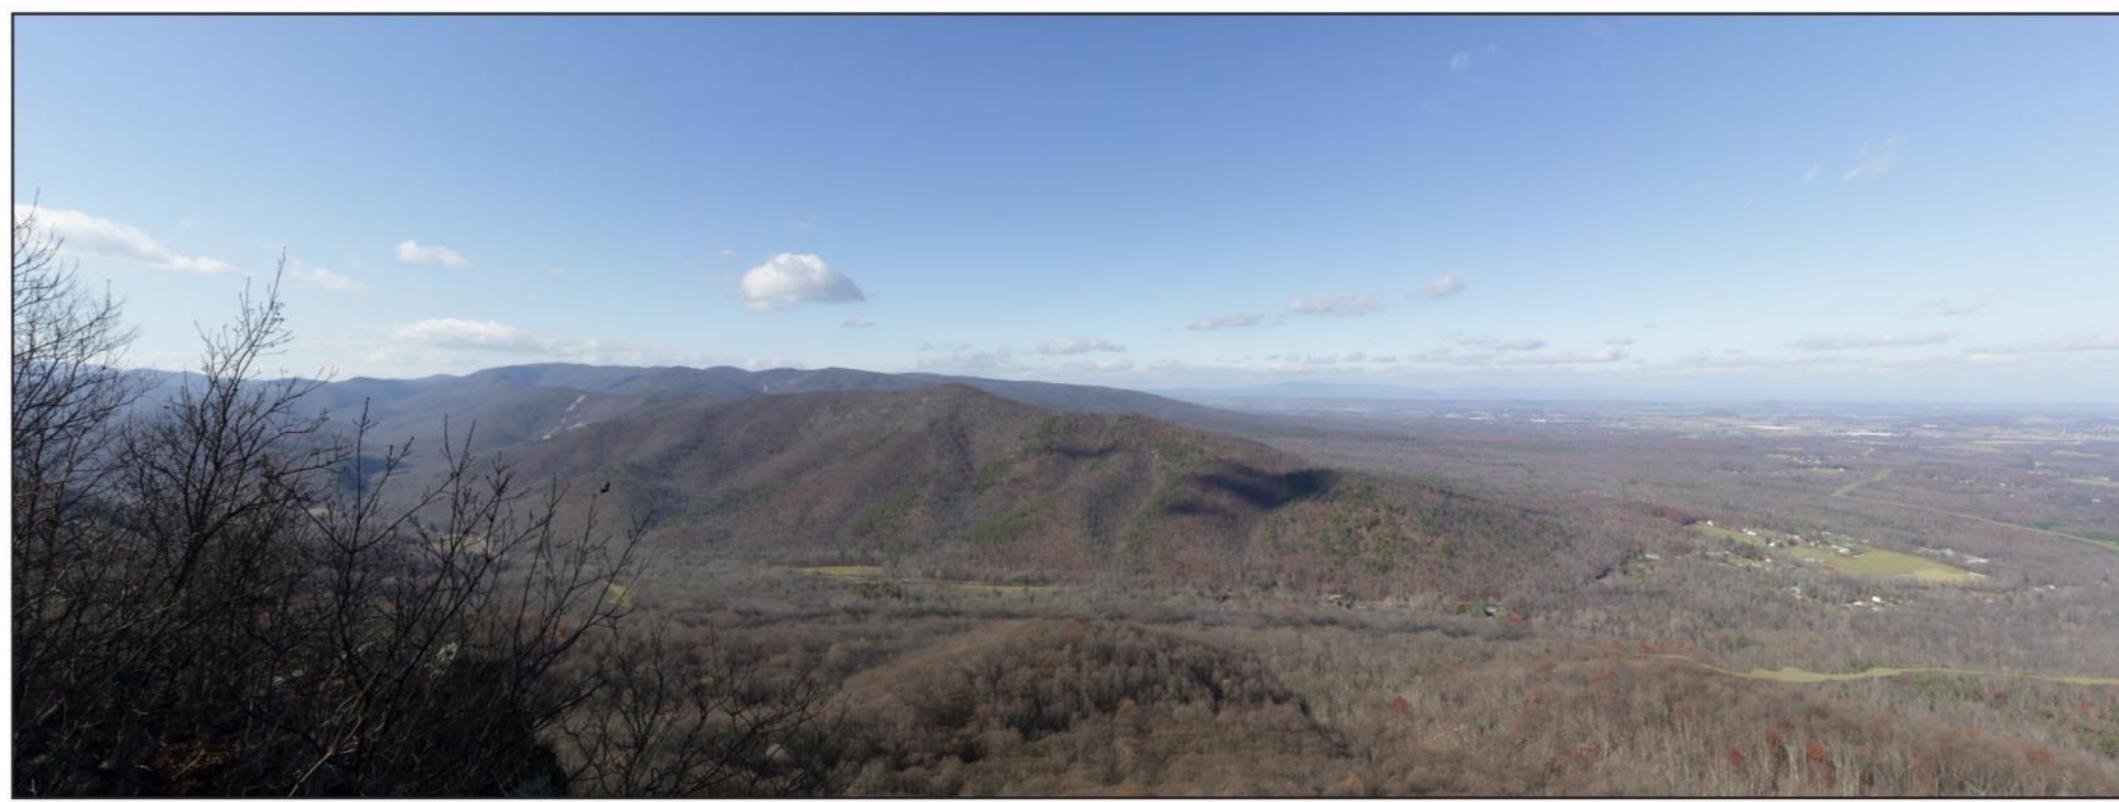
ANST 06 - Little Ravens Roost A, Looking West-Northwest - Proposed View: 75' Permanent ROW, 50' Temp. ROW

Figure 3-39, 3-40, and 3-41 show the full simulation images for KOP ANST 06. From this KOP, the ACP corridor would be visible as a narrow band of vegetated open land wrapping around Torry Ridge (the mountain feature in the approximate center of the image), approximately from MPs 152 to 156 (from right to left). The corridor is approximately 0.65 mile from KOP ANST 06 at its closest point (bottom-center of the image, corresponding approximately to MP 155), with MP 152 approximately 3.3 miles away (middle-right of the images, approaching the horizon). The appearance of the corridor would be similar to the cleared areas along Back Creek and Mount Torry Road, closer to the base of Torry Ridge. As shown in the Figures, Project-related changes in color, line, texture, and other characteristics considered in the SMS would be apparent to the viewer, although these changes would not dominate the view. The corridor would become less prominent over time, as vegetation reclaims the temporary right-of-way.

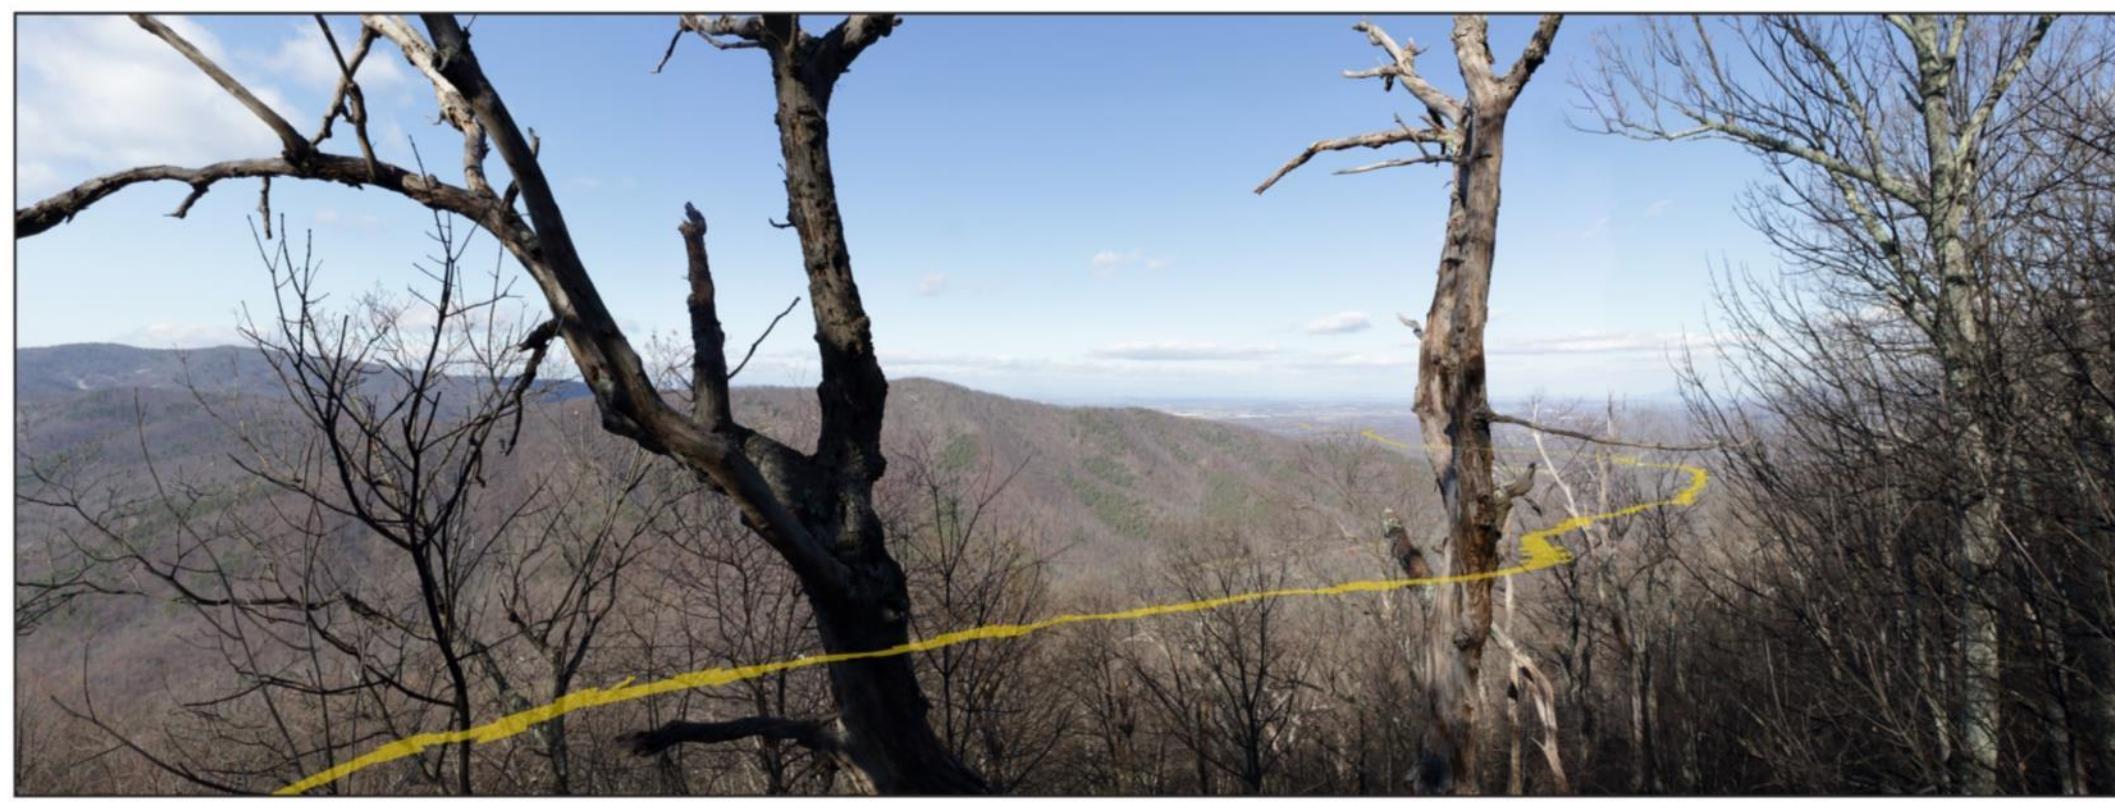
Figure 3-43: Full Simulation, KOP ANST 07, Regrowth Following Construction, Permanent ROW Outlined

ANST 07 - Sherando Valley B, Looking North - Indicative Overlay: 75' Permanent ROW, 50' Temp. ROW

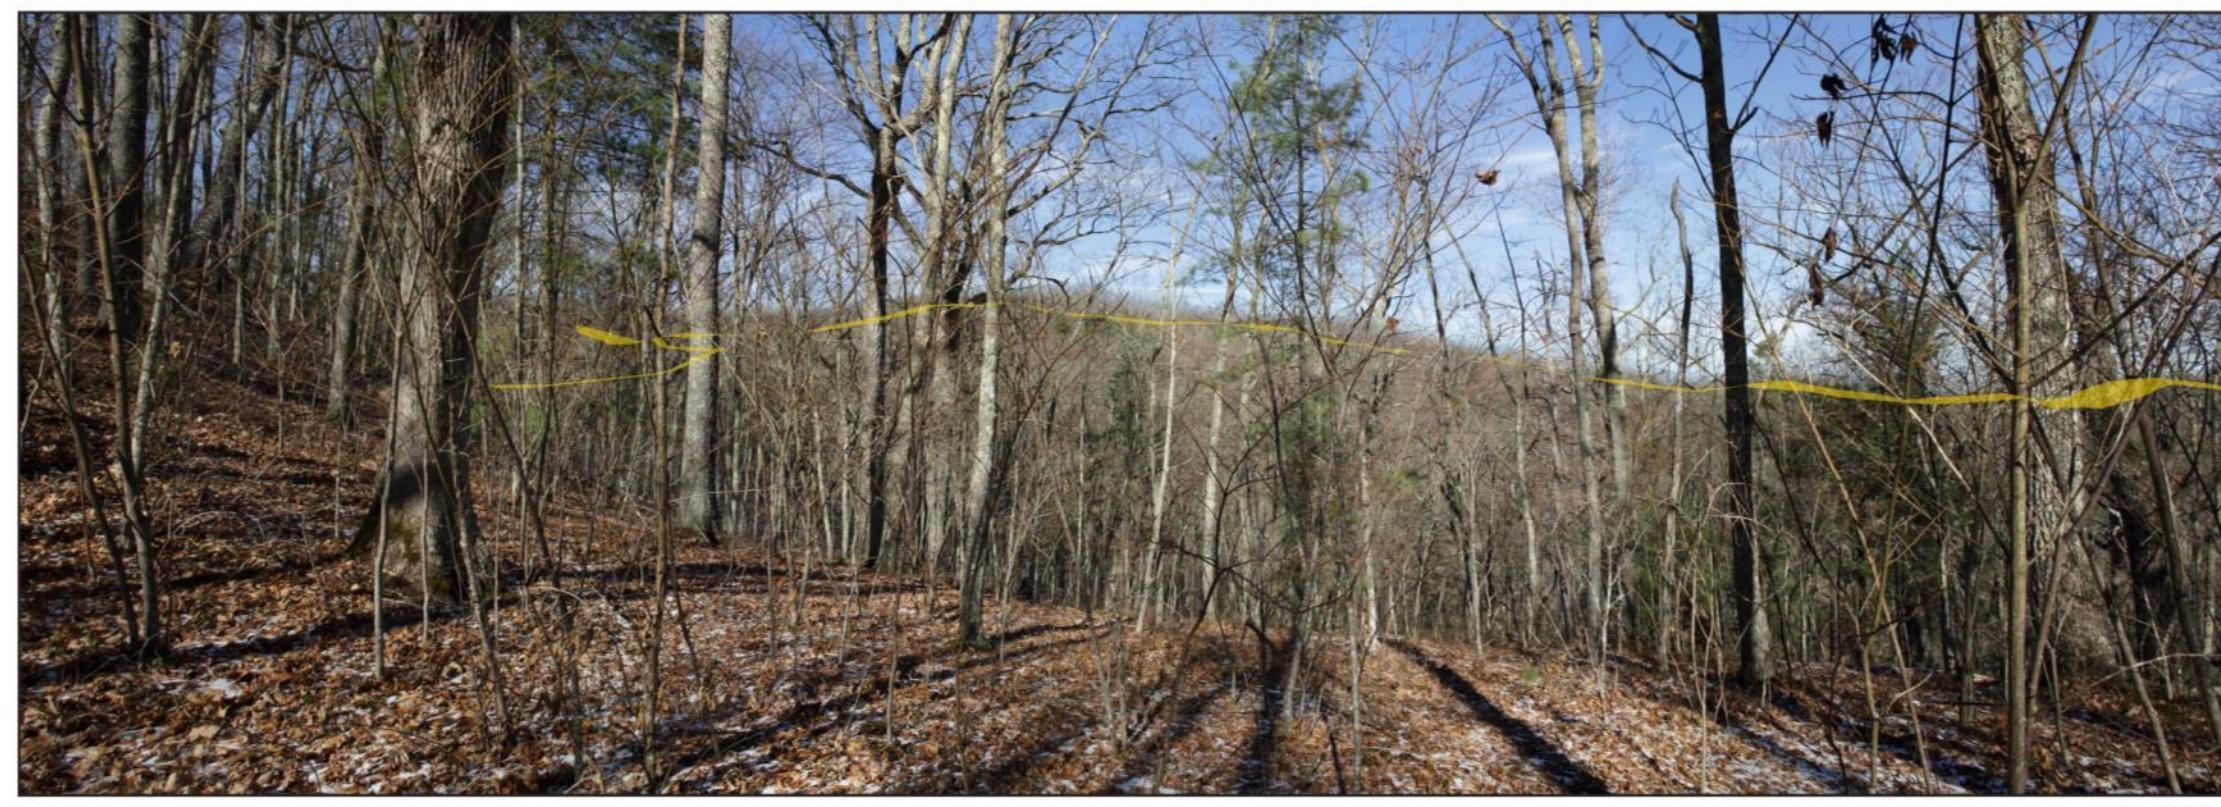
Figure 3-58: Full Simulation, KOP SSF 04, Regrowth Following Construction, Permanent ROW Outlined

SSF 04 - Public Loop Road 1/10, Looking North - Indicative Overlay: 75' Permanent ROW, 50' Temp. ROW

Figure 3-58 shows the full simulation images for KOP SSF 04, immediately following construction, and shows the permanent right-of-way outlined in yellow, for viewer clarity. The segment of the ACP represented by the yellow overlay corresponds to approximately MP 77.5, and would be 0.4 mile away from the viewer at its closest point. As shown in Figure 3-58, the view of the right-of-way would be entirely blocked by existing dense mature forest vegetation, even in leaf-off conditions (e.g., in November, when the baseline imagery was captured).
