Linear Waterbody Data Sheet

Survey Description				
Project Name: ACP		Waterbody Name: Unit to Meherrin River		Waterbody ID: SSDP002
State: VA		County/Parish: Southampton	Company: ESI	Date: 4/1/15
Tract Number(s): 25-001-A005, 25-001-A001, 25-001-A003		Nearest Milepost: 2.5 (new)	Crew Member Initials: LR, RT	
Survey Type: <small>(check one)</small>		Associated Wetland ID(s): WSOP001		
<input type="checkbox"/> Centerline		<input checked="" type="checkbox"/> Re-Route		
<input type="checkbox"/> Access Road		<input type="checkbox"/> Other:		
Physical Attributes				
Stream Classification: <small>(check one)</small>				
<input type="checkbox"/> Ephemeral				
<input type="checkbox"/> Intermittent				
<input checked="" type="checkbox"/> Perennial				
Waterbody Type: <small>(check one)</small>				
<input type="checkbox"/> River				
<input type="checkbox"/> Stream				
<input type="checkbox"/> Ditch				
<input checked="" type="checkbox"/> Canal

Environmental Field Surveys
Waterbody Photo Page

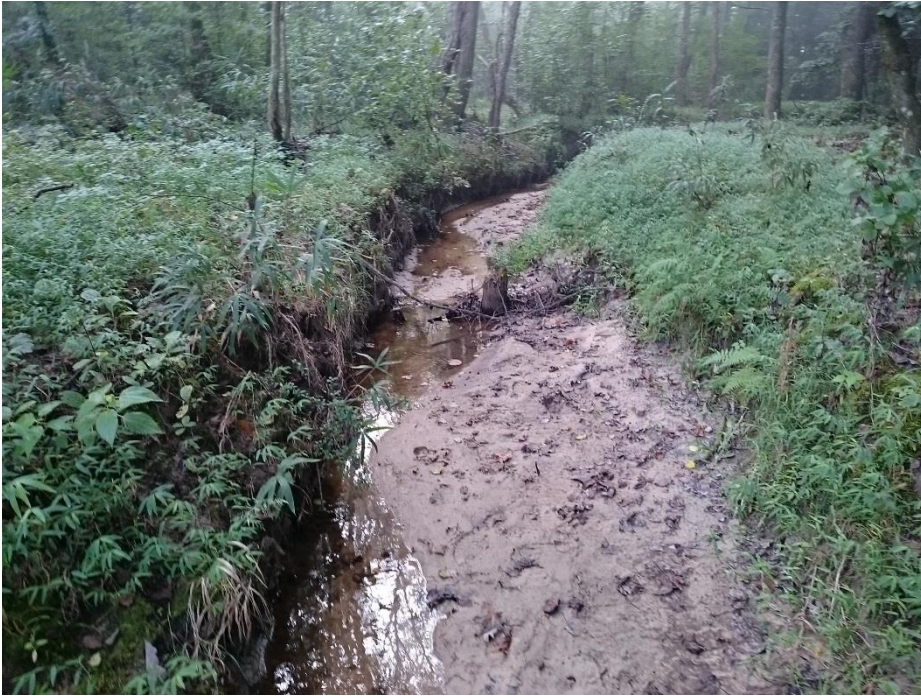
Stream continues out of corridor in both directions; flows through wetland complex wsoa076; sediment input from agricultural fields and existing power line ROW is excessive.

Waterbody SSOA074 facing southeast upstream

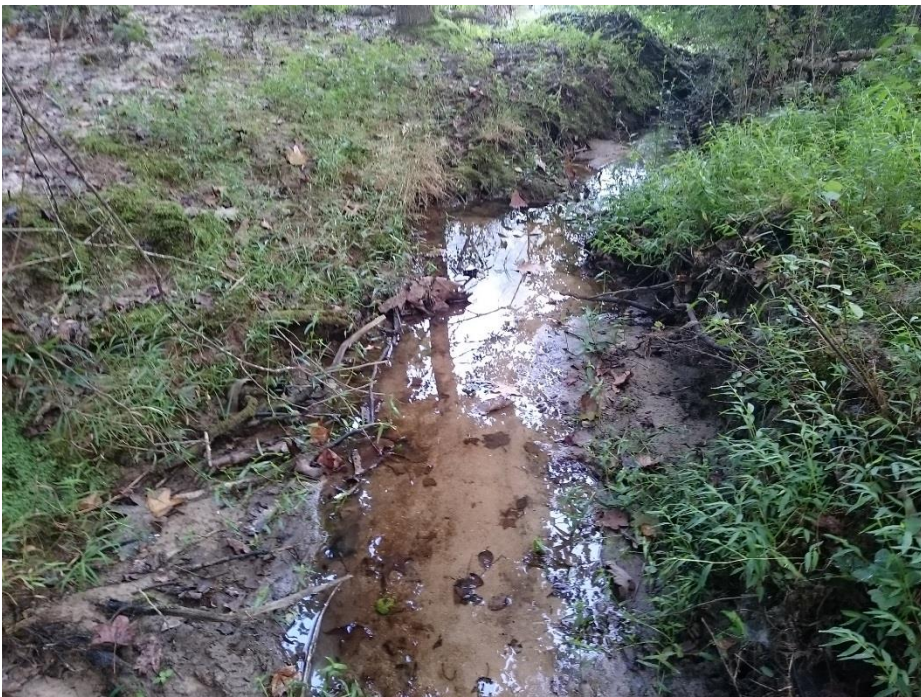
Waterbody SSOA074 facing northwest downstream

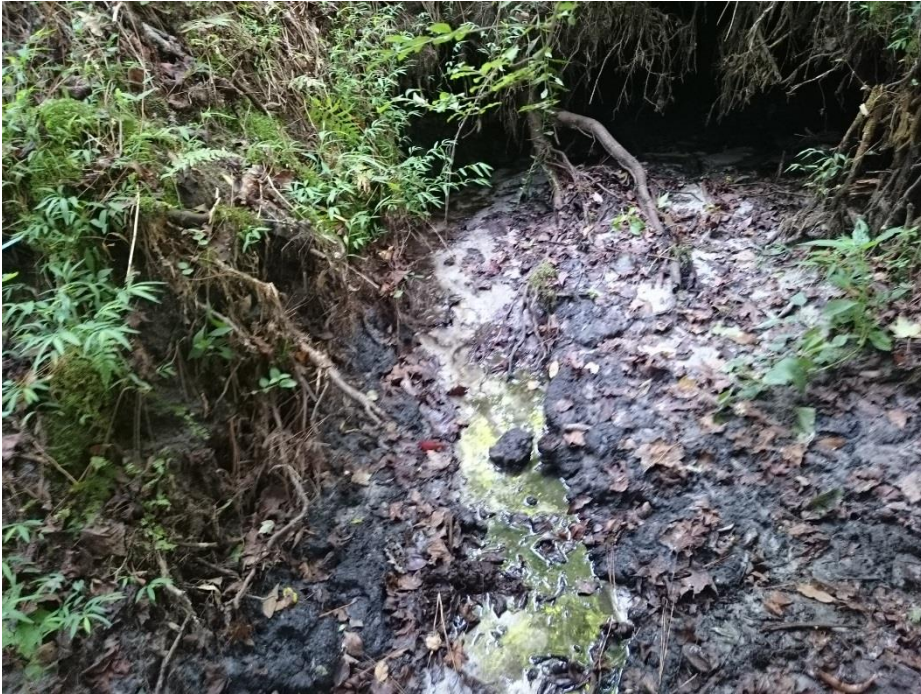
Flows through wetland complex WSOA075; continues out of corridor in both directions. The severe down cutting and numerous bank failures make this a very low quality feature.

Waterbody SSOA073 facing east upstream

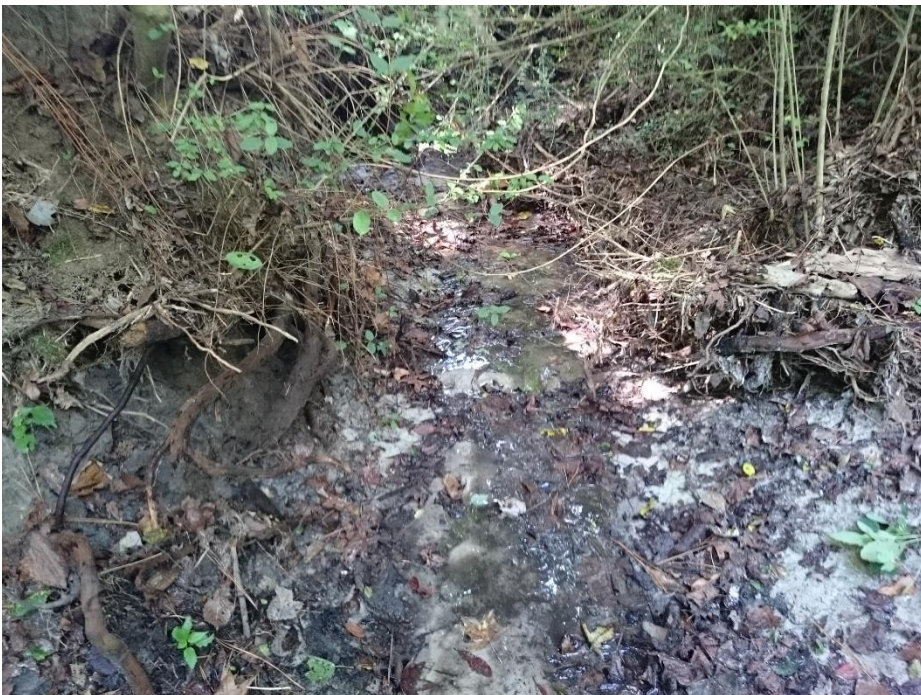
Waterbody SSOA073 facing west downstream

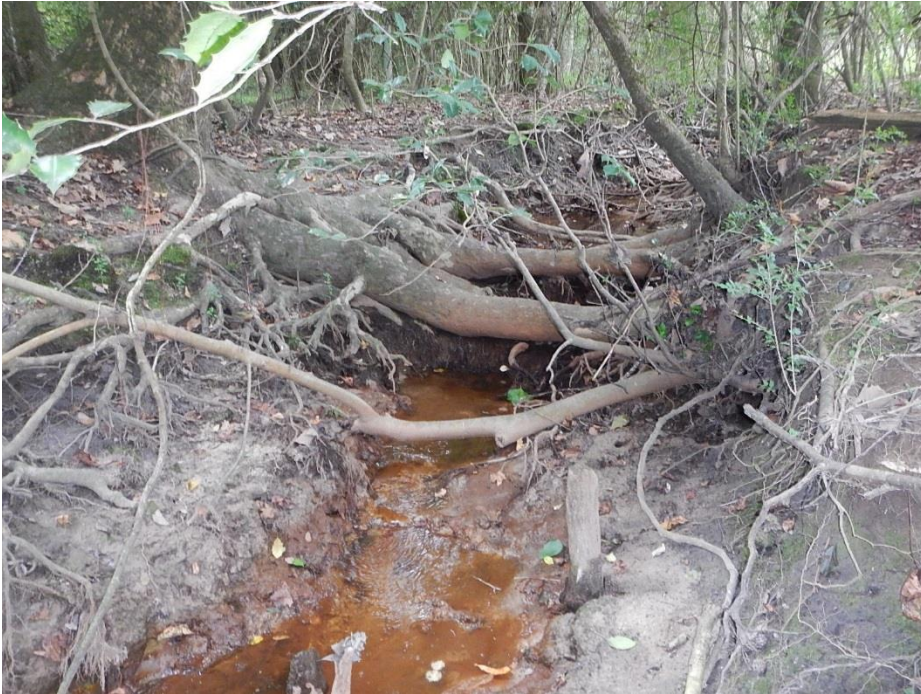
Continues out in both directions, iron oxidation sheen on water surface, stream is highly incised and has lowered water table in riparian zone eliminating probable past wetland abutting stream; PSS wetland wsoa006 is above floodplain in concave side slope below a slope break, this wetland is not directly connected to stream.

SSOA001 facing south upstream

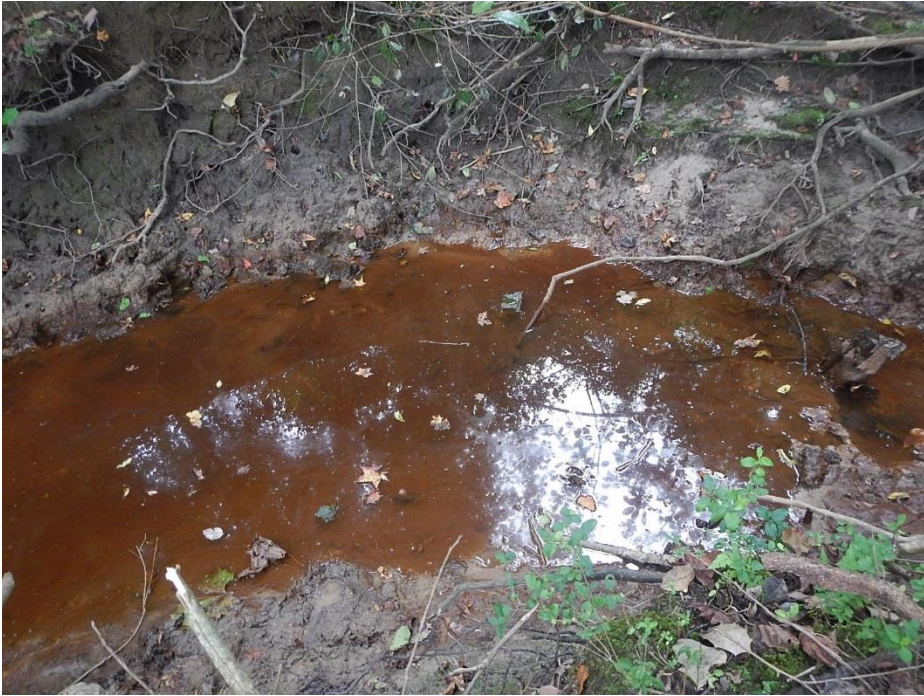
SSOA001 facing east across
