Linear Waterbody Data Sheet

Survey Description			
Project Name: Atlantic Coast Pipeline		Waterbody Name: UNT to Slaty Fork	
Waterbody ID: spoa420		Date: 6/1/2016	
State: West Virginia	County: Pocahontas	Company: NRG/ERM	Crew Member Initials: GB, KO
Photos: 4 photos			
Tract Number(s): access road 05-001-C008.AR1		Nearest Milepost: 72.1	Associated Wetland ID(s): none
Survey Type: <i>(check one)</i> <input type="checkbox"/> Centerline <input type="checkbox"/> Re-Route <input checked="" type="checkbox"/> Access Road <input type="checkbox"/> Other:			
Physical Attributes			
Stream Classification: <i>(check one)</i> <input type="checkbox"/> Ephemeral <input checked="" type="checkbox"/> Intermittent <input type="checkbox"/> Perennial			
Waterbody Type: <i>(check one)</i> <input type="checkbox"/> River <input checked="" type="checkbox"/> Stream <input type="checkbox"/> Ditch <input type="checkbox"/> Canal <input type="checkbox"/> Other:

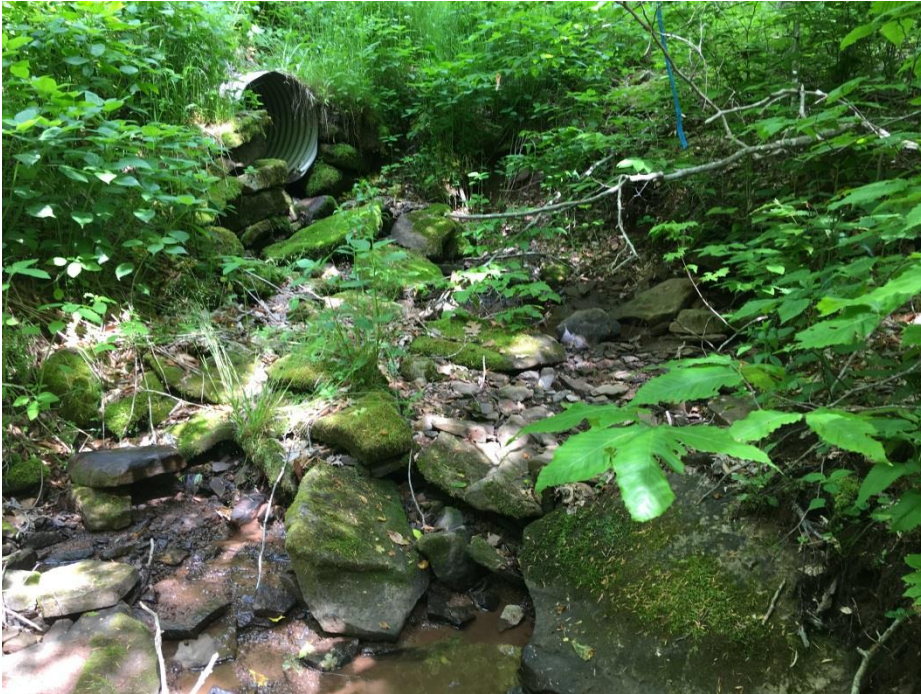
Bank slope Right: 65 degrees Left: 80 degrees			
Analysis of Bank Stability (i.e. root structure, vegetation, substrate characteristics): Banks exhibit loose soil/rock and exposed roots and is being undercut at culvert outlet			
Qualitative Attributes			
Water Appearance: <i>(check one)</i> <input type="checkbox"/> No water <input checked="" type="checkbox"/> Clear <input type="checkbox"/> Turbid <input type="checkbox"/> Sheen on surface <input type="checkbox"/> Surface scum <input type="checkbox"/> Algal mats <input type="checkbox"/> Other:			
Substrate: <i>(check all that apply)</i> <input type="checkbox"/> Bedrock <input checked="" type="checkbox"/> Boulder <input checked="" type="checkbox"/> Cobble <input checked="" type="checkbox"/> Gravel <input type="checkbox"/> Sand <input checked="" type="checkbox"/> Silt/ clay <input checked="" type="checkbox"/> Organic <input type="checkbox"/> Other:

Waterbody spoa420 facing east upstream

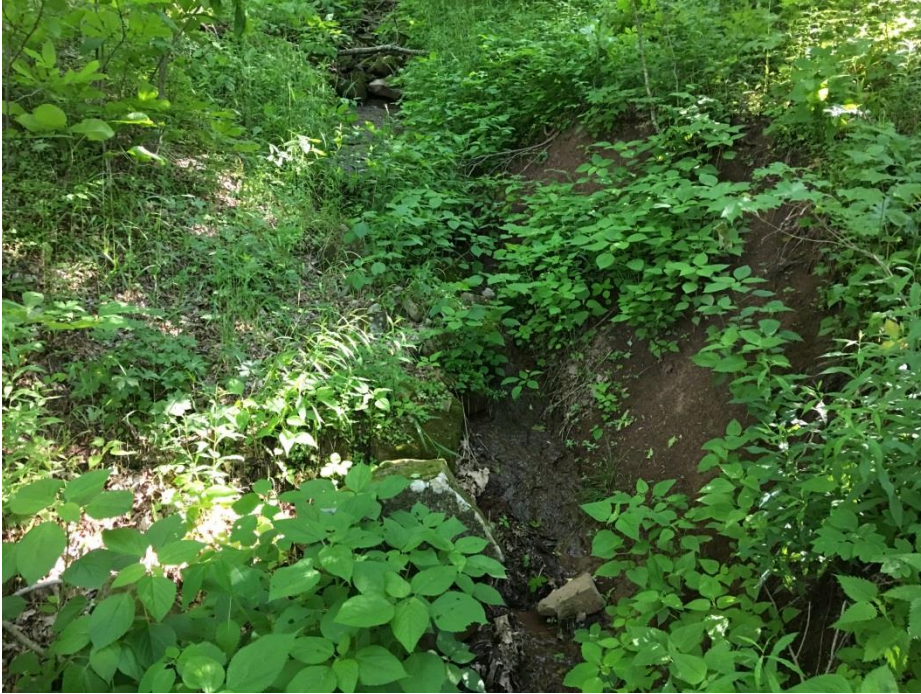
Analysis of Bank Stability (i.e. root structure, vegetation, substrate characteristics): Bank instability present as evidenced by exposed roots and loose rock and soil			
Qualitative Attributes			
Water Appearance: <i>(check one)</i> <input type="checkbox"/> No water <input checked="" type="checkbox"/> Clear <input type="checkbox"/> Turbid <input type="checkbox"/> Sheen on surface <input type="checkbox"/> Surface scum <input type="checkbox"/> Algal mats <input type="checkbox"/> Other:			
Substrate: <i>(check all that apply)</i>			
% of Substrate: _____% _____% 20% 20% 15% 40% 5% _____%			
Width of Riparian Zone: N/A <input checked="" type="checkbox"/> _____ ft.	Vegetative Layers: <i>(check all that apply)</i>		
	<input checked="" type="checkbox"/> Trees: 14.0 in.		
	<input checked="" type="checkbox"/> Saplings/Shrubs: 2.0 in.		
	<input checked="" type="checkbox"/> Herbs		
Dominant Bank Vegetation (list): Sugar maple, red elm, shagbark hickory, basswood, Frasier's magnolia, stonecrop, jewel weed, wood nettle, bee balm, violet, Dutchman's pipe vine, wild rye, red elderberry

Waterbody SPOA439 facing north upstream

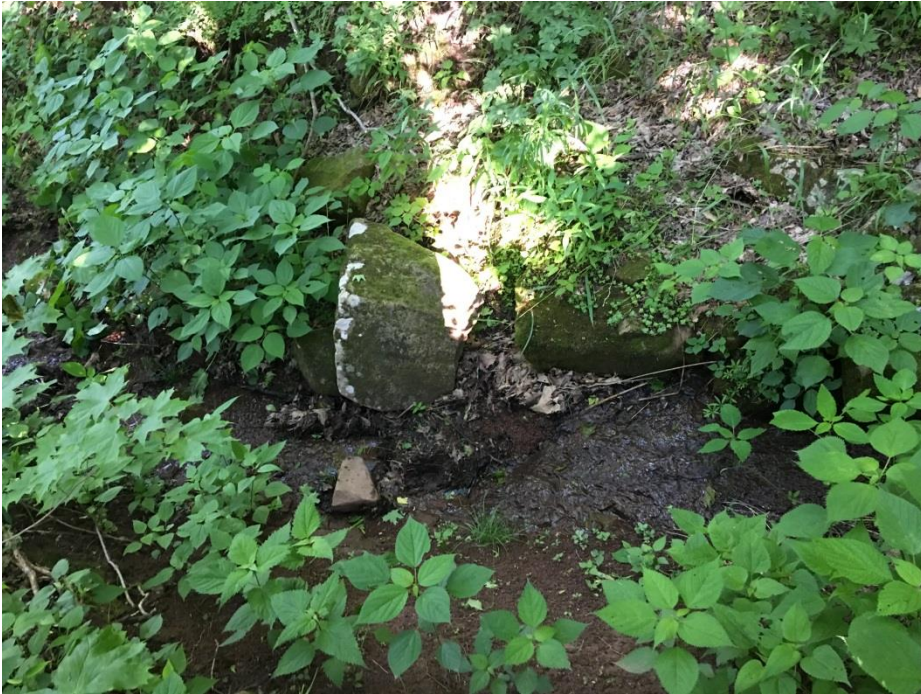
Waterbody SPOA439 facing west across

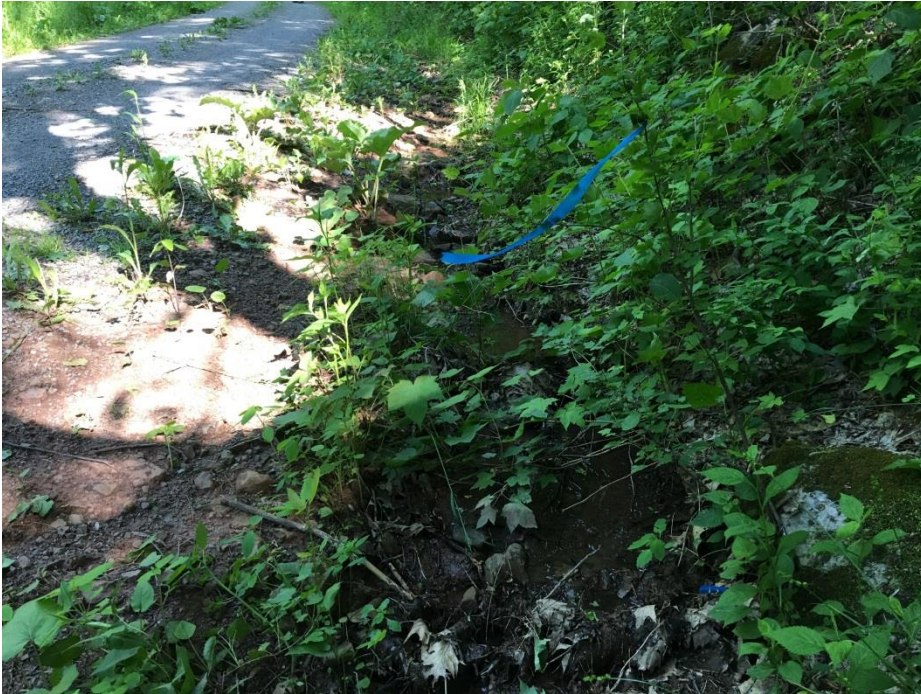
Waterbody SPOA440 facing west upstream

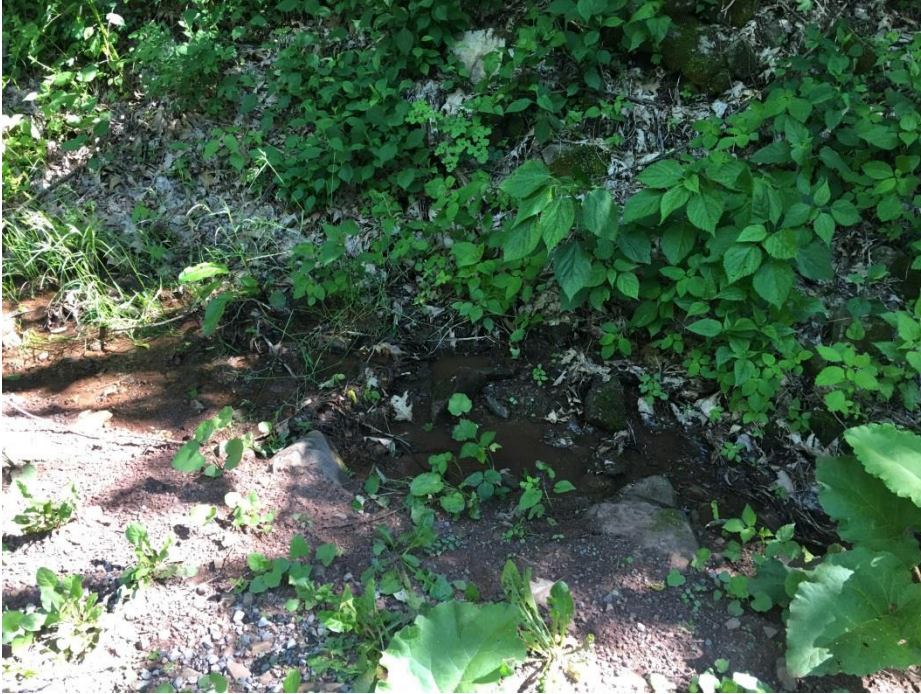
Waterbody SPOA440 facing north across

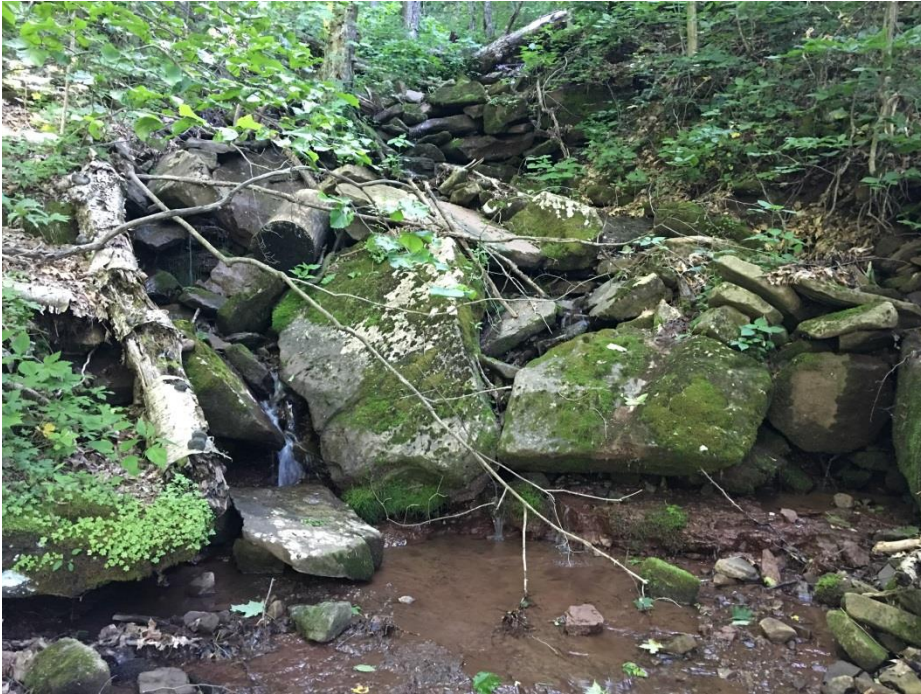
Waterbody SPOA441 facing northeast upstream

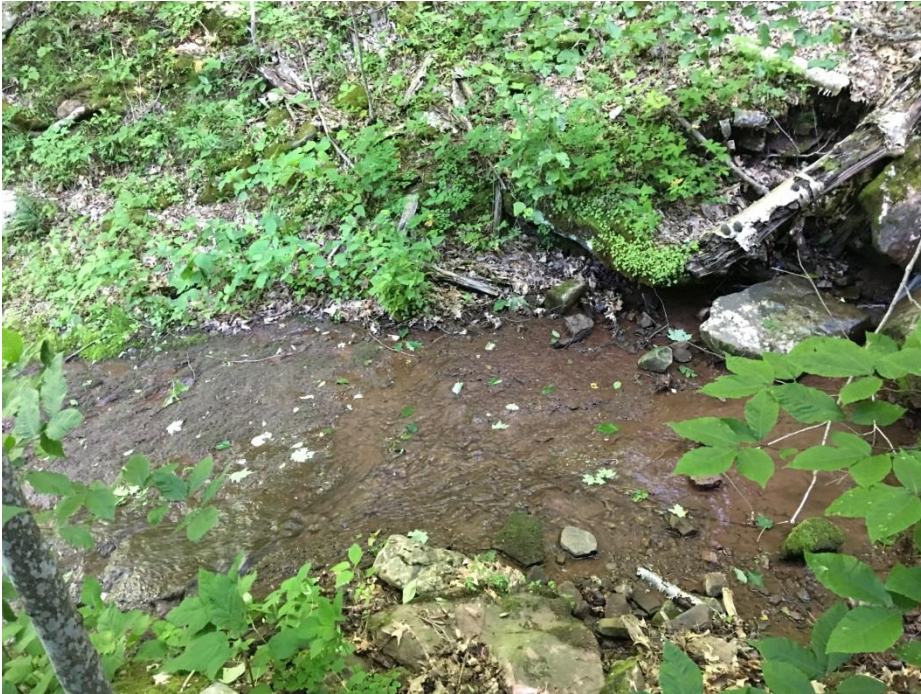
Waterbody SPOA441 facing northwest across

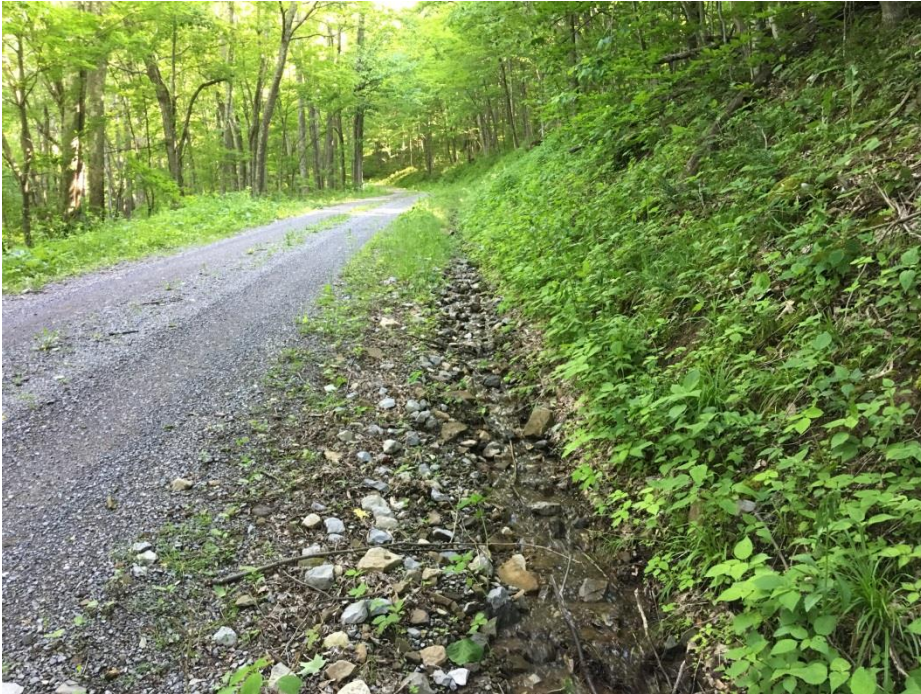
Waterbody SPOA434 facing north upstream

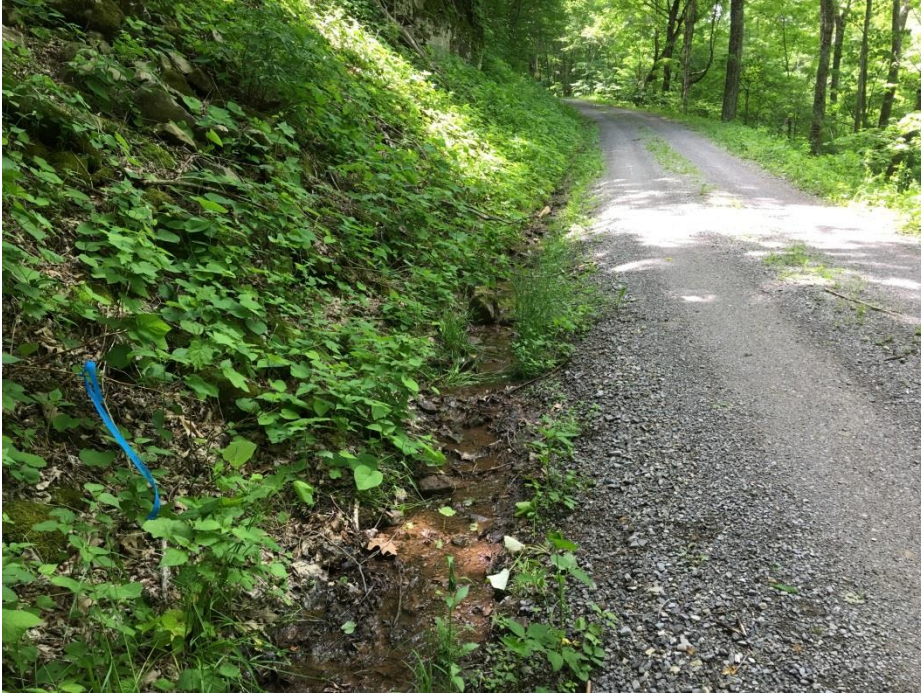
Waterbody SPOA435 facing south upstream

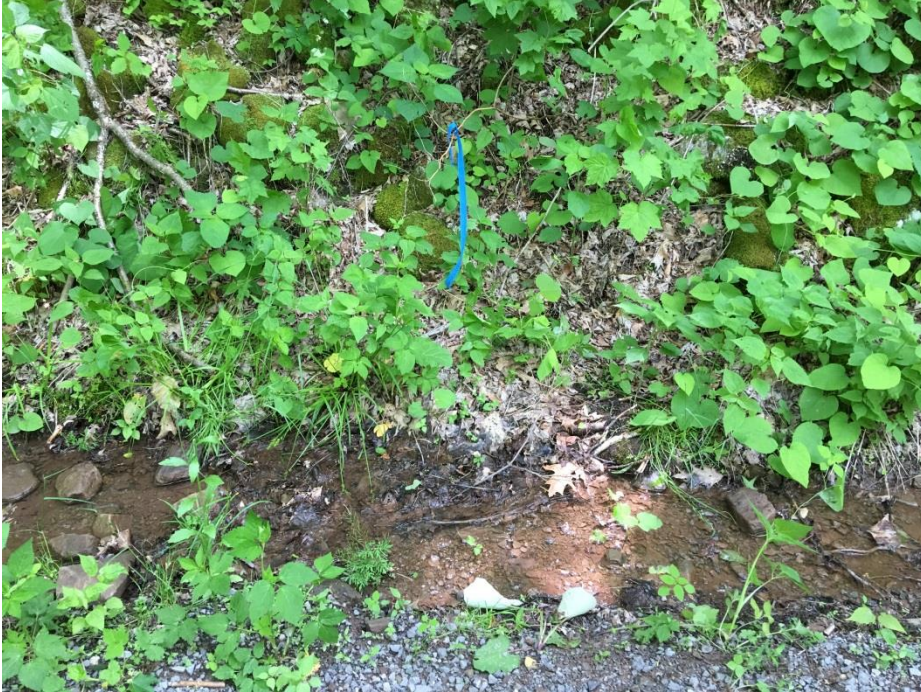
Waterbody SPOA435 facing east across

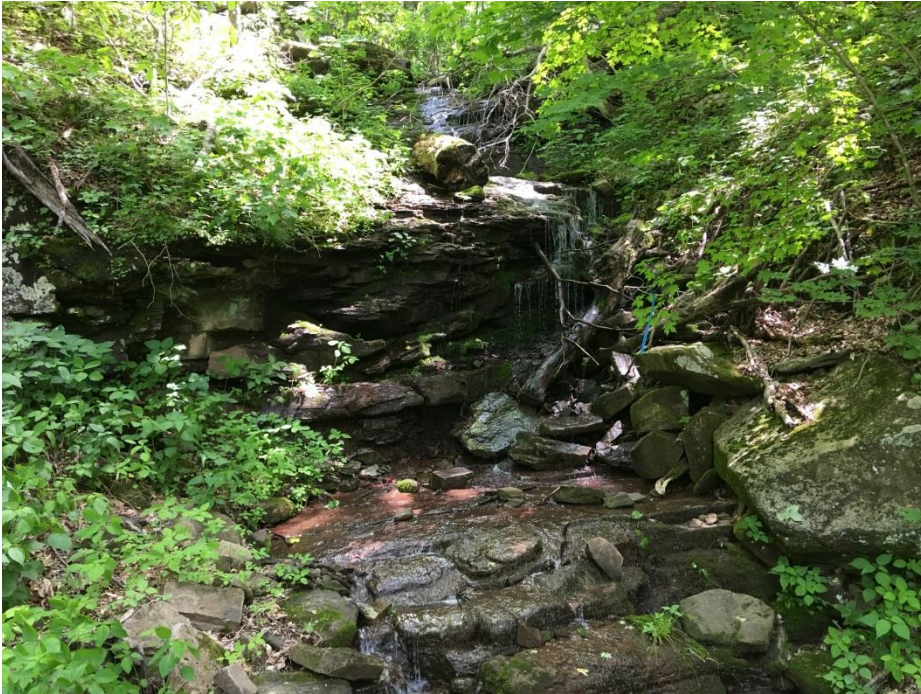
Waterbody SPOA436 facing east upstream

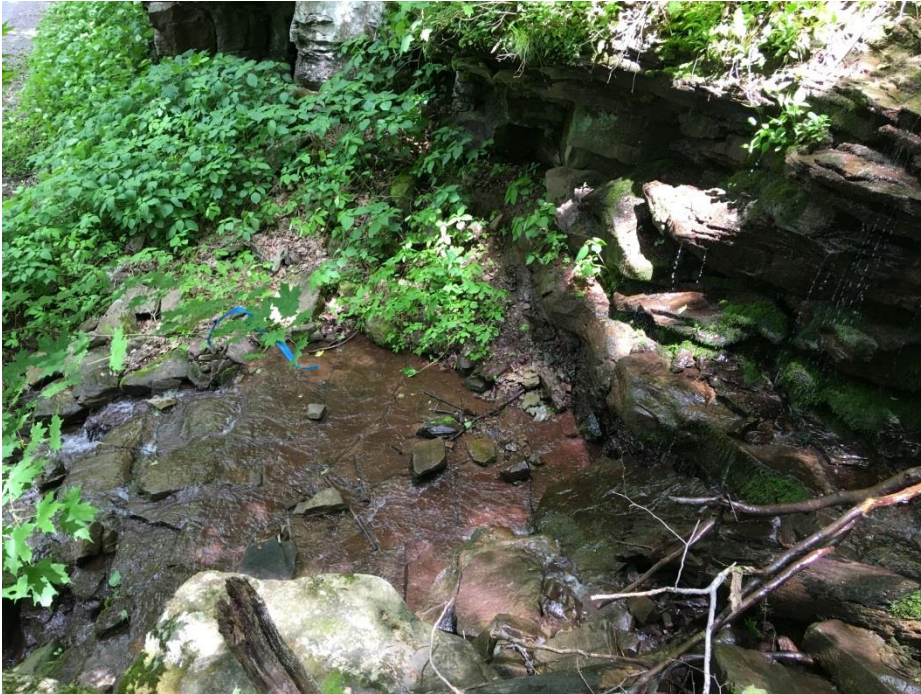
Waterbody SPOA436 facing north across

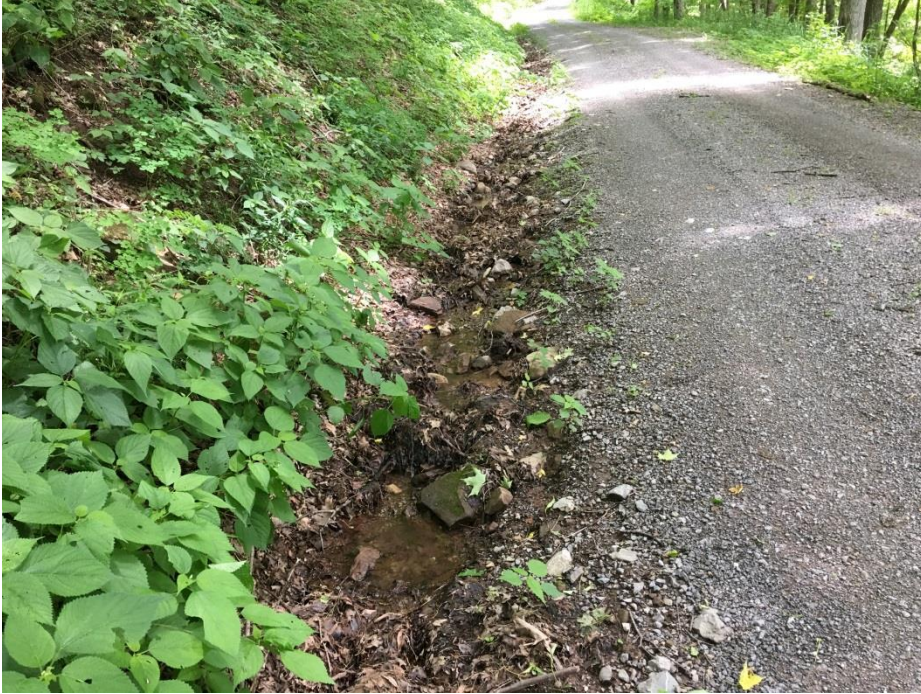
Waterbody SPOA437 facing east upstream

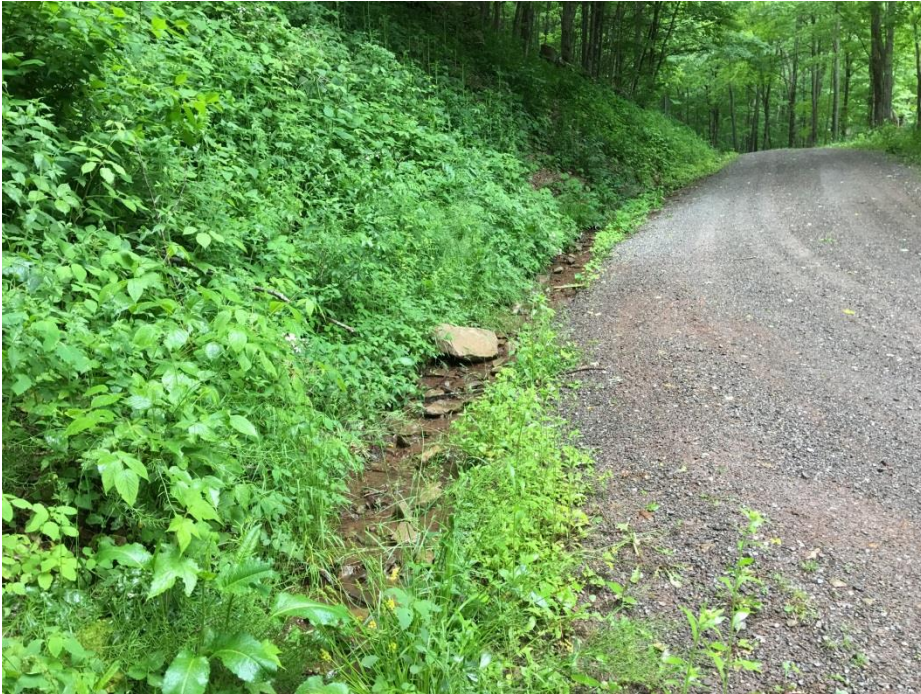
Waterbody SPOA438 facing east upstream

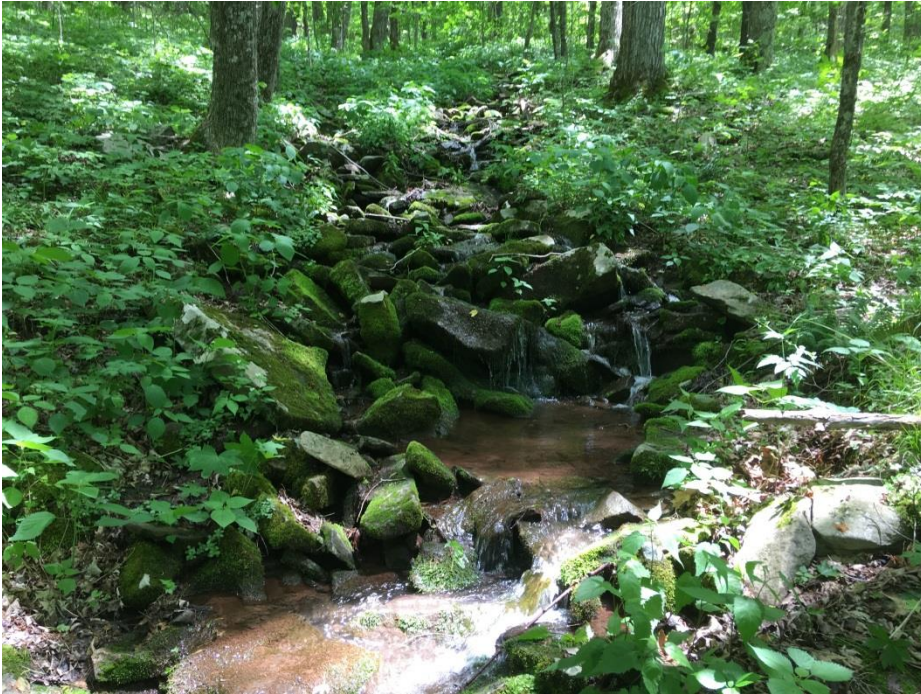
Waterbody SPOA432 facing east upstream

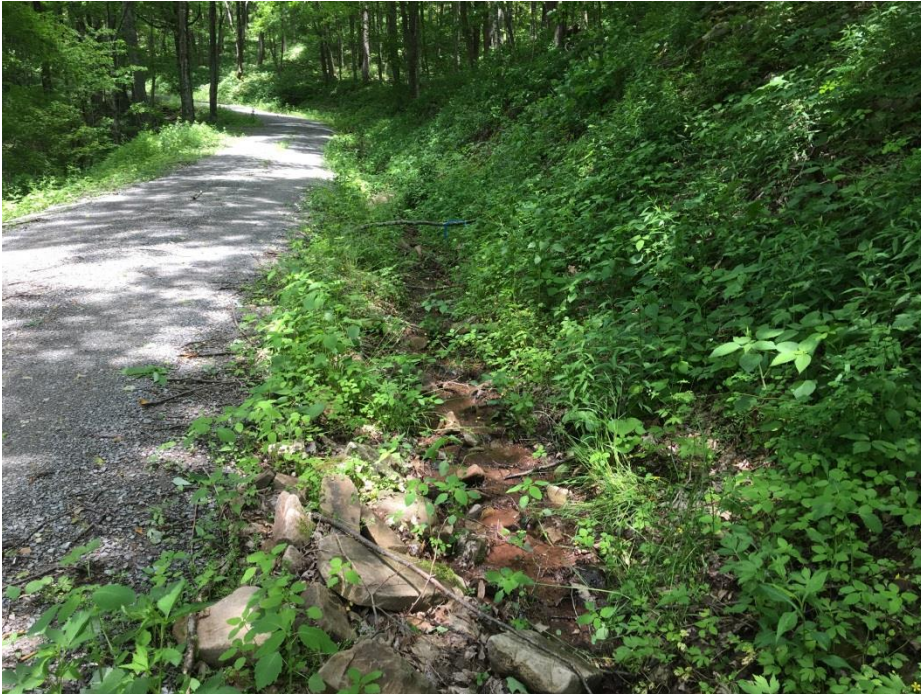
Waterbody SPOA433 facing north upstream

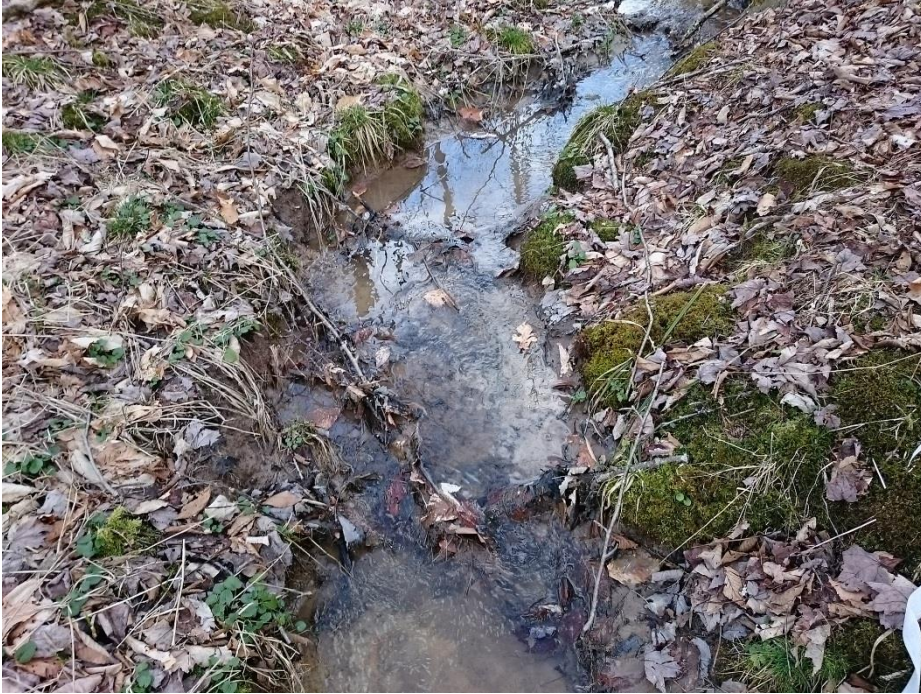
Waterbody SPOC105 facing north upstream

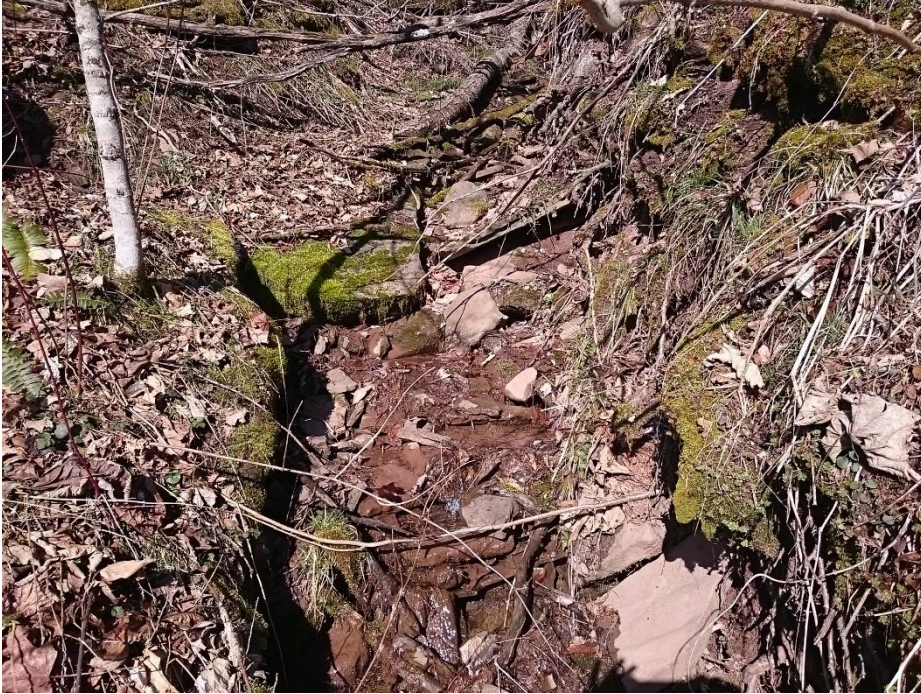
Waterbody SPOC110 facing northwest upstream

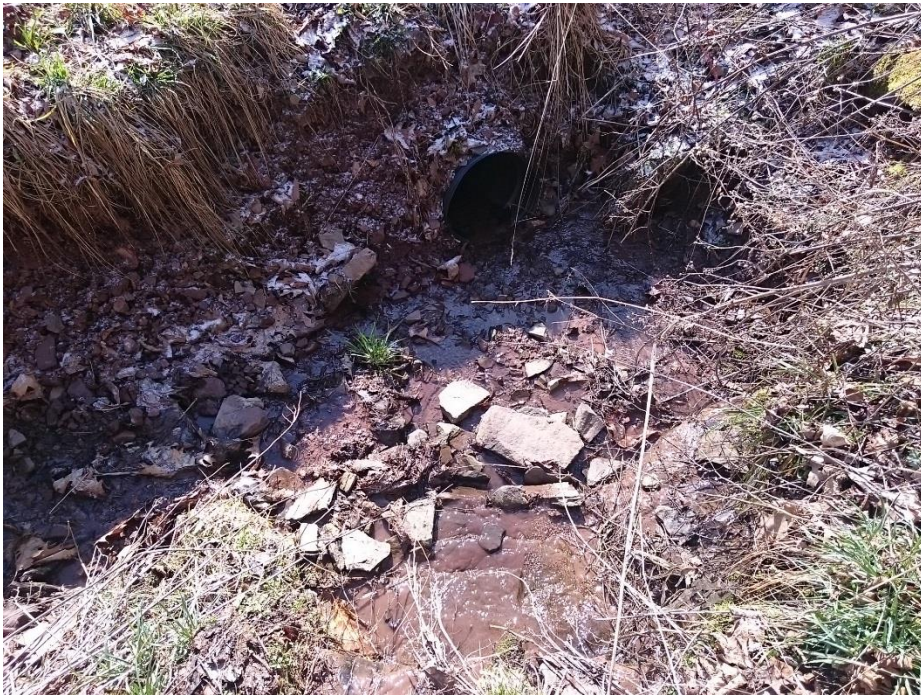
Waterbody SPOC110 facing southeast downstream
