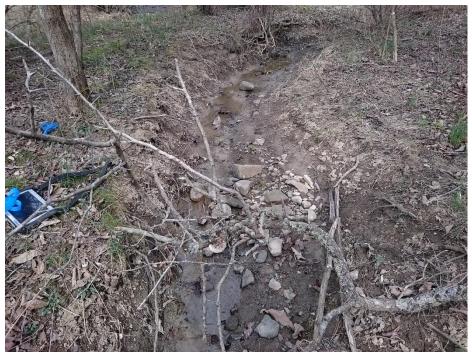
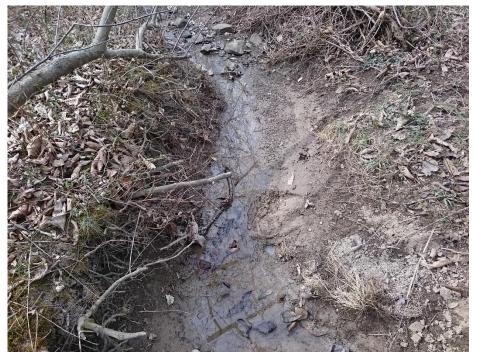
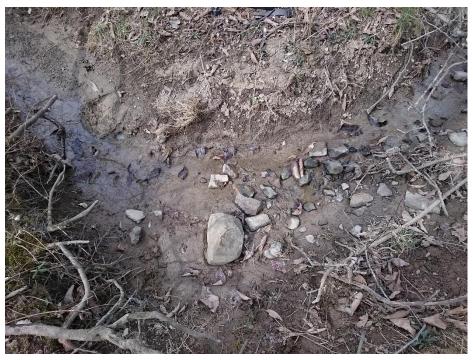
Waterbody SAUC128 facing northwest upstream

Waterbody SAUC128 facing southwest downstream

Waterbody SAUC128 facing west across

ivestock have historically had access to the stream and have altered hydrology

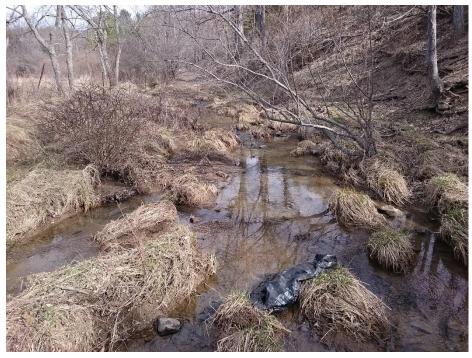
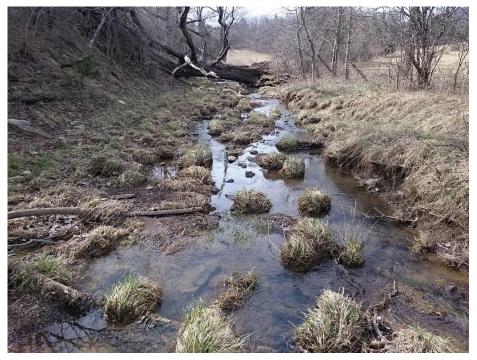
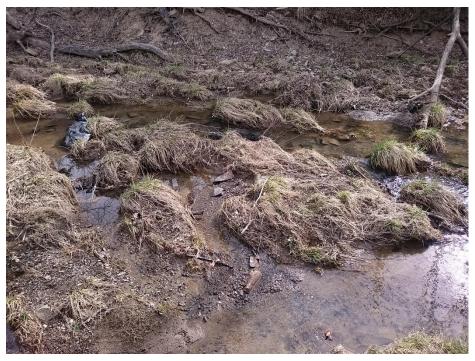
Waterbody SAUC127 facing northeast upstream

Waterbody SAUC127 facing southwest downstream

Waterbody SAUC127 facing southeast across

Highly degraded stream that contains hammocks from cattle access,, manure, and algae. The banks are highly susceptible to erosion.

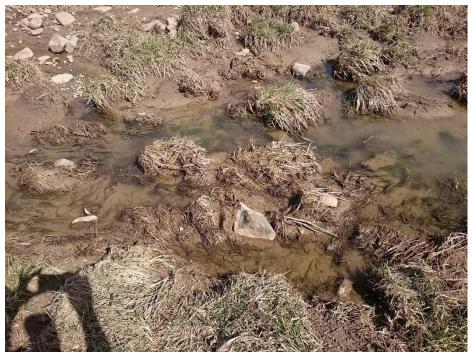
Waterbody SAUC129 facing east across

Highly degraded stream that contains hammocks from cattle access. The banks are highly susceptible to erosion.

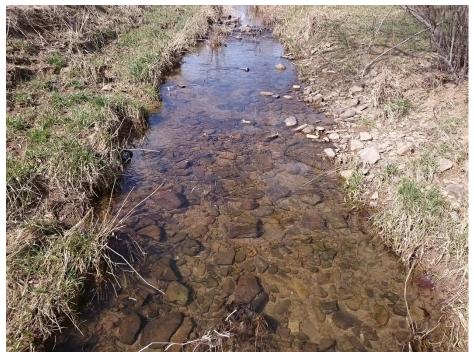
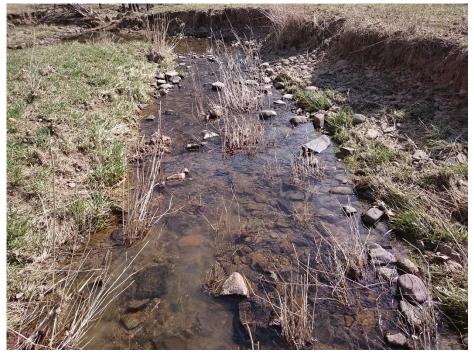
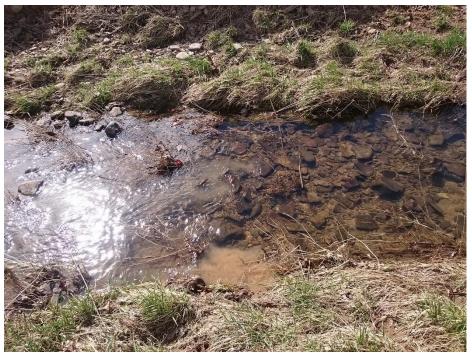
Waterbody SAUC130 facing northwest upstream

Waterbody SAUC130 facing southeast downstream

Waterbody SAUC130 facing southwest across

Highly degraded stream that contains hammocks from cattle access. The banks are highly susceptible to erosion.

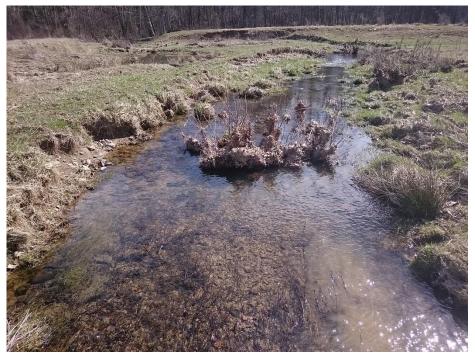
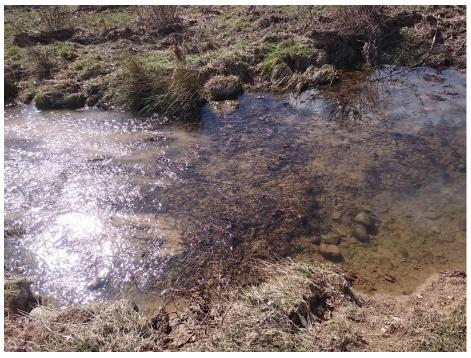
Waterbody SAUC131 facing south downstream

Waterbody SAUC131 facing west across

Stream has cattle access. The banks are slightly susceptible to erosion.

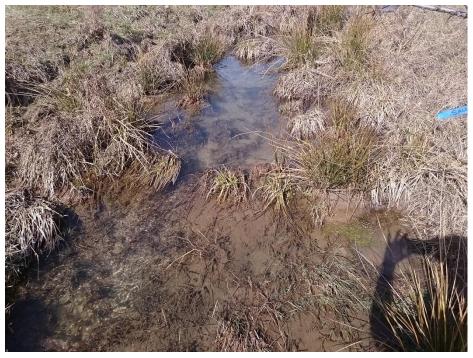
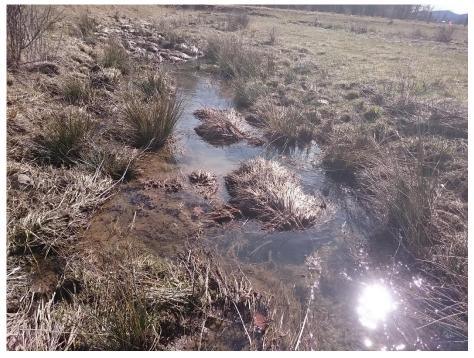
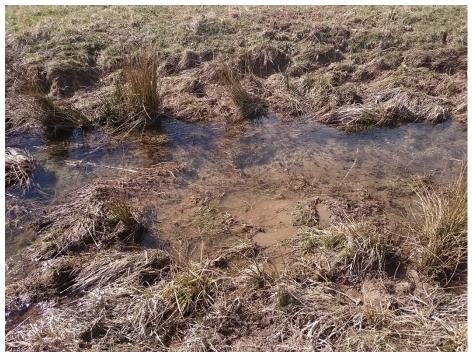
Waterbody SAUC132 facing northeast upstream

Waterbody SAUC132 facing southwest downstream

Waterbody SAUC132 facing northwest across

Stream has cattle access and manure in stream. The banks are highly susceptible to erosion. SAUR010 is part of SAUC133. This stream was extended to include that part of the stream.

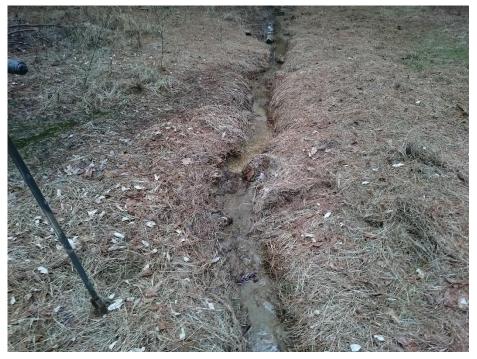
Waterbody SAUC119 facing southeast downstream

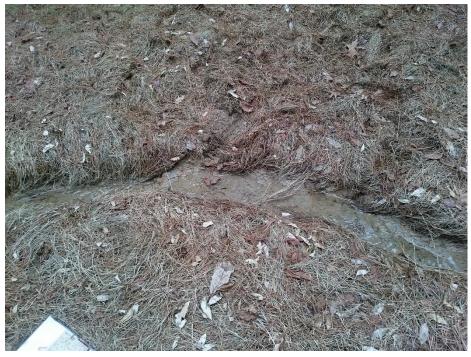
Waterbody SAUC119 facing southwest across

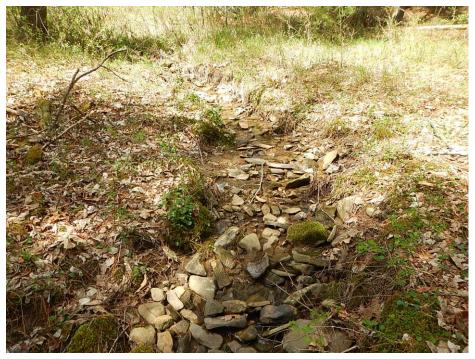
Waterbody SAUB103 facing north upstream

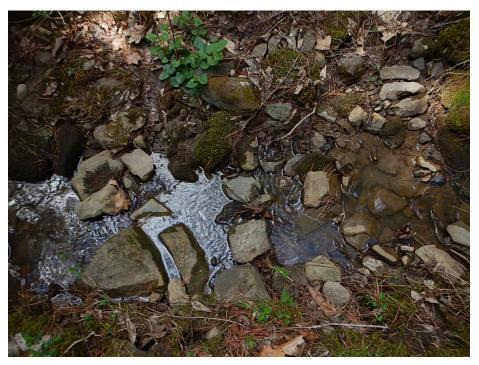
Waterbody SAUB103 facing west across

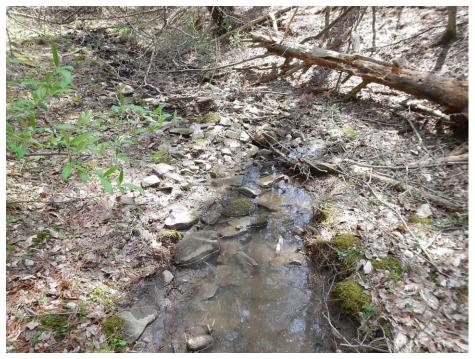
Waterbody SAUB103 facing south downstream

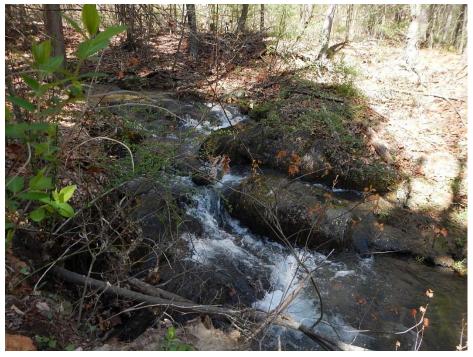
Waterbody SAUB104 facing north upstream

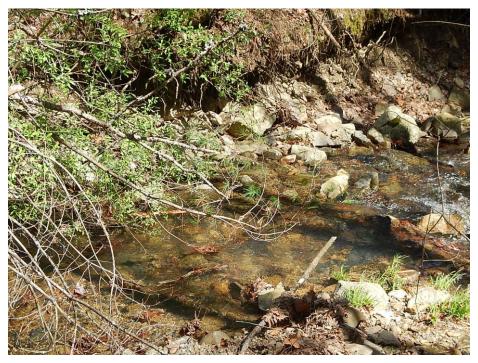
Waterbody SAUB104 facing east across
