# Linear Waterbody Data Sheet

Survey Description			
Project Name: Atlantic Coast Pipeline		Waterbody Name: Middle River	
Waterbody ID: saua070		Date: 5/12/2015	
State: Virginia	County: Augusta	Company: NRG	Crew Member Initials: GB, SA
Photos: 3 photos			
Tract Number(s): 07-001-A079; 07-001-A080; 07-001-A081		Nearest Milepost: 125.6	Associated Wetland ID(s): No wetlands within corridor
Survey Type: <i>(check one)</i> <input checked="" type="checkbox"/> Centerline <input type="checkbox"/> Re-Route <input type="checkbox"/> Access Road <input type="checkbox"/> Other:			
Physical Attributes			
Stream Classification: <i>(check one)</i> <input type="checkbox"/> Ephemeral <input type="checkbox"/> Intermittent <input checked="" type="checkbox"/> Perennial			
Waterbody Type: <i>(check one)</i> <input checked="" type="checkbox"/> River <input type="checkbox"/> Stream <input type="checkbox"/> Ditch <input type="checkbox"/> Canal <input type="checkbox"/> Other:

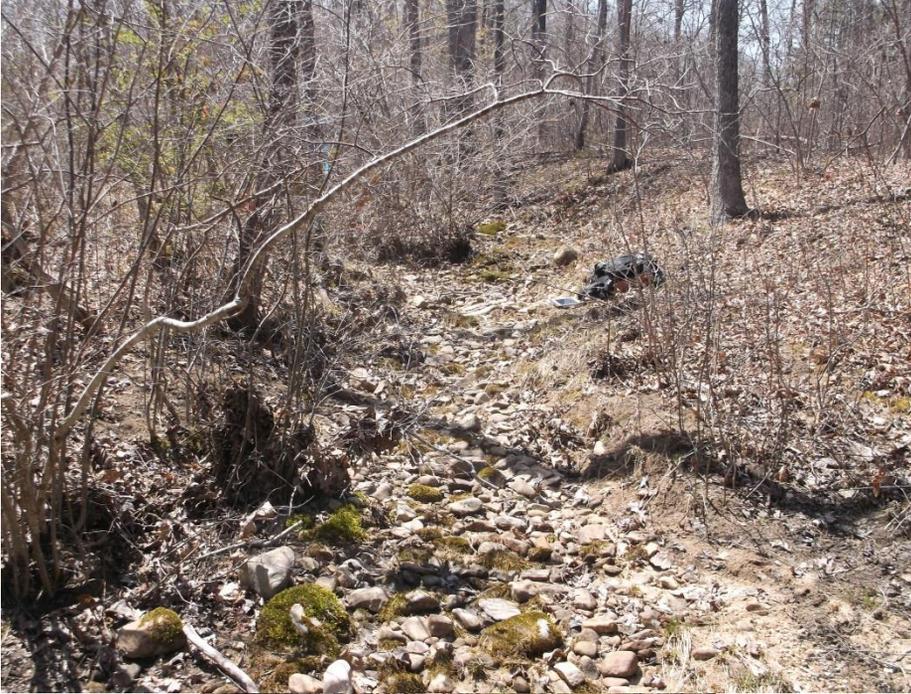
Waterbody SAUA407 facing southwest upstream

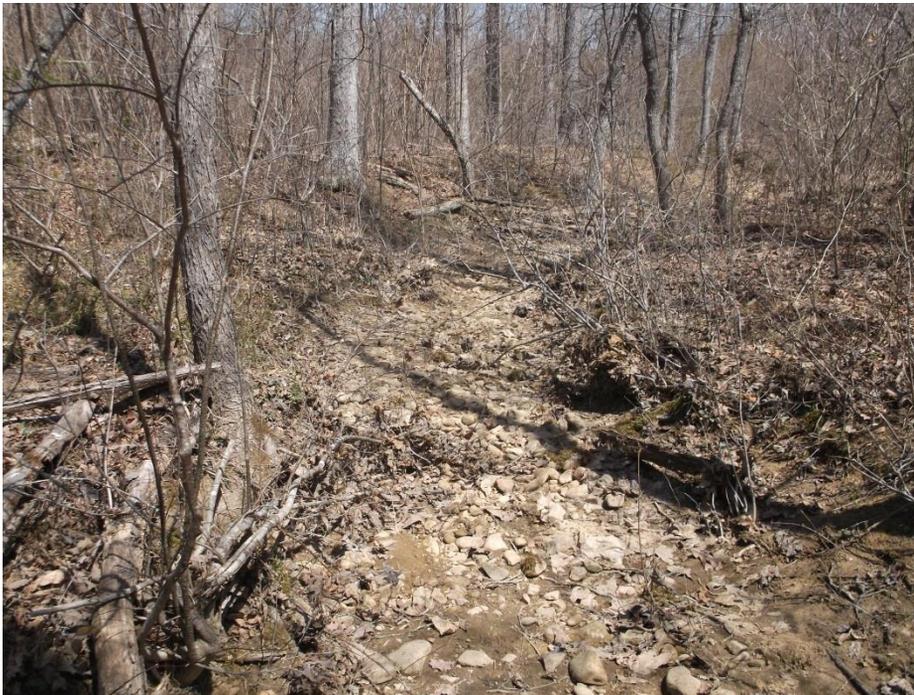
Waterbody SAUA407 facing northeast downstream

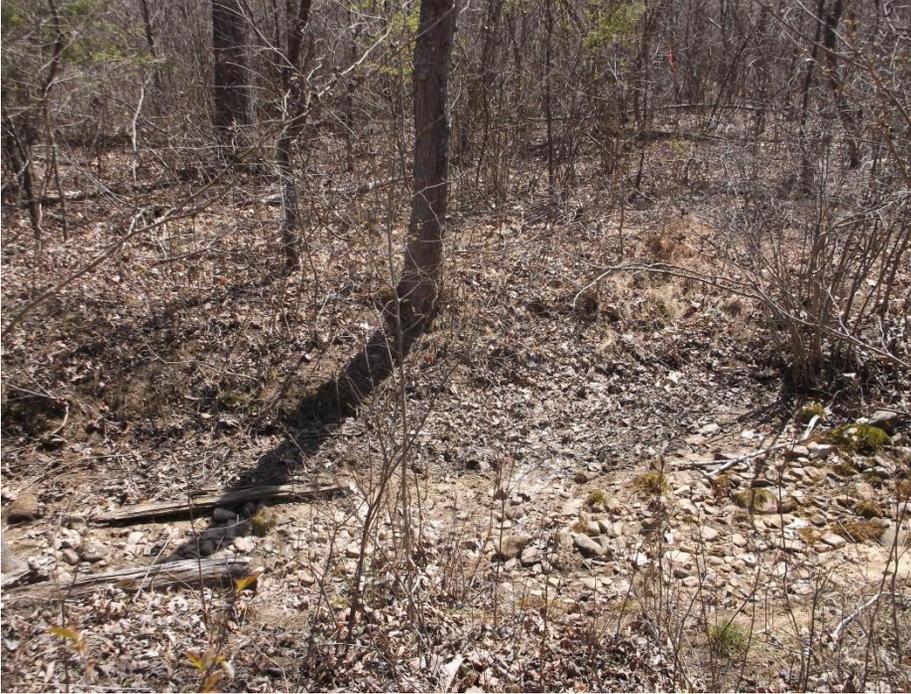
Waterbody SAUA407 facing southeast across

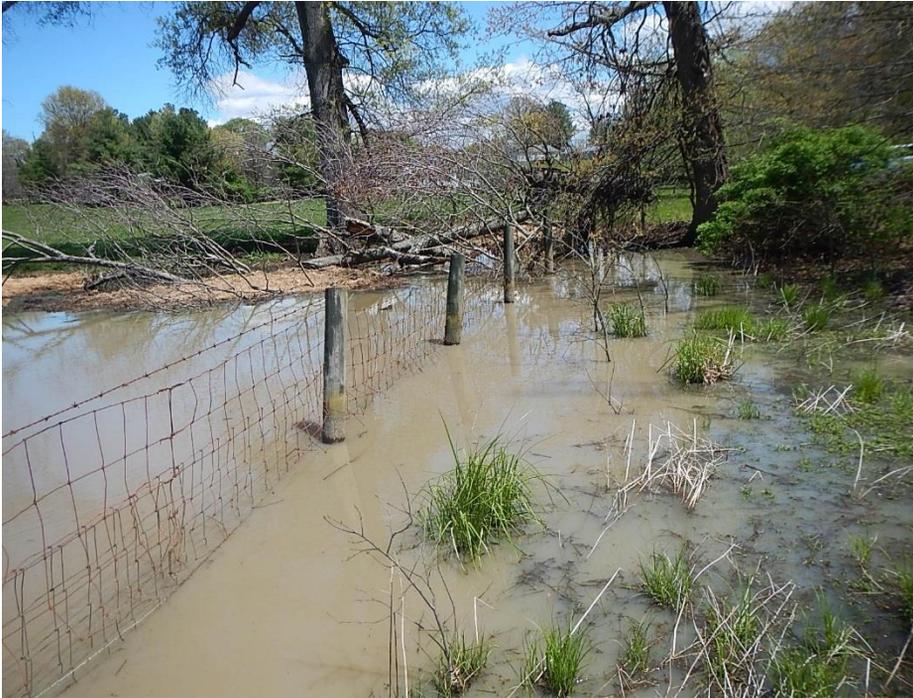
Open waterbody OAUB100 facing east

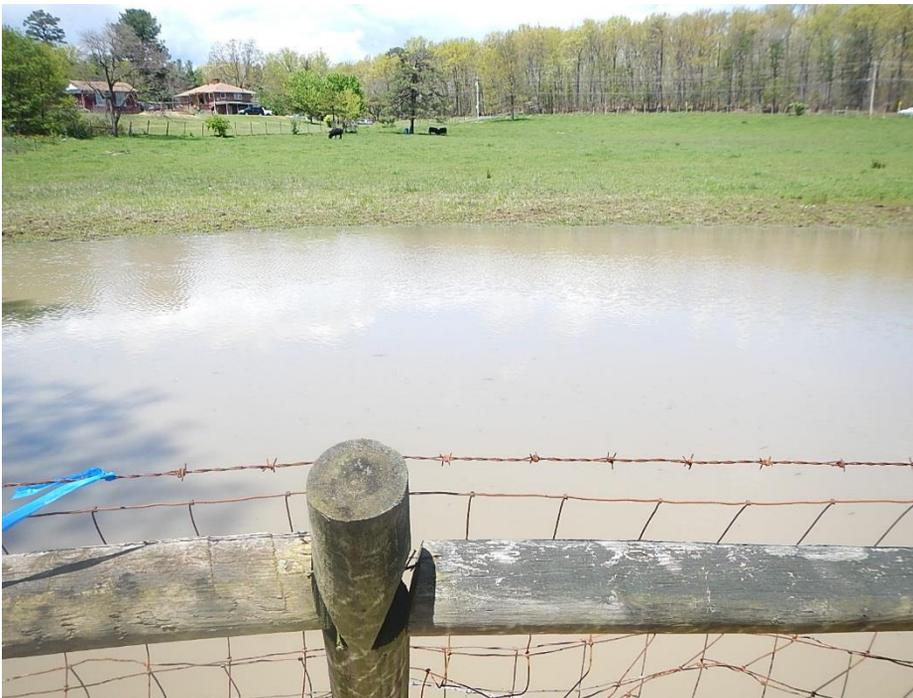
Open waterbody OAUB100 facing north

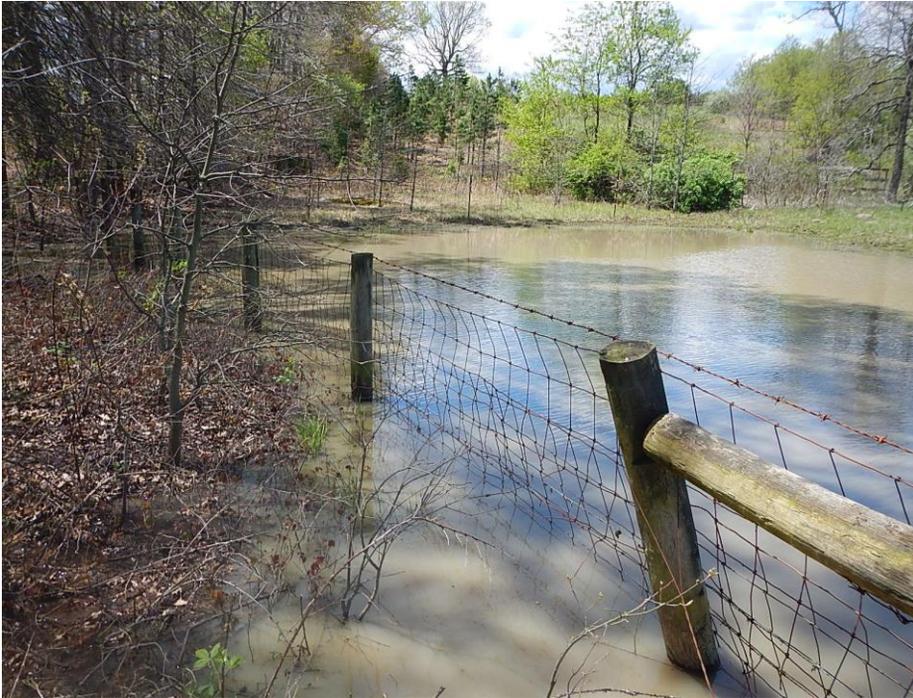
Open waterbody OAUB100 facing west

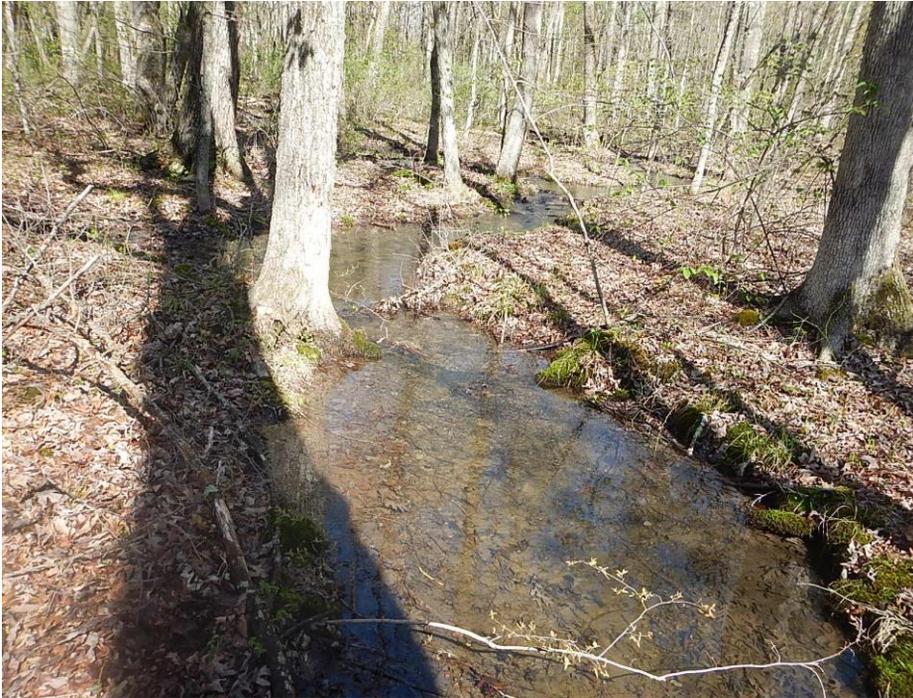
Waterbody SAUB115 facing west upstream

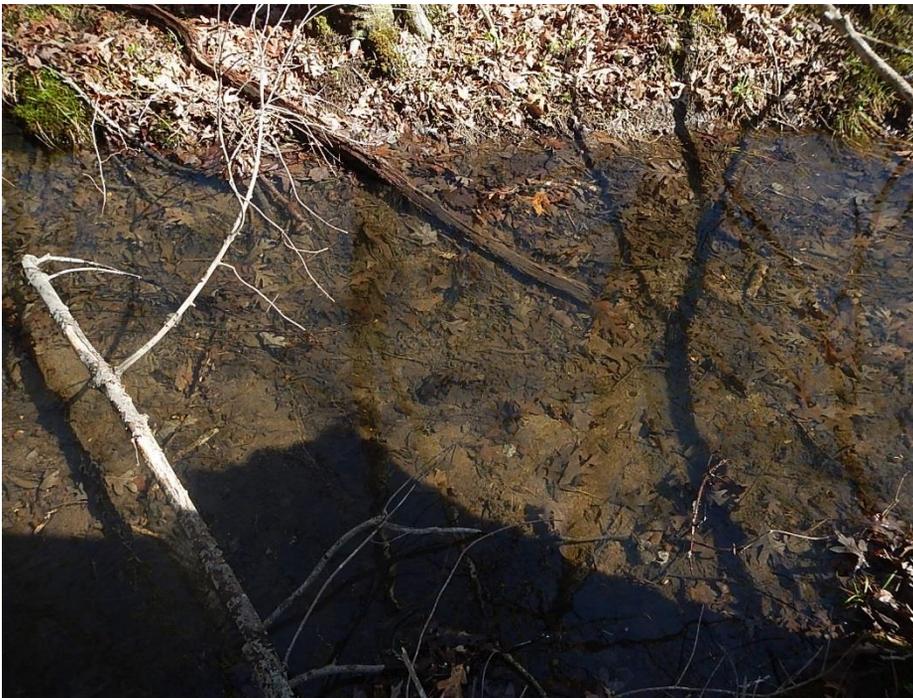
Waterbody SAUB115 facing north across

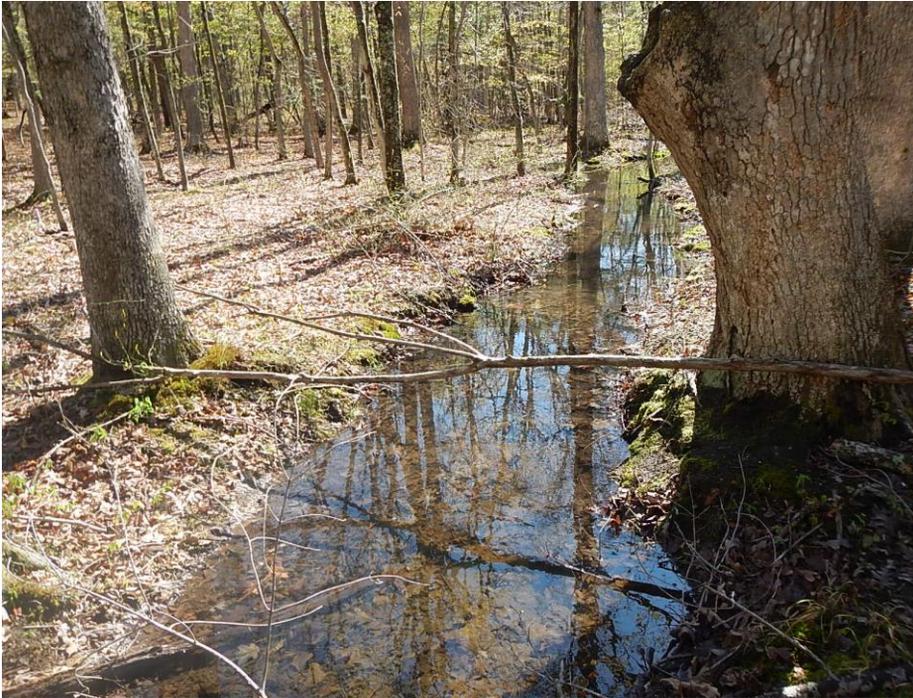
Waterbody SAUB115 facing east downstream

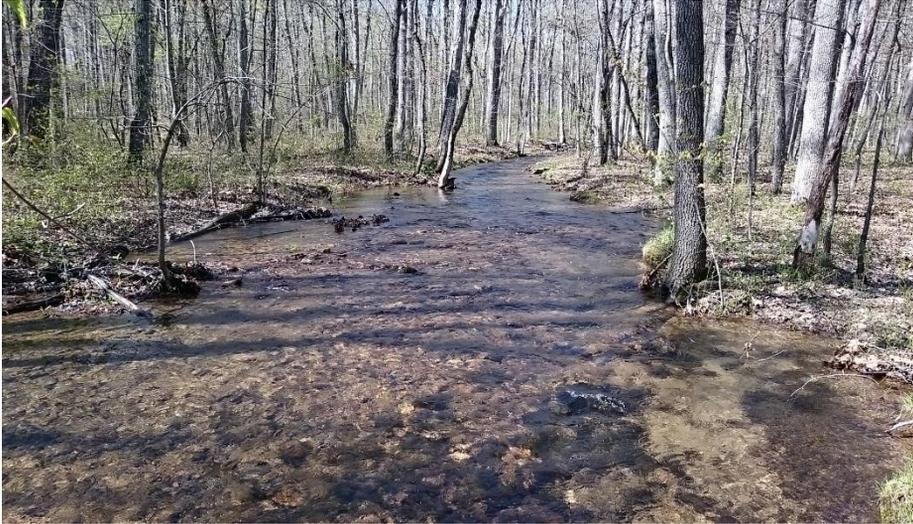
Waterbody SAUA052 facing southwest upstream

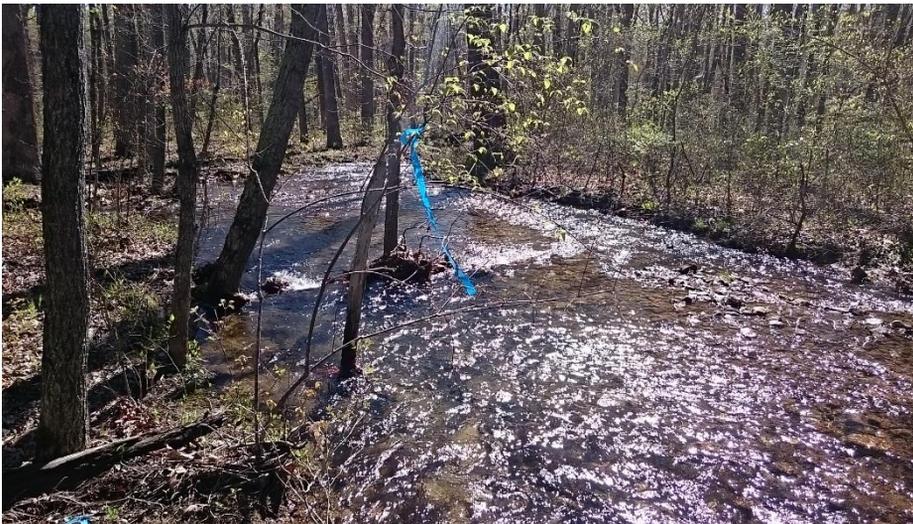
Waterbody SAUA052 facing east downstream

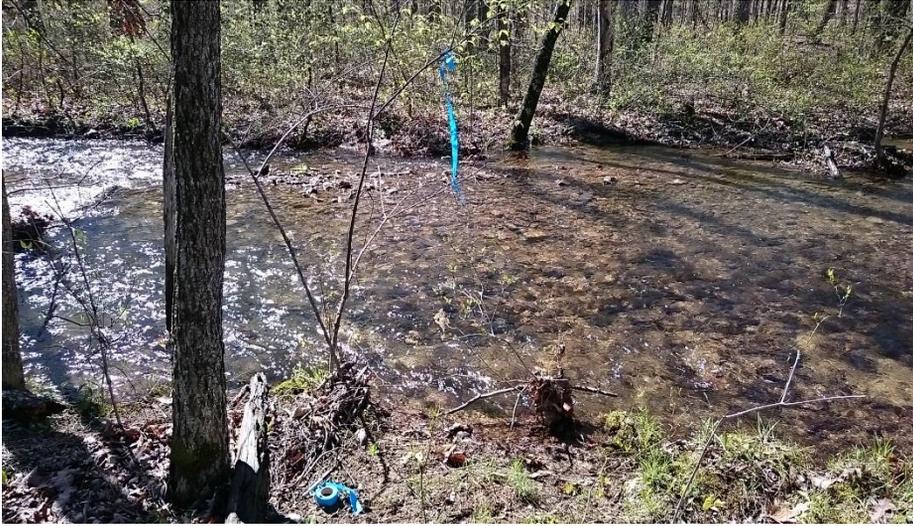
Waterbody SAUA052 facing south across

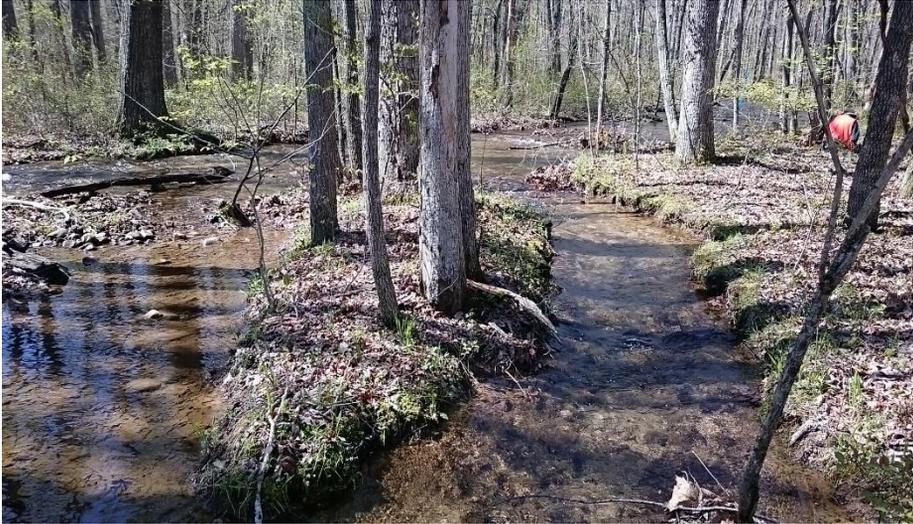
Waterbody SAUA052 facing southwest upstream

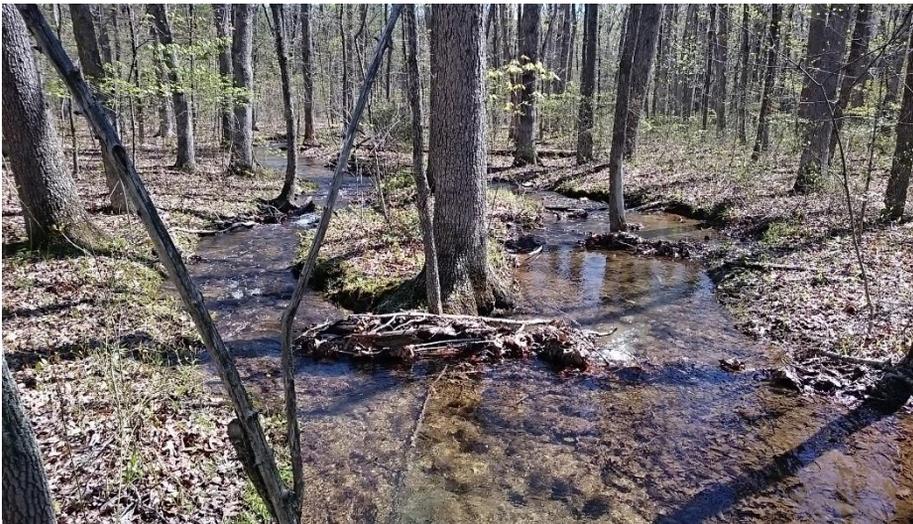
Waterbody SAUA052 facing northeast downstream

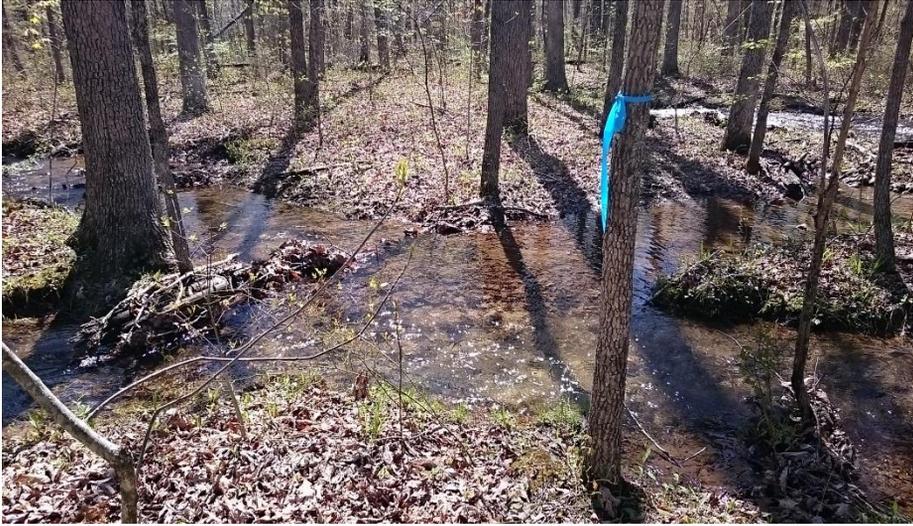
Waterbody SAUA052 facing southeast across

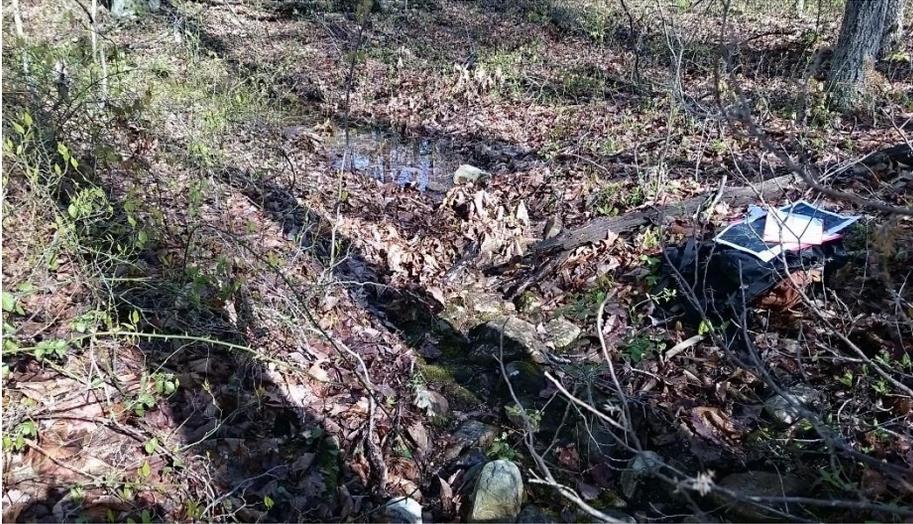
Waterbody SAUA051 facing northwest upstream

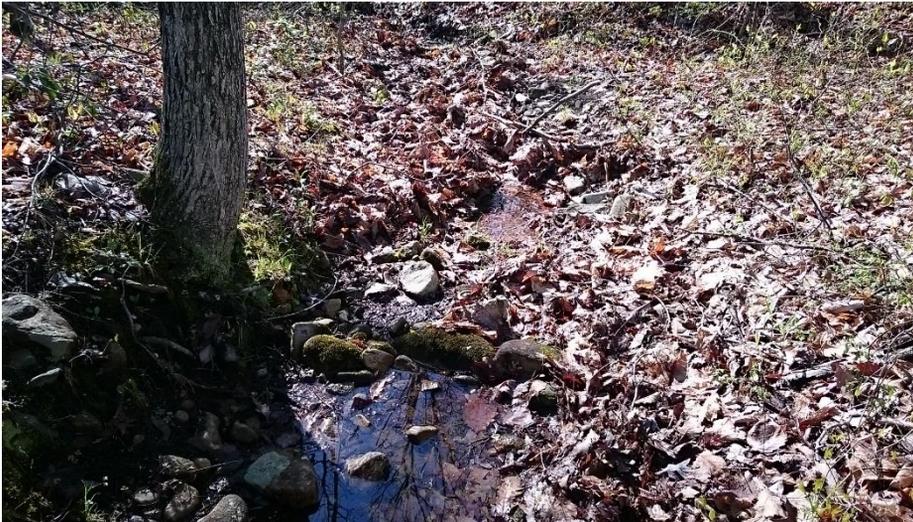
Waterbody SAUA051 facing southeast downstream

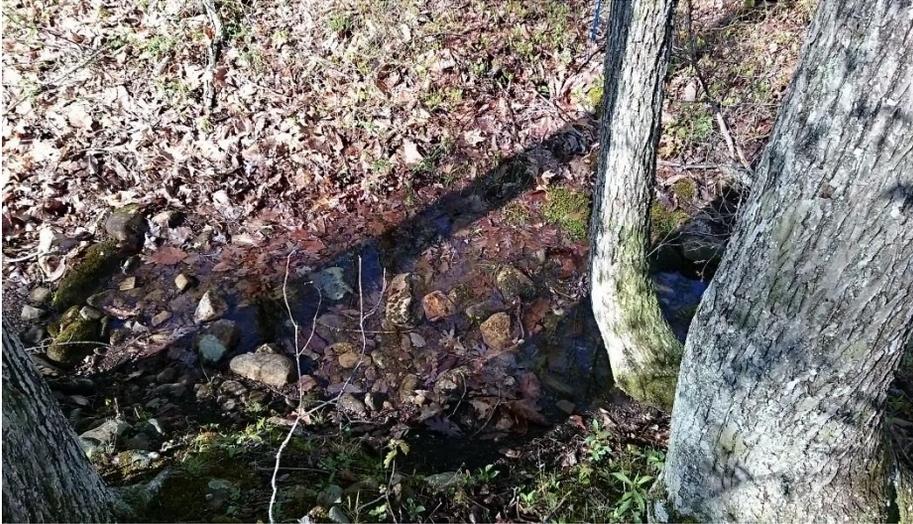
Waterbody SAUA051 facing southwest across

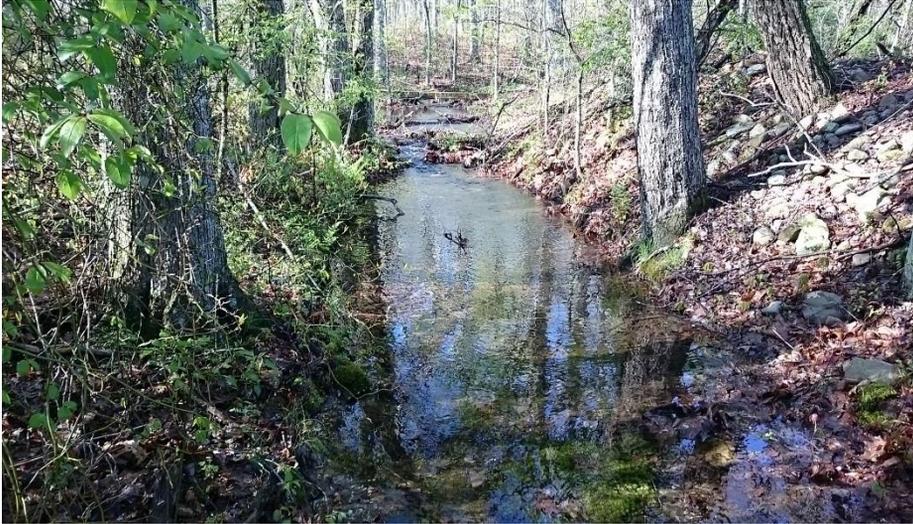
Waterbody SAUA050 facing southwest upstream

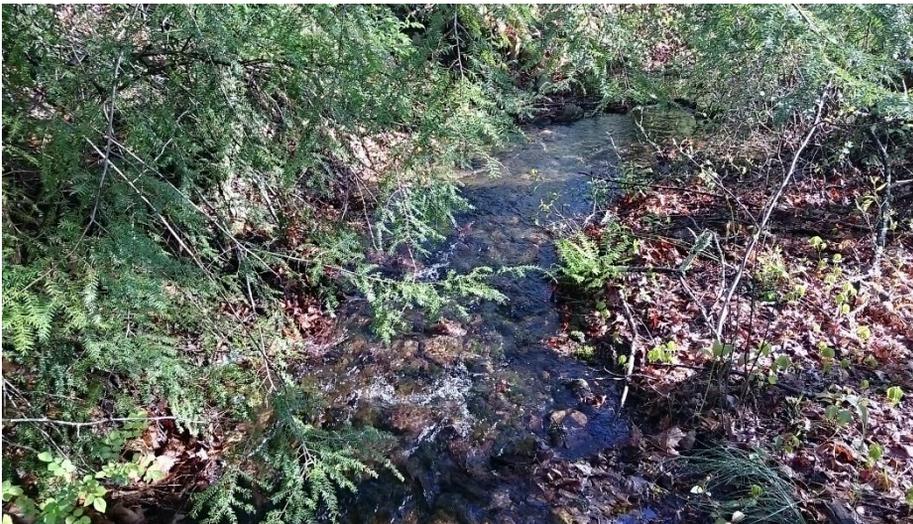
Waterbody SAUA050 facing northeast downstream

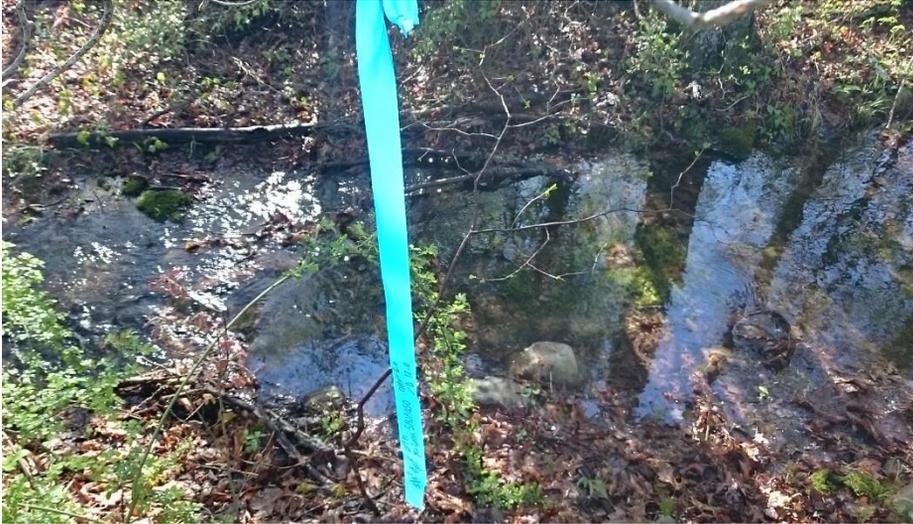
Waterbody SAUA050 facing southeast across

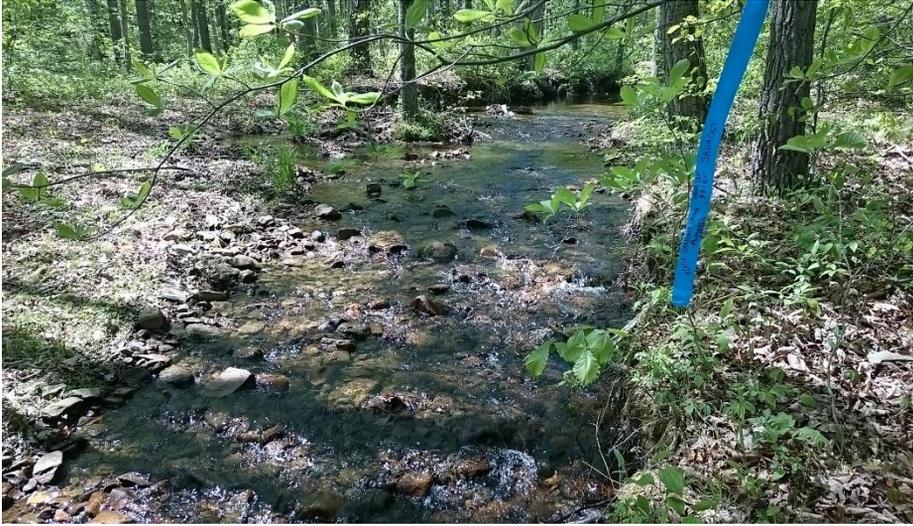
Waterbody SAUA067 facing south-southwest upstream

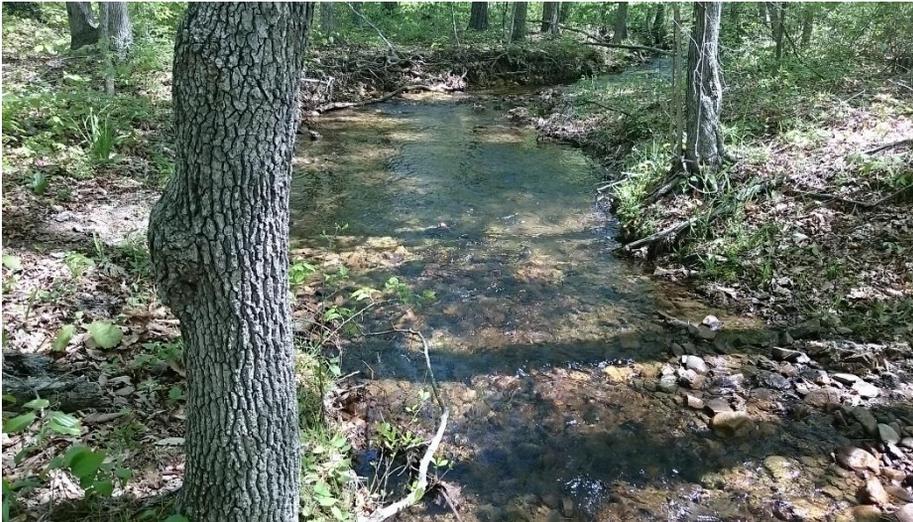
Waterbody SAUA067 facing northeast downstream

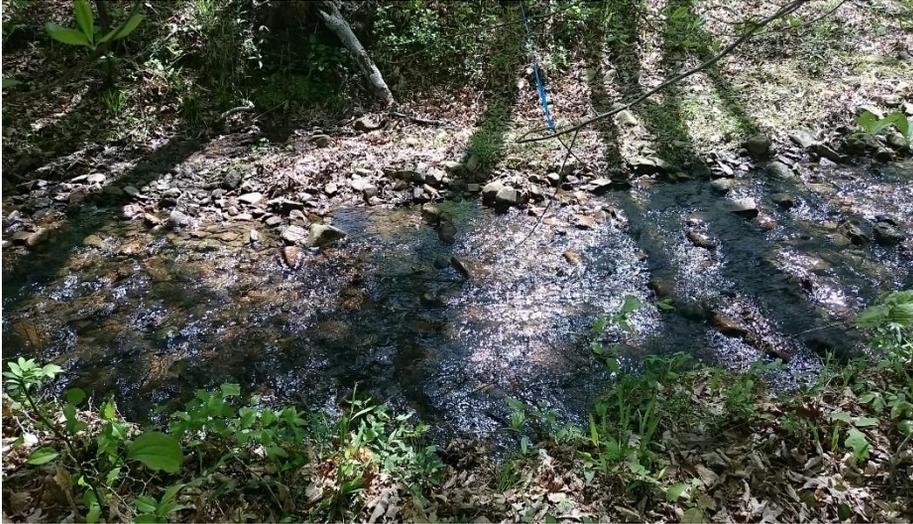
Waterbody SAUA067 facing southeast across

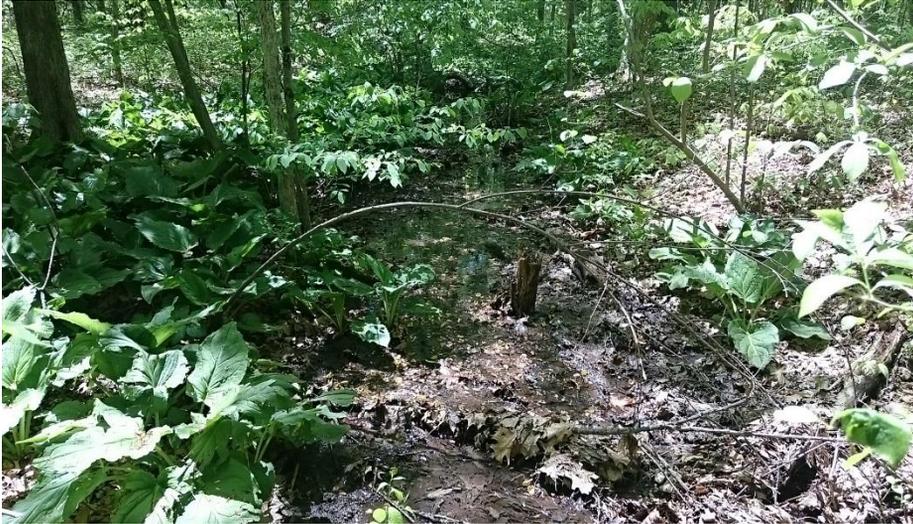
Waterbody SAUA069 facing west-southwest upstream

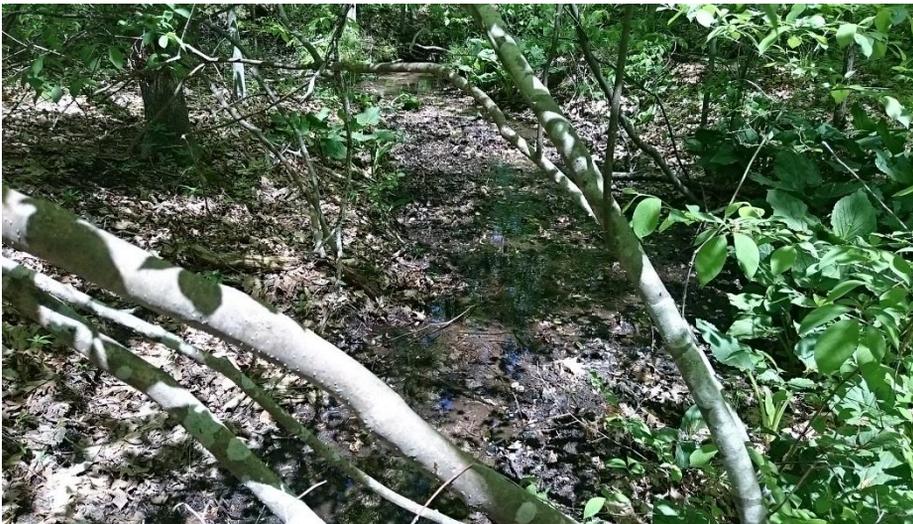
Waterbody SAUA069 facing east downstream

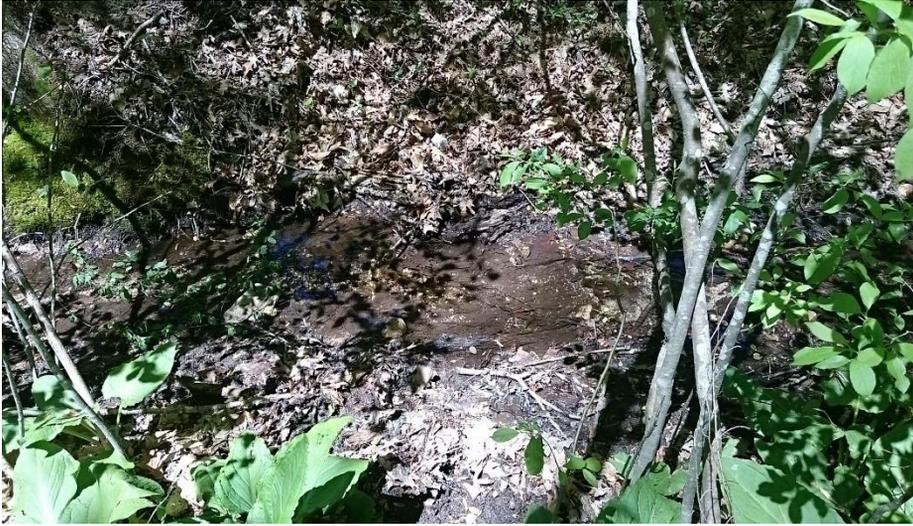
Waterbody SAUA069 facing north-northeast across

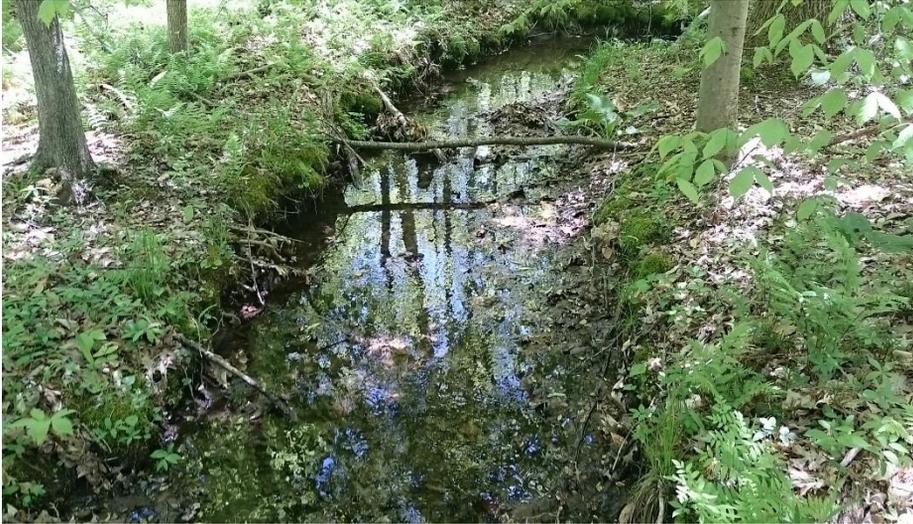
Waterbody SAUA068 facing south-southwest upstream

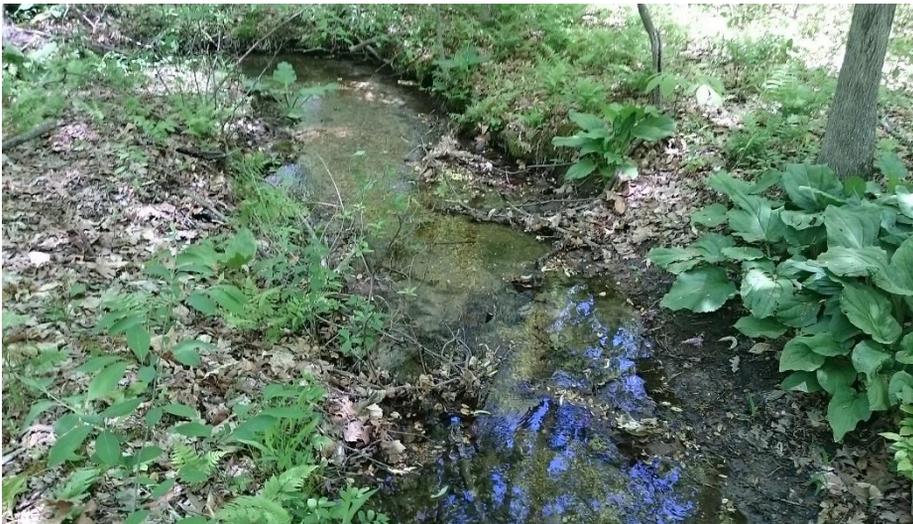
Waterbody SAUA068 facing northeast downstream

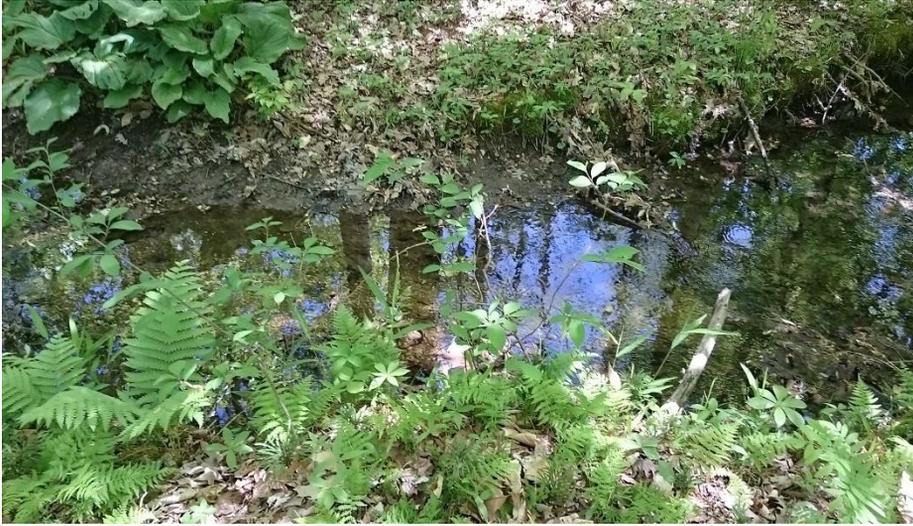
Waterbody SAUA068 facing southeast across

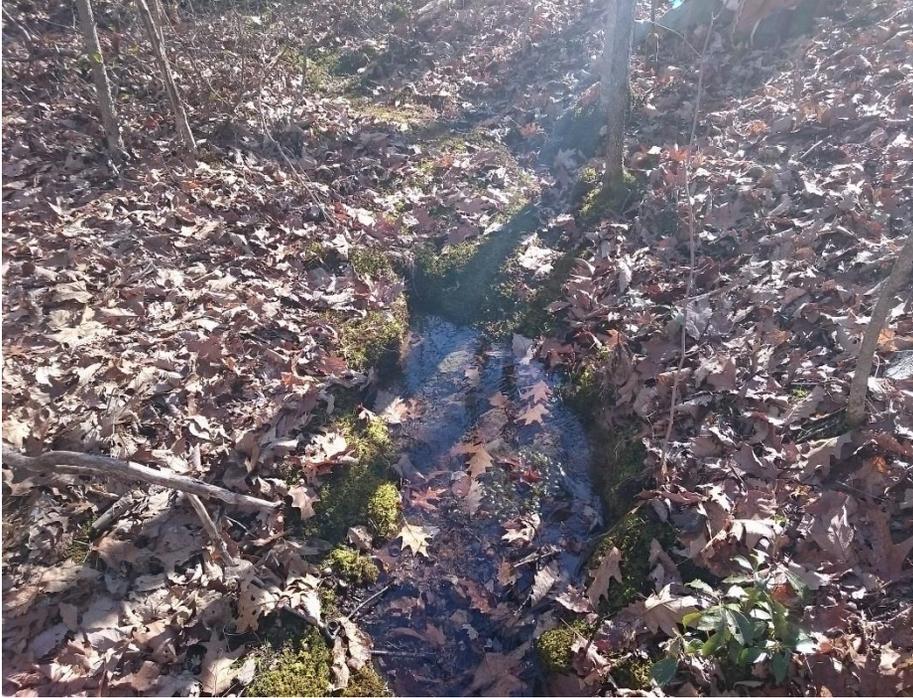
Waterbody SAUA072 facing south upstream

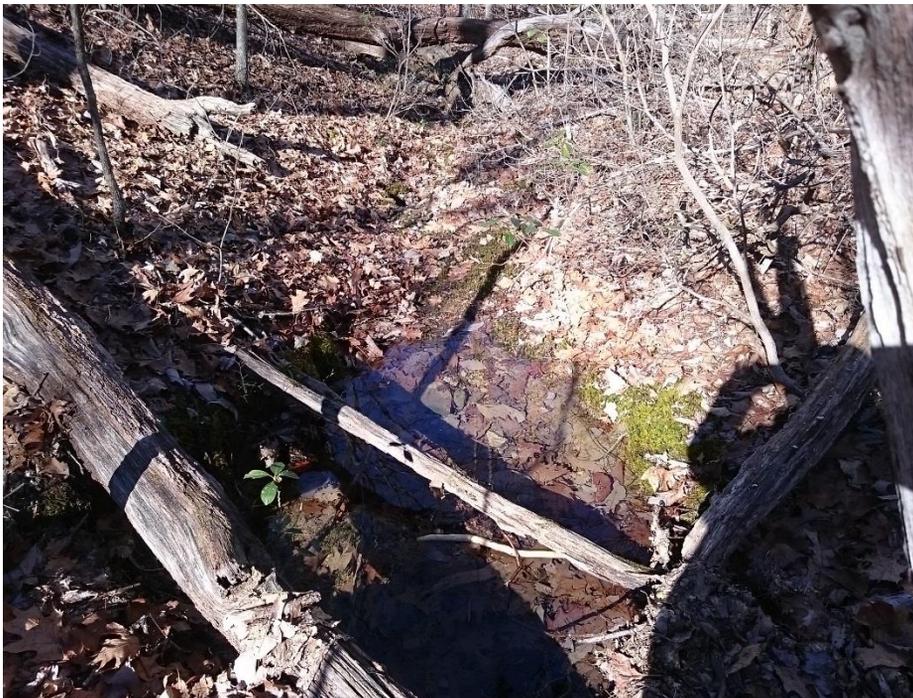
Waterbody SAUA072 facing north downstream

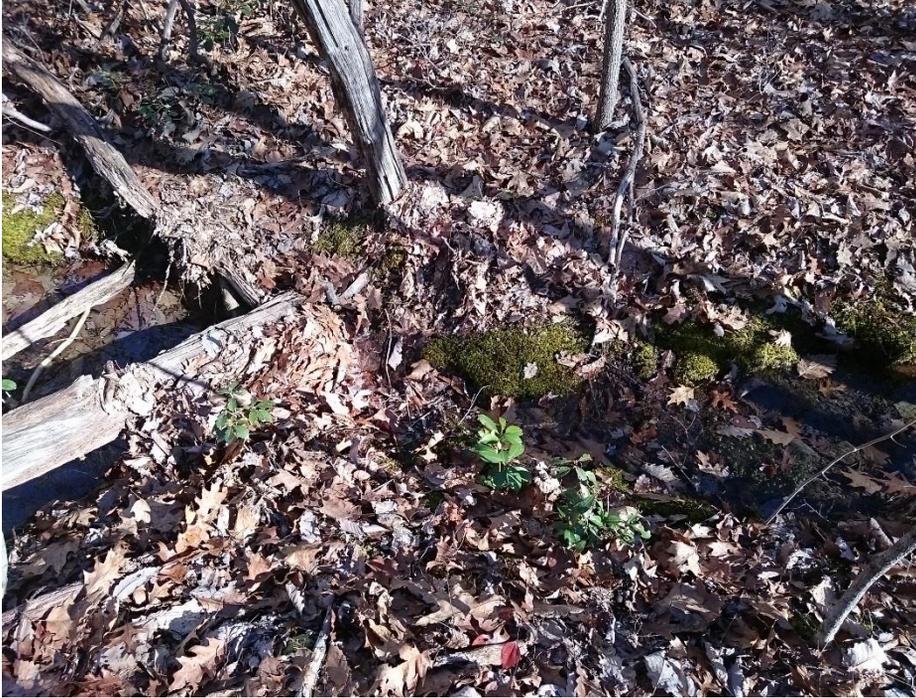
Waterbody SAUA072 facing east across

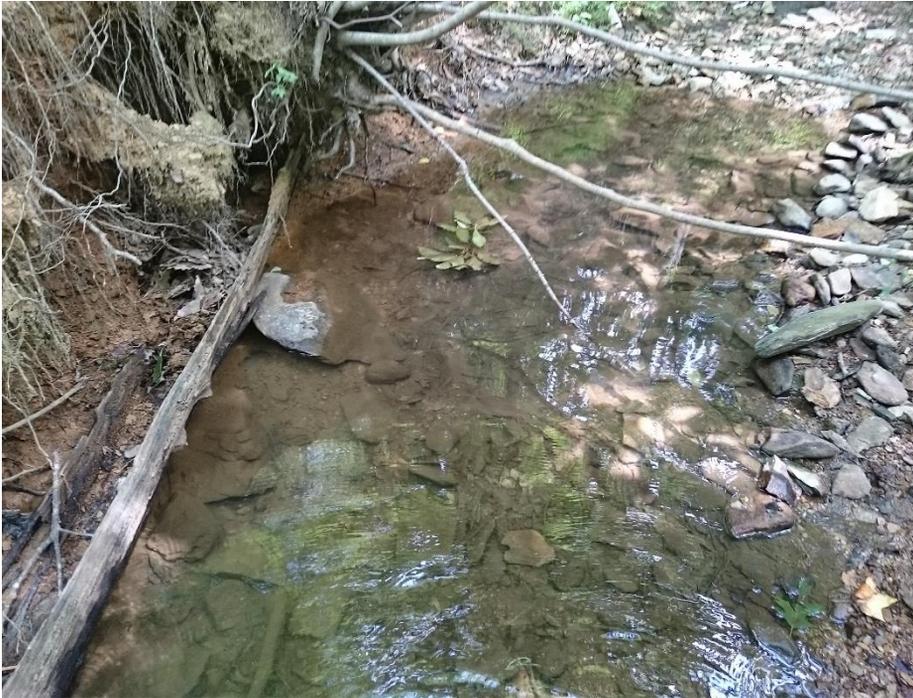
Waterbody SAUA434 facing northeast upstream

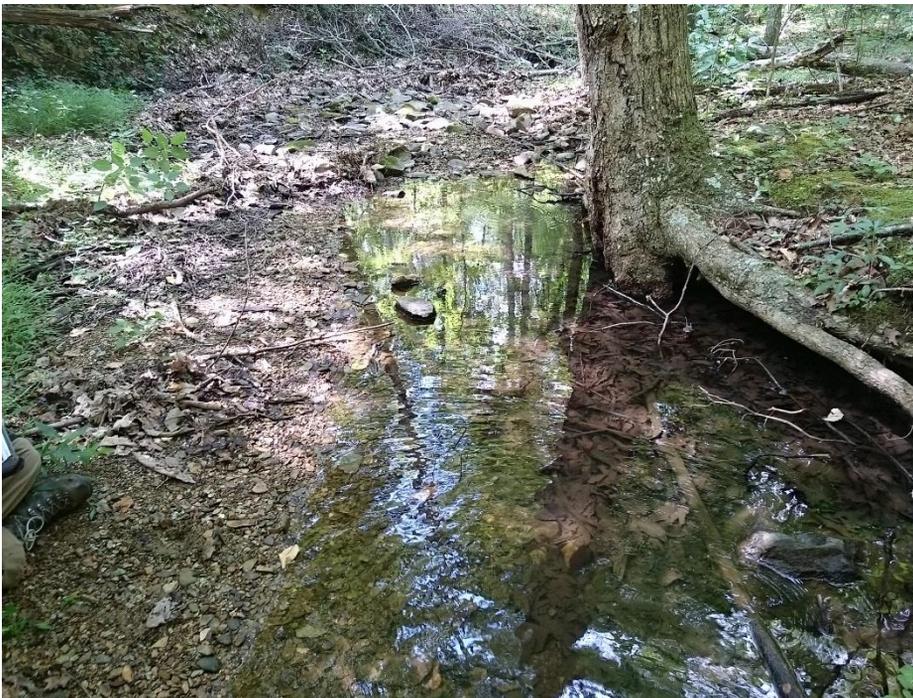
Waterbody SAUA434 facing southwest downstream

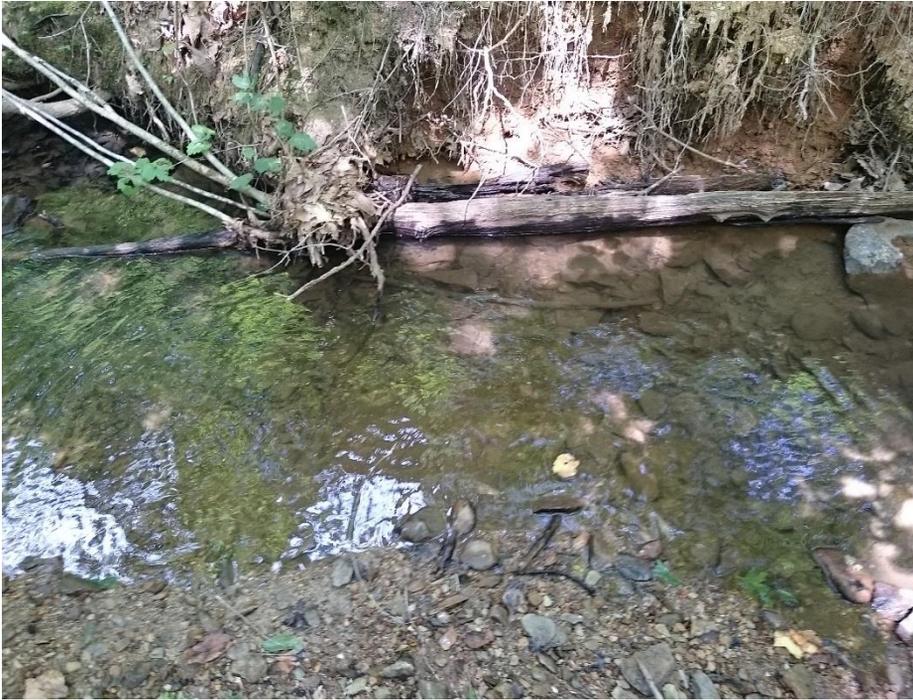
Waterbody SAUA434 facing northwest across

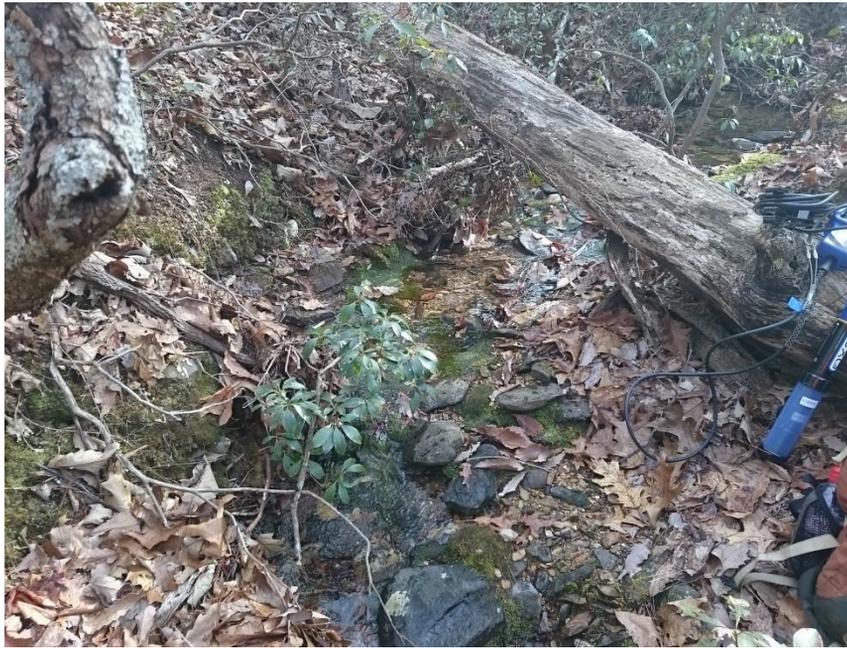
Waterbody SAUA071 facing east upstream

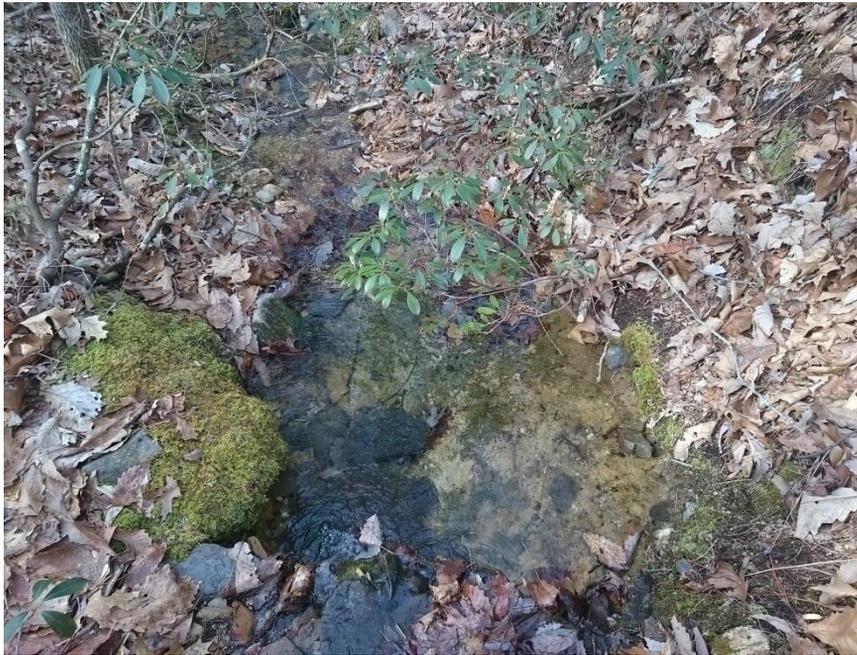
Waterbody SAUA071 facing west downstream

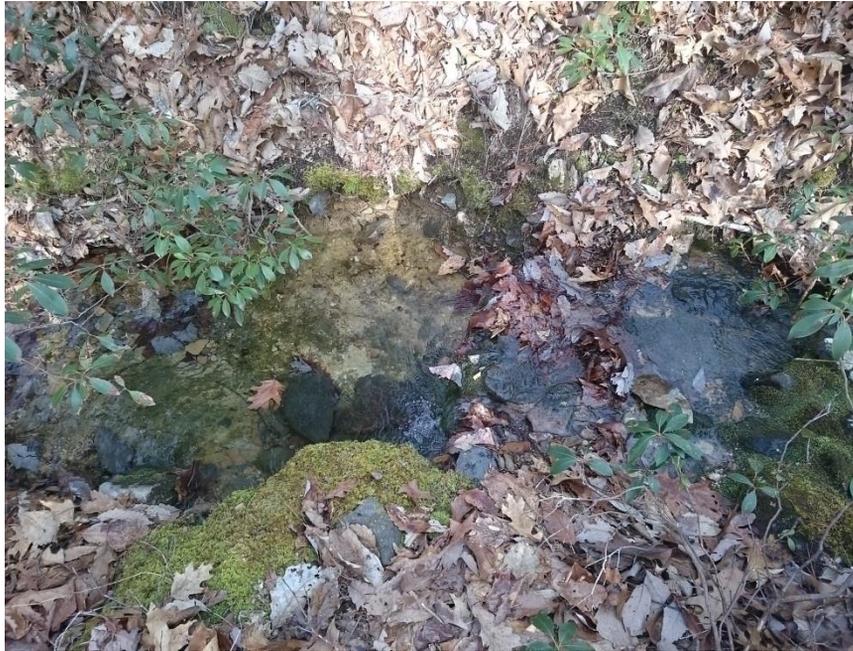
Waterbody SAUA071 facing north across

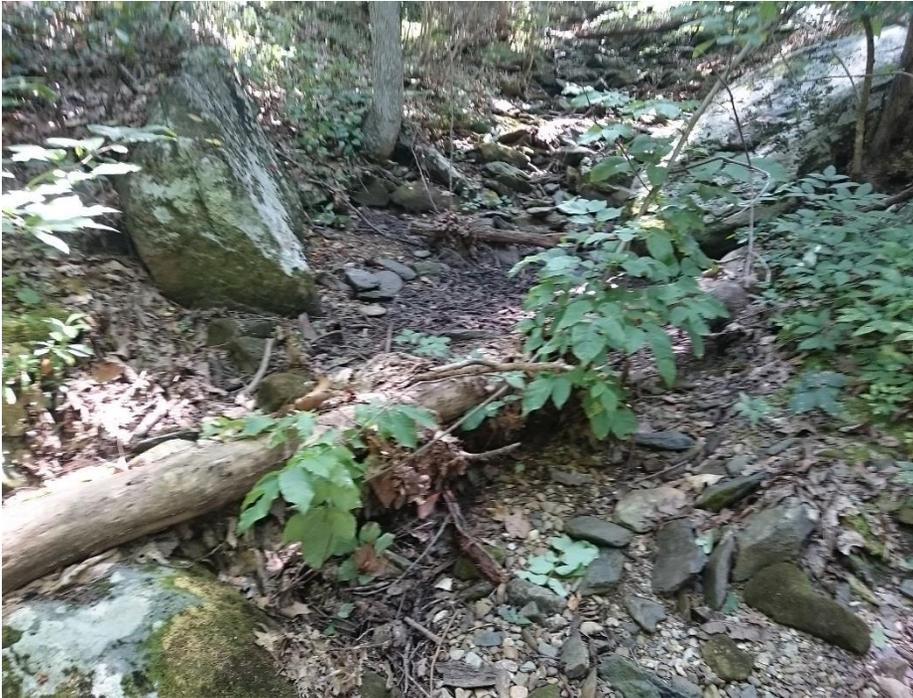
Waterbody SAUA433 facing southeast upstream

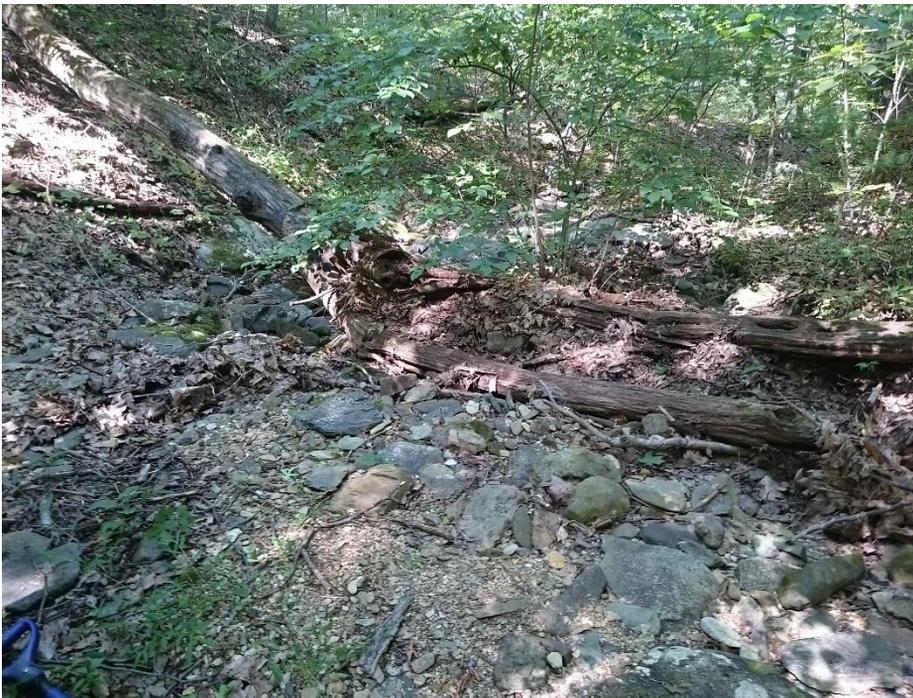
Waterbody SAUA433 facing northwest downstream
