# Linear Waterbody Data Sheet

Survey Description			
Project Name: Atlantic Coast Pipeline		Waterbody Name: Middle River	
Waterbody ID: saua070		Date: 5/12/2015	
State: Virginia	County: Augusta	Company: NRG	Crew Member Initials: GB, SA
Photos: 3 photos			
Tract Number(s): 07-001-A079; 07-001-A080; 07-001-A081		Nearest Milepost: 125.6	Associated Wetland ID(s): No wetlands within corridor
Survey Type: <i>(check one)</i> <input checked="" type="checkbox"/> Centerline <input type="checkbox"/> Re-Route <input type="checkbox"/> Access Road <input type="checkbox"/> Other:			
Physical Attributes			
Stream Classification: <i>(check one)</i> <input type="checkbox"/> Ephemeral <input type="checkbox"/> Intermittent <input checked="" type="checkbox"/> Perennial			
Waterbody Type: <i>(check one)</i> <input checked="" type="checkbox"/> River <input type="checkbox"/> Stream <input type="checkbox"/> Ditch <input type="checkbox"/> Canal <input type="checkbox"/> Other:

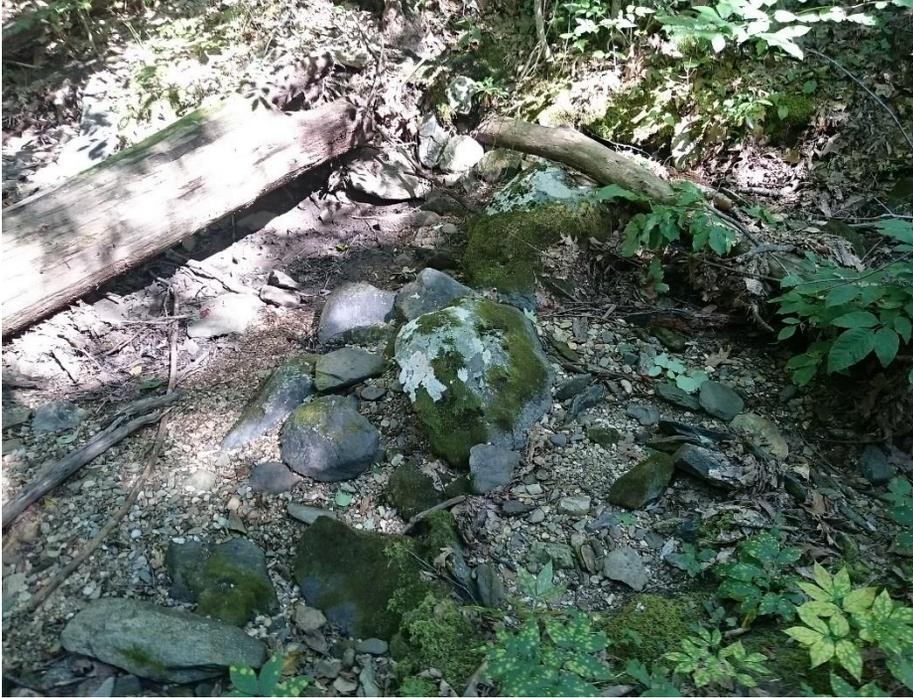
Waterbody SAUA433 facing northeast across

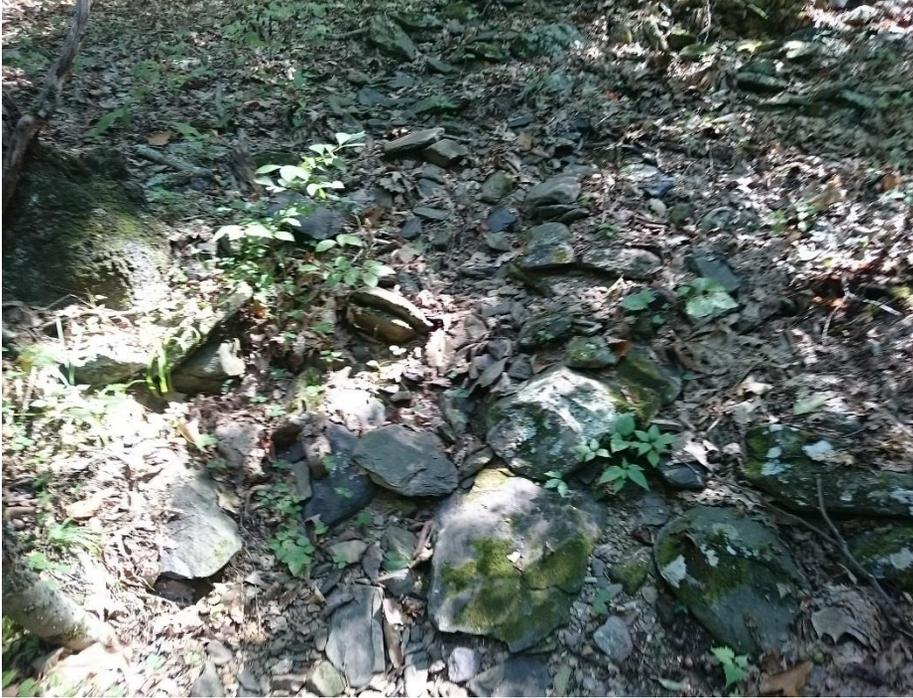
Waterbody SAUA432 facing east upstream

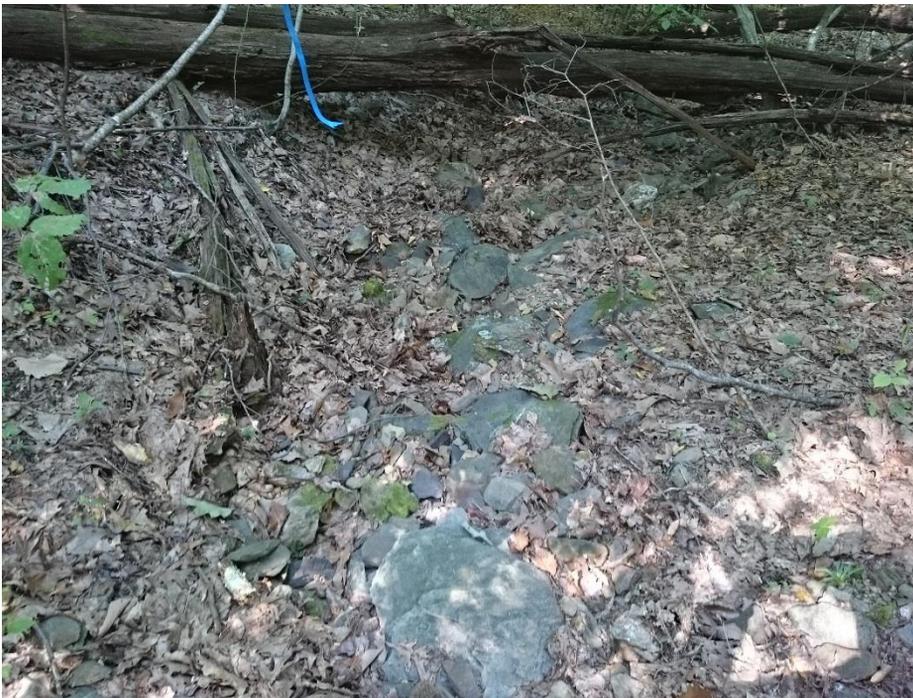
Waterbody SAUA432 facing west downstream

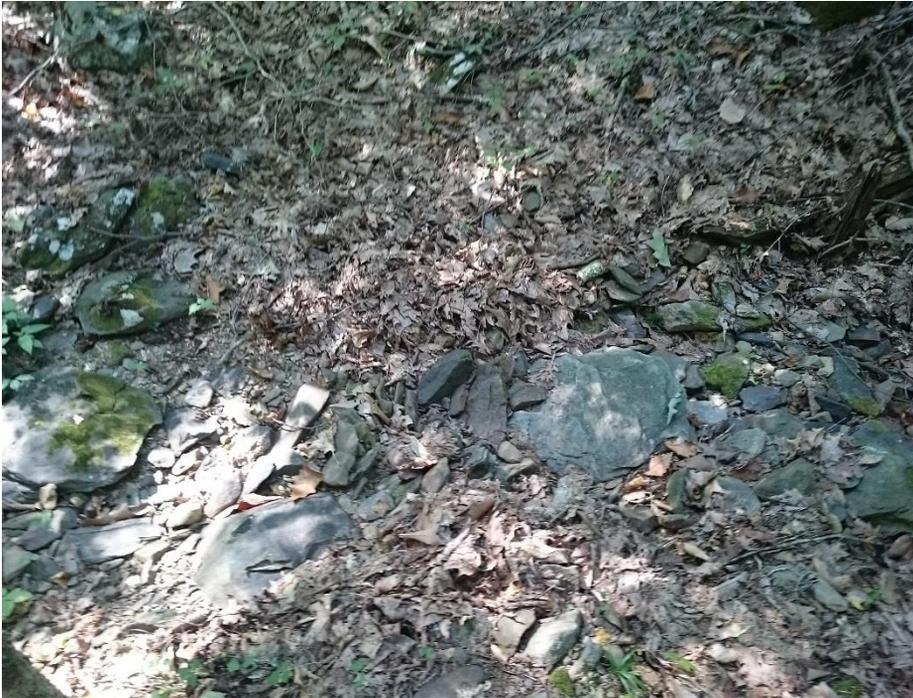
Waterbody SAUA432 facing south across

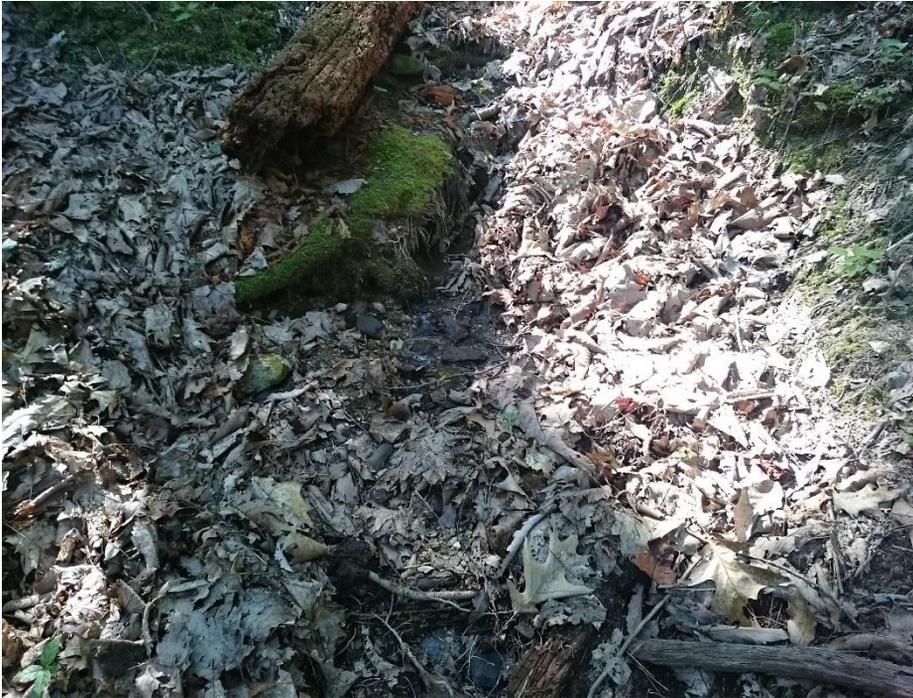
Waterbody SAUA431 facing southeast upstream

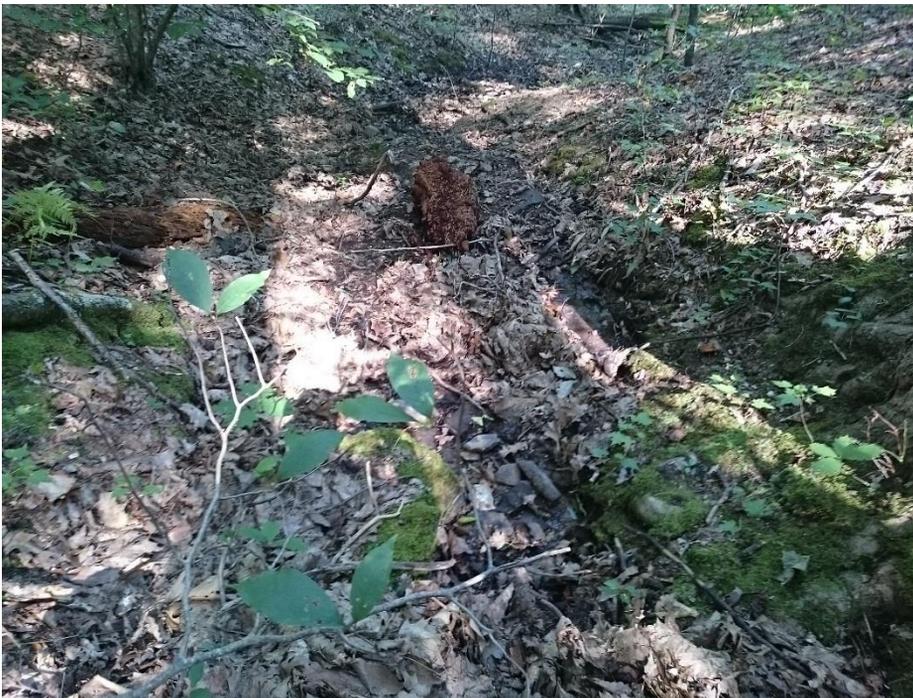
Waterbody SAUA431 facing northwest downstream

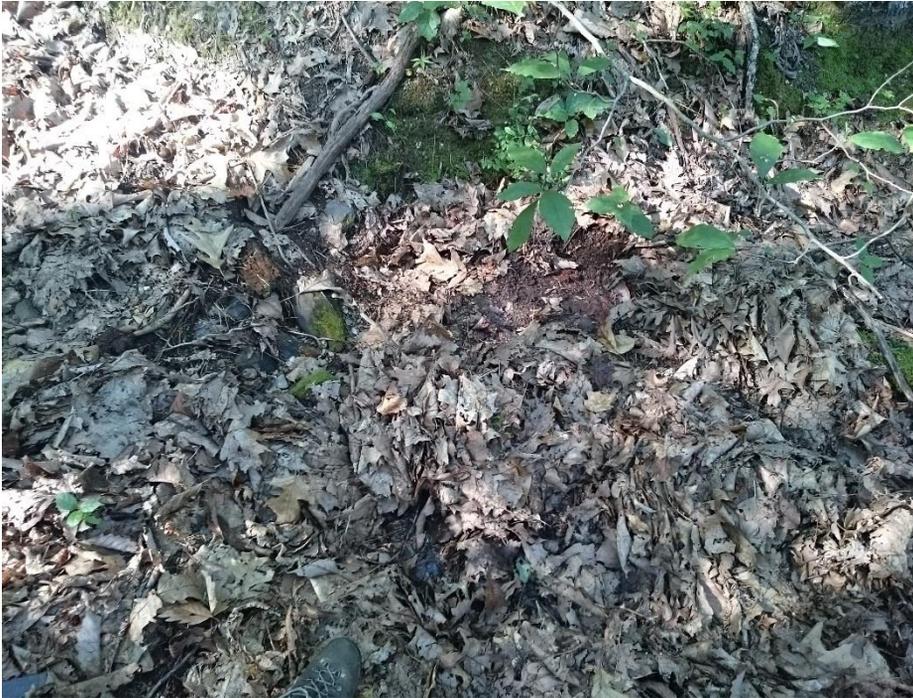
Waterbody SAUA431 facing southwest across

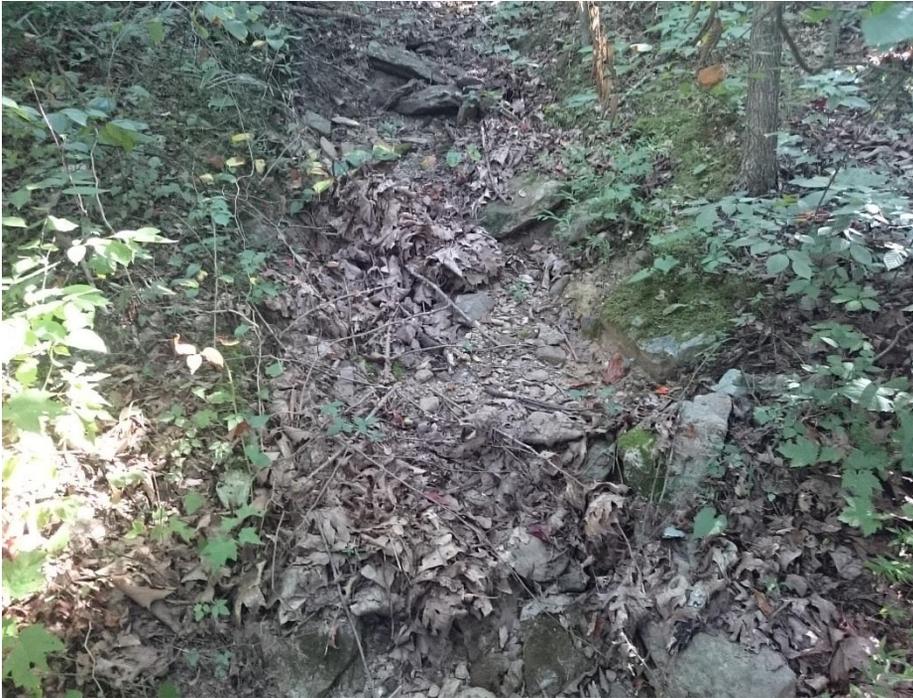
Waterbody SAUA430 facing east upstream

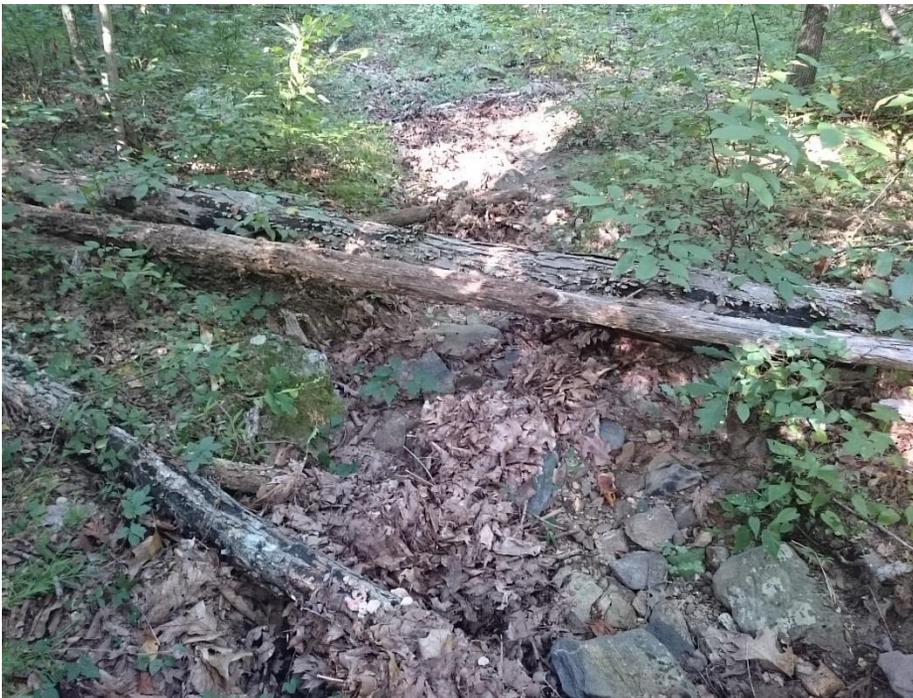
Waterbody SAUA430 facing west downstream

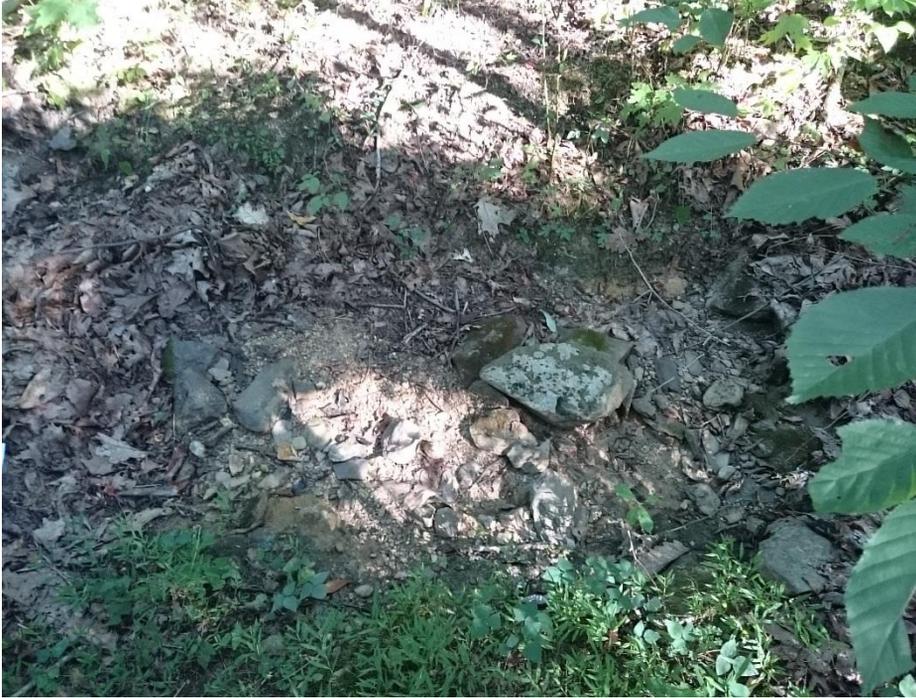
Waterbody SAUA430 facing north across

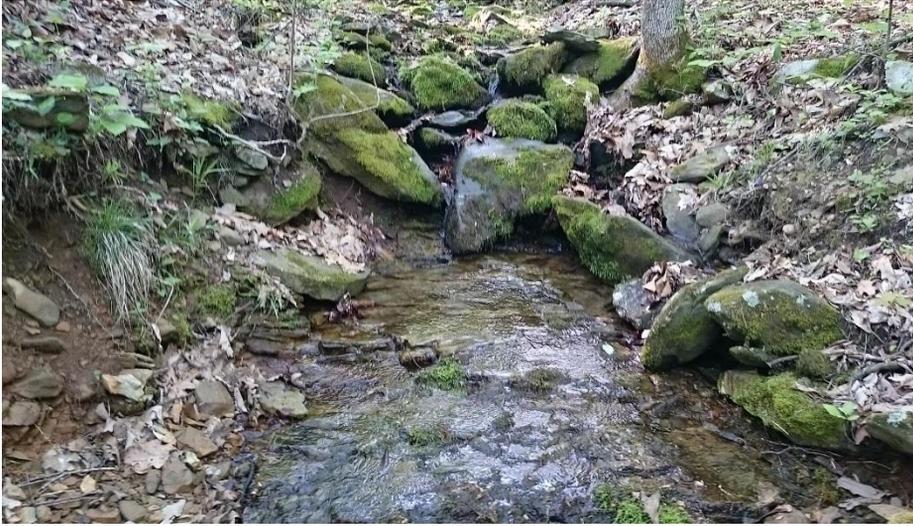
Waterbody SAUA064 facing south-southeast upstream

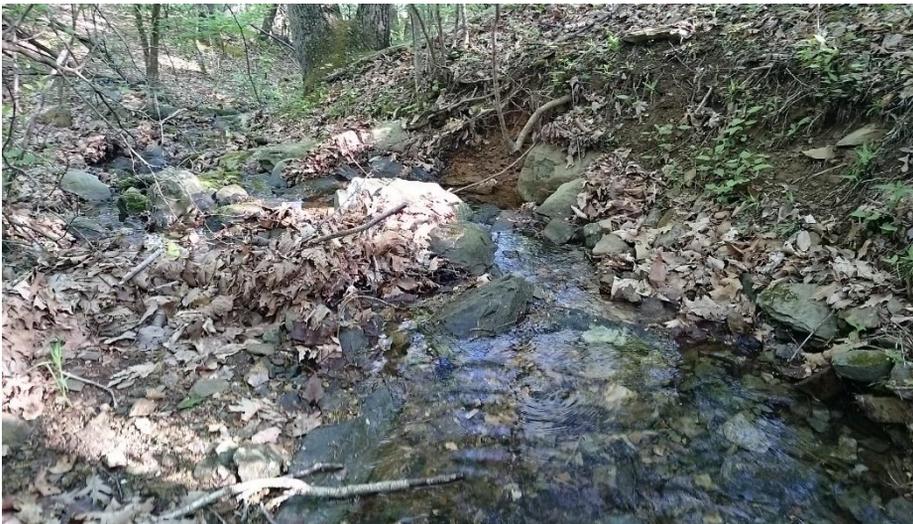
Waterbody SAUA064 facing north-northwest downstream

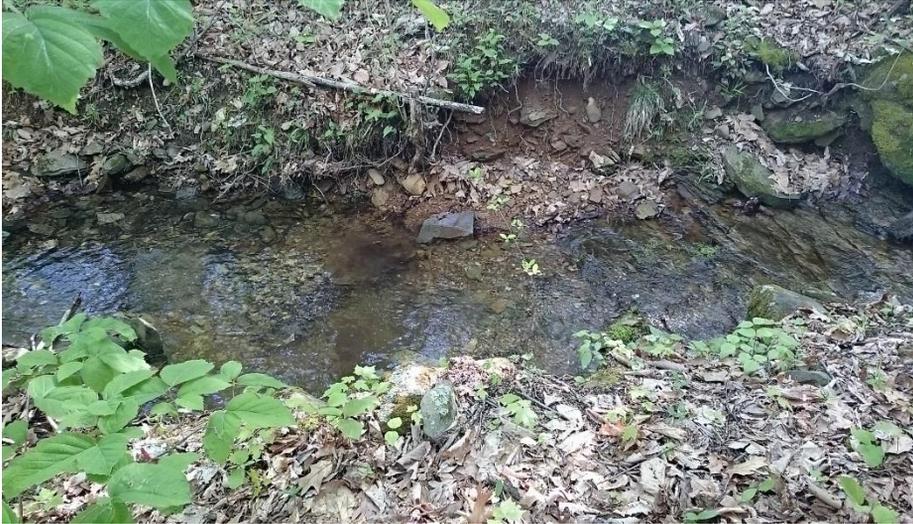
Waterbody SAUA064 facing east-northeast across

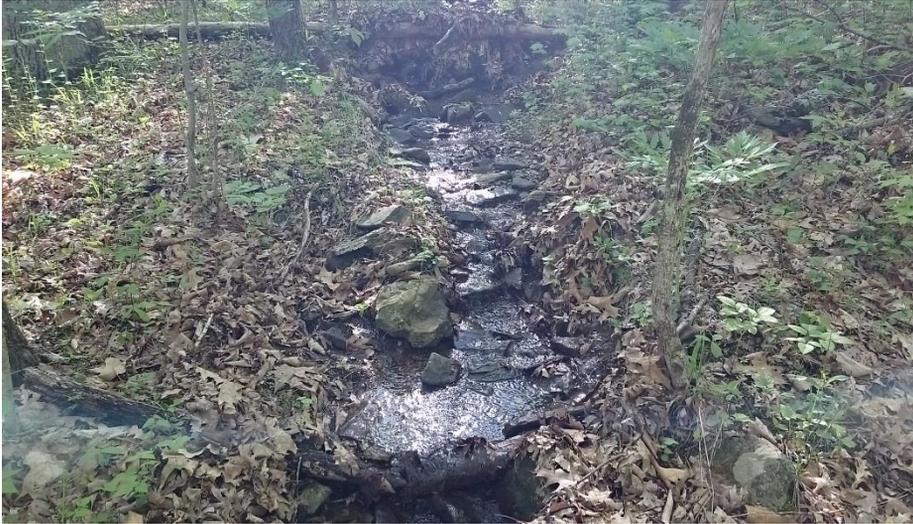
Waterbody SAUA065 facing east upstream

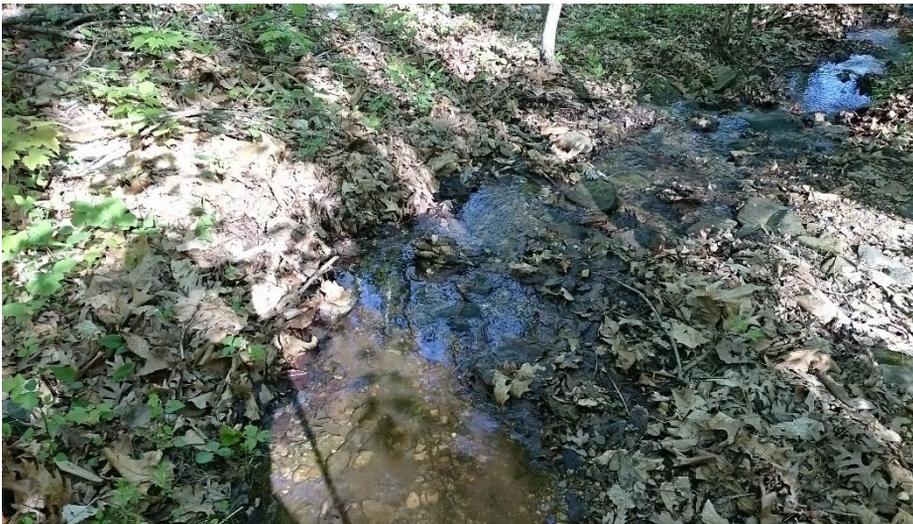
Waterbody SAUA065 facing west downstream

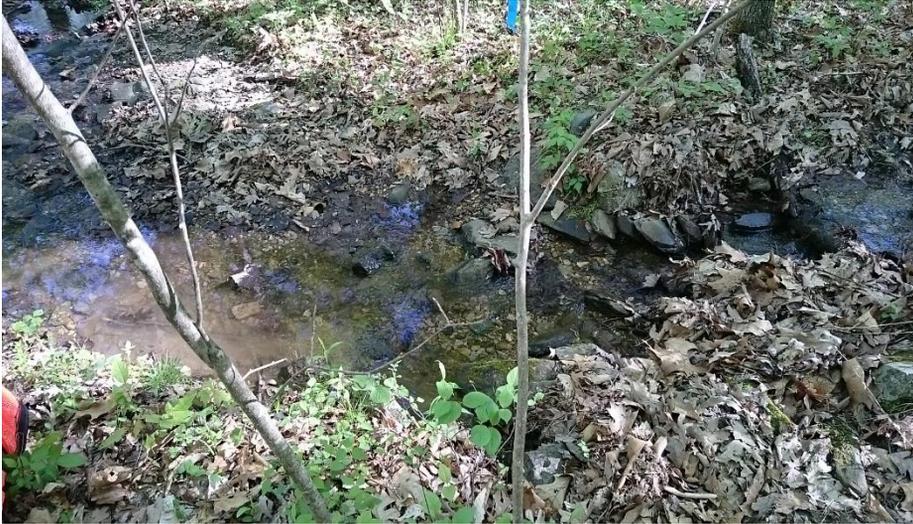
Waterbody SAUA065 facing north across

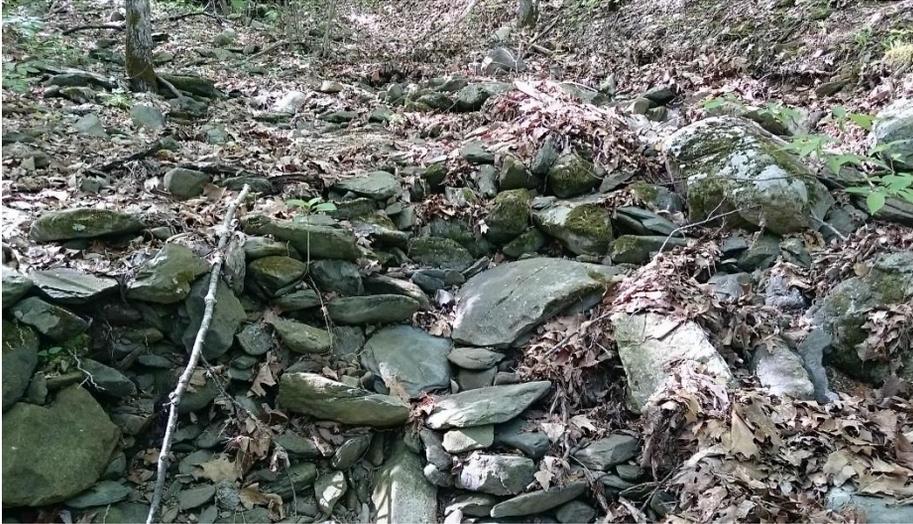
Waterbody SAUA066 facing south upstream

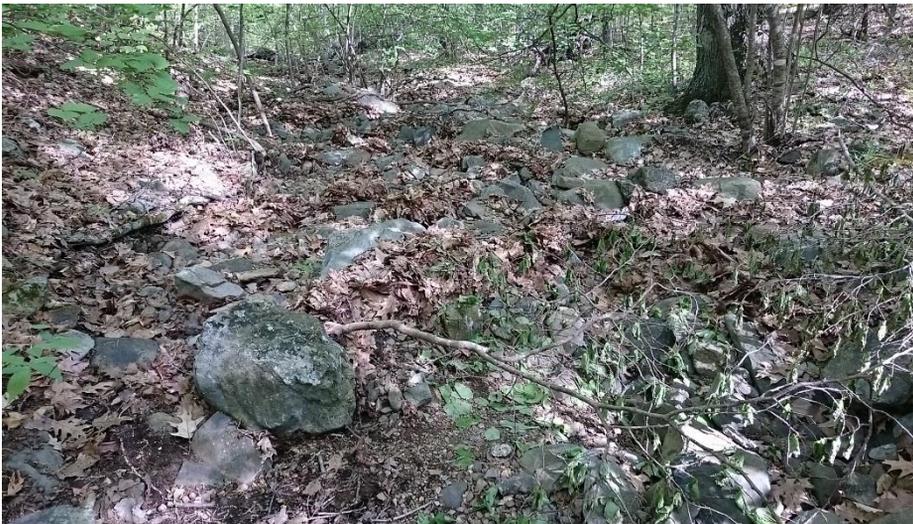
Waterbody SAUA066 facing north-northwest downstream

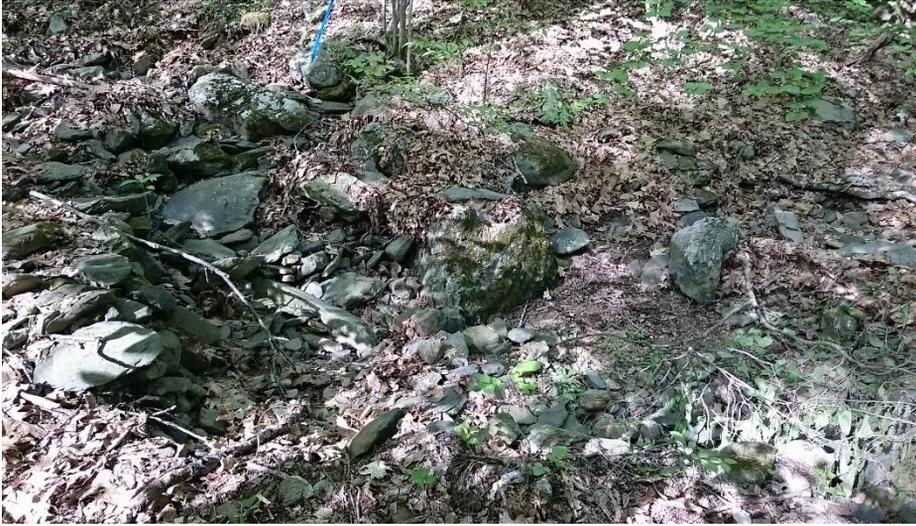
Waterbody SAUA066 facing west across
