# Linear Waterbody Data Sheet

Survey Description			
Project Name: Southeast Reliability		Waterbody Name: UNNAMED TRIB TO NORTH RIVER	
Waterbody ID: SBUK005		Date: 7/18/2014	
State: Virginia	County: Buckingham	Company: WOODARD & CURRAN	Crew Member Initials: RS, JS
Photos: 0052-0054			
Tract Number(s): 09-045		Nearest Milepost: 191	Associated Wetland ID(s): NA
Survey Type: <i>(check one)</i> <input checked="" type="checkbox"/> Centerline <input type="checkbox"/> Re-Route <input type="checkbox"/> Access Road <input type="checkbox"/> Other:			
Physical Attribute			
Stream Classification: <i>(check one)</i> <input type="checkbox"/> Ephemeral <input type="checkbox"/> Intermittent <input checked="" type="checkbox"/> Perennial			
Waterbody Type: <i>(check one)</i> <input type="checkbox"/> River <input checked="" type="checkbox"/> Stream <input type="checkbox"/> Ditch <input type="checkbox"/> Canal <input type="checkbox"/> Other:			
OHWM Width: <u>10</u> ft.		OHWM Indicator: <i>(check all that apply)</i> <input checked="" type="checkbox"/> Clear line on bank <input checked="" type="checkbox"/> Shelving <input checked="" type="checkbox"/> Wrested vegetation <input checked="" type="checkbox"

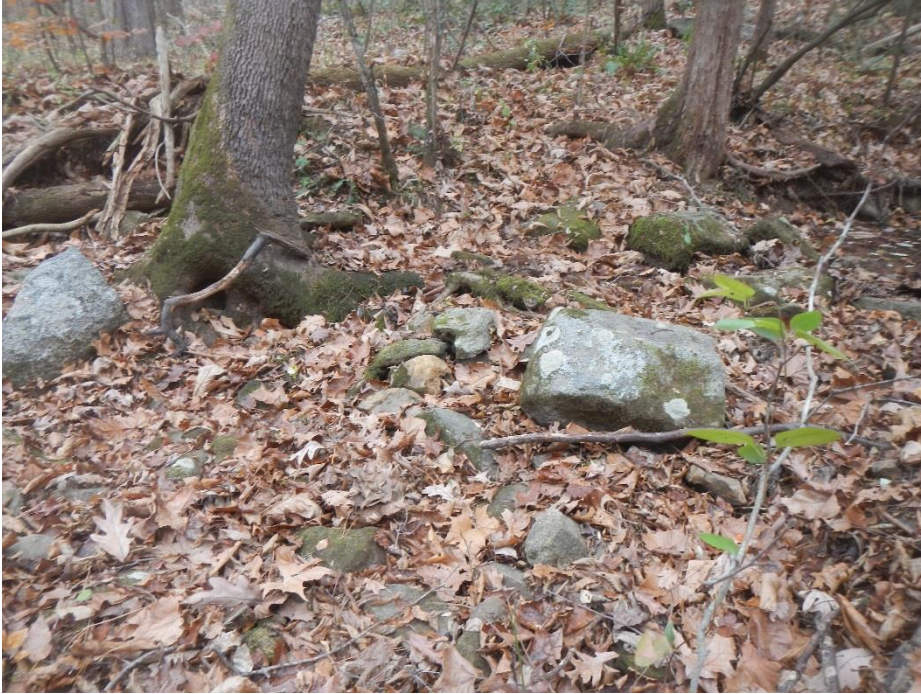
Stream SBUC007 facing southeast across

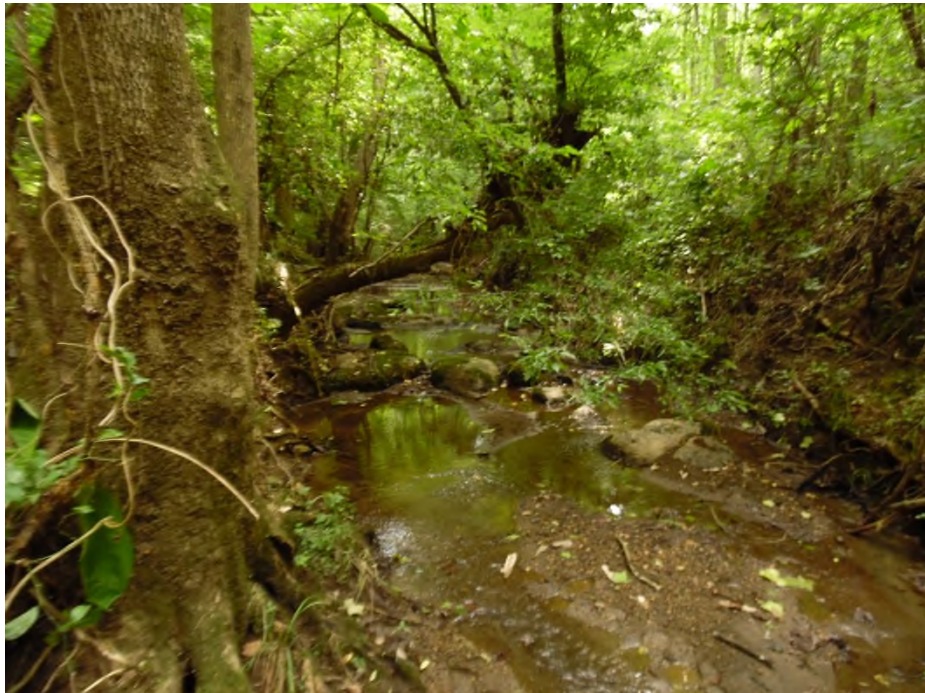
Waterbody point sbuk005 facing southwest and upstream

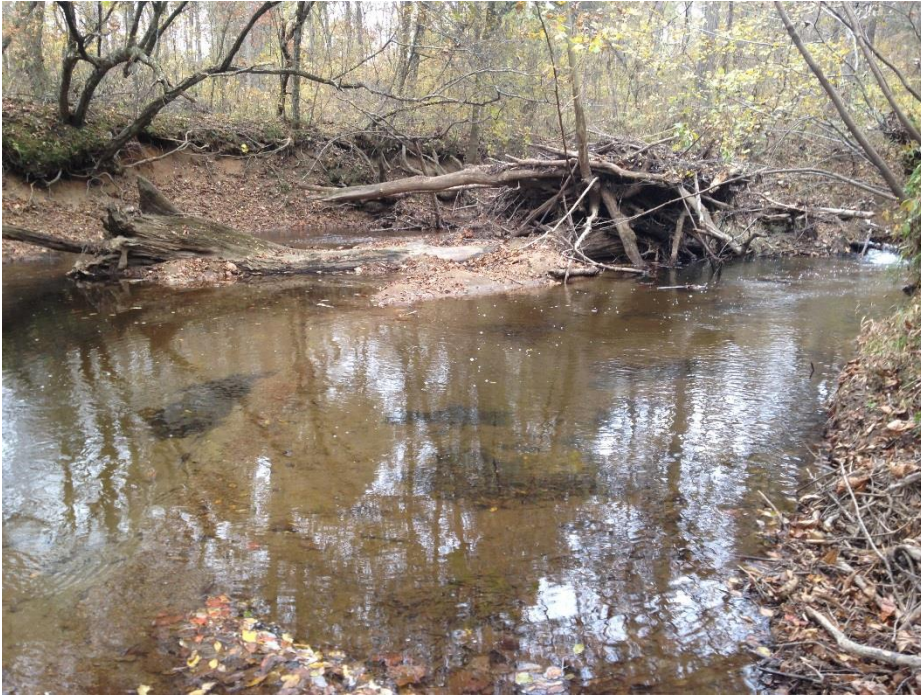
Waterbody SBUC105 facing southwest upstream

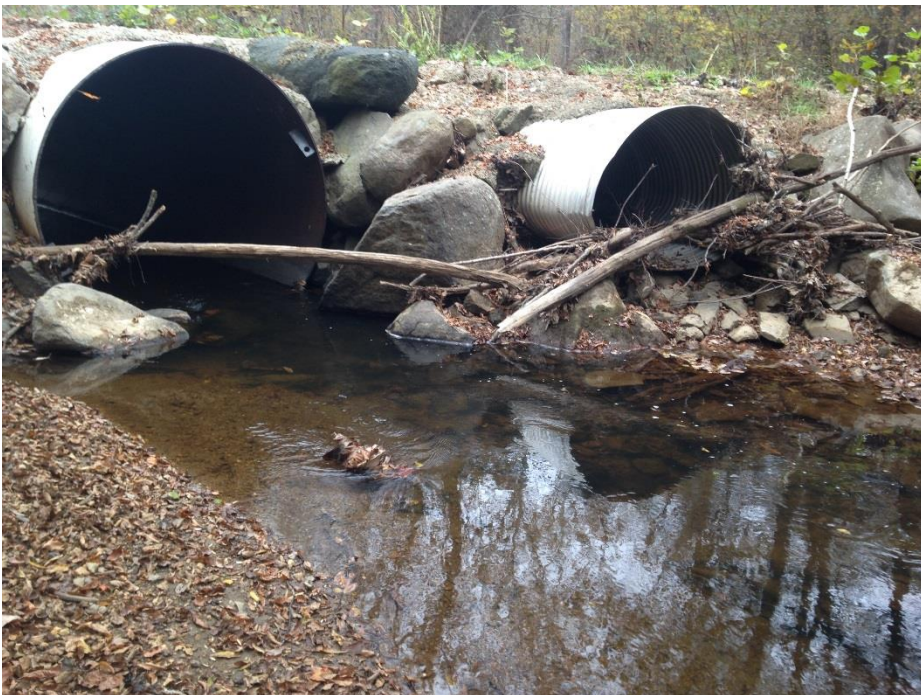
Waterbody SBUC105 facing northeast downstream

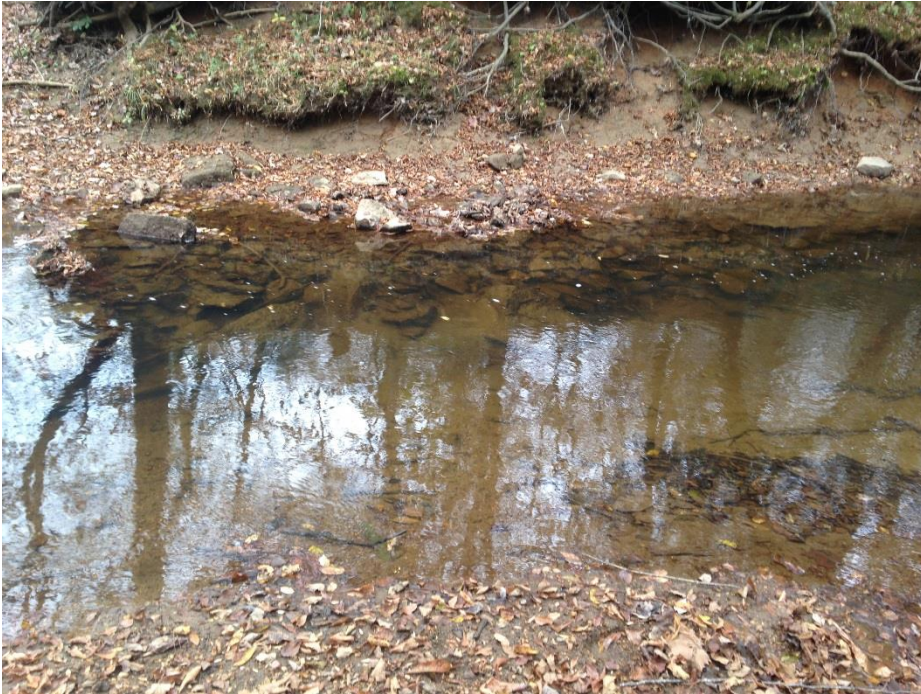
Waterbody SBUC105 facing northwest across

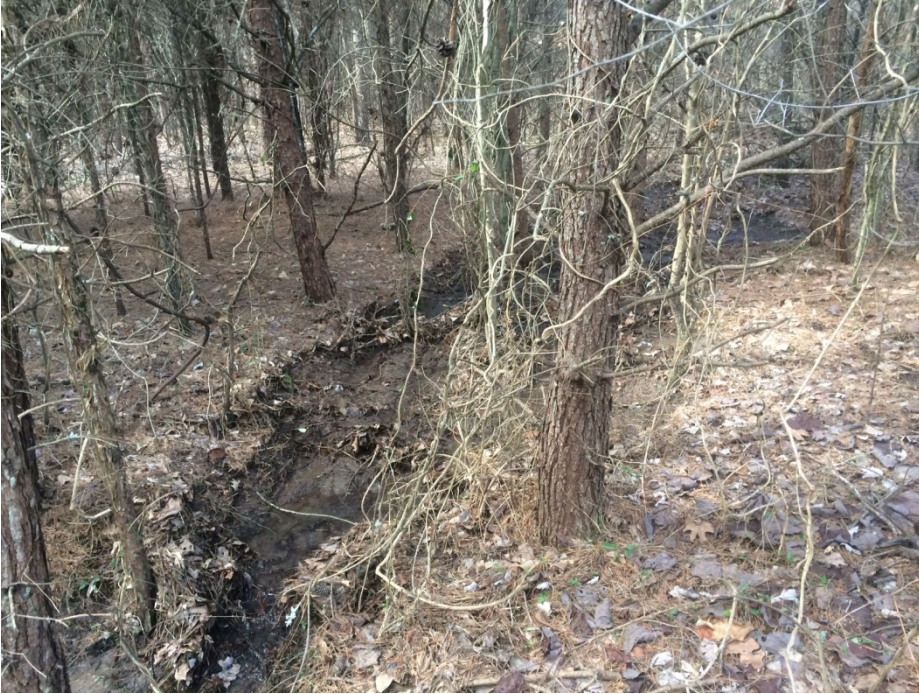
SBUE002 facing west upstream

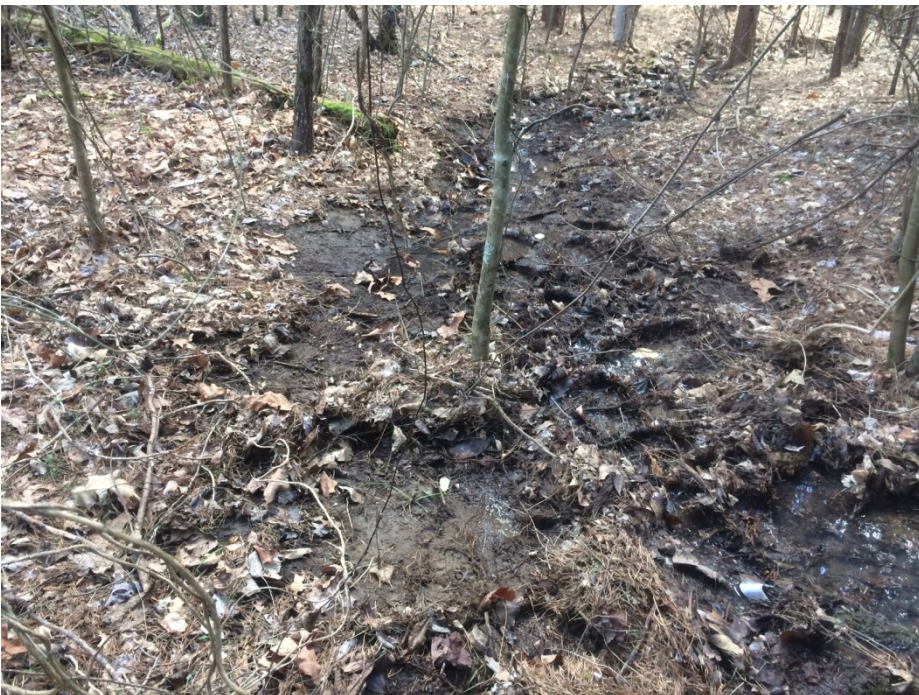
SBUE002 facing east downstream

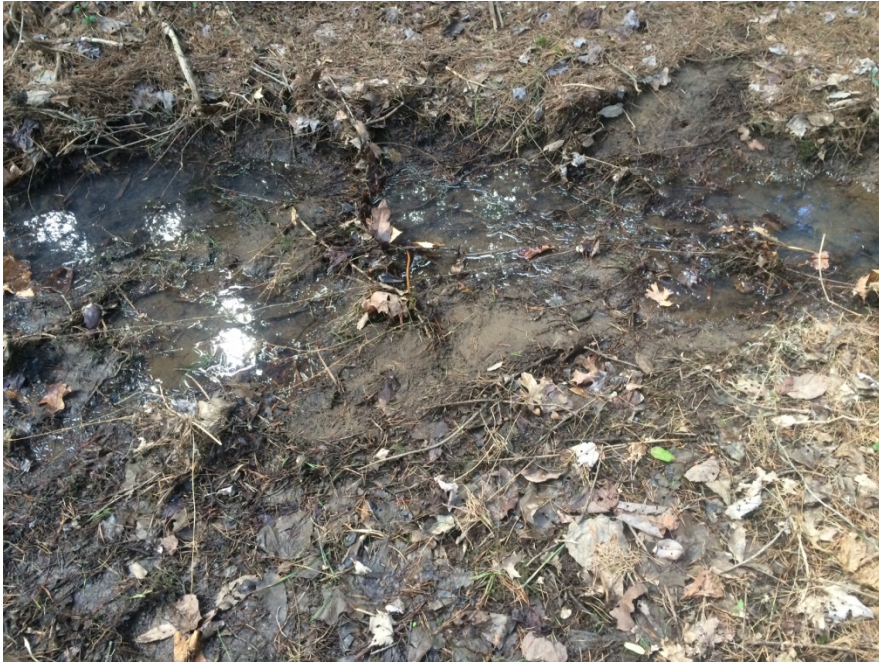
SBUE002 facing south across

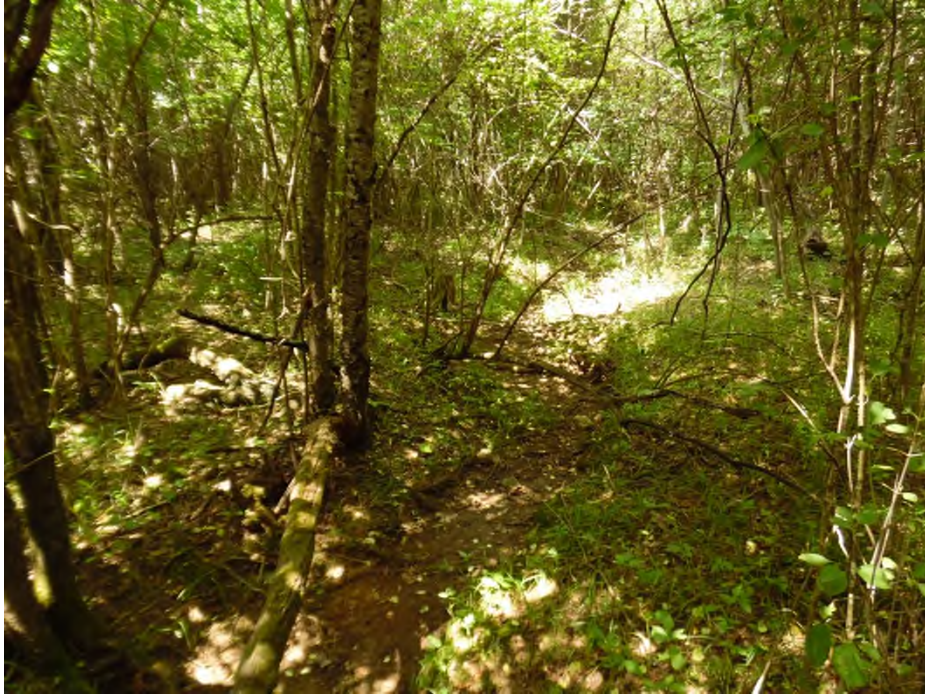
Waterbody point sbuk004 facing north and downstream

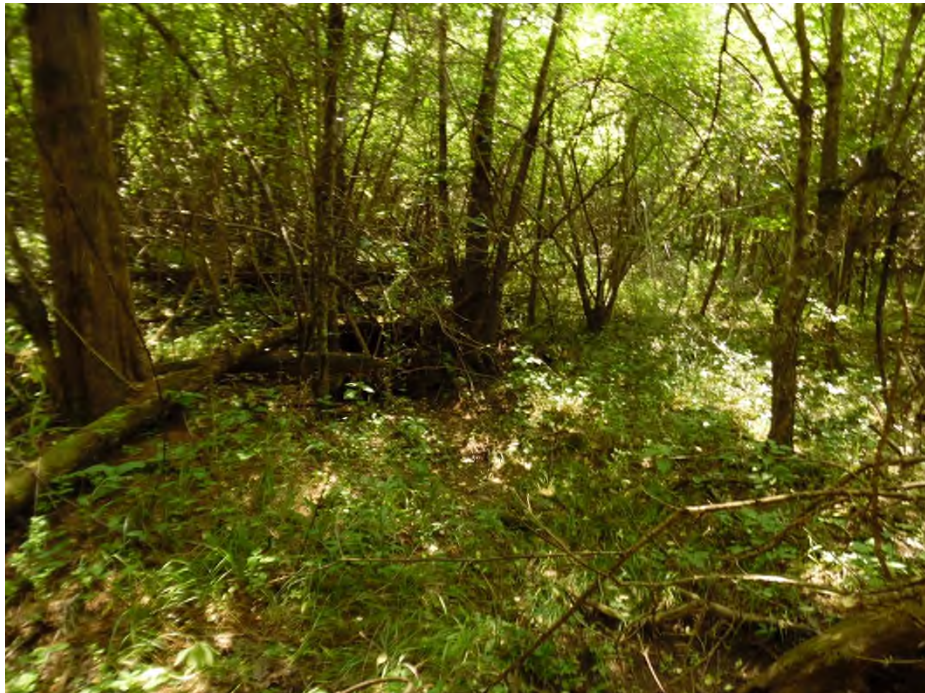
Waterbody point sbuk004 facing south and upstream

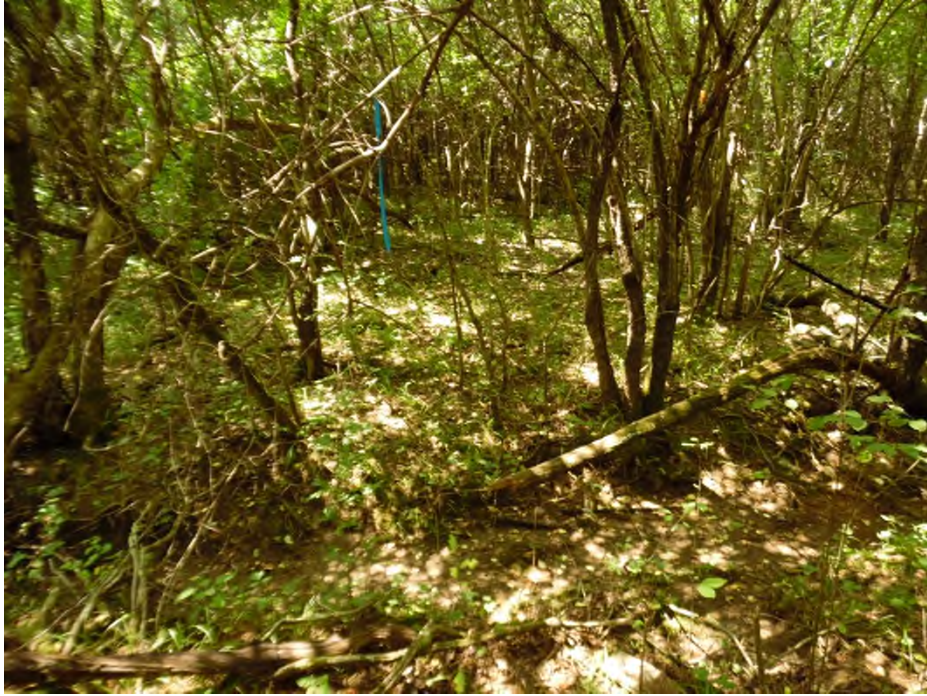
Waterbody point sbuk004 facing west and across

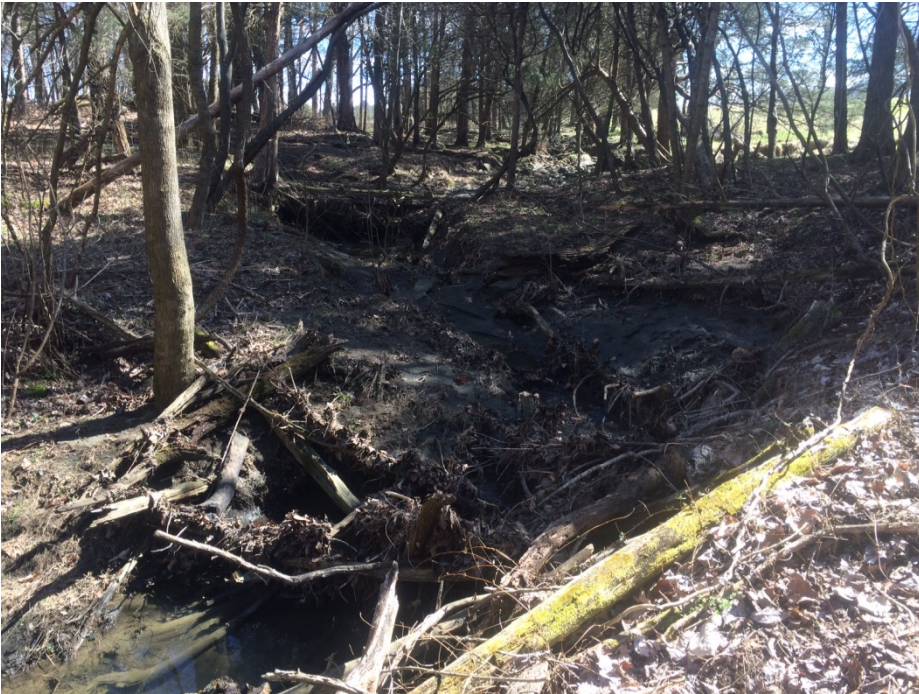
SBUE003 facing south upstream

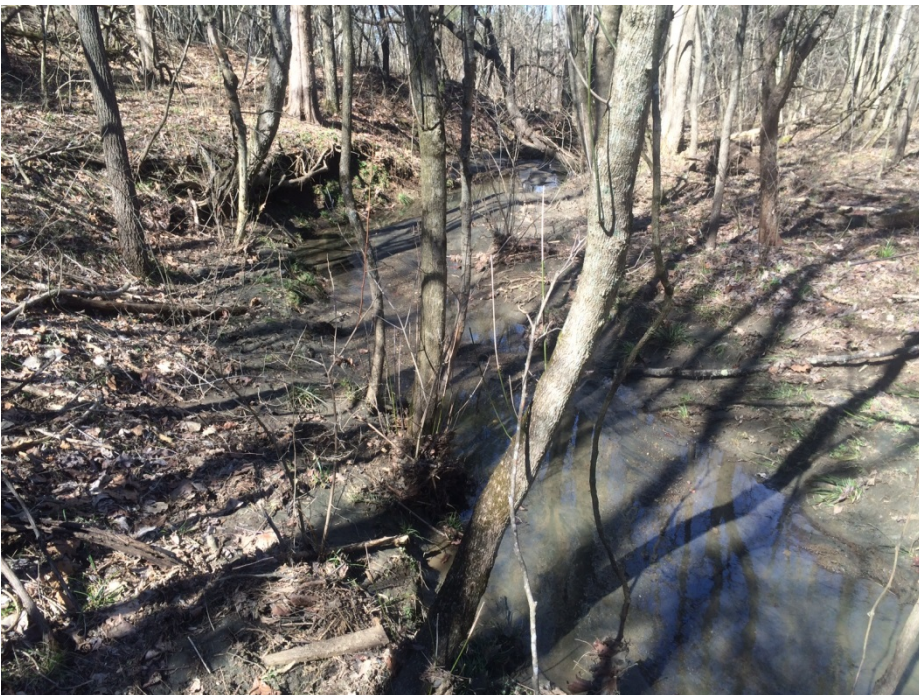
SBUE003 facing north downstream

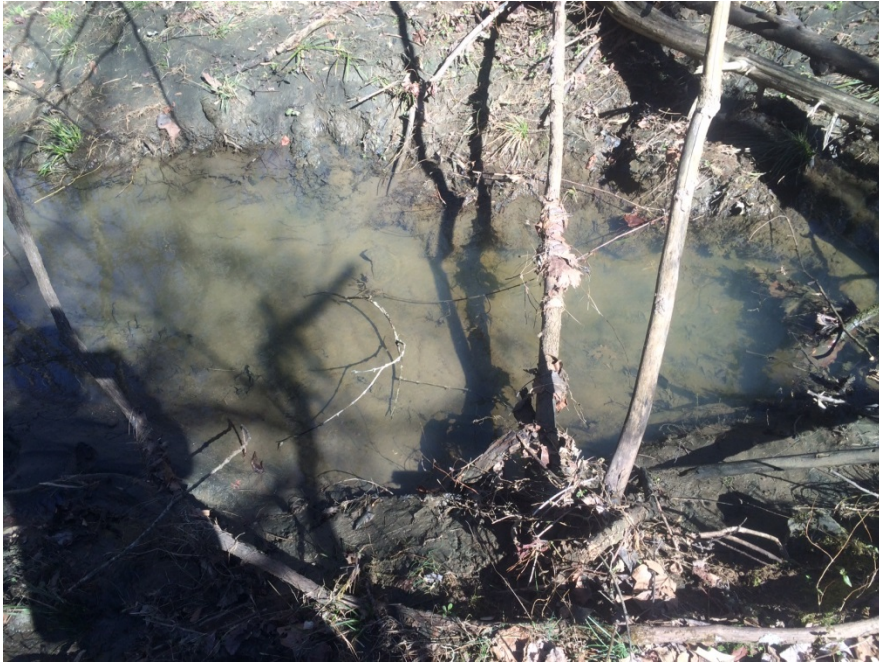
SBUE003 facing east across

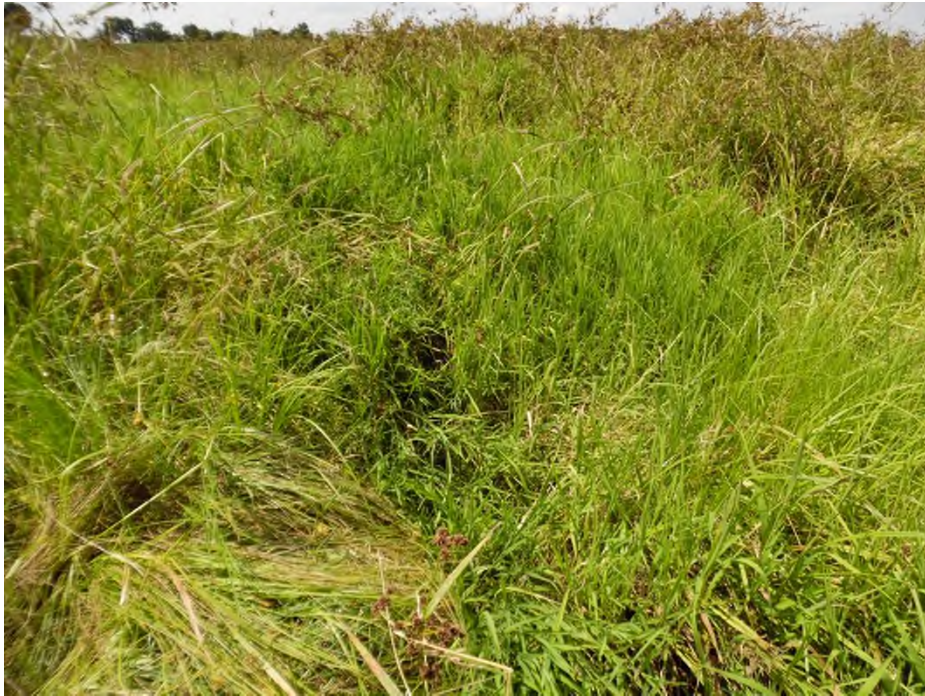
Waterbody point sbuk003 facing south and upstream

INCISED STREAM WITHIN PASTURE DEGRADED BY CATTLE. POOLS PRESENT WITH SLIGHT FLOW. SPRING FED.

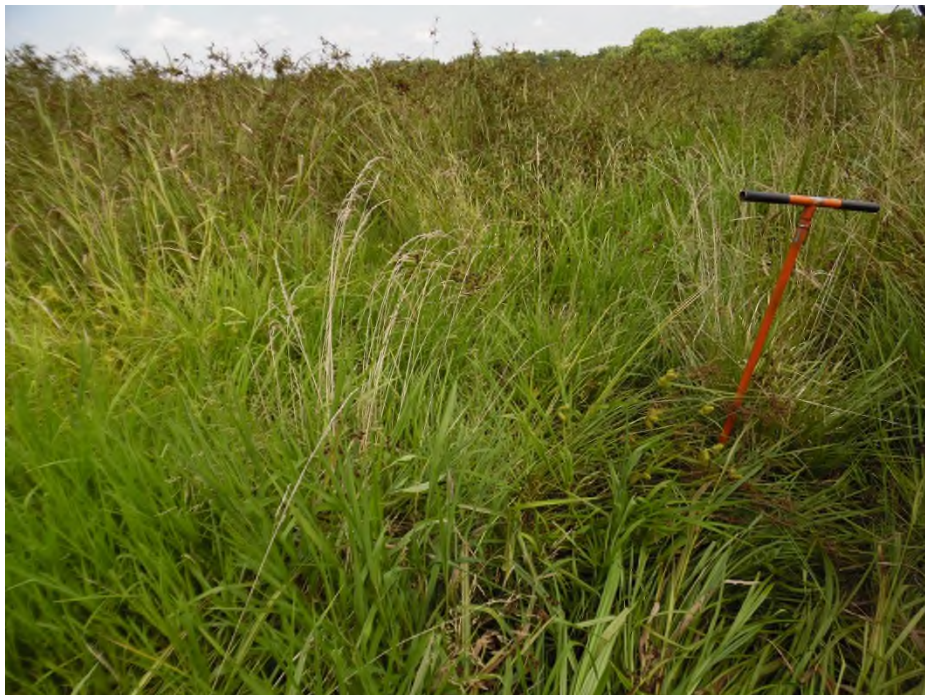
Waterbody point sbuk003 facing northwest and downstream

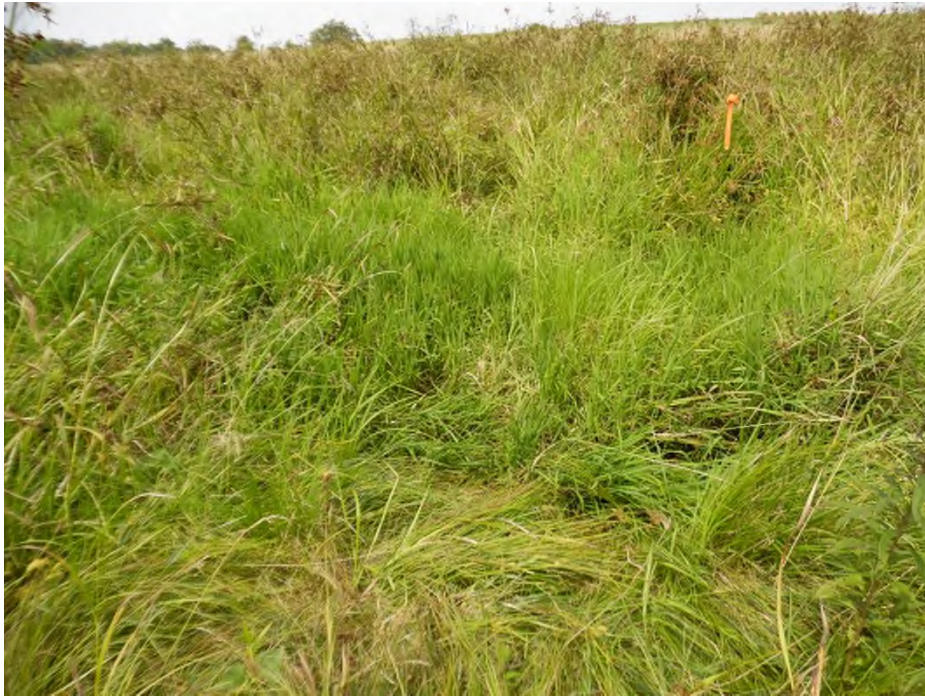
Waterbody point sbuk003 facing west and across

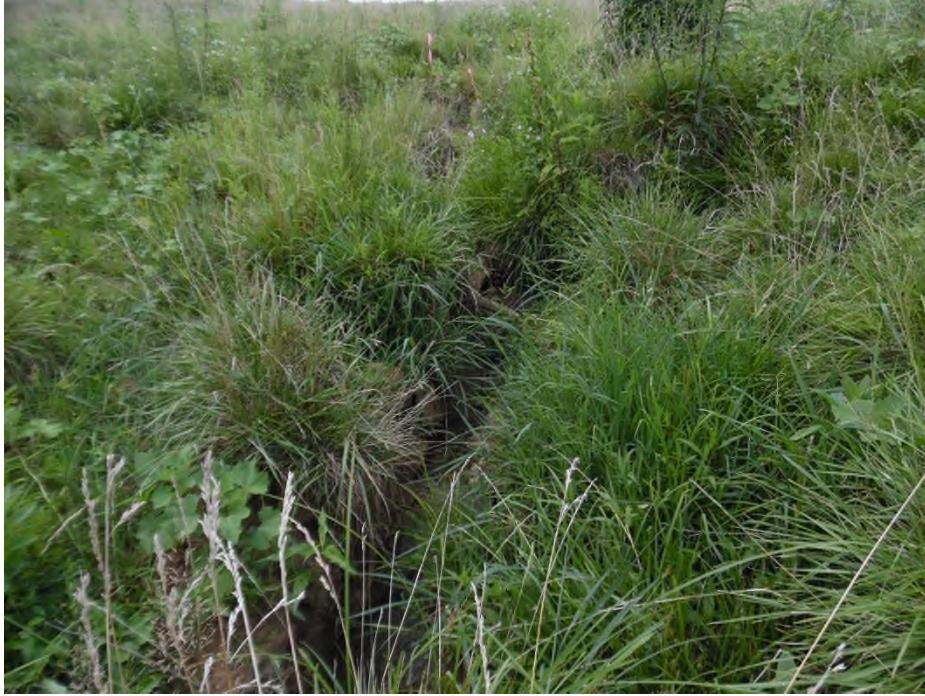
Waterbody point sbuk002 facing west and upstream

INCISED STREAM WITHIN PASTURE DEGRADED BY CATTLE. NO FLOW AT TIME OF SURVEY. POOLS PRESENT

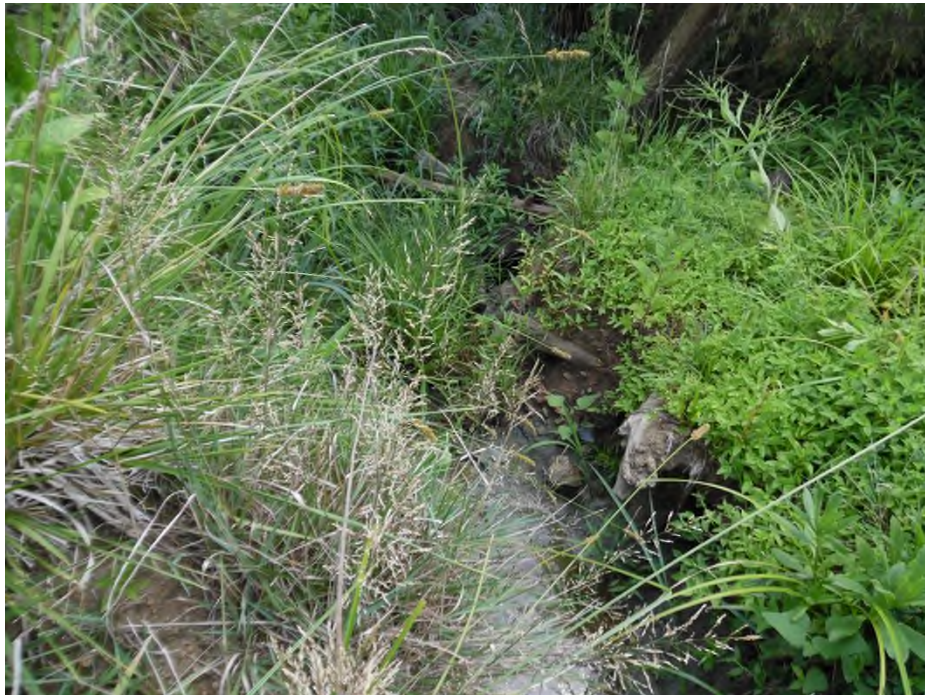
Waterbody point sbuk002 facing east and downstream

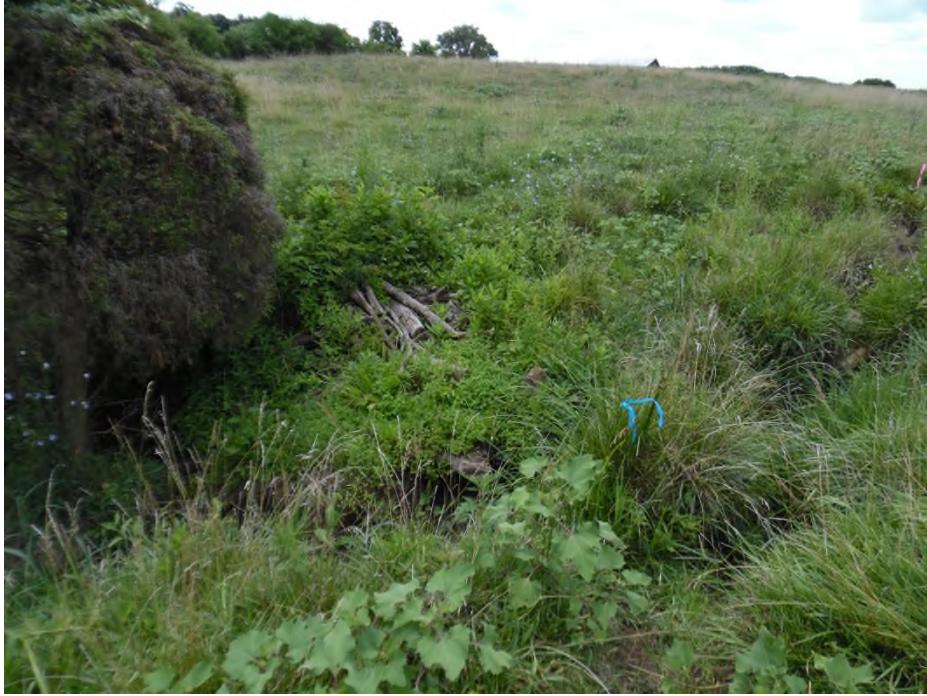
Waterbody point sbuk002 facing south and across

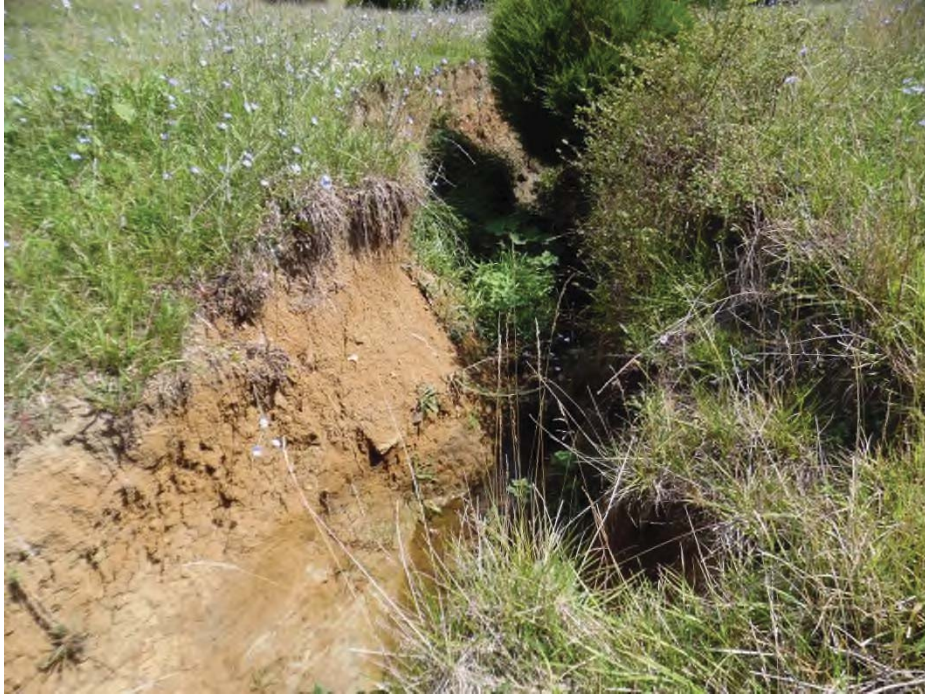
Waterbody point sbuk001 facing northeast and downstream

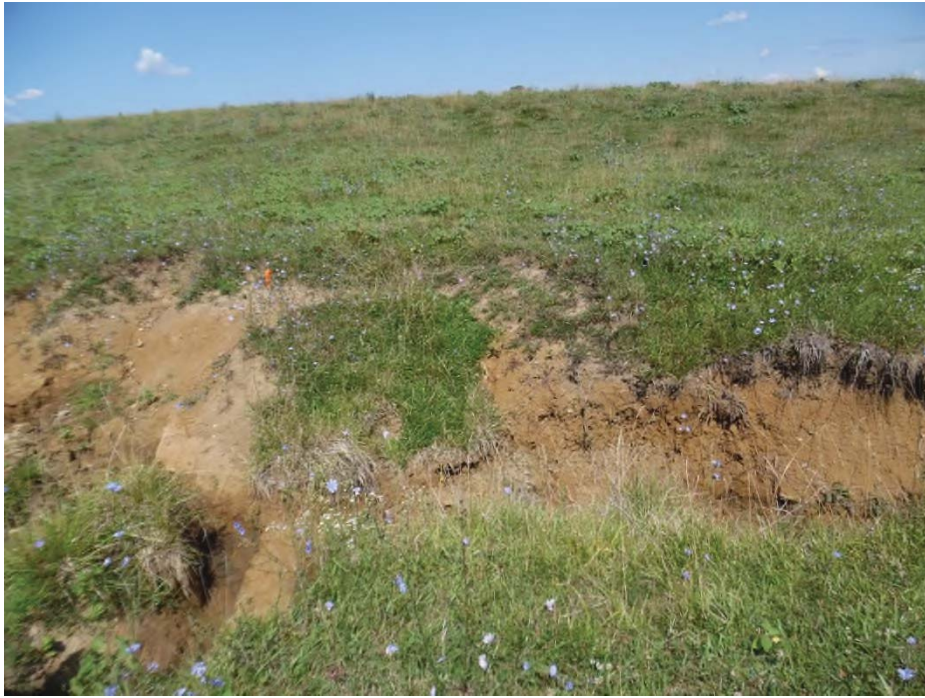
Waterbody point sbuk001 facing west and across

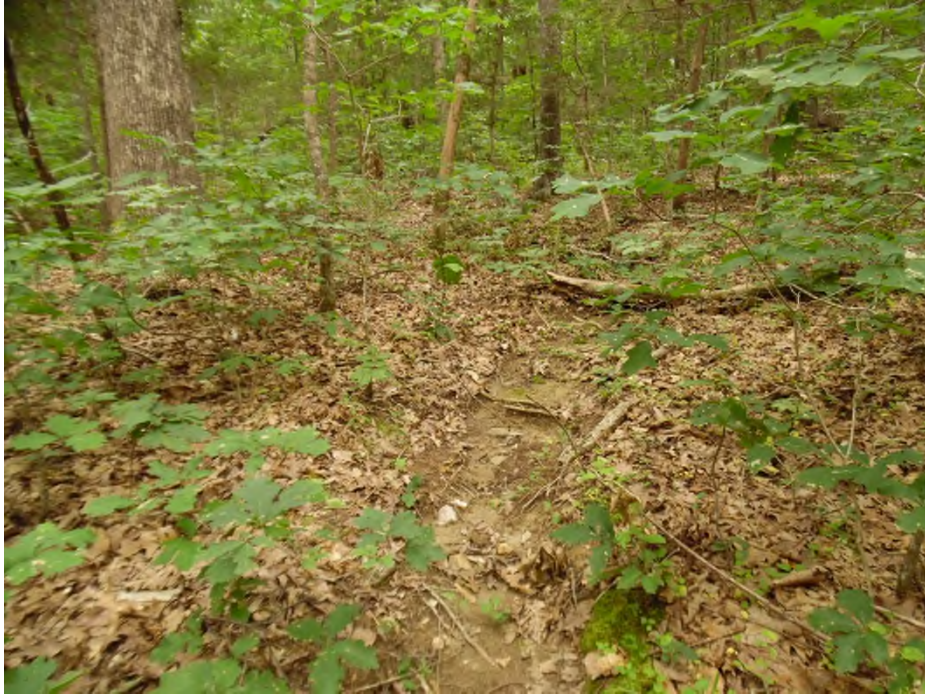
Waterbody point sbuk006 facing east and downstream

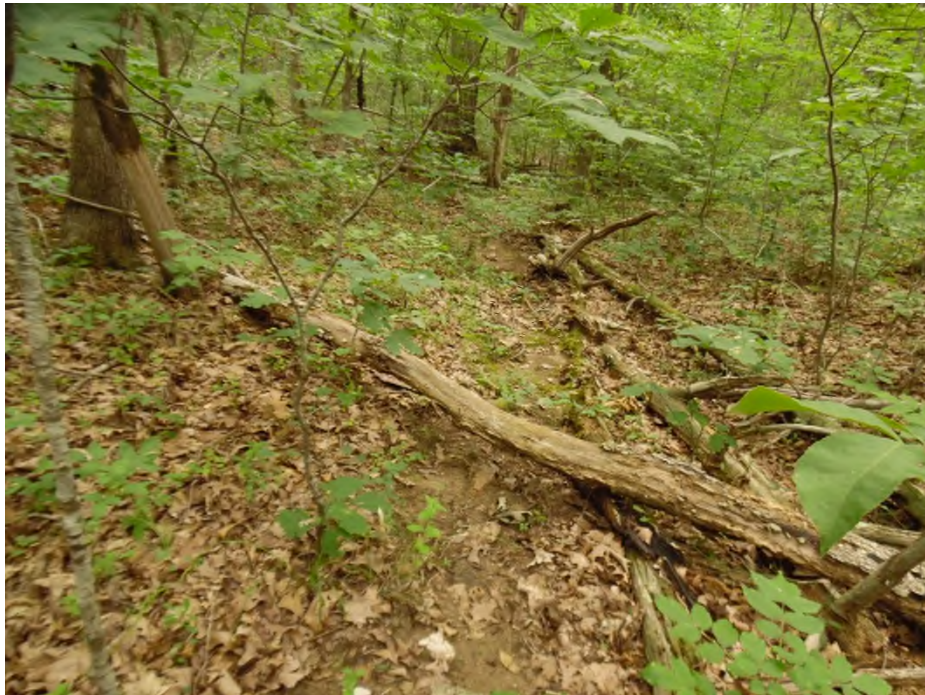
Waterbody point sbuk006 facing west and upstream

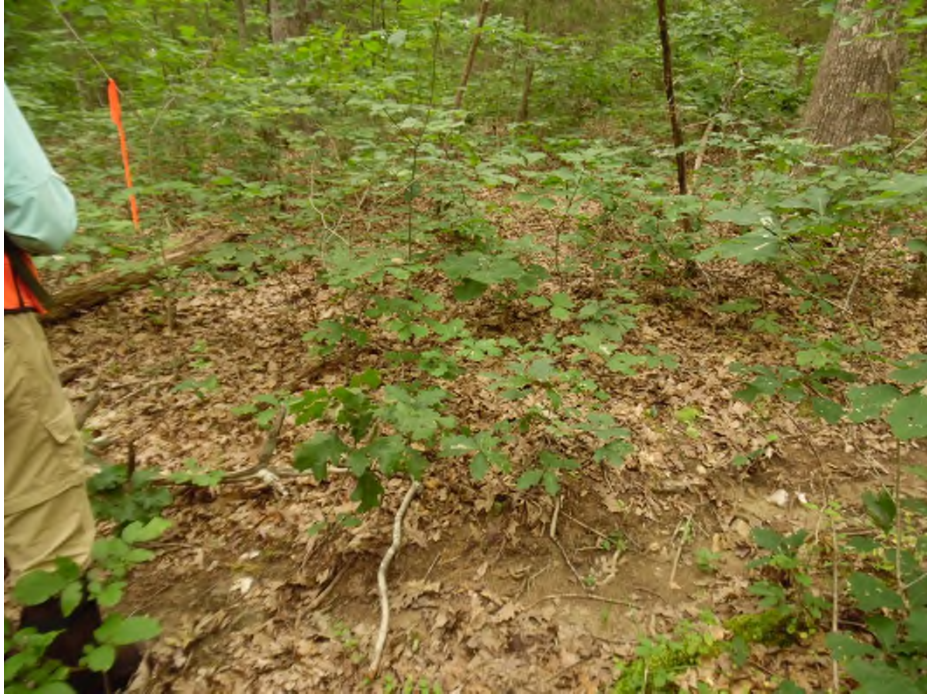
Waterbody point sbuk006 facing south and across

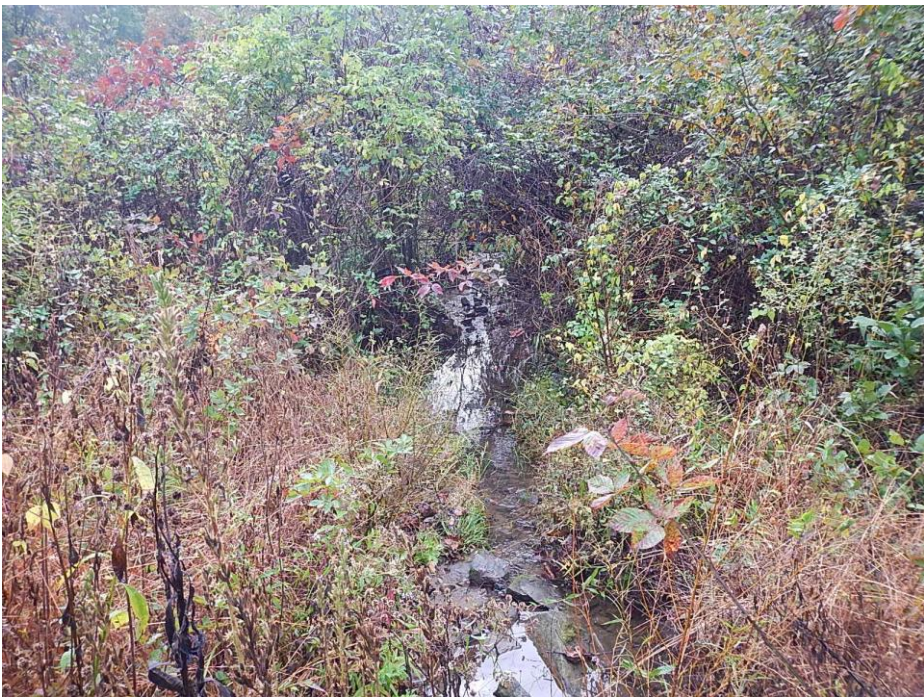
SBUA004 facing south downstream

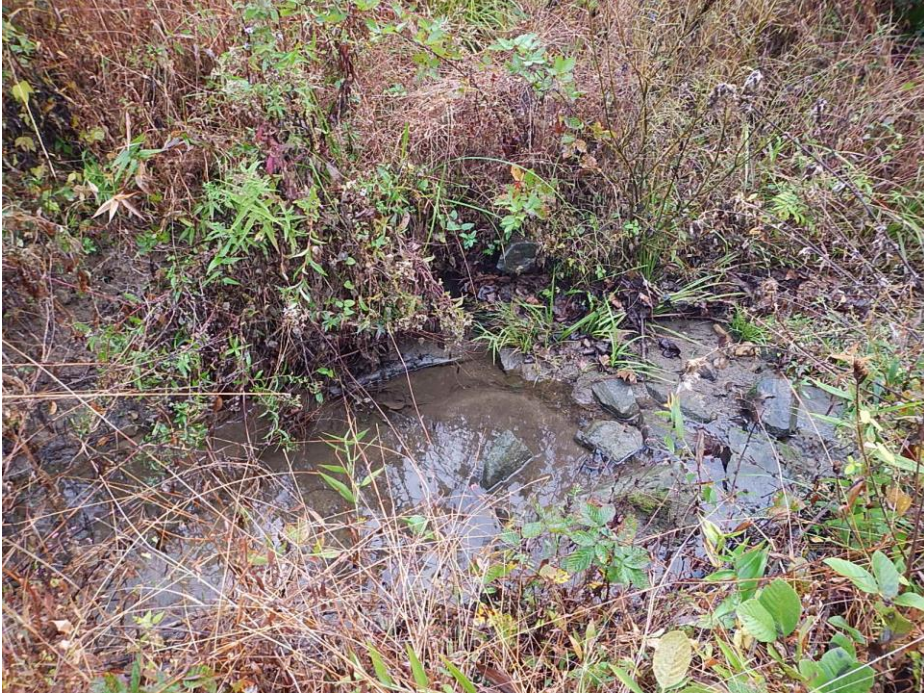
SBUA004 facing east across

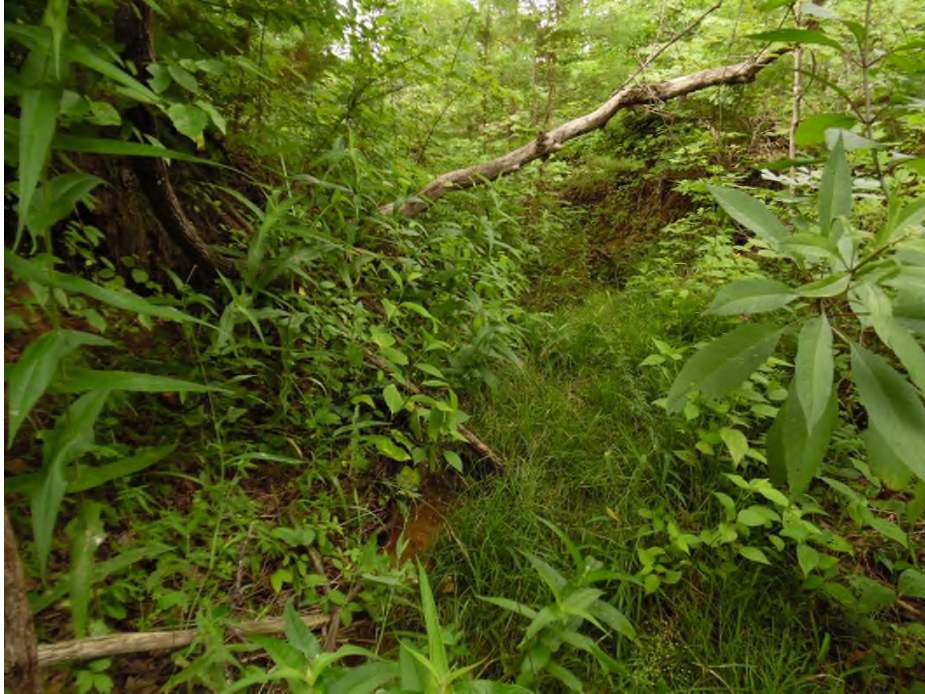
EPHEMERAL STREAM. SLASH PILES IN STREAM.

Waterbody point sbuk007a facing northeast and upstream

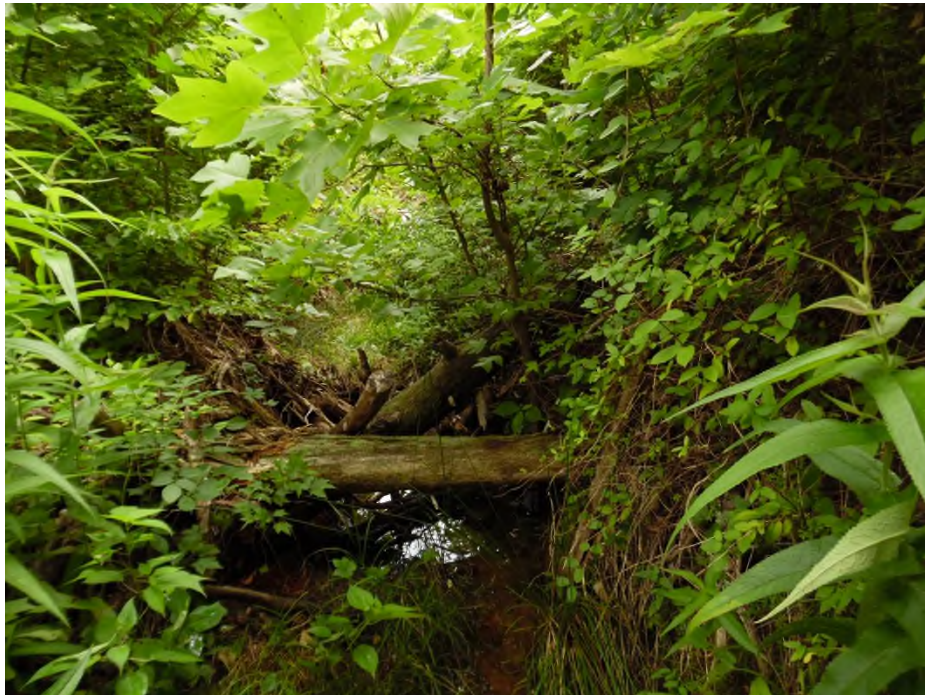
Waterbody point sbuk007a facing southwest and downstream
