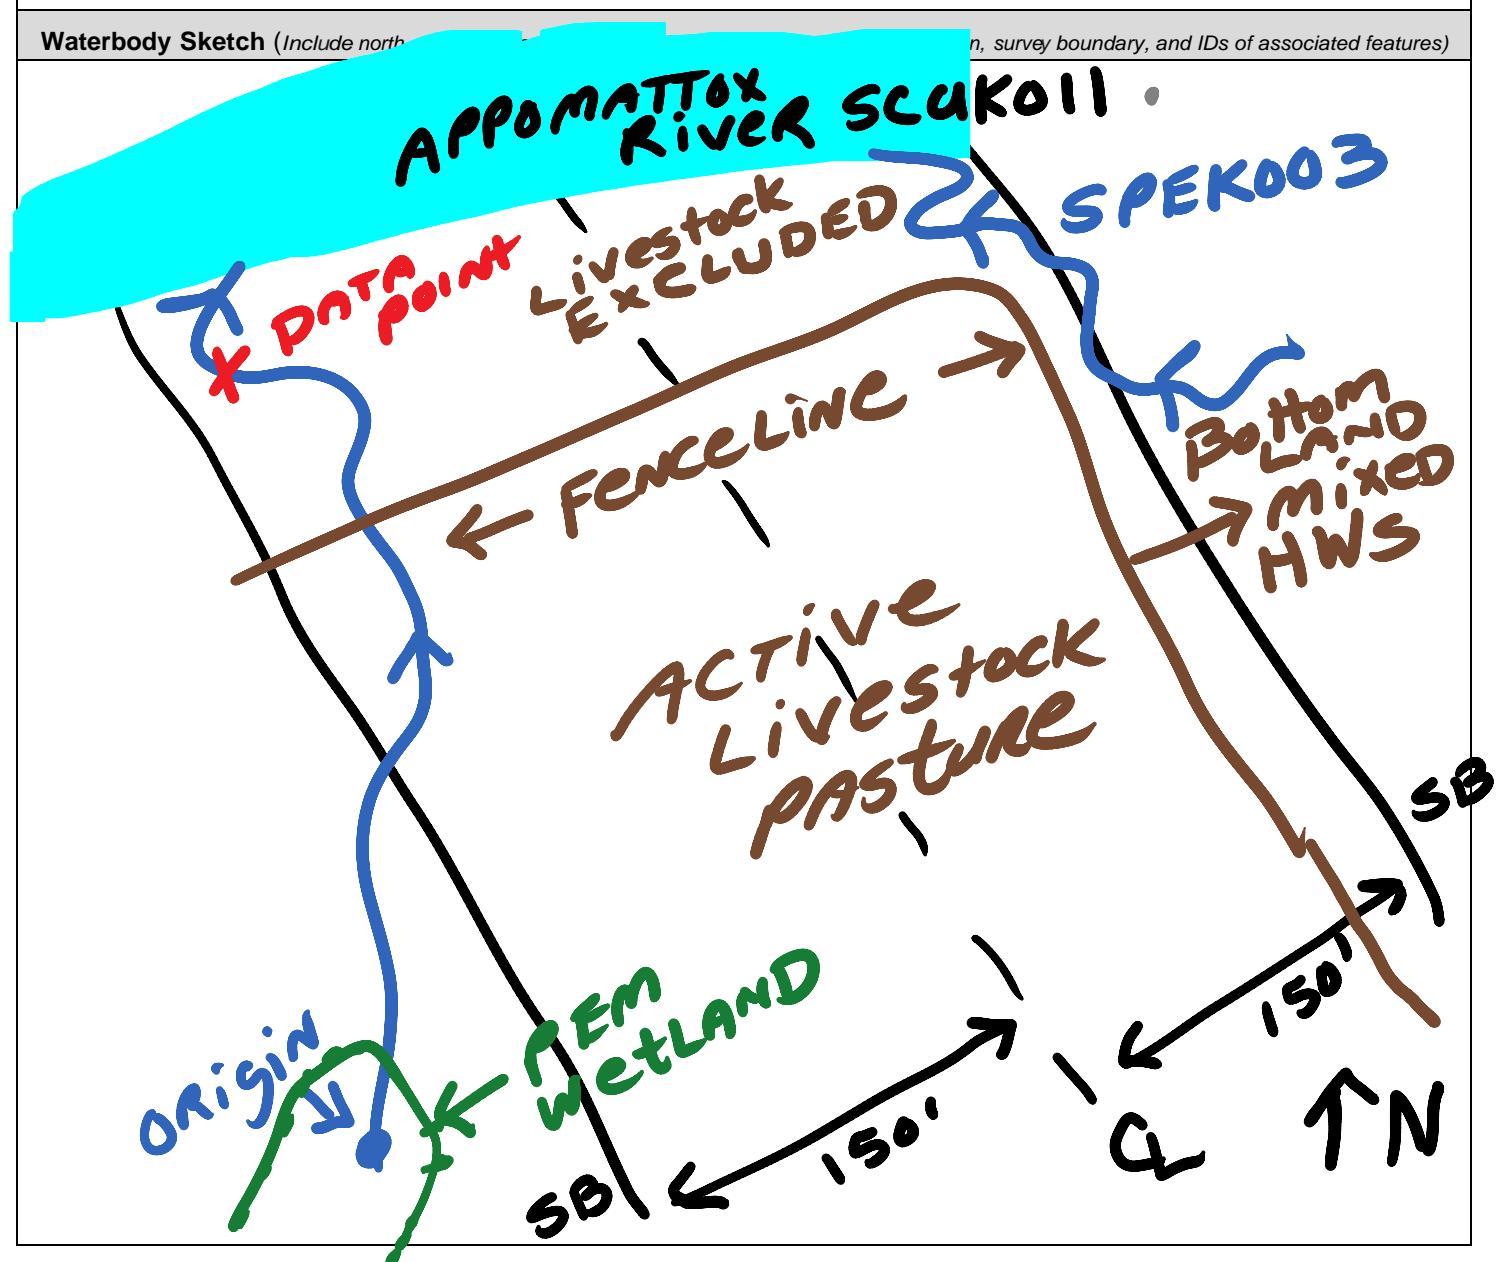
Stream begins within PEM wetland in an active livestock pasture outside of corridor; downstream flows into Appomattox River at edge of survey corridor. Loses bed and bank in segments where trampled by cattle, but lacks hydric soils.

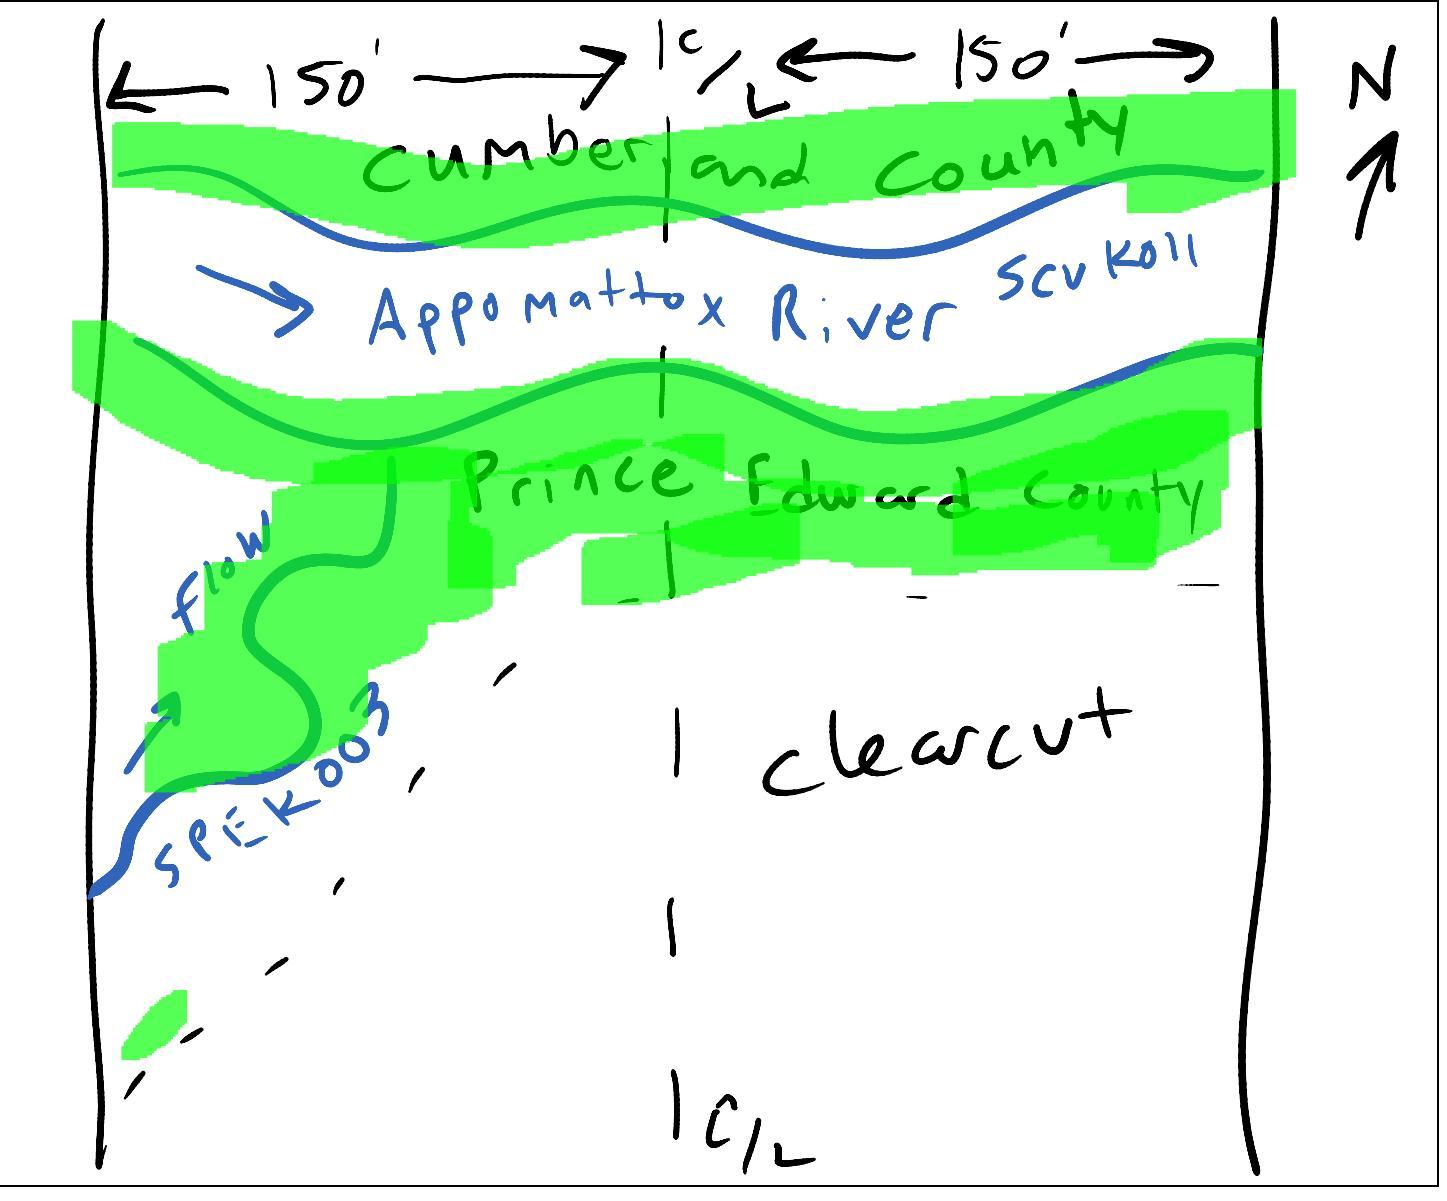
Waterbody Sketch (Include north arrow, centerline, distance from centerline, data point location, survey boundary, and IDs of associated features)

CLEARCUT/LAND	GRADIN	G/SITE PRE	P NEA	RBY, BUT	STREAM INT	ACT			
Tributary is: (check one)	⊠ Na	atural	□ Art	ificial, man-m	ade 🗆 Manipi	ulated			
Stream Quality <sup>a</sup> : (check one)	🗆 Hi	gh	⊠ Mo	derate	□ Low

PERENNIAL STREAM IN BOTTOMLAND HW FOREST; INCISED CHANNEL AT DATA POINT

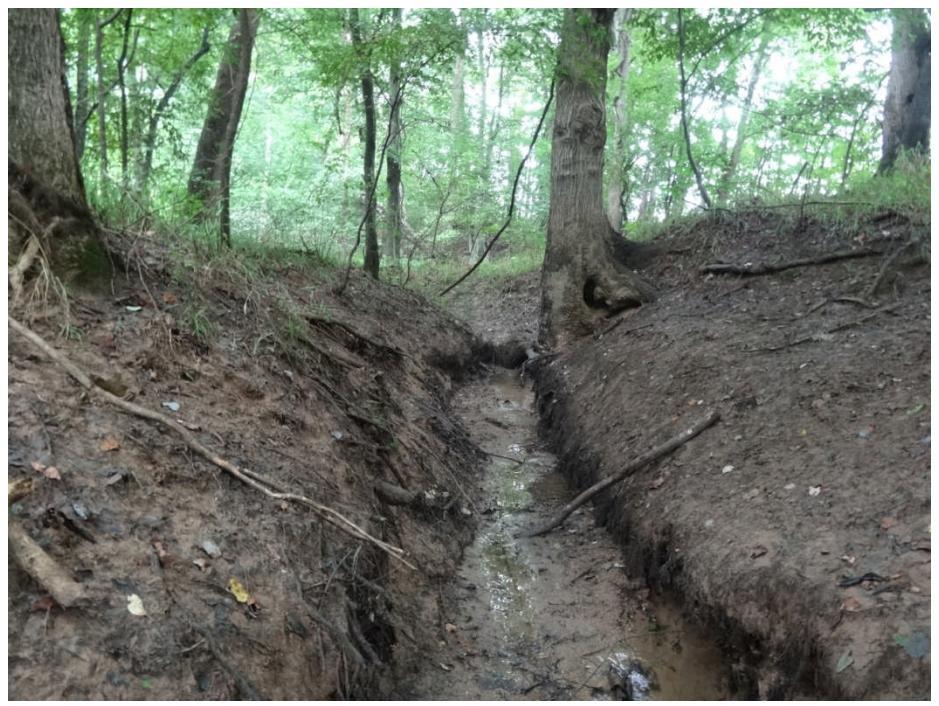
Waterbody point spek003 facing southwest and upstream

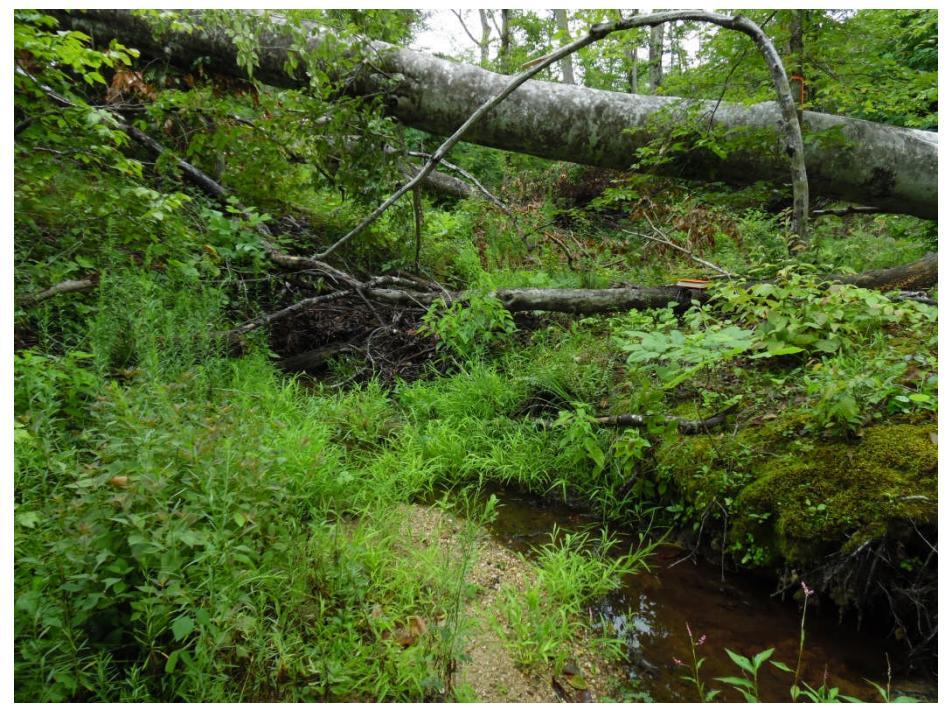
Waterbody point spek004 facing North and downstream

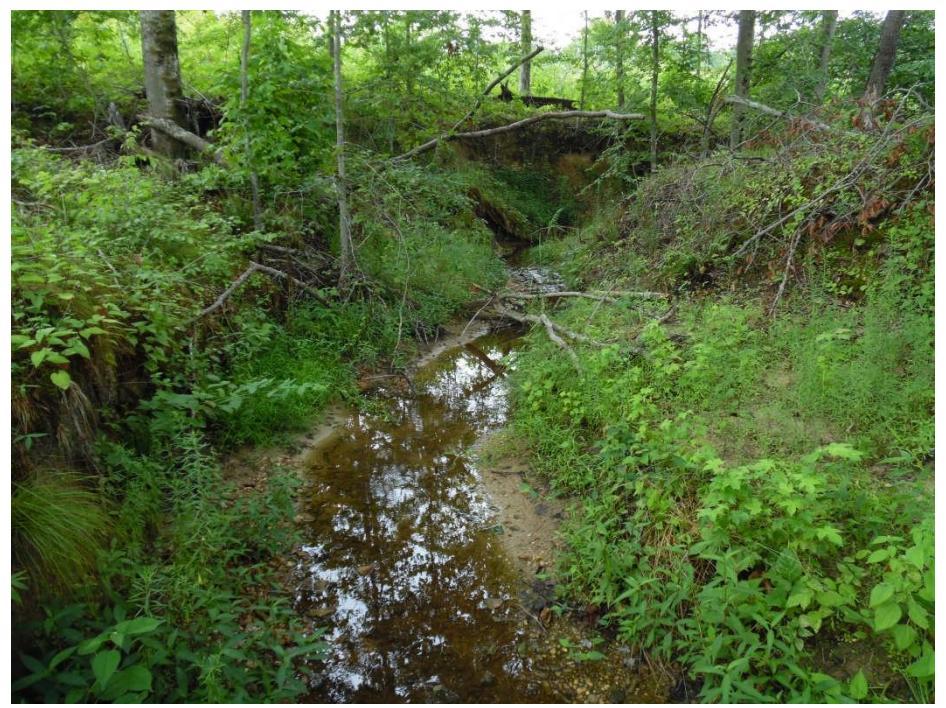
Waterbody point spek006 facing South and upstream

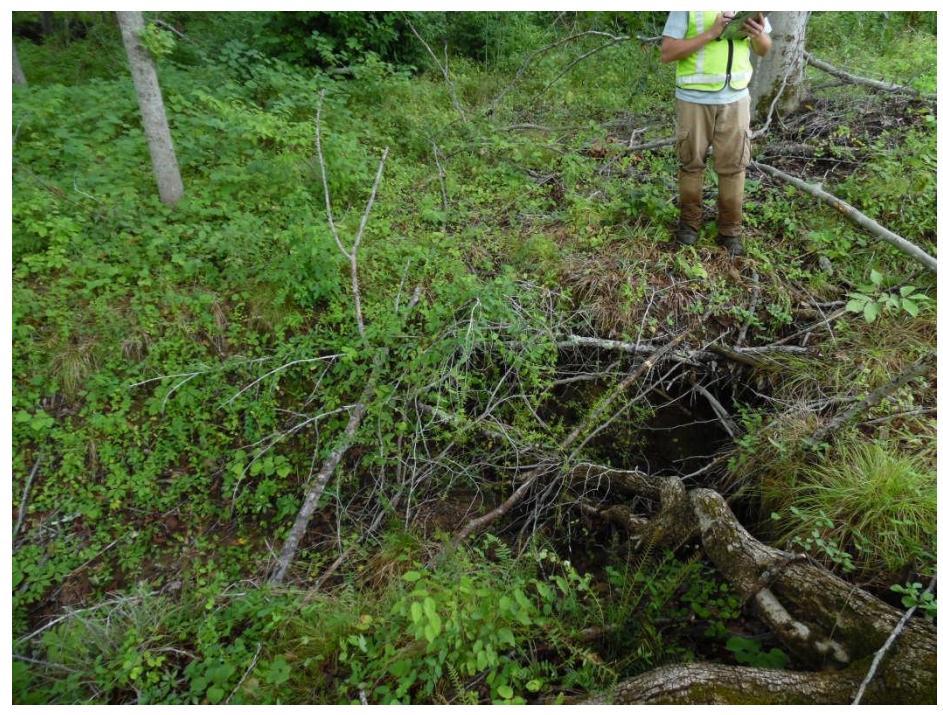
Waterbody point spek005 facing South and across

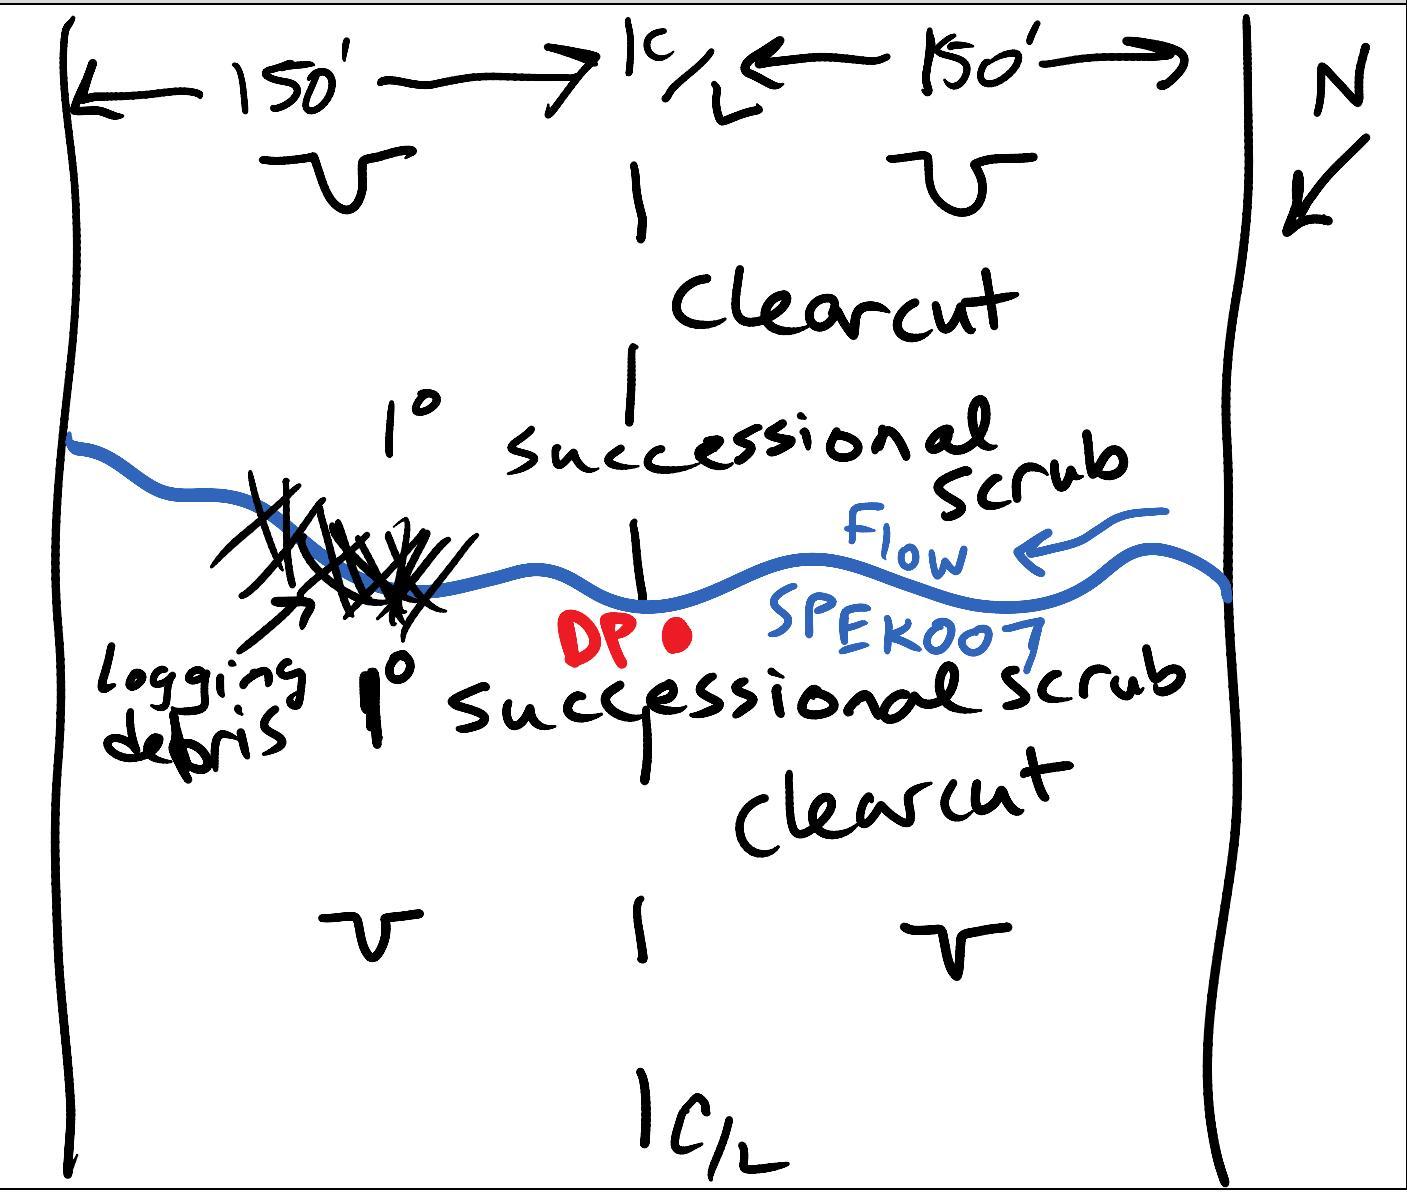
Waterbody Sketch (Include north arrow, centerline, distance from centerline, data point location, survey boundary, and IDs of associated features)

SOFT SAND, LWD,	OVERHANG	ING VEG							
Aquatic Organisms Ob	served (list):								
FROGS									
T&E Species Observed	(list):								
NA									
Disturbances (ex: livesto	ock access, manure i	in waterbody, wa	ste discharge pip	es):					
CLEARCUT/LAND	GRADING/SIT	E PREP NE	EARBY; LOO	GGING DEBRIS	S PILE	D IN STREA	M		
Tributary is: (check one)	⊠ Natural		Artificial, man-m	nade 🗌 🗆 Manip	ulated				
Stream Quality <sup>a</sup> : (check one)	□ High		Moderate	⊠ Low

HEADWATER INTERMITTENT STREAM IN CLEARCUT; POOR AQUATIC HABITAT; SOME SEEPY STREAMBANK AREAS

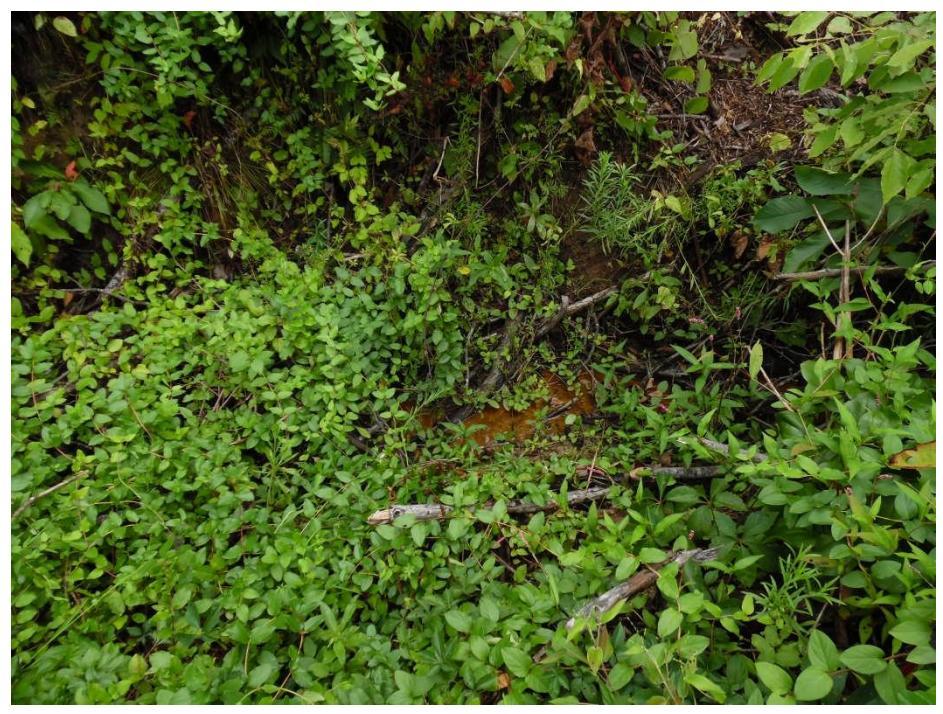
Waterbody point spek007 facing East and across

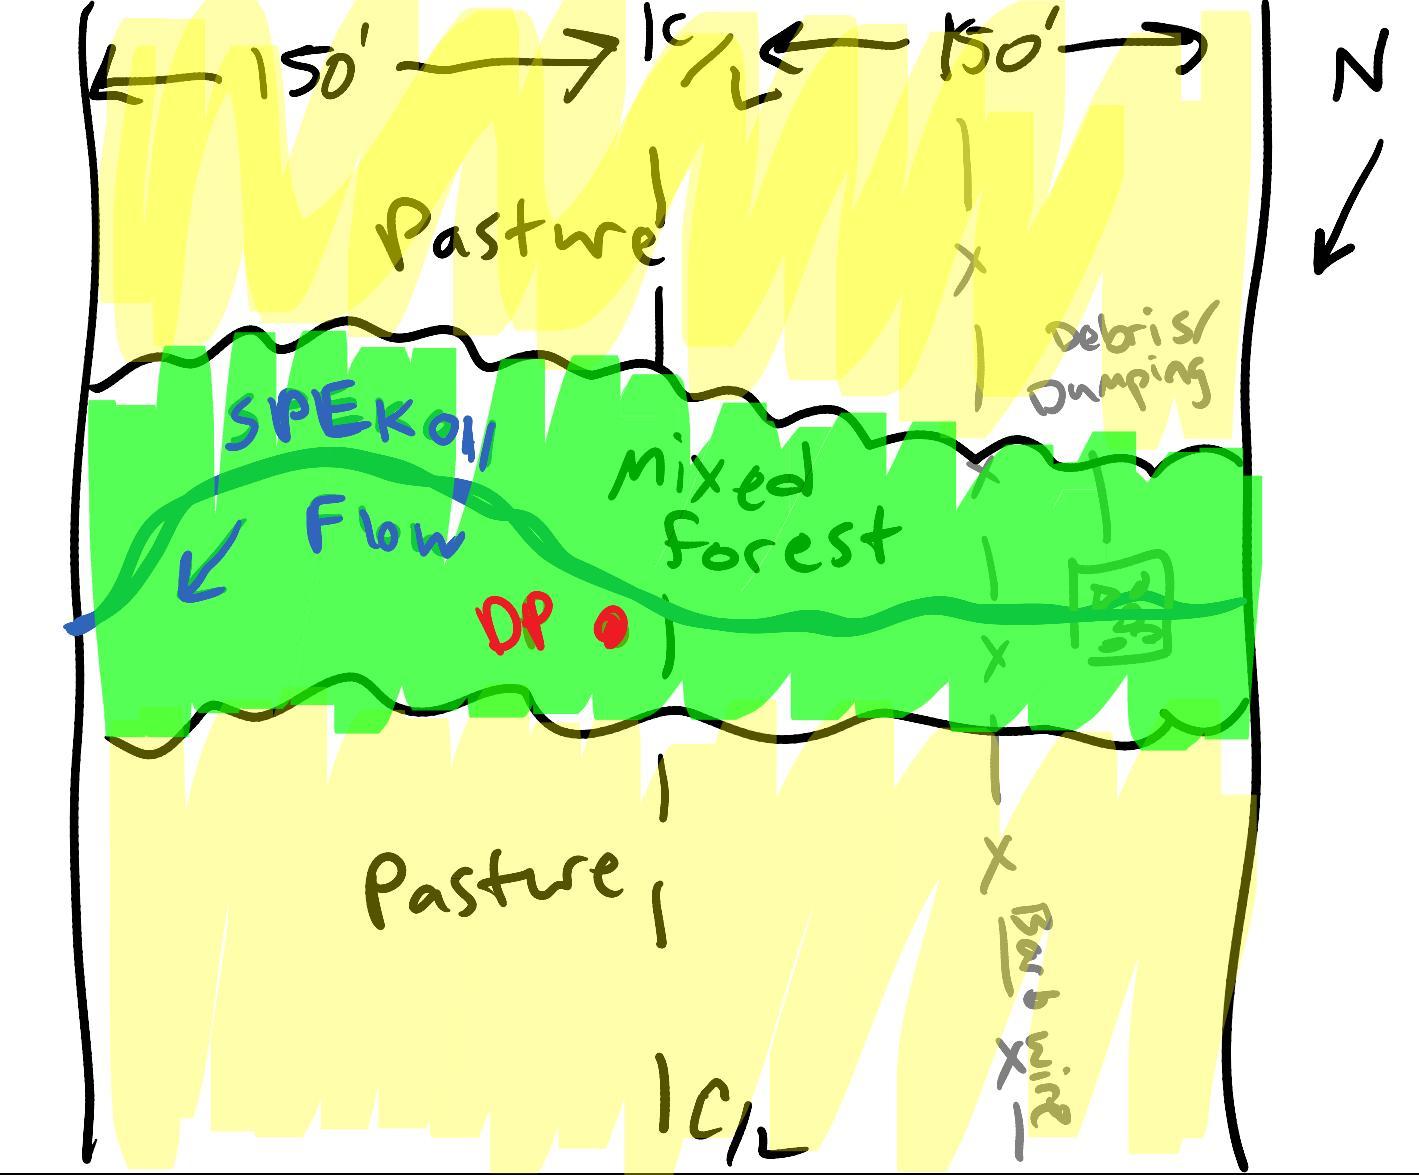
INTERMITTENT STREAM WITH SIGNIFICANT DISTURBANCE; POOR AQUATIC HABITAT

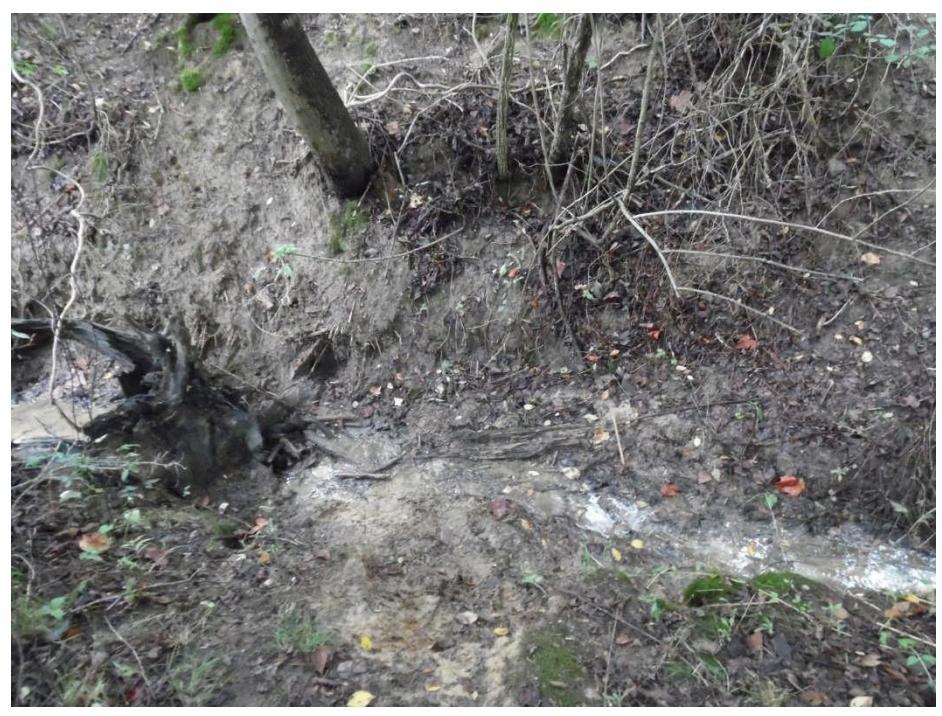
Waterbody point spek011 facing East and across

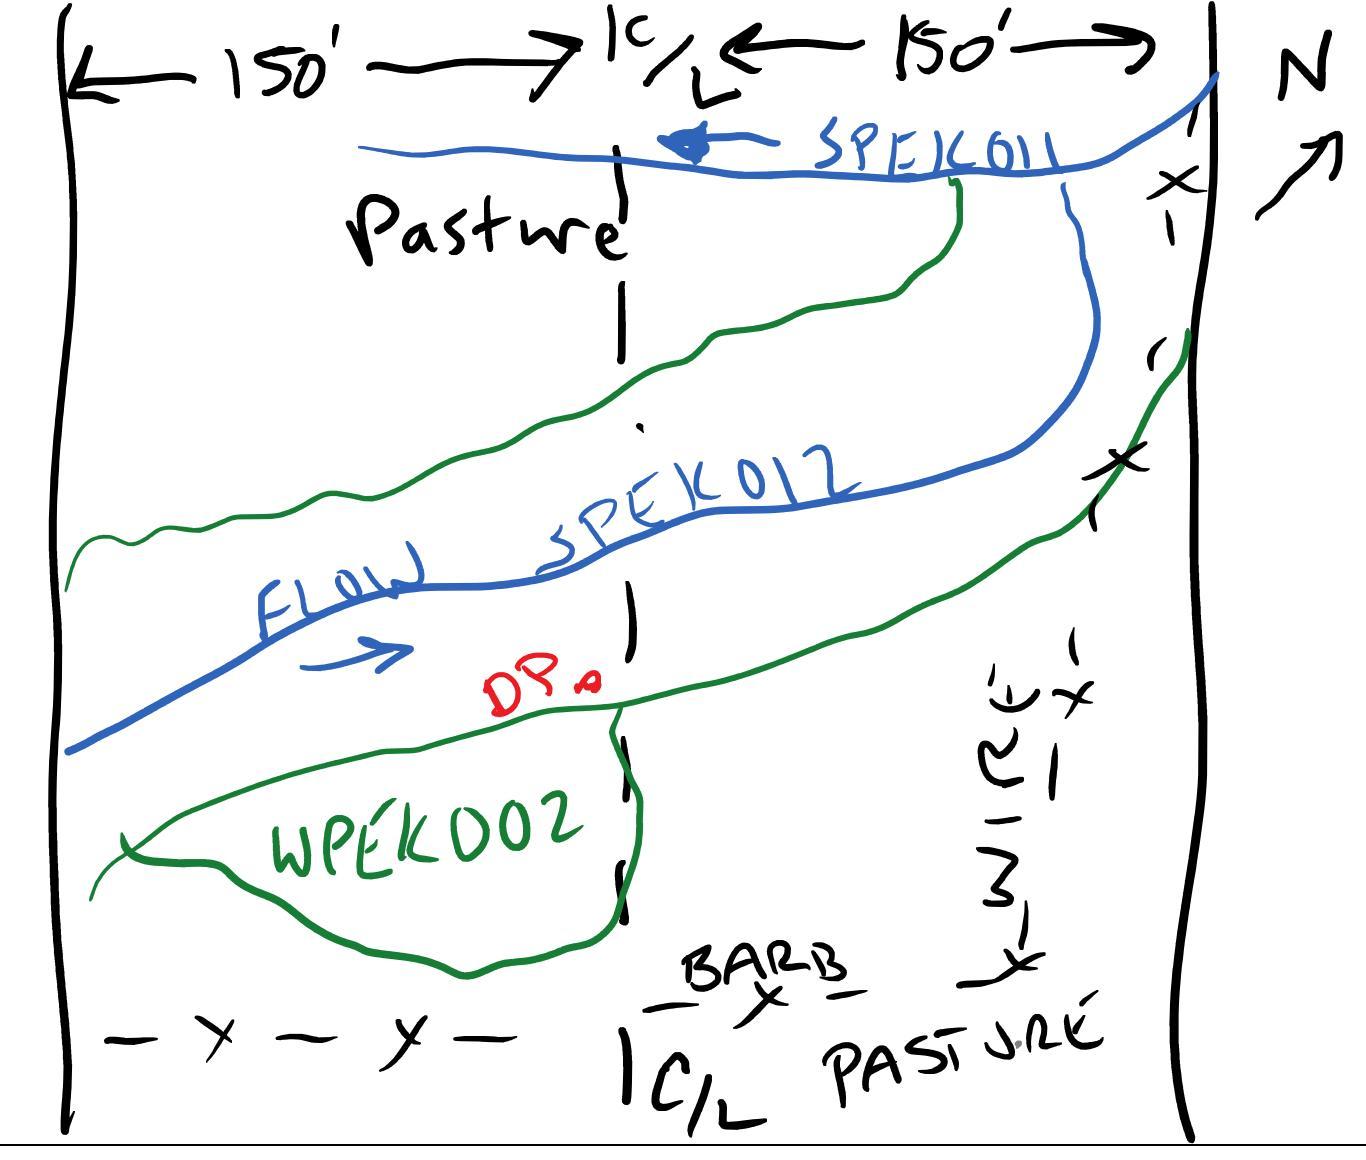
INTERMITTENT STREAM WITH SIGNIFICANT DISTURBANCE; POOR AQUATIC HABITAT

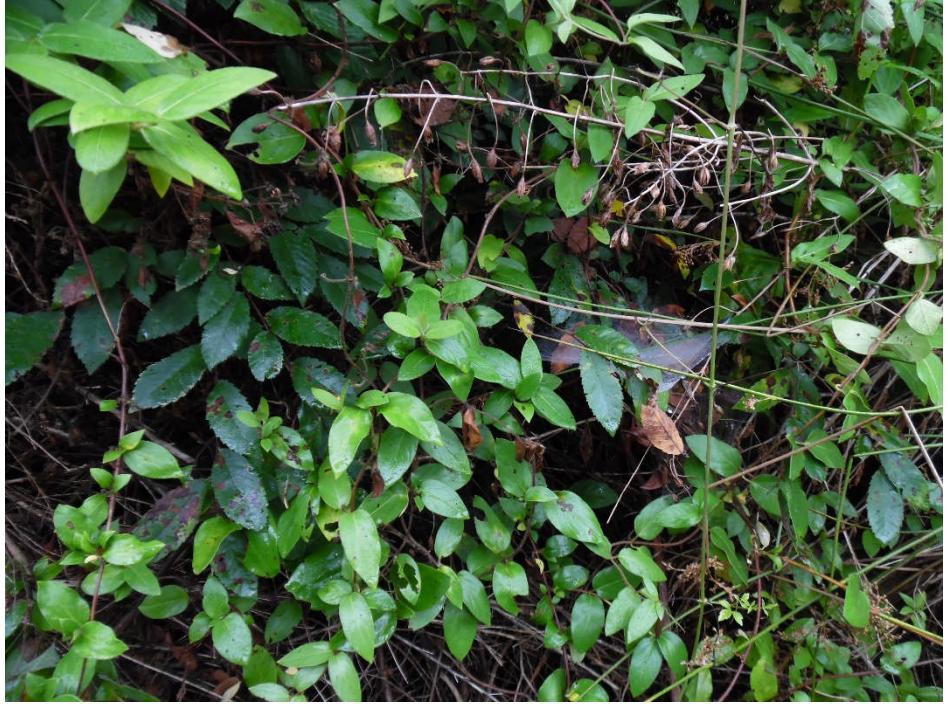
Waterbody point spek012 facing South and downstream

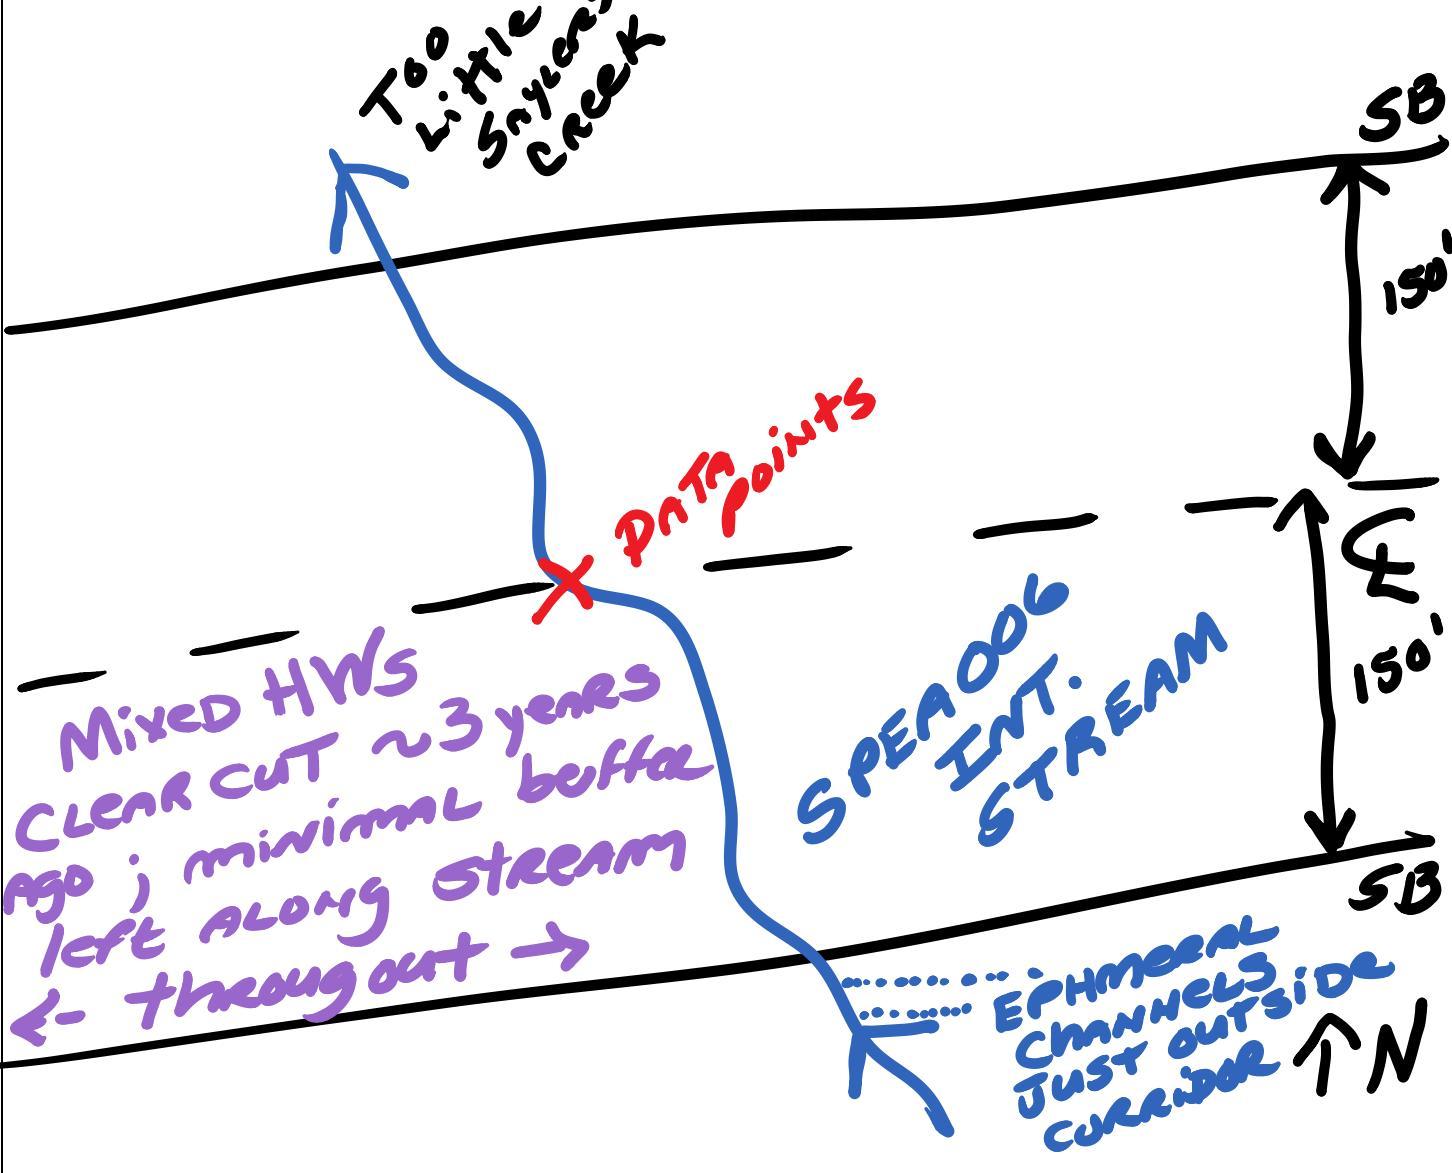
Aquatic Organisms Ob	oserved (list):							
Water striders, cade	disfly larvae							
T&E Species Observed	<b>d</b> (list):							
none								
Disturbances (ex: livest	ock access, manure	in waterbody, w	aste discharge pip	es):				
Surrounding clear of	cut with minima	al buffer						
Tributary is: (check one)	⊠ Natural		Artificial, man-n	nade 🗌 Manip	ulated			
Stream Quality <sup>a</sup> : (check one)	🗆 High	$\boxtimes$	Moderate	□ Low

Stream continues out of corridor in both directions, flows through mixed hardwoods that were clear cut about three years ago, minimal buffer was left along stream course,
