Linear Waterbody Data Sheet

Survey Description				
Project Name: ACP		Waterbody Name: UNT to WESTERN BRANCH RESERVOIR	Waterbody ID: SSU0100	Date: 3-8-16
State: VA	County/Parish: Suffolk	Company: ESI	Crew Member Initials: LR, WV	Photos: Facing E, W, N
Tract Number(s): 26-060-4068		Nearest Milepost: 61.8	Associated Wetland ID(s): WSU0029	
Survey Type: (check one) <input checked="" type="checkbox"/> Centerline <input type="checkbox"/> Re-Route <input type="checkbox"/> Access Road <input type="checkbox"/> Other:				
Physical Attributes				
Stream Classification: (check one) <input type="checkbox"/> Ephemeral <input type="checkbox"/> Intermittent <input checked="" type="checkbox"/> Perennial				
Waterbody Type: (check one) <input type="checkbox"/> River <input checked="" type="checkbox"/> Stream <input type="checkbox"/> Ditch <input type="checkbox"/> Canal <input type="checkbox"/> Other:				
OHWM Width: 3 ft.	OHWM Height: 0.5 ft.	OHWM Indicator: (check all that apply) <input checked="" type="checkbox"/> Clear line on bank <input type="checkbox"/> Shelving <input checked="" type="checkbox"/> Wrested vegetation <input type="checkbox"/> Scouring <input checked="" type="checkbox"/> Water s

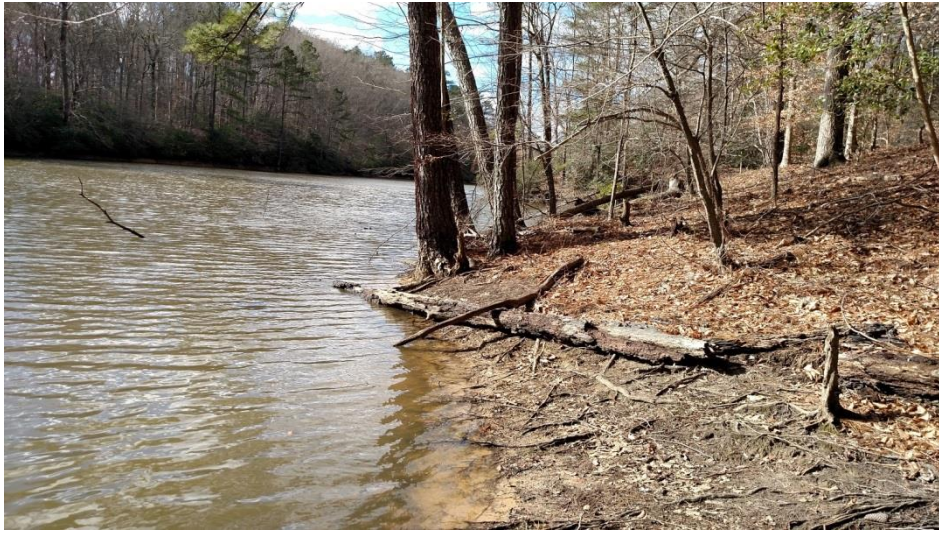
Open waterbody OSUA400 facing southeast

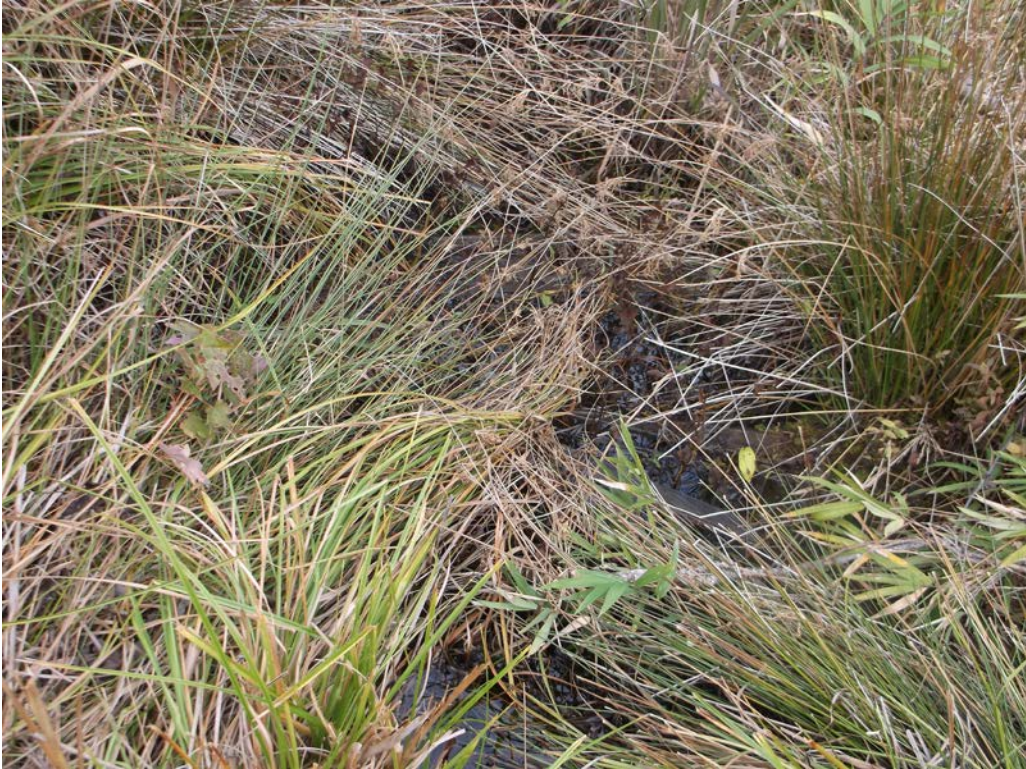
Waterbody ssuo020 facing northeast upstream.

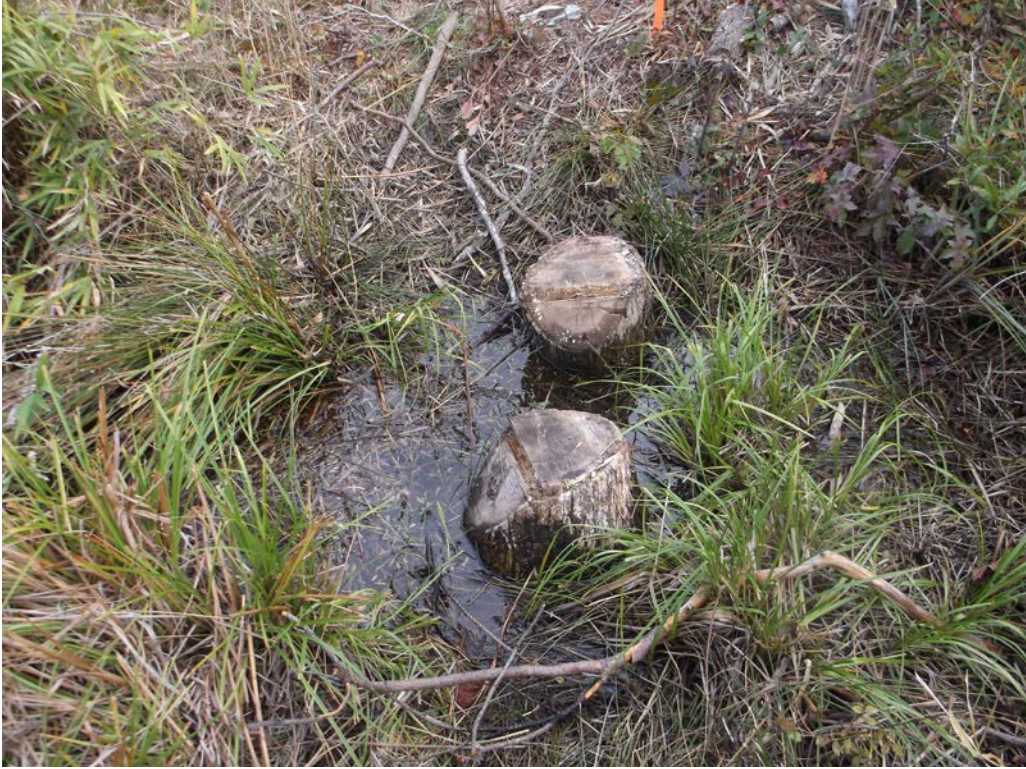
Waterbody ssuo020 facing southeast across bank.

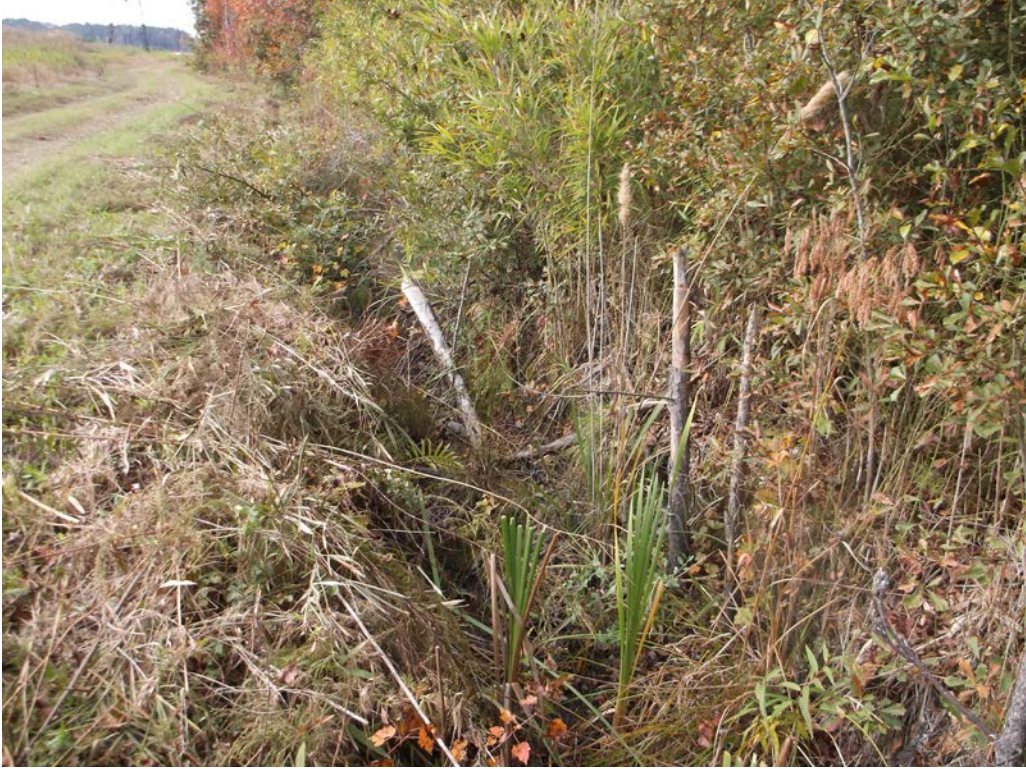
Waterbody ssuo021 facing northwest upstream.

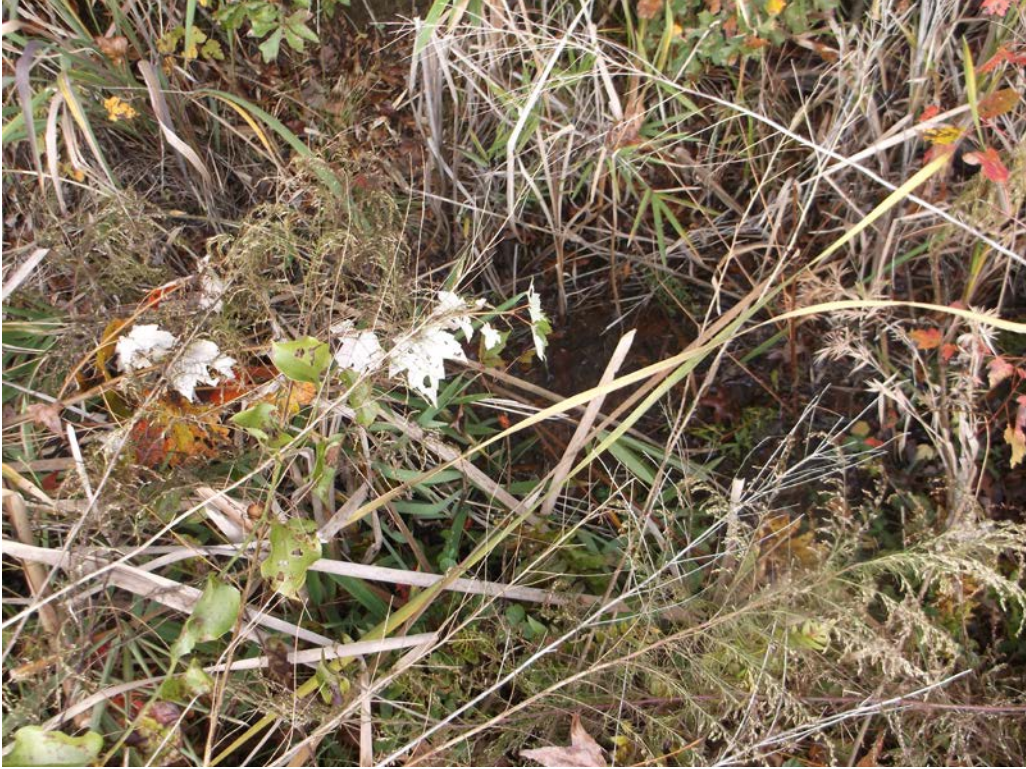
Waterbody ssuo021 facing northeast across bank.
