Linear Waterbody Data Sheet

Survey Description			
Project Name: Southeast Reliability		Waterbody Name: UNT to Jenks Fork	
Waterbody ID: SRAB101		Date: 8/19/2014	
State: West Virginia	County: Randolph	Company: NRG	Crew Member Initials: TP, S
Photos: 001-003			
Tract Number(s): 04-002-A002, 04-002-A003		Nearest Milepost: 43.05	Associated Wetland ID(s): none
Survey Type: <i>(check one)</i> <input checked="" type="checkbox"/> Centerline <input type="checkbox"/> Re-Route <input type="checkbox"/> Access Road <input type="checkbox"/> Other:			
Physical Attributes			
Stream Classification: <i>(check one)</i> <input type="checkbox"/> Ephemeral <input checked="" type="checkbox"/> Intermittent <input type="checkbox"/> Perennial			
Waterbody Type: <i>(check one)</i> <input type="checkbox"/> River <input checked="" type="checkbox"/> Stream <input type="checkbox"/> Ditch <input type="checkbox"/> Canal <input type="checkbox"/> Other:			
OHWM Width: 4 ft.		OHWM Indicator: <i>(check all that apply)</i> <input checked="" type="checkbox"/> Clear line on bank <input type="checkbox"/> Shelving <input type="checkbox"/> Wrested vegetation <input type="checkbox"/> Scouring <input type="checkbox"/> Water

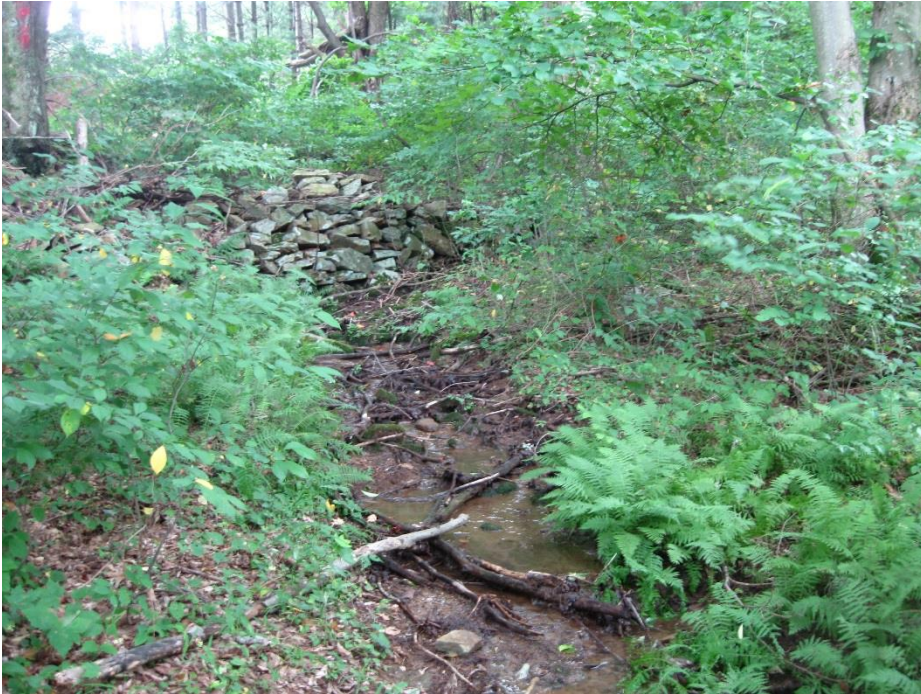
Waterbody SRAB101 facing southeast upstream

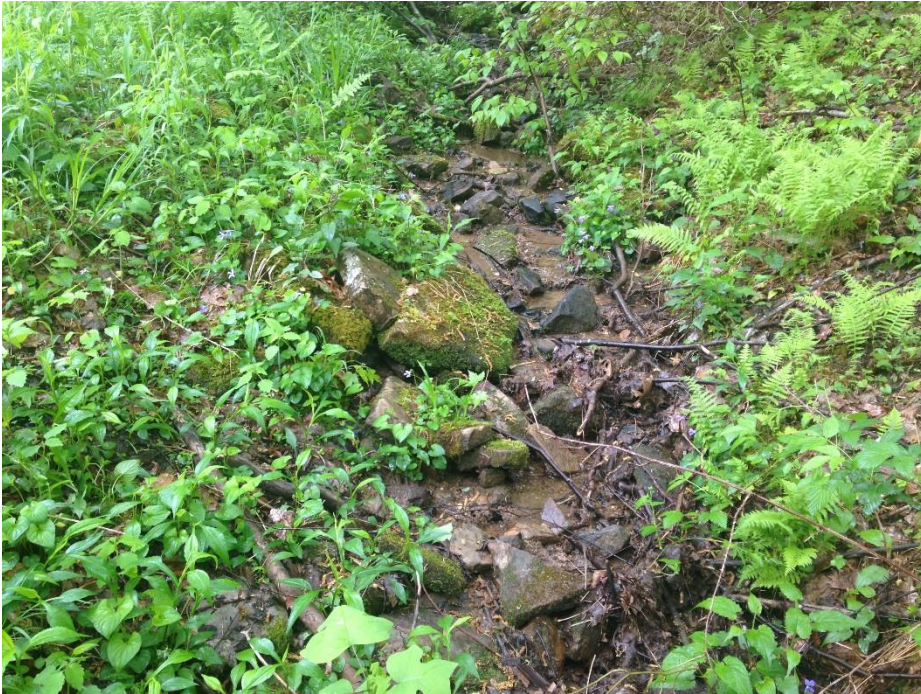
Waterbody SRAC001 facing south upstream

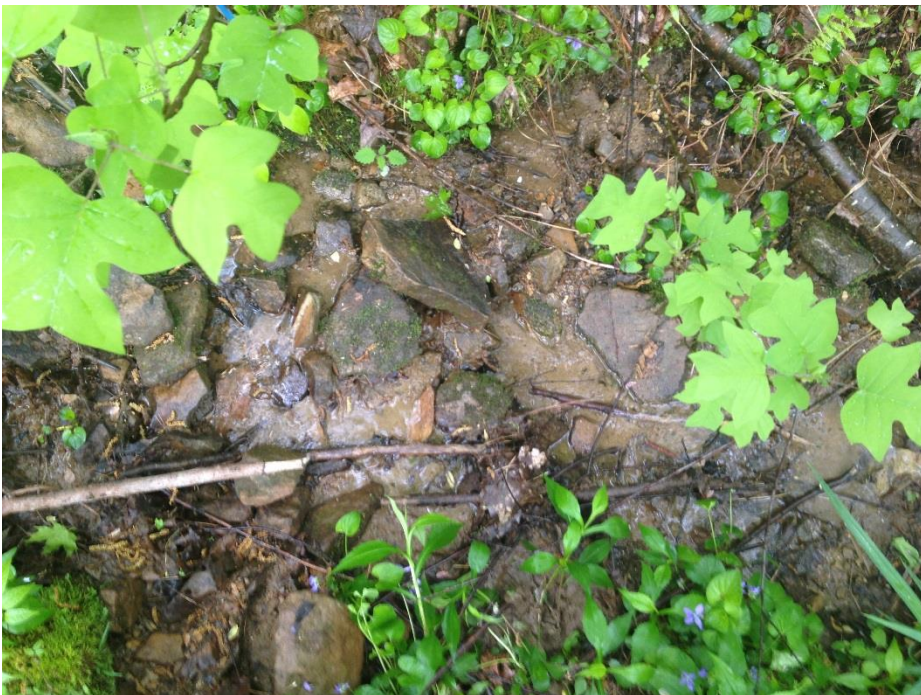
Waterbody SRAC001 facing west across

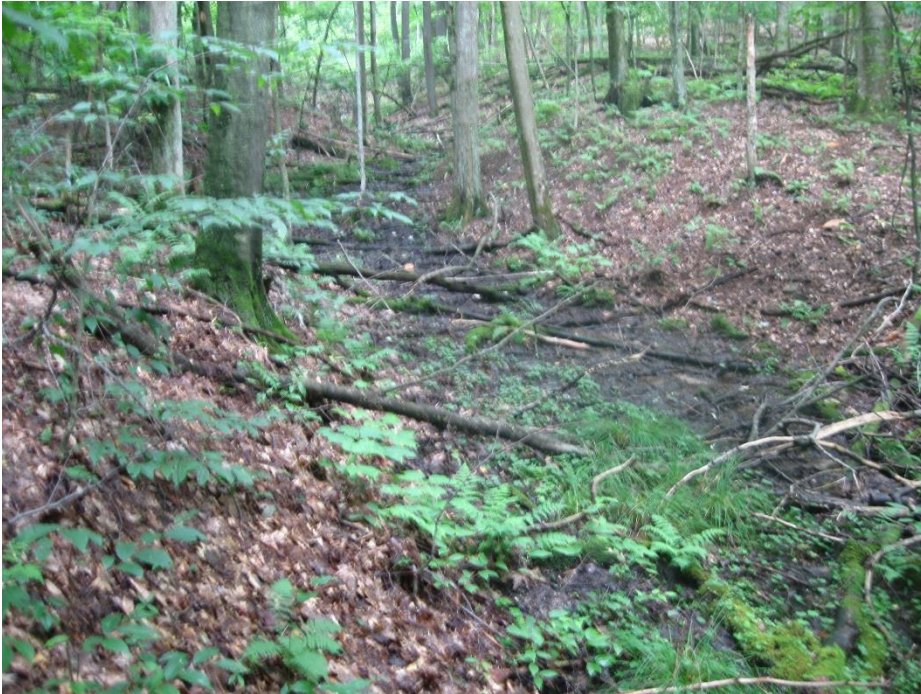
Waterbody SRAB102 facing south upstream

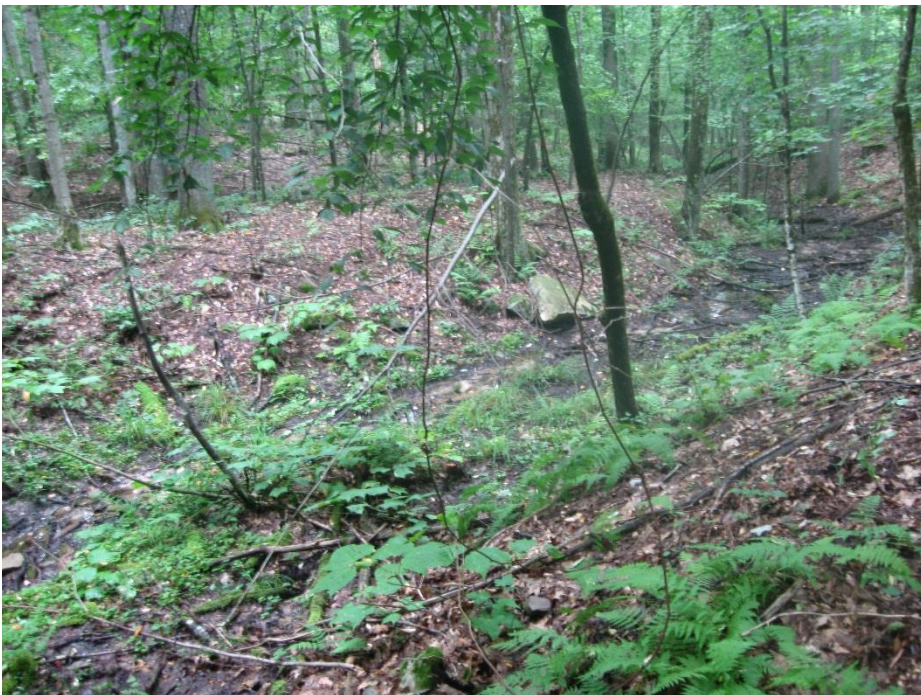
Waterbody SRAB102 facing north downstream

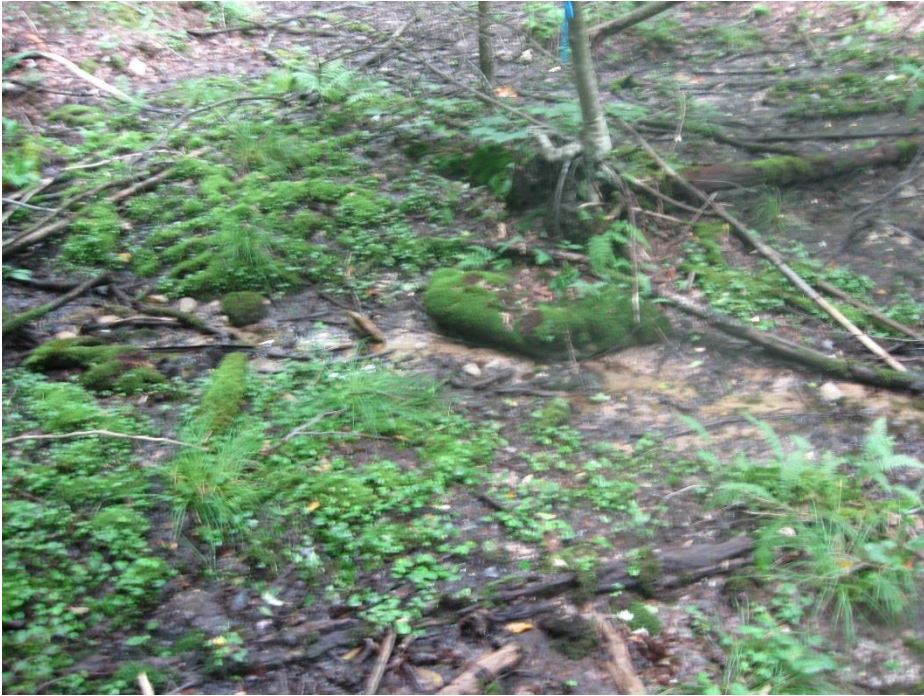
Waterbody SRAB102 facing west across

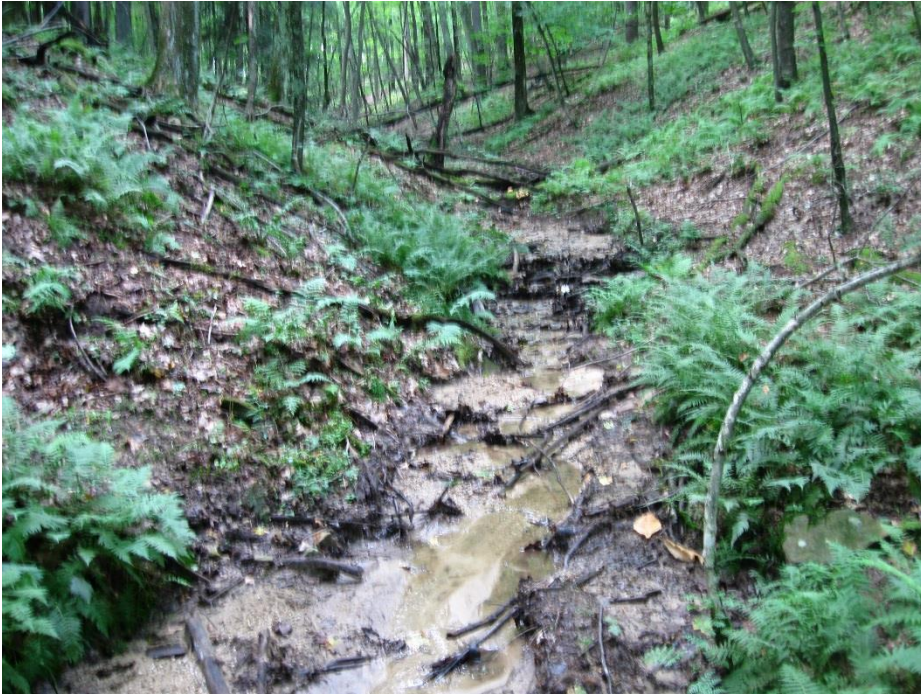
Waterbody SRAB103 facing west upstream

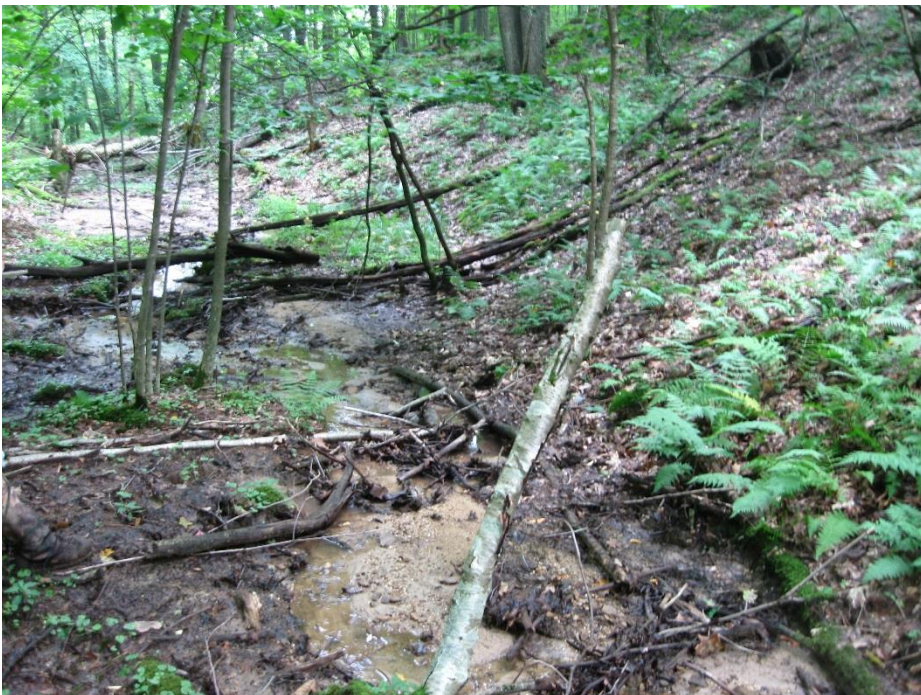
Waterbody SRAB103 facing east downstream

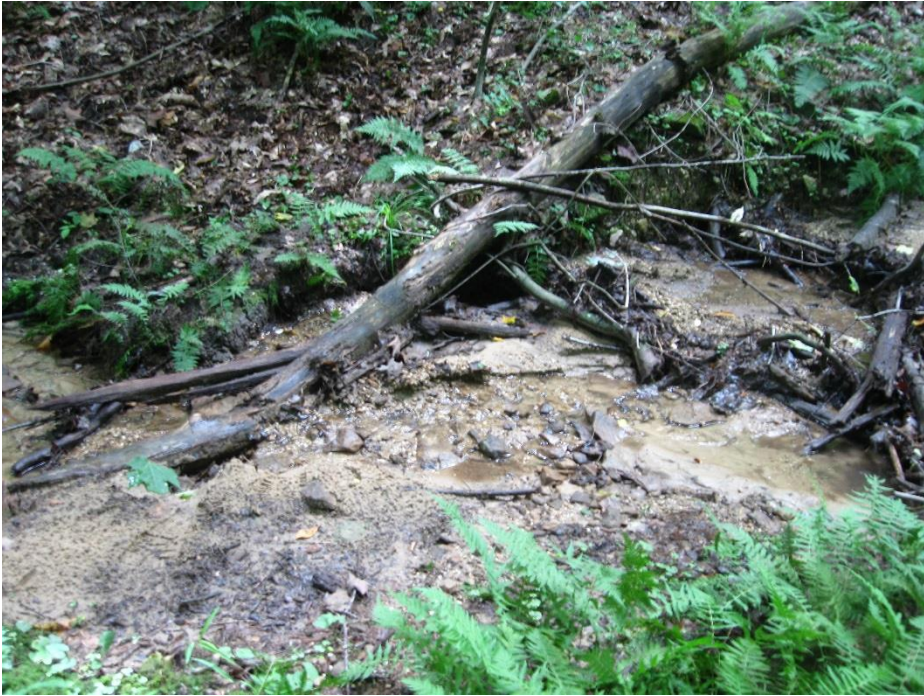
Waterbody SRAB103 facing south across

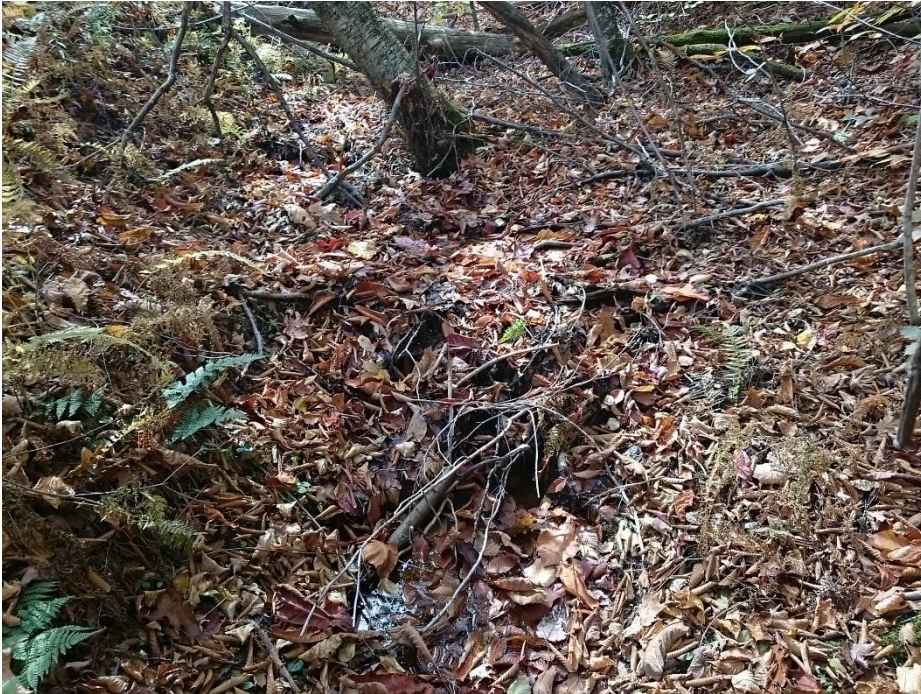
Waterbody SRAA066 facing south upstream

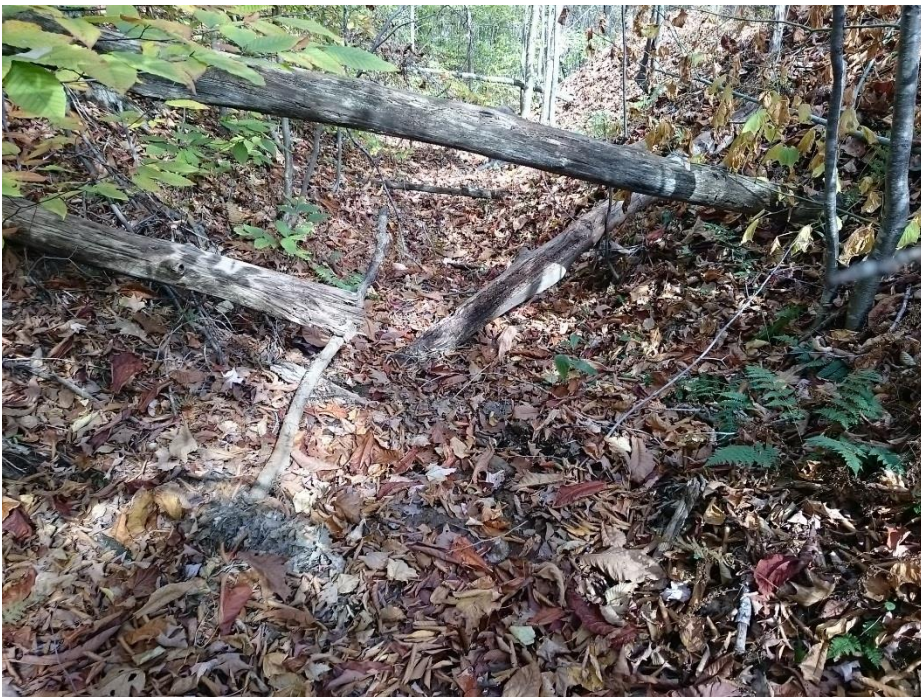
Waterbody SRAA066 facing north downstream

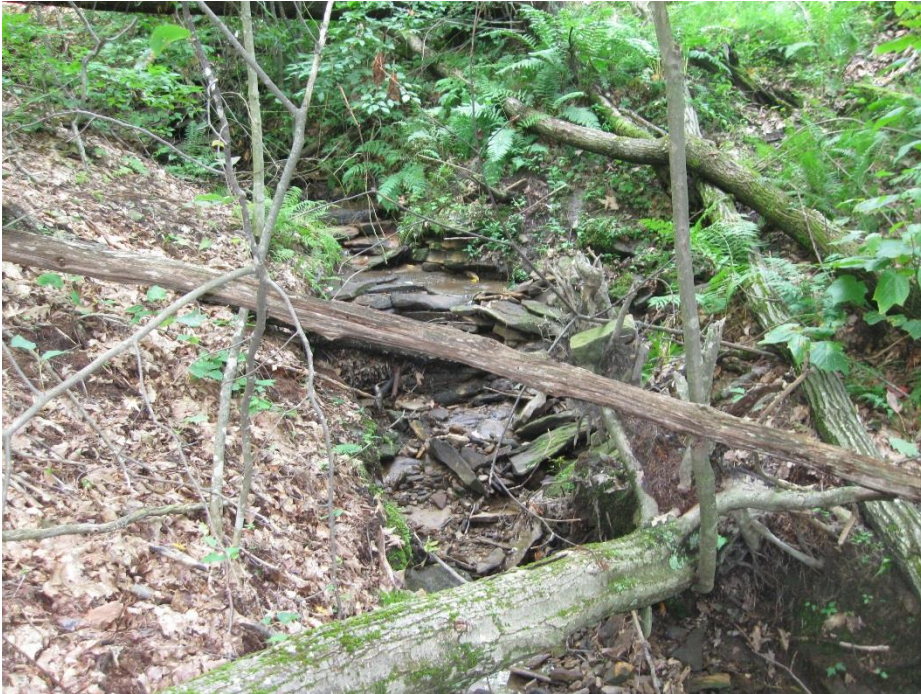
Waterbody SRAB104 facing northeast upstream

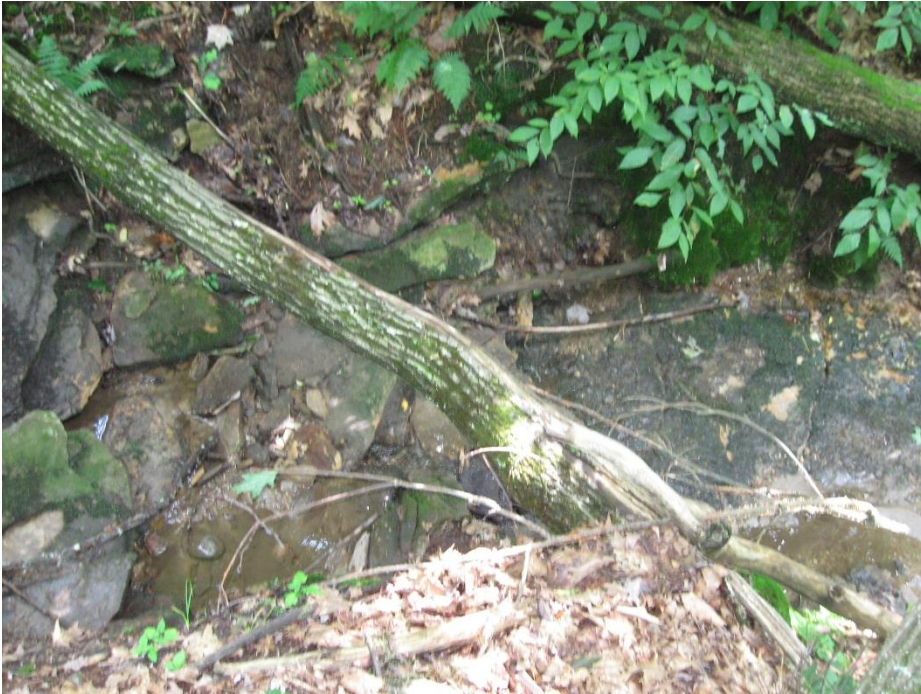
Waterbody SRAB104 facing southeast across

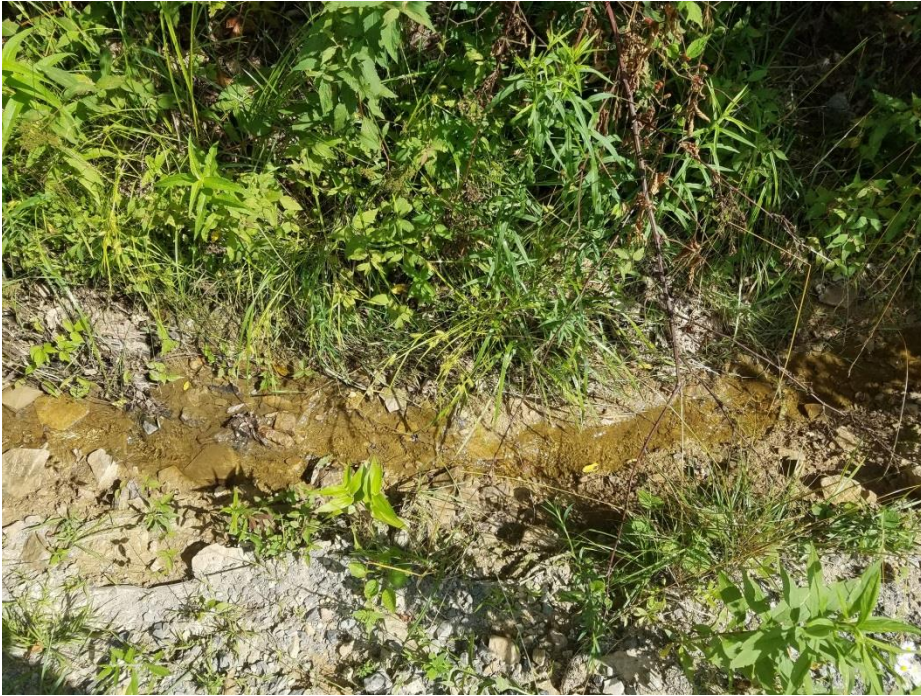
Waterbody srae204 facing northwest across

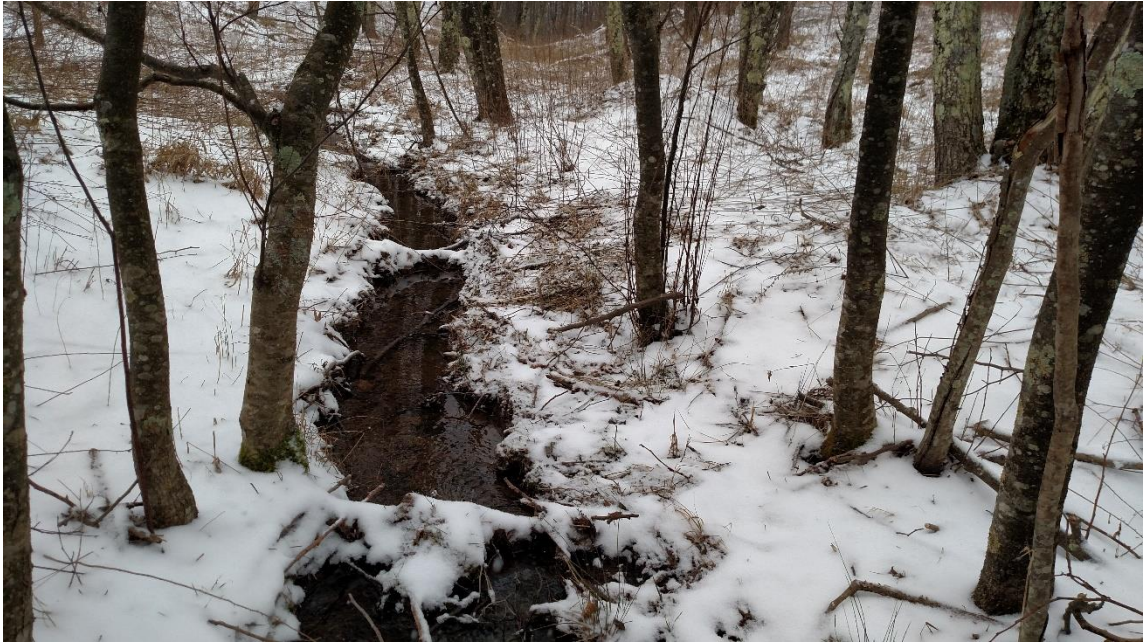
Waterbody SRAC100 facing east upstream

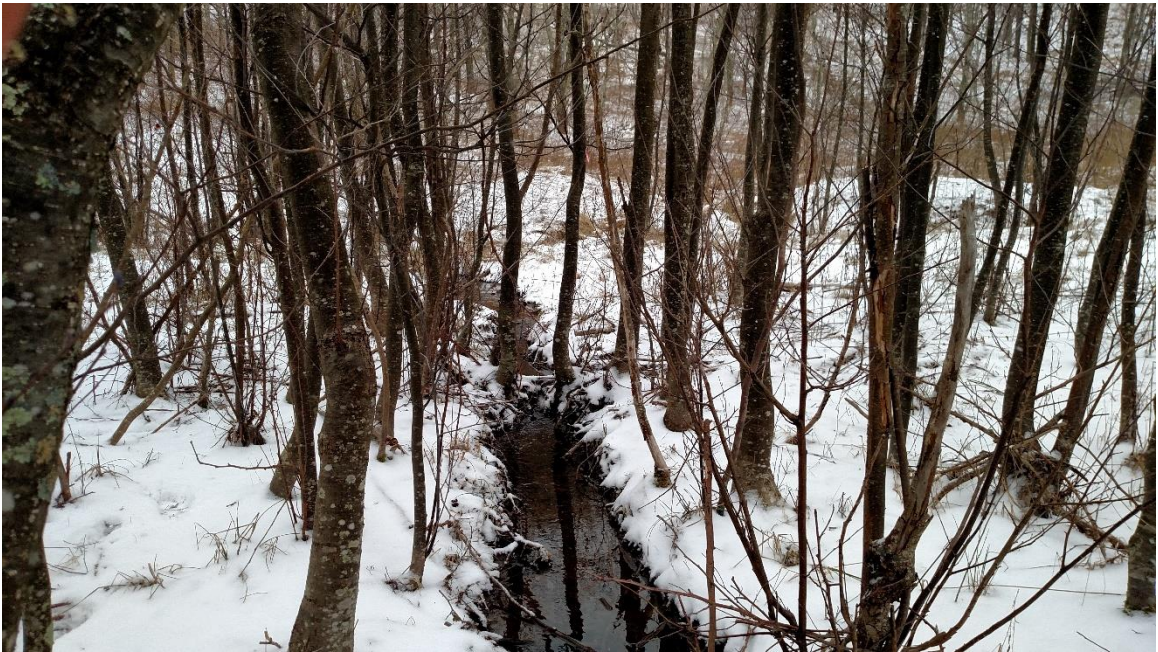
Waterbody SRAC100 facing west downstream

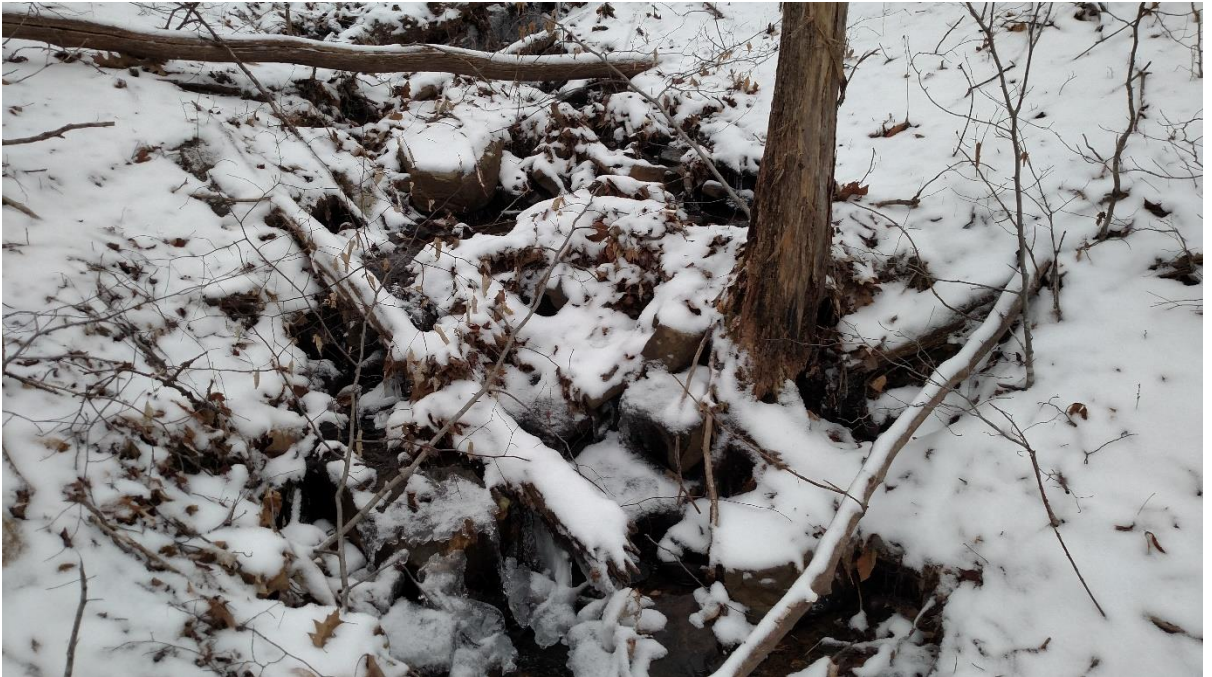
Waterbody SRAC101 facing east upstream

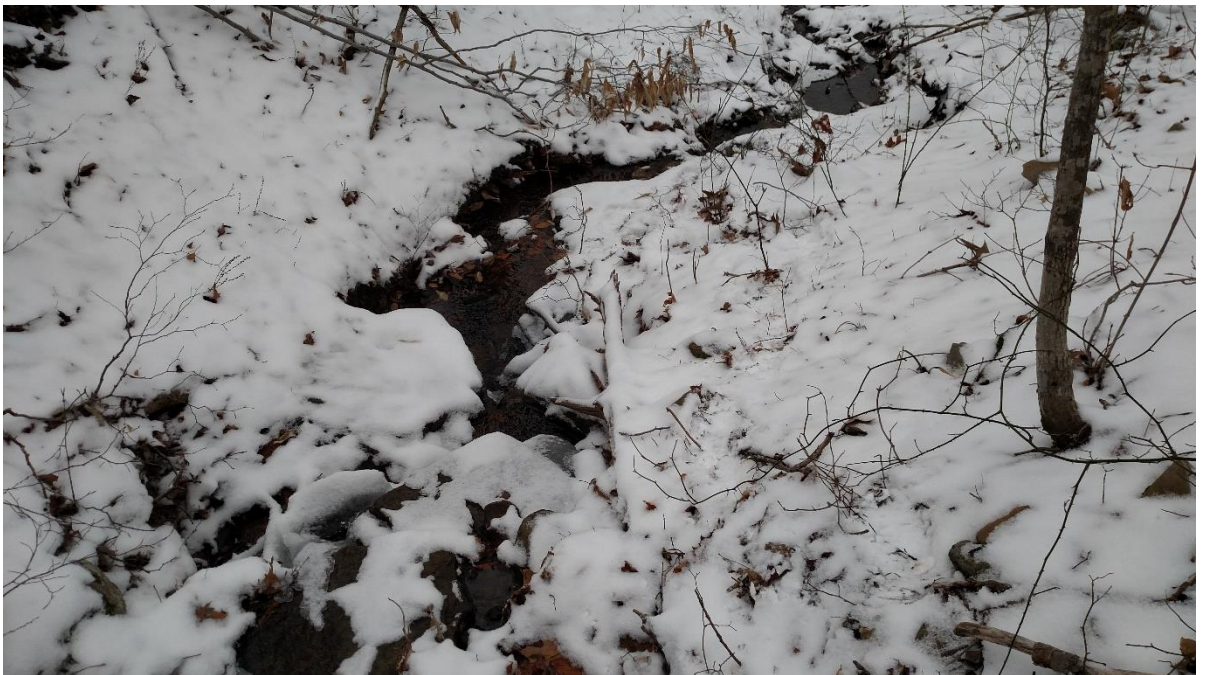
Waterbody SRAC101 facing west downstream

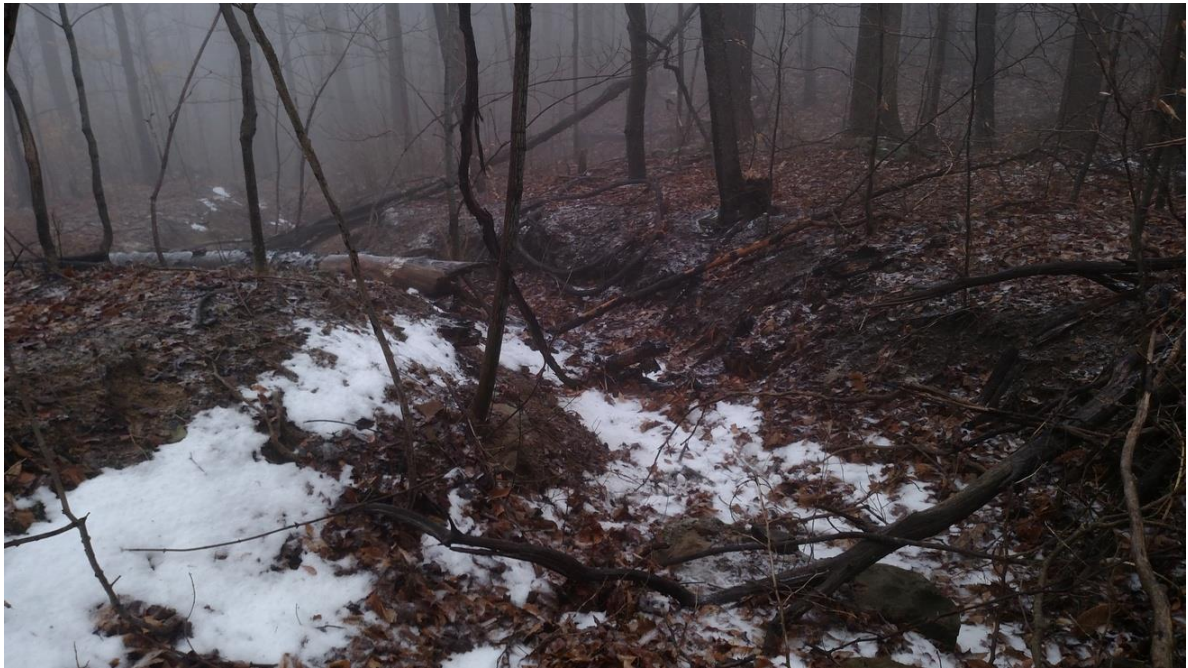
Waterbody srac102 facing west downstream
