SUPPLY HEADER PROJECT ENVIRONMENTAL SURVEY

Wetland and Waterbody Delineation Report

APPENDIX B

Waterbody Datasheets and Photo Pages

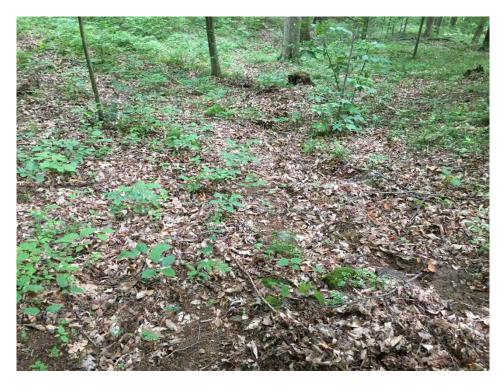
Waterbody sdoa007 facing downstream

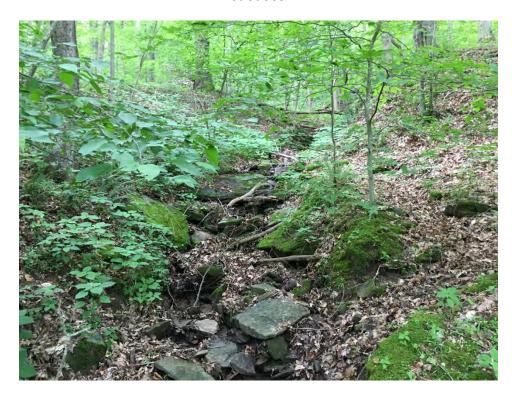
Aquatic Organisms (Observed	(list):									
n/a											
Disturbances (ex: live n/a	stock acces	s, manure	in waterbo	dy, waste disch	arge pi	ipes):					
Observation Notes:											
Hillside ephemeral dr	ainage.

Waterbody sdoa009 facing upstream

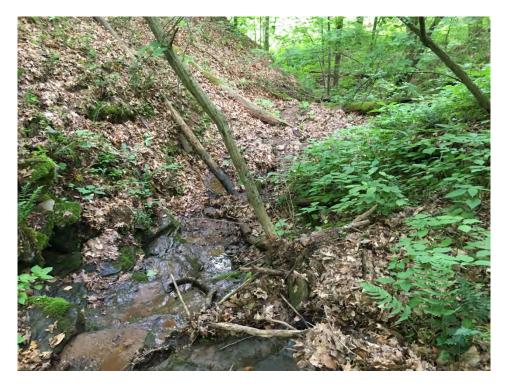
Waterbody sdoa009 facing downstream

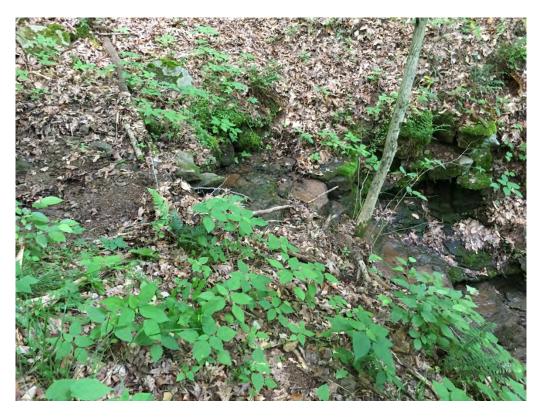
Waterbody sdoa009 cross stream

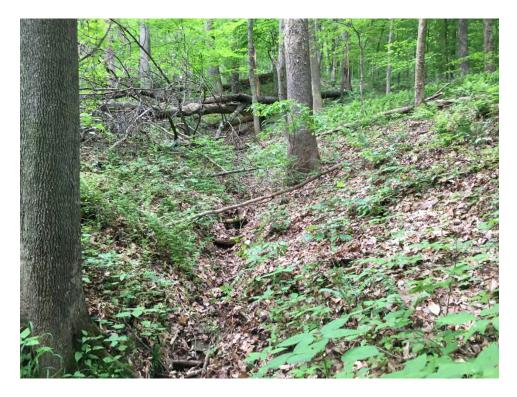
n/a Aquatic Organisms	Opeoniod	(lict)									
n/a	CDSCI VEU	(1101).									
Disturbances (ex: live	estock acces	s, manure	e in waterbo	dy, waste disc	harge pi	pes):					
n/a		-,		,,	g- p.	,,-					
Observation Notes:											
Hillside ephemeral dr	ainage.										
1											
l											
ı

Waterbody sdoa008 facing upstream

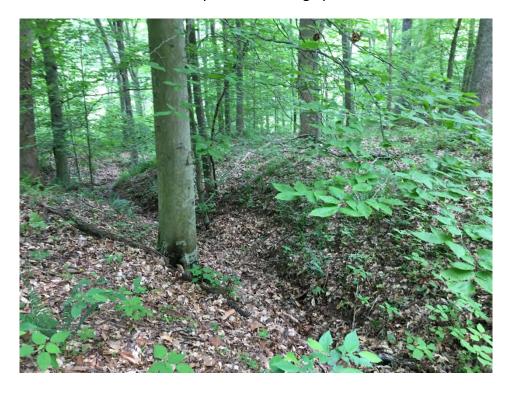
Waterbody sdoa008 facing downstream

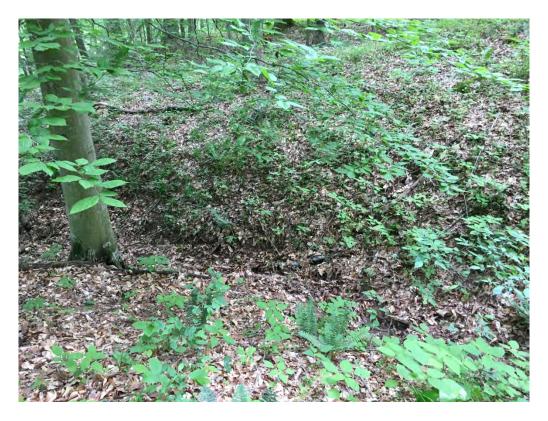
Waterbody sdoa008 cross stream

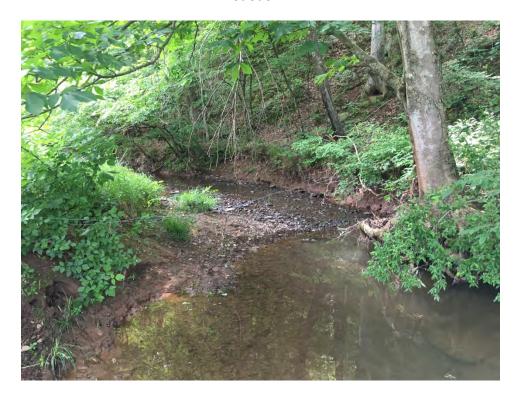
Disturbances (ex: livest	tock access	s, manure i	in waterboo	dy, waste disch	arge p	ipes):					
adjacent to pasture/dist	turbed floo	odplain									
Observation Notes:											_
Moderate size snapping	g turtle ob	served fo	oraging. S	everal differe	nt spe	ecies of dams	elfly and dran	gonfly observe	ed.

Waterbody sdoa011 facing upstream

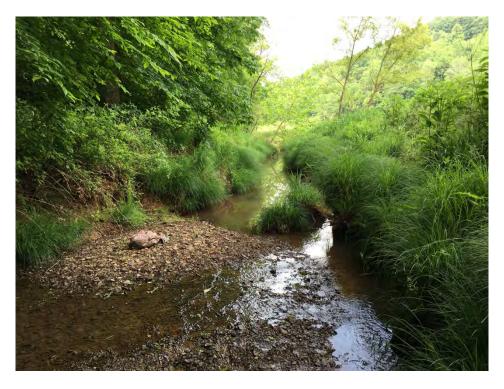
Waterbody sdoa011 facing downstream

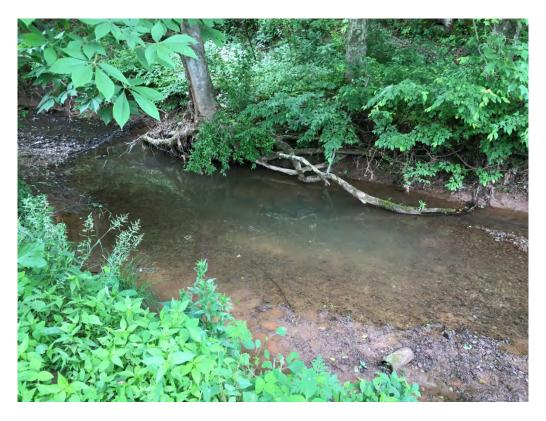
Waterbody sdoa011 cross stream

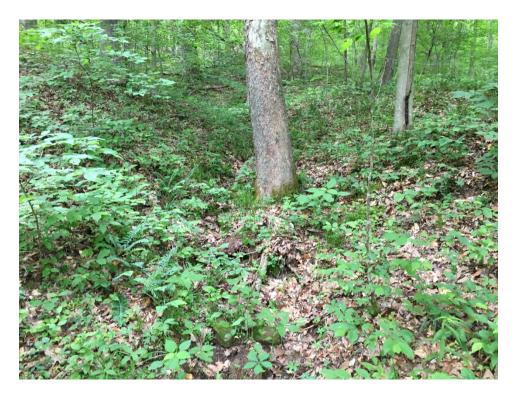
n/a										
Disturbances (ex: live n/a	estock acces	s, manure	in waterbo	dy, waste discha	arge pi	ipes):				
Observation Notes:										
Hillside ephemeral dra	ainage.

Waterbody sdoa010 facing upstream

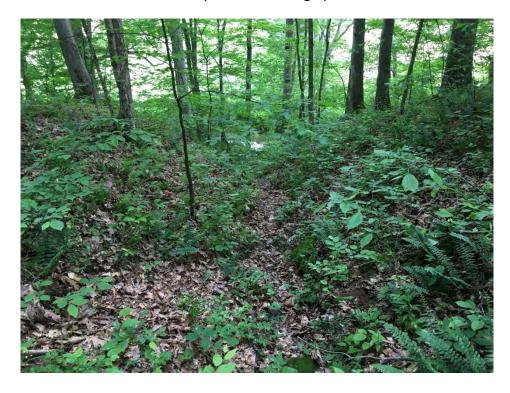
Waterbody sdoa010 facing downstream

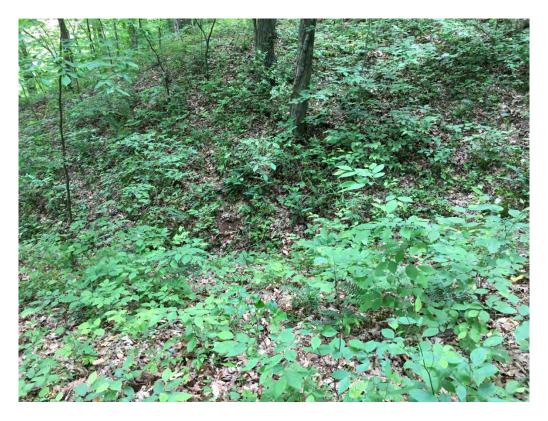
Waterbody sdoa010 cross stream

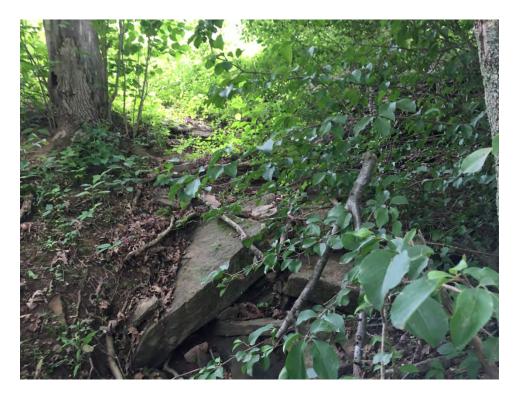
Aquatic Organisms (Doserved	(1151):									
Disturbances (ex: live	estock acces	s. manure	e in waterho	odv. waste di	ischarge n	ipes):					
n/a		_,		, , , , , , , , , , , , , , , , ,	urgo p	-F-00/1					
Observation Notes:											+
Upland ephemeral str	ream drain	ane									
Opiana epitemetal sti	cam uralli	uye

Waterbody sdoa013 facing upstream

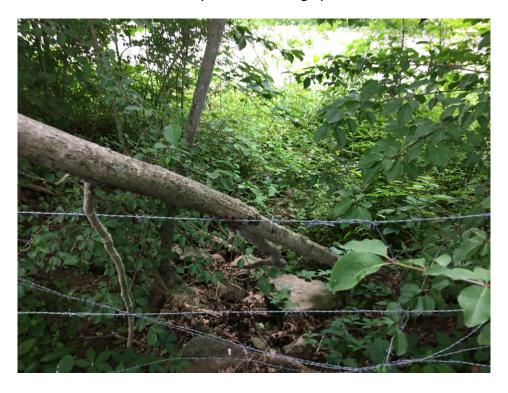
Waterbody sdoa013 facing downstream

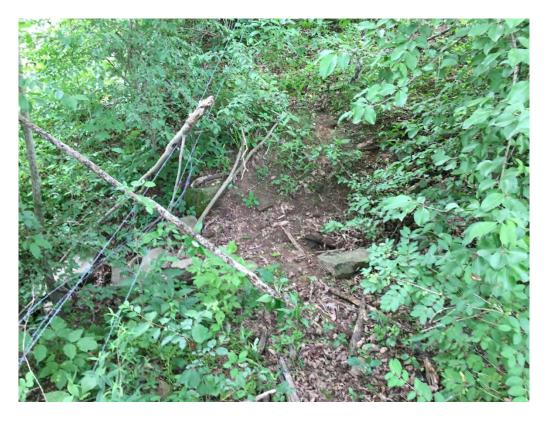
Waterbody sdoa013 cross stream

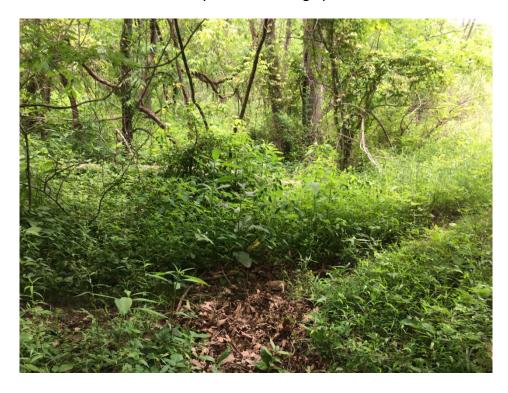
Aquatic Organisms (Observed ((list):									
n/a											
Disturbances (ex: live livestock access	stock access	s, manure	in waterbo	dy, waste discha	rge pi	ipes):					
Observation Notes:											
Cattle and horse acce	ess to ephe	meral str	eam that	is overgrown w	ith ir	nvasive plants

Waterbody sdoa012 facing downstream

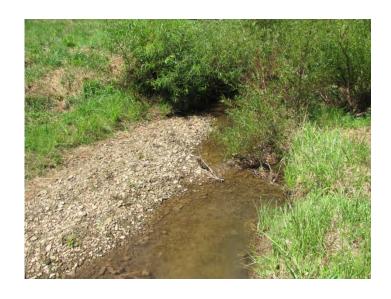
Waterbody *SDOJ005* facing downstream

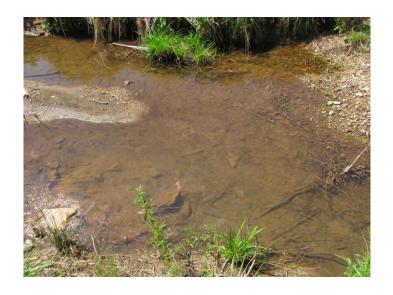
Waterbody SDOJ005 facing upline cross stream

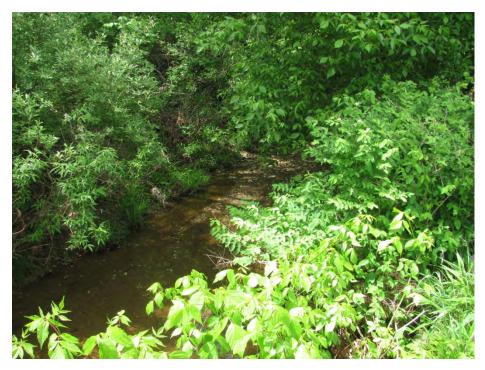
Waterbody sdog033 facing upstream

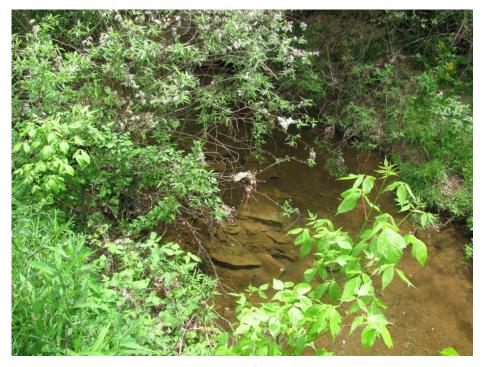
Waterbody sdog033 facing downstream

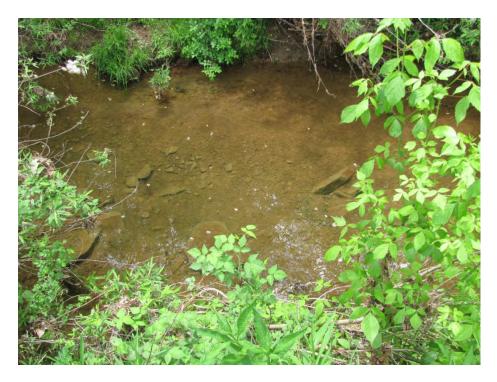
Waterbody sdog033 facing upline cross stream

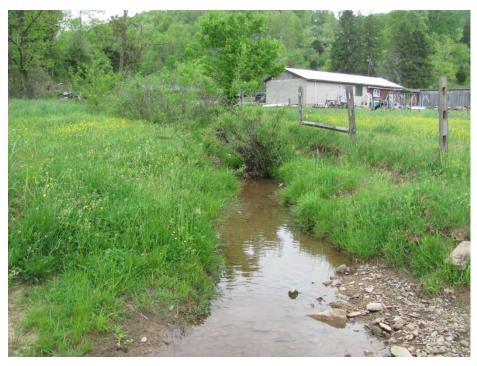
Waterbody sdog034 facing upstream

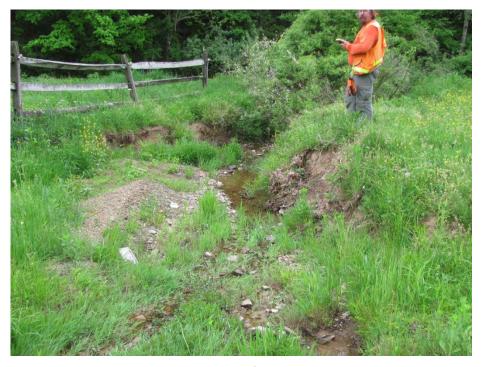
Waterbody sdog034 facing downstream

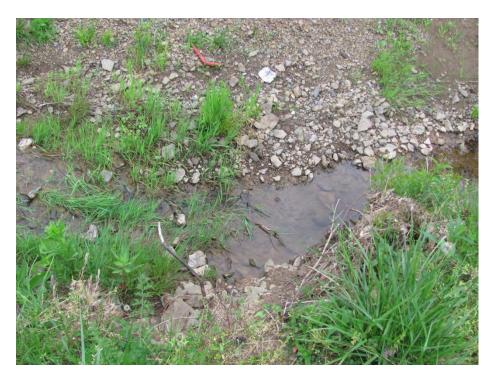
Waterbody sdog034 facing upline cross stream

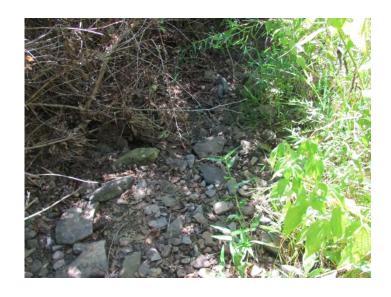
Waterbody *SDOJ004* facing downstream

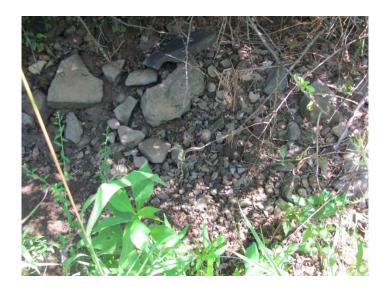
Waterbody SDOJ004 facing upline cross stream

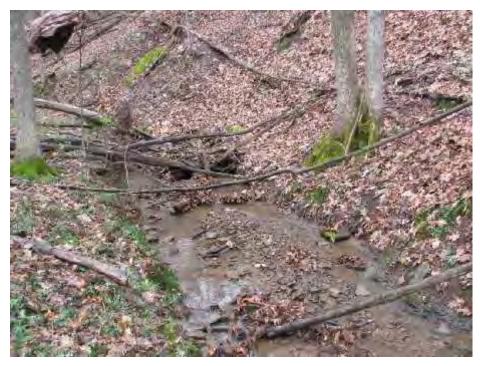
Waterbody sdog023 facing upstream

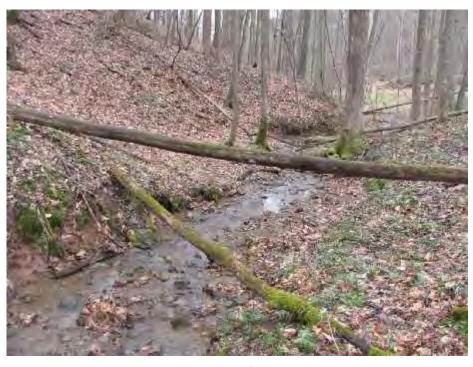
Waterbody sdog023 facing downstream

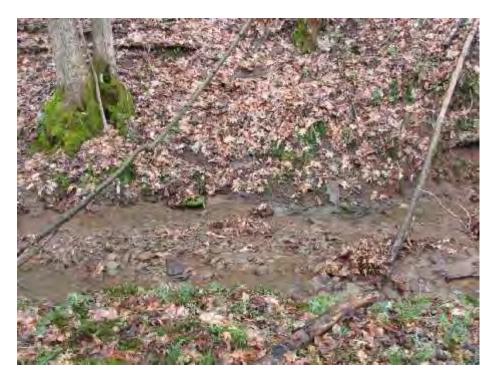
Sdog023

Waterbody sdog023 facing upline cross stream

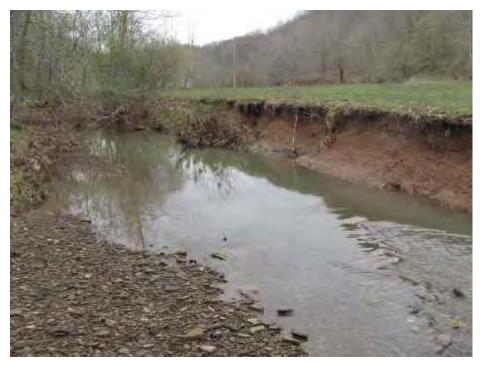
Waterbody sdog024 facing upstream

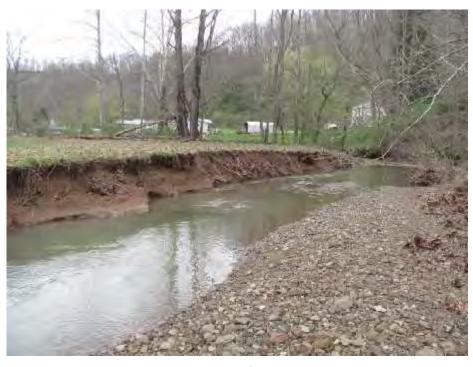
Waterbody sdog024 facing downstream

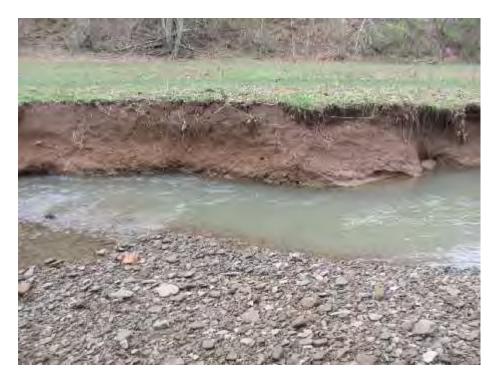
Sdog024

Waterbody sdog024 facing upline cross stream

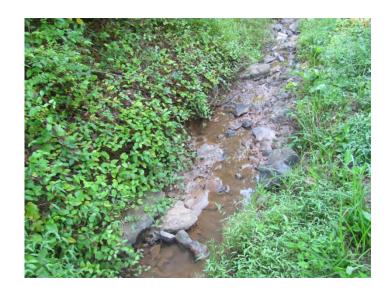
Waterbody *SDOJ003* facing downstream

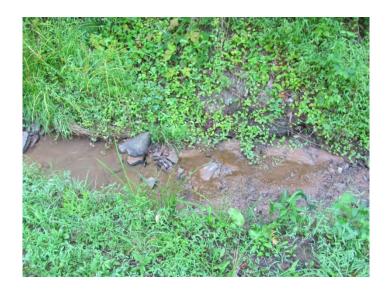
Waterbody SDOJ003 facing upline cross stream

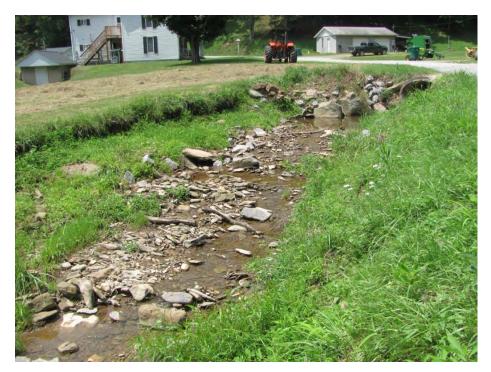
Waterbody *SDOH016* facing upstream

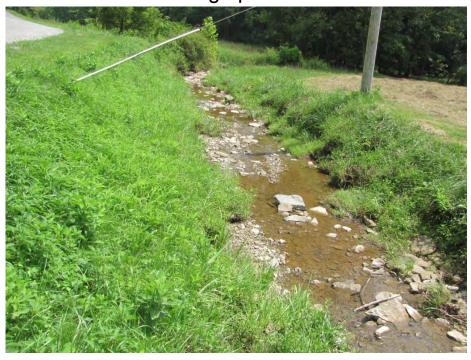
Waterbody *SDOH016* facing downstream

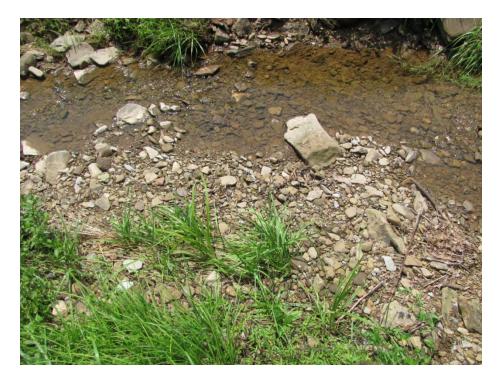
Waterbody SDOH016 facing upline cross stream

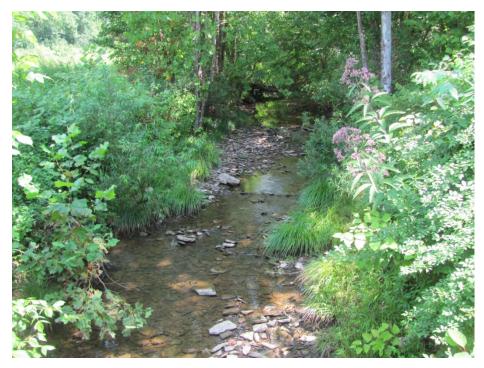
Waterbody *SDOH015* facing upstream

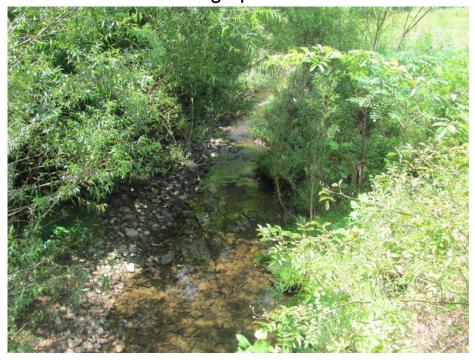
Waterbody *SDOH015* facing downstream

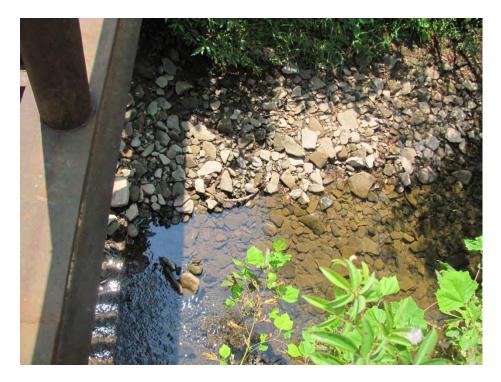
Waterbody SDOH015 facing upline cross stream

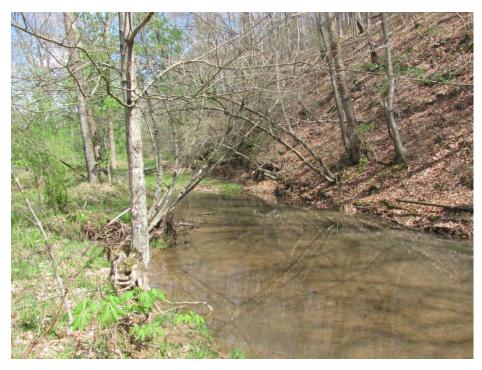
Waterbody sdog032 facing upstream

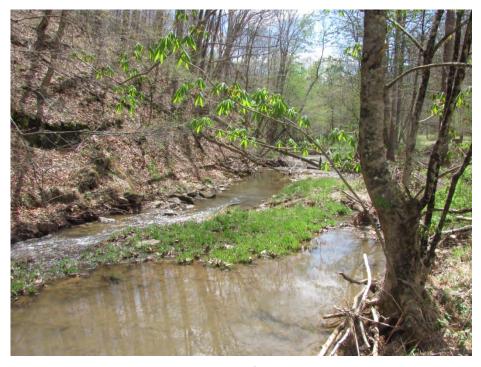
Waterbody sdog032 facing downstream

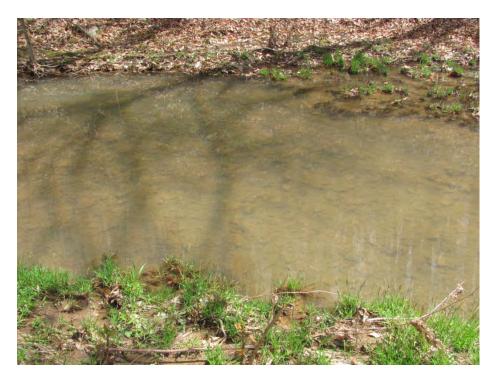
Waterbody sdog032 facing upline cross stream

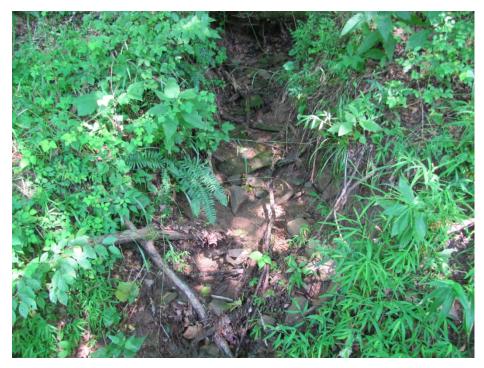
Waterbody *SDOH014* facing upstream

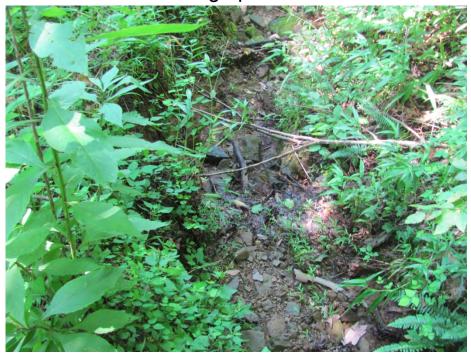
Waterbody *SDOH014* facing downstream

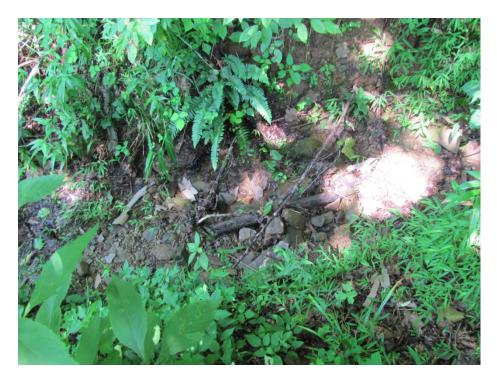
Waterbody SDOH014 facing upline cross stream

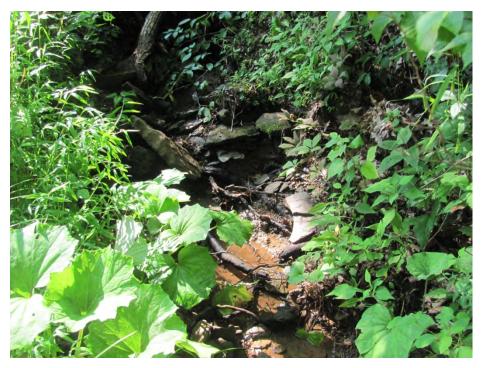
Waterbody *SDOH013* facing upstream

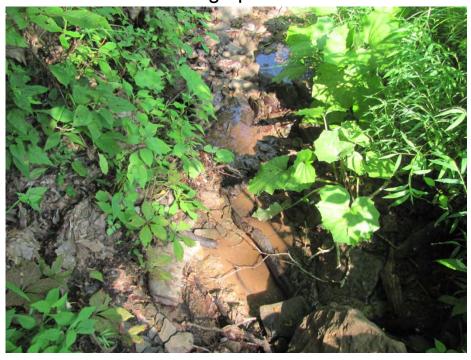
Waterbody *SDOH013* facing downstream

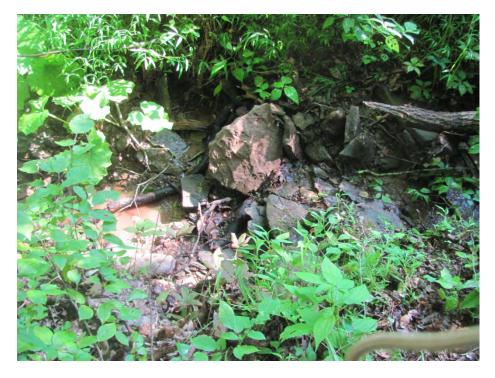
Waterbody SDOH013 facing upline cross stream
